Ref No.: 100440EN131613

**Contract No. EP/SP/58/08**  
**Sludge Treatment Facilities**  
**Environmental Monitoring and Audit Report**  
**For**  
**July 2013**

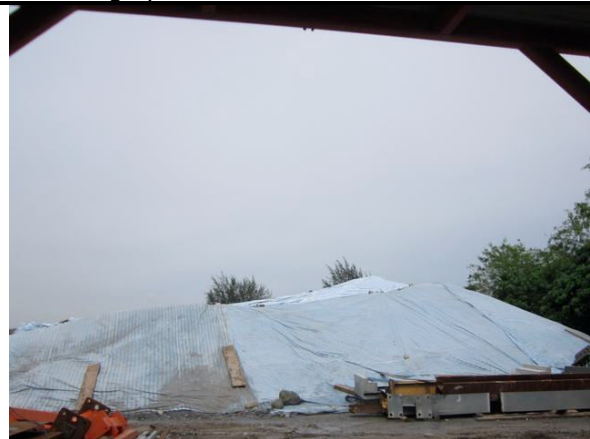
| 1. Photographic Record of the PFA Treatment | |

Topsoil found within the project site is PFA. Suitable topsoil already imported for planting. All PFA excavated during the tree felling works has been retained in the site confinement. The PFA has been under dehydration and concealed properly to prevent spreading in the air. Backfill of PFA to its original location inside site area is under progress.

| Capping of the PFA is established to prevent spreading in air. | Suitable topsoil has been imported to the site for softscape planting. |

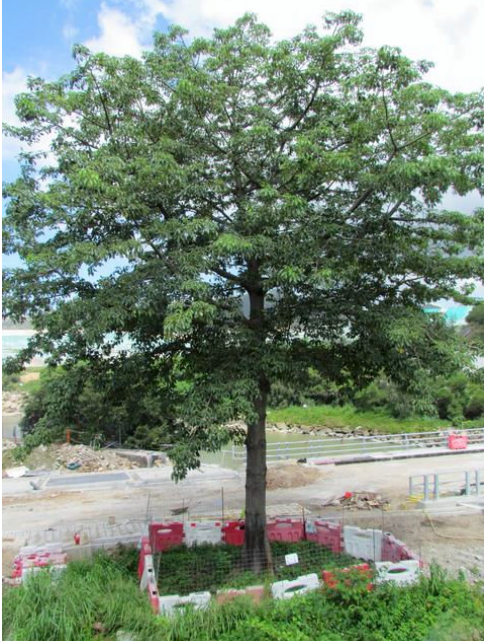
| 2. Photographic Record of Protection to the Fell / Retained Trees | |

The Tree felling work approved under the Phase 1 and 2 tree felling application has been completed. Proper procedures of tree felling have been observed. The tree felling works should not cause damages to the existing trees on site. T758 has been confirmed to be retained on site. Proper tree protection should be set up for T758.

| T758 is confirmed to be retained on site. Proper tree protection should be applied to protect T758. | |
