Contract No. EP/SP/58/08

Sludge Treatment Facilities

Environmental Monitoring and Audit Report

January 2014

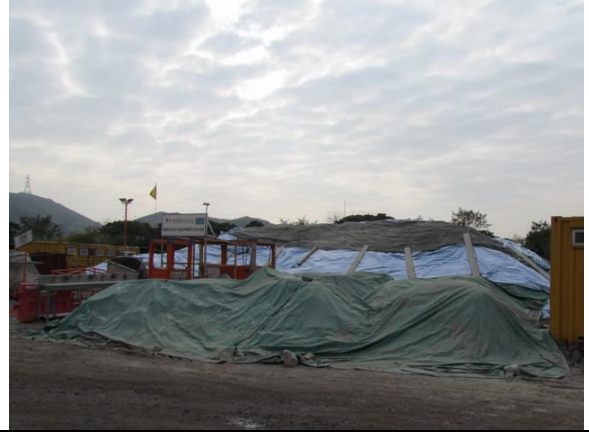
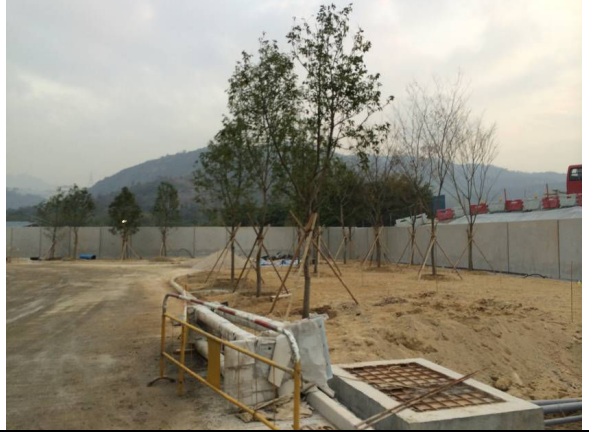
<p>1. Photographic Record of the PFA Treatment</p>

<p>Capping of the PFA is established to prevent spreading in air.</p>	<p>Suitable topsoil has been imported to the site for softscape planting.</p>
<p>2. Photographic Record of Protection to the Fell / Retained Trees</p>	<p>3. Photographic Record of the Original Transplant Trees Location</p>

Topsoil found within the project site is PFA. Suitable topsoil already imported for planting. All PFA excavated during the tree felling works has been retained in the site confinement. The PFA has been under dehydration and concealed properly to prevent spreading in the air. Backfill of PFA to its original location inside site area is under progress.

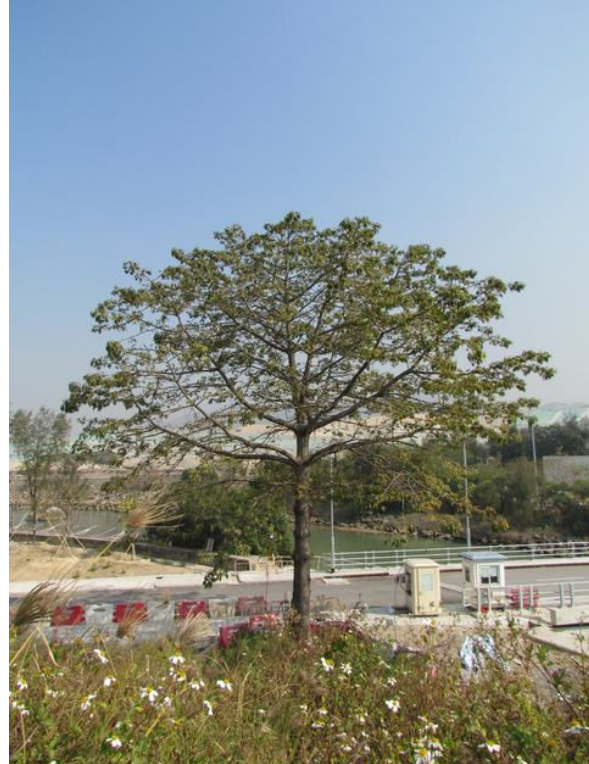
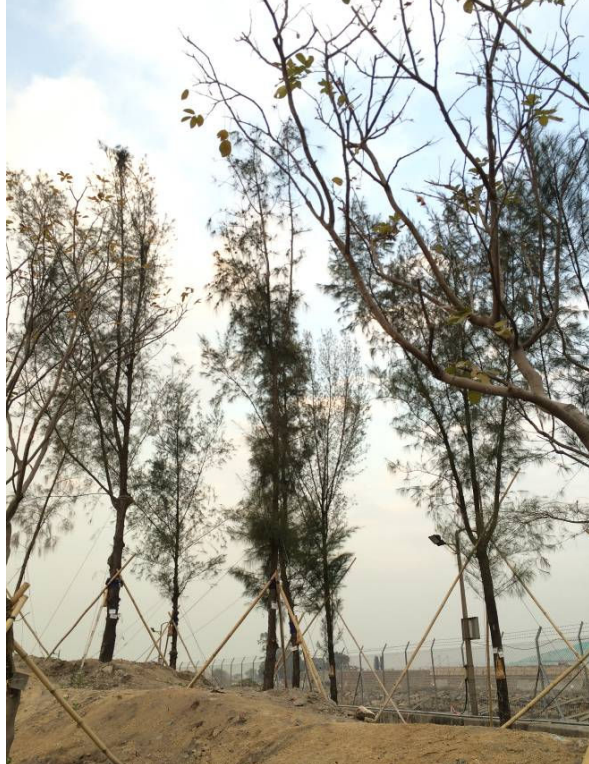
<p>T758 is confirmed to be retained on site. Proper tree protection should be applied to protect T758.</p>	<p>Total 13 nos. of transplant trees have been transplanted back to the site in August and September 2013. Status of the transplant trees under close monitoring.</p>

CM3	Design / Construction Planning	Trees unavoidably affected by the works should be transplanted where practical.	Total 13 nos. of transplant trees have been transplanted back to the site.	Conditions of the transplanted trees under close monitoring.
CM4	Design / Construction Planning	Compensatory tree planting should be provided to compensate for felled trees.	First batch of compensatory trees has completed. Trees sizes, girth, species tailored with the submitted compensatory tree plan.	First batch of compensatory trees has finished. Site photos refer to Table 4.5.

CM2 – Existing trees to be retained on site should be carefully protected during construction. The Tree felling work approved under the Phase 1 and 2 tree felling application has been completed. Proper procedures of tree felling have been observed. The tree felling works should not cause damages to the existing trees on site. T758 has been confirmed to be retained on site. Proper tree protection should be set up for T758.

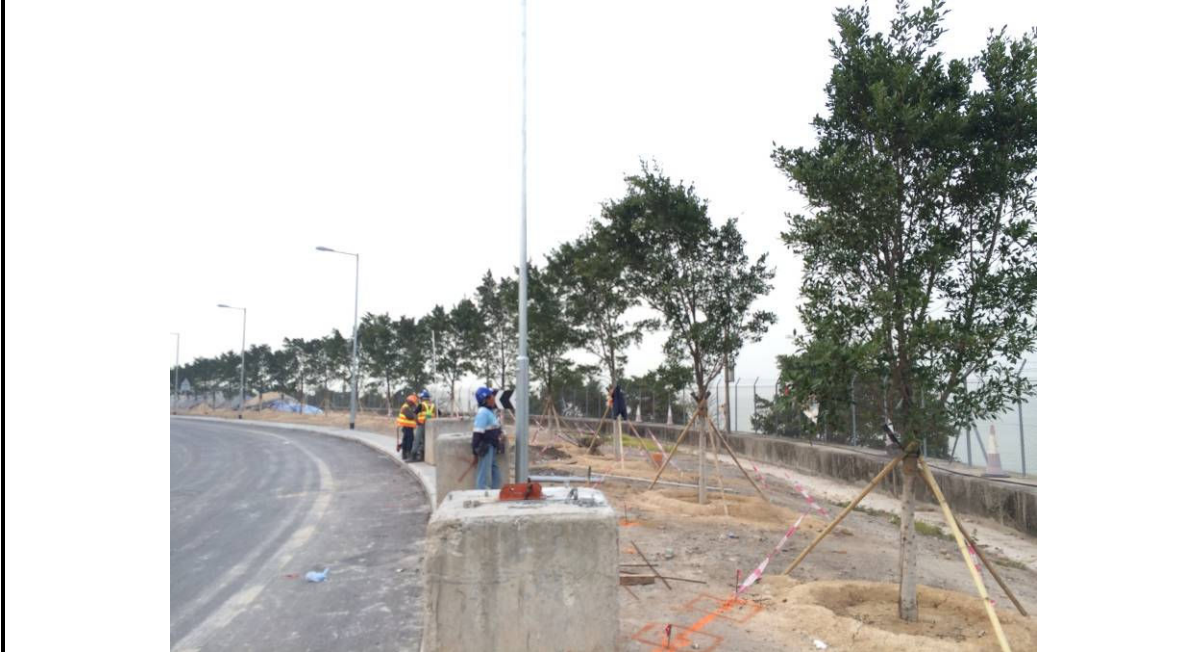
4. Photographic Record of the Compensatory Tree Locations

Second batch of compensatory trees has finished.

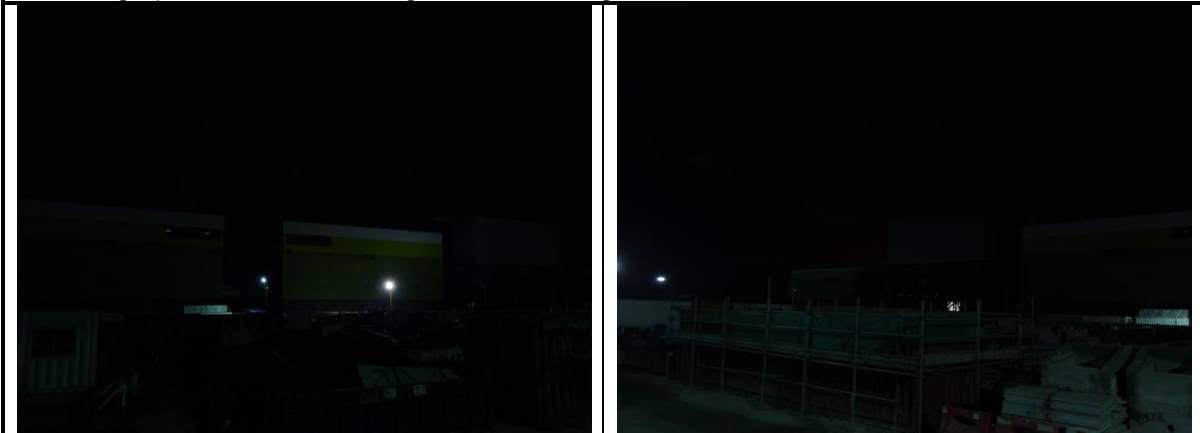
5. Photographic Record of the Night-Time Working

The lighting during night-time working is confined within the working area within the site boundary. Periphery area and the sensitive receivers are not affected by the lighting during night-time working.
