Ref No.: 100440EN140304

Contract No. EP/SP/58/08
Sludge Treatment Facilities
Environmental Monitoring and Audit Report
For
March 2014

Construction work commenced on 22 December 2010. It was of main concern to ascertain whether there was any undesirable effect of the construction activities on various environmental parameters over the site area and the surrounding environment. Impact environmental monitoring on water quality, landfill gas, ecology and landscape and visual impact were carried out to acquire data for assessing any impact associated with the construction activities. This report covers the period from 25 February 2014 to 24 March 2014 inclusive.

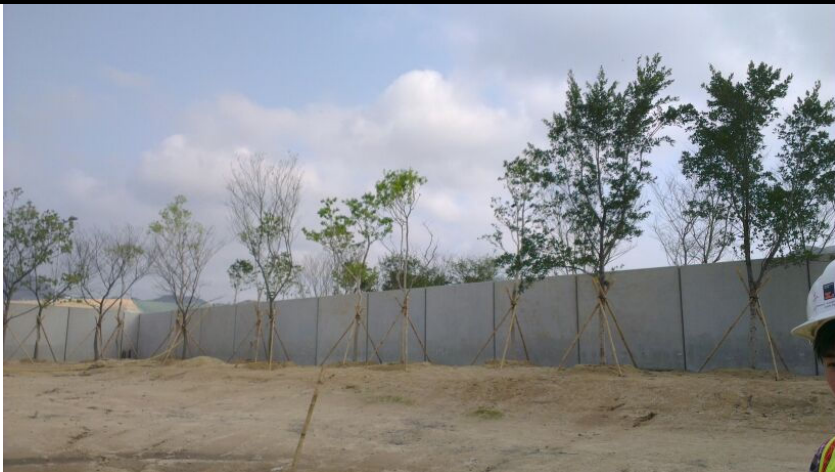
<p>4. Photographic Record of the Compensatory Tree Locations</p>

<p>Second batch of compensatory trees has finished.</p>	
<p>5. Photographic Record of the Night-Time Working</p>

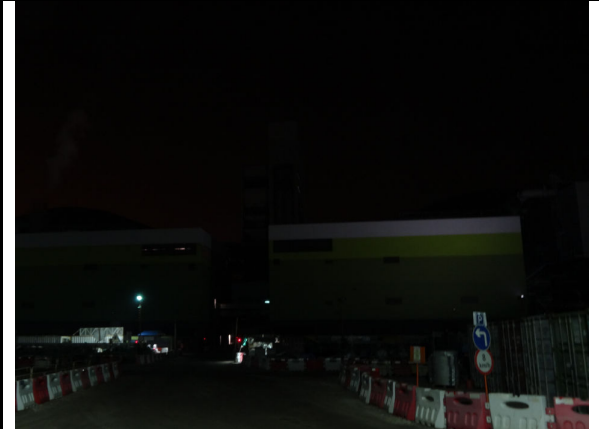
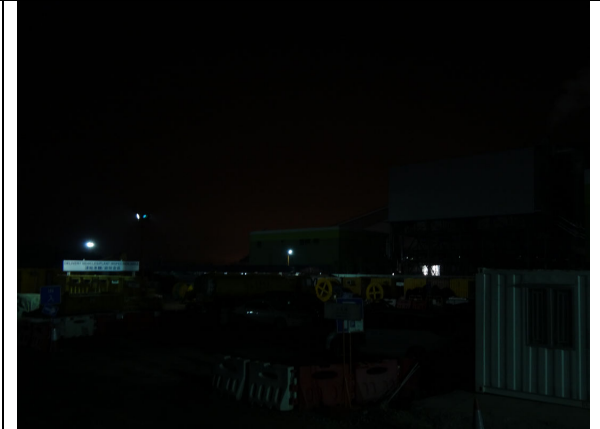
<p>The lighting during night-time working is confined within the working area within the site boundary. Periphery area and the sensitive receivers are not affected by the lighting during night-time working.</p>	<p>The lighting during night-time working is confined within the working area within the site boundary. Periphery area and the sensitive receivers are not affected by the lighting during night-time working.</p>

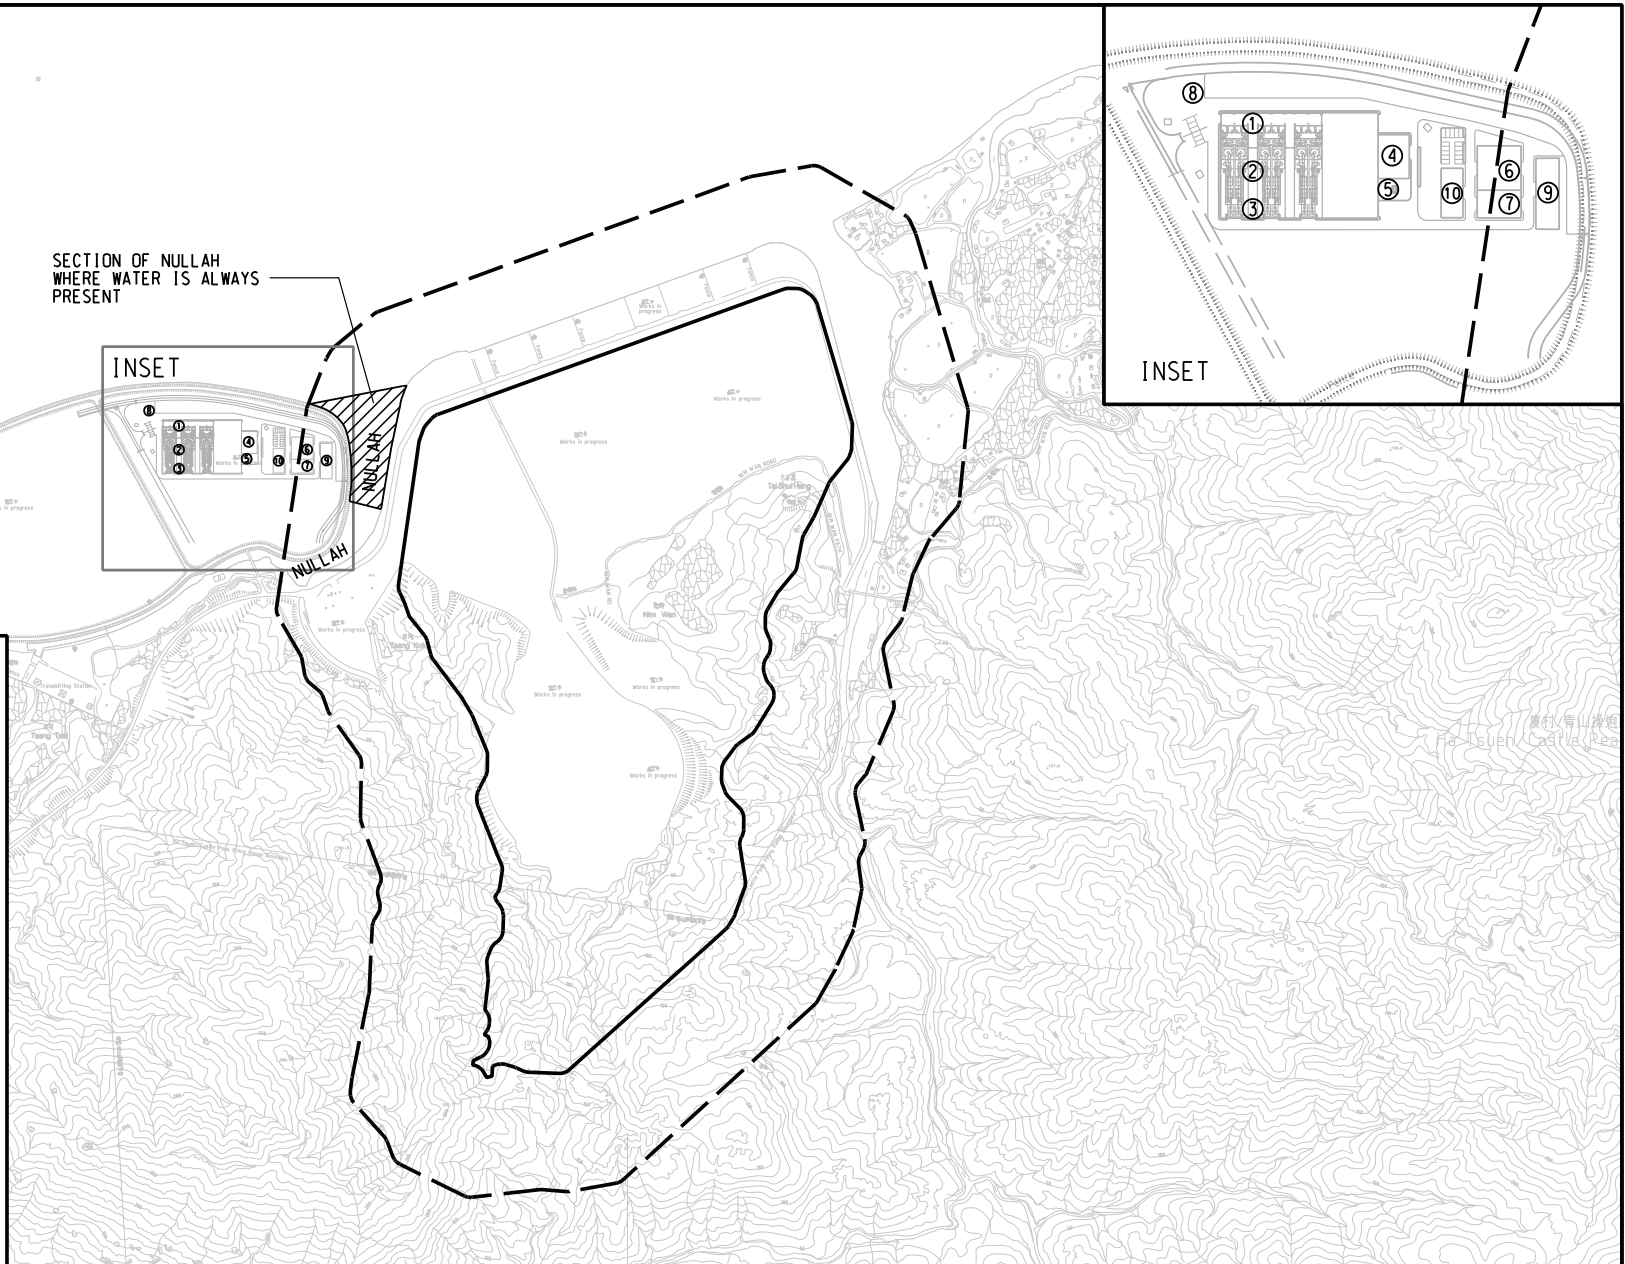
- ① DELIVERY BAY
- ② INCINERATORS AND AIR CONTROL EQUIPMENT
- ③ FUEL GAS RESIDUE SILOS, ASH SILOS & LOADING AREA
- ④ CHEMICAL / FUEL STORAGE AND FEEDING
- ⑤ STACK
- ⑥ ADMINISTRATION BUILDING & LABORATORY
- ⑦ MAINTENANCE WORKSHOP
- ⑧ UTILITY YARD
- ⑨ DESALINATION PLANT, SEAWATER PUMPING STATION & STORAGE TANK
- ⑩ SEWAGE TREATMENT WORKS

WENT LANDFILL
CONSULTATION ZONE
BOUNDARY

WENT LANDFILL
WASTE BOUNDARY
