Ref No.: 100440EN140443

Contract No. EP/SP/58/08
Sludge Treatment Facilities
Environmental Monitoring and Audit Report
For
April 2014

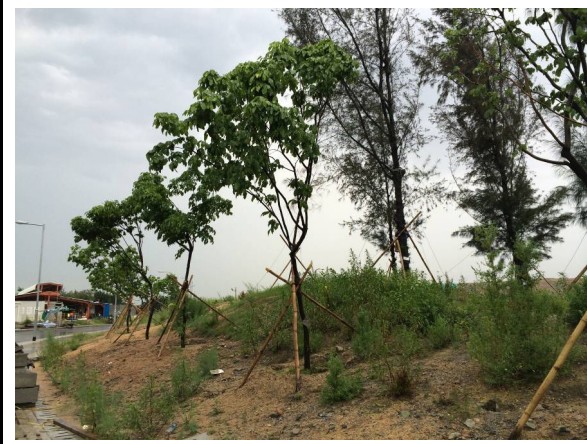
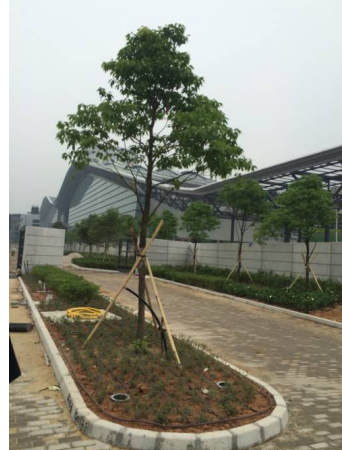
4. Photographic Record of the Compensatory Tree Locations

Second batch of compensatory trees has finished.

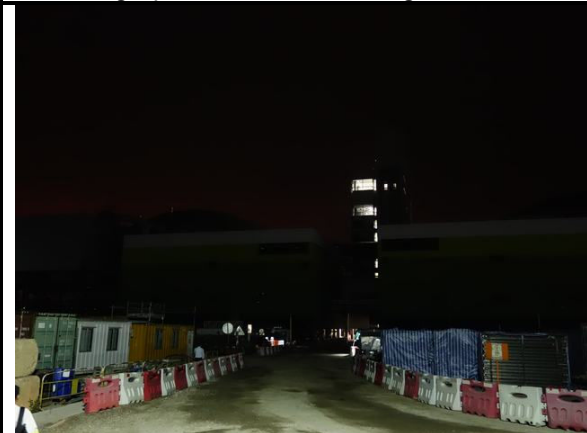
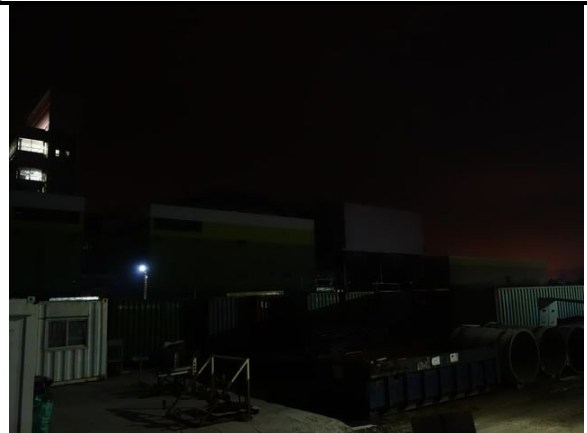
5. Photographic Record of the Night-Time Working

The lighting during night-time working is confined within the working area within the site boundary. Periphery area and the sensitive receivers are not affected by the lighting during night-time working.
