Ref No.: 100440EN140526

Contract No. EP/SP/58/08
Sludge Treatment Facilities
Environmental Monitoring and Audit Report
For
May 2014

13 June 2014

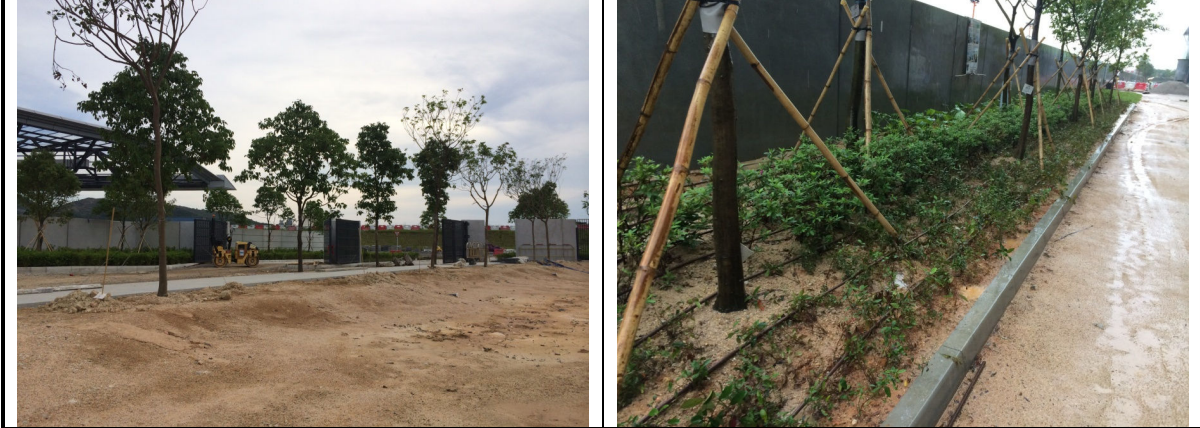
4. Photographic Record of the Compensatory Tree Locations

Second batch of compensatory trees has finished.

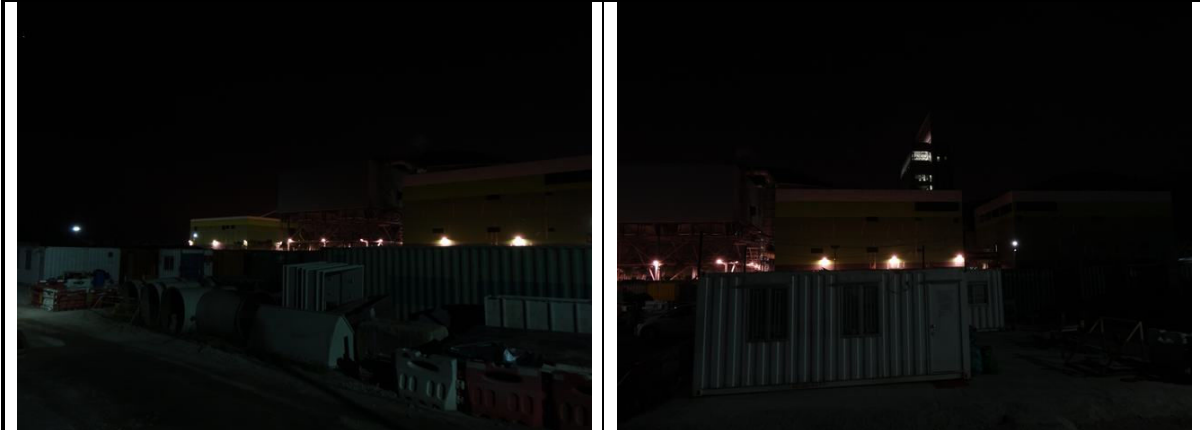
5. Photographic Record of the Night-Time Working

The lighting during night-time working is confined within the working area within the site boundary. Periphery area and the sensitive receivers are not affected by the lighting during night-time working.
