Contract No. EP/SP/58/08
Sludge Treatment Facilities
Environmental Monitoring and Audit Report
For
August 2014

Table 4.4 Photographic Record of Landscape and Visual Impact Survey

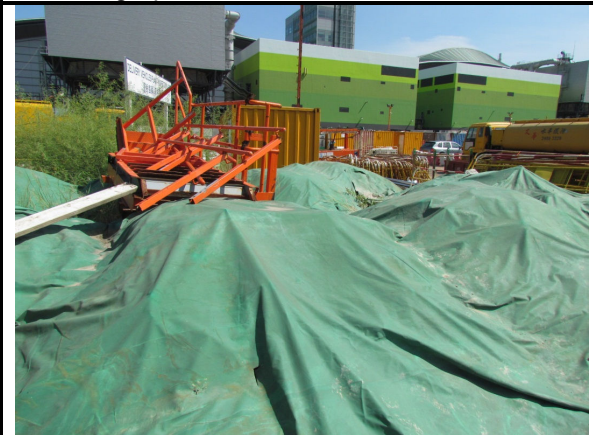
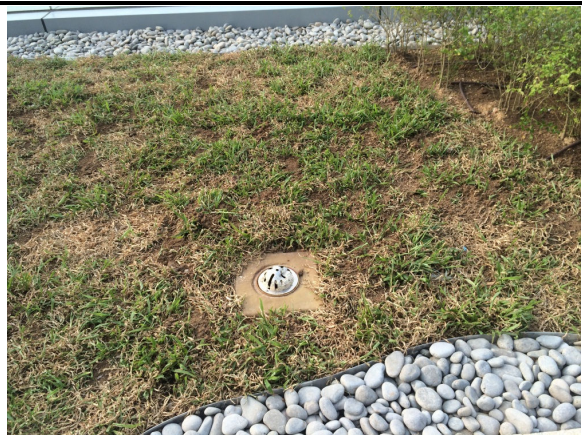
1. Photographic Record of the PFA Treatment

Topsoil found within the project site is PFA. Suitable topsoil already imported for planting. All PFA excavated during the tree felling works has been retained in the site confinement. The PFA has been under dehydration and concealed properly to prevent spreading in the air. Backfill of PFA to its original location inside site area is under progress.

<p>Capping of the PFA is established to prevent spreading in air.</p>	<p>Suitable topsoil has been imported to the site for softscape planting.</p>

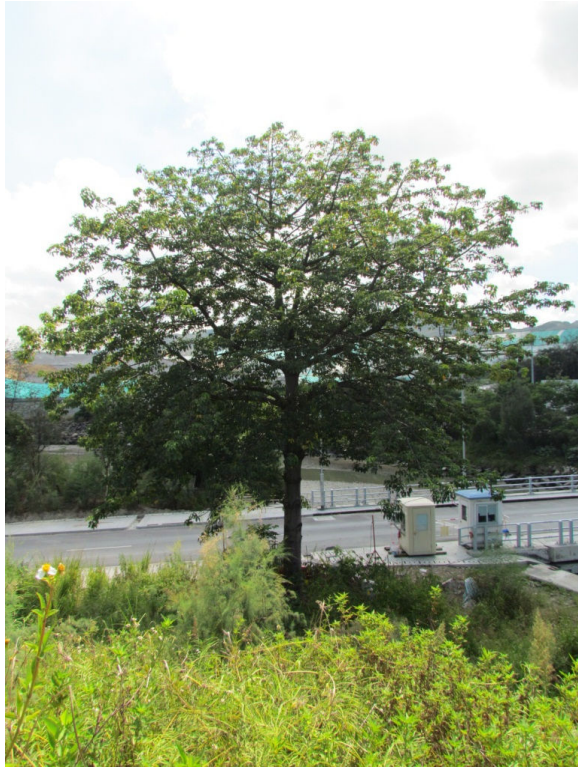
The Tree felling work approved under the Phase 1 and 2 tree felling application has been completed. Proper procedures of tree felling have been observed. The tree felling works should not cause damages to the existing trees on site. T758 has been confirmed to be retained on site. Proper tree protection should be set up for T758.

<p>T758 is confirmed to be retained on site. Proper tree protection should be applied to protect T758.</p>	<p>Total 13 nos. of transplant trees have been transplanted back to the site in August and September 2013. There have 2 transplant trees found dead in March. Status of the other transplant trees is under close monitoring.</p> <p>4. Photographic Record of the Compensatory Tree Locations</p>

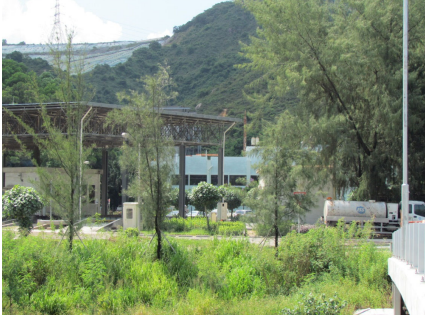
- CM3** – Trees unavoidably affected by the works should be transplanted where practical. Total 13 nos. of transplant trees have been transplanted back to the site in August and September 2013. There have 2 more transplant trees found dead in the March. Compensatory trees will be proposed in the revised compensatory planting proposal in compensation for the loss of the 2 trees. Status of the other transplant trees is under close monitoring.

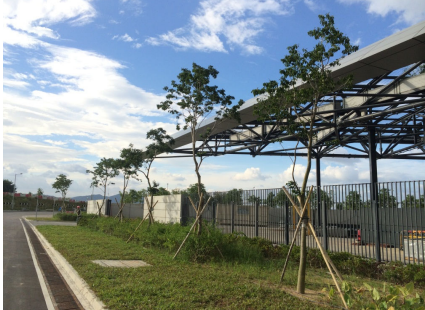
<p>Second batch of compensatory trees has finished.</p>
<p>5. Photographic Record of the Night-Time Working</p>

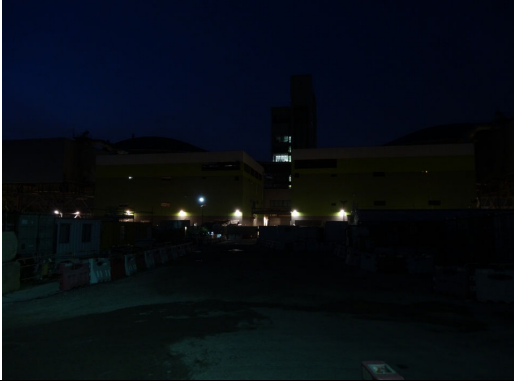
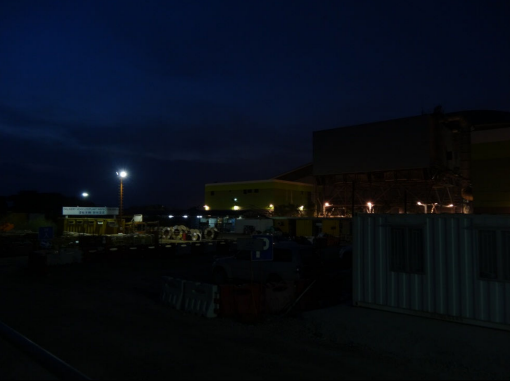
<p>The lighting during night-time working is confined within the working area within the site boundary. Periphery area and the sensitive receivers are not affected by the lighting during night-time working.</p>	<p>The lighting during night-time working is confined within the working area within the site boundary. Periphery area and the sensitive receivers are not affected by the lighting during night-time working.</p>
