Contract No. EP/SP/58/08
Sludge Treatment Facilities
Environmental Monitoring and Audit Report
For
November 2014

Table 4.4 Photographic Record of Landscape and Visual Impact Survey

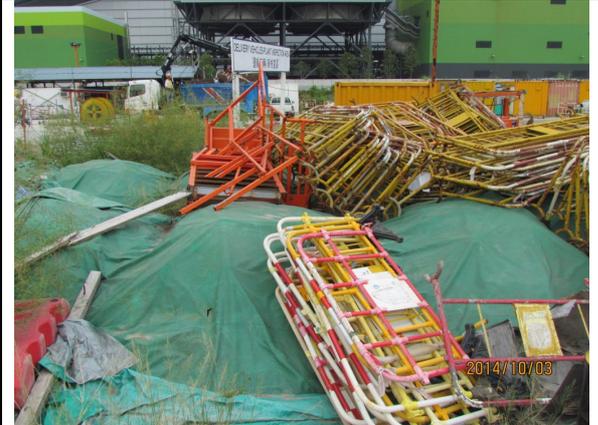
1. Photographic Record of the PFA Treatment

<p>Capping of the PFA is established to prevent spreading in air.</p>	<p>Suitable topsoil has been imported to the site for softscape planting.</p>

Topsoil found within the project site is PFA. Suitable topsoil already imported for planting. All PFA excavated during the tree felling works has been retained in the site confinement. The PFA has been under dehydration and concealed properly to prevent spreading in the air. Backfill of PFA to its original location inside site area is under progress.

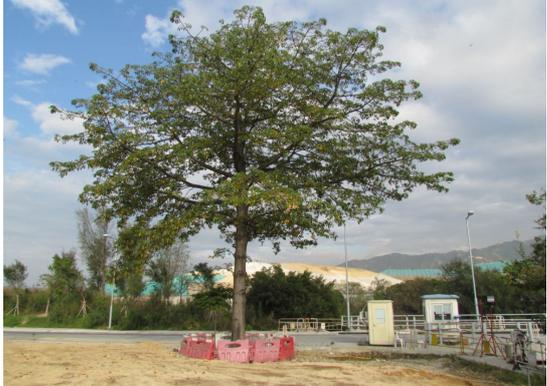
<p>T758 is confirmed to be retained on site. Proper tree protection should be applied to protect T758.</p>	<p>Total 13 nos. of transplant trees have been transplanted back to the site in August and September 2013. There have 2 transplant trees found dead in March. Status of the other transplant trees is under close monitoring.</p>
<p>4. Photographic Record of the Compensatory Tree Locations</p>

The Tree felling work approved under the Phase 1 and 2 tree felling application has been completed. Proper procedures of tree felling have been observed. The tree felling works should not cause damages to the existing trees on site. T758 has been confirmed to be retained on site. Proper tree protection should be set up for T758.

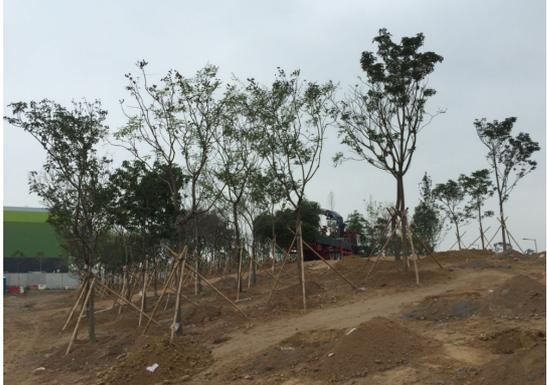
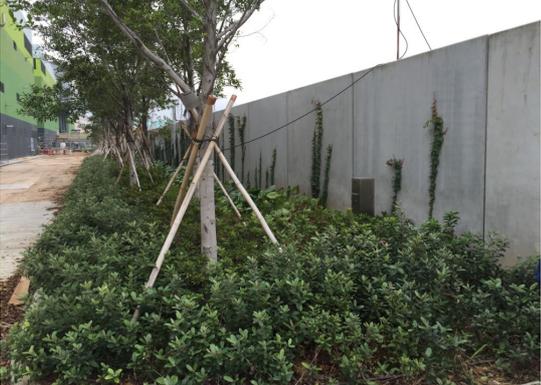
<p>Second batch of compensatory trees has finished.</p>	
<p>5. Photographic Record of the Night-Time Working</p>

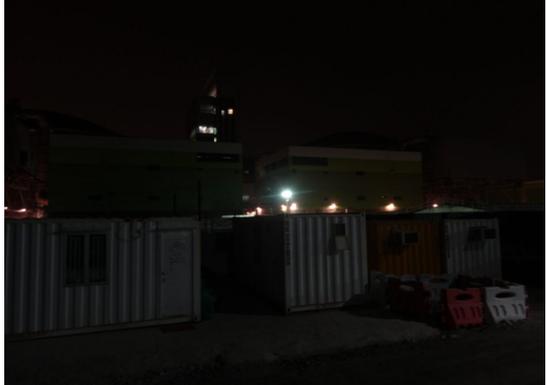
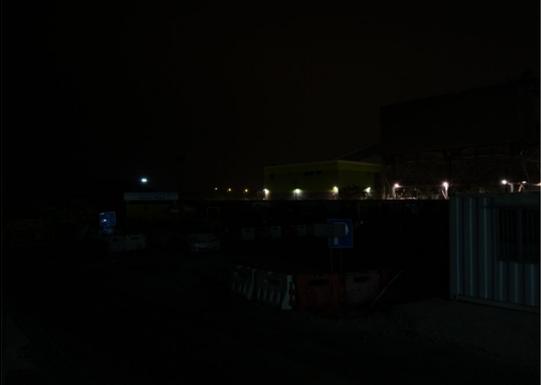
<p>The lighting during night-time working is confined within the working area within the site boundary. Periphery area and the sensitive receivers are not affected by the lighting during night-time working.</p>	<p>The lighting during night-time working is confined within the working area within the site boundary. Periphery area and the sensitive receivers are not affected by the lighting during night-time working.</p>
