Ref No.: 100440EN141306

**Contract No. EP/SP/58/08**  
**Sludge Treatment Facilities**  
**Environmental Monitoring and Audit Report**  
**For**  
**December 2014**

Table 4.4 Photographic Record of Landscape and Visual Impact Survey

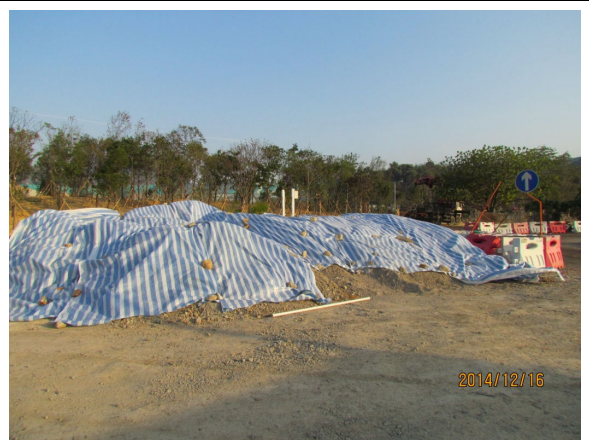
1. Photographic Record of the PFA Treatment

Topsoil found within the project site is PFA. Suitable topsoil already imported for planting. All PFA excavated during the tree felling works has been retained in the site confinement. The PFA has been under dehydration and concealed properly to prevent spreading in the air. Backfill of PFA to its original location inside site area is under progress.

<p>Capping of the PFA is established to prevent spreading in air.</p>	<p>Suitable topsoil has been imported to the site for softscape planting.</p>

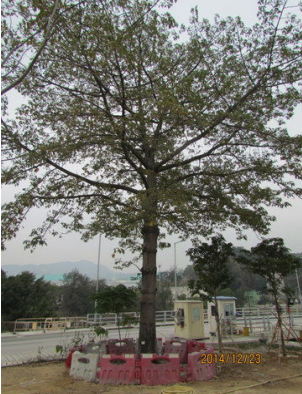
<p>2. Photographic Record of Protection to the Fell / Retained Trees</p>	<p>3. Photographic Record of the Original Transplant Trees Location</p>

The Tree felling work approved under the Phase 1 and 2 tree felling application has been completed. Proper procedures of tree felling have been observed. The tree felling works should not cause damages to the existing trees on site. T758 has been confirmed to be retained on site. Proper tree protection should be set up for T758.

<p>T758 is confirmed to be retained on site. Proper tree protection should be applied to protect T758.</p>	<p>Total 13 nos. of transplant trees have been transplanted back to the site in August and September 2013. There have 2 transplant trees found dead in March. Status of the other transplant trees is under close monitoring.</p>
<p>4. Photographic Record of the Compensatory Tree Locations</p>

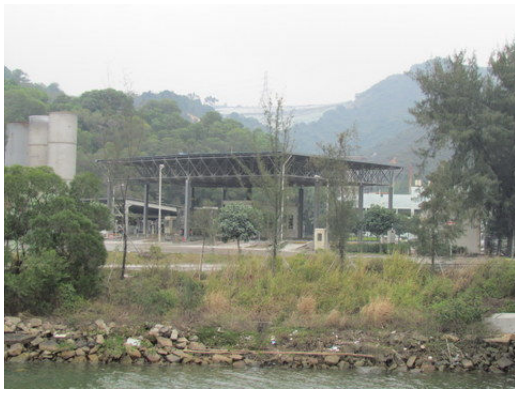
- CM3** – Trees unavoidably affected by the works should be transplanted where practical. Total 13 nos. of transplant trees have been transplanted back to the site in August and September 2013. There have 2 more transplant trees found dead in the March. Compensatory trees will be proposed in the revised compensatory planting proposal in compensation for the loss of the 2 trees. Status of the other transplant trees is under close monitoring.

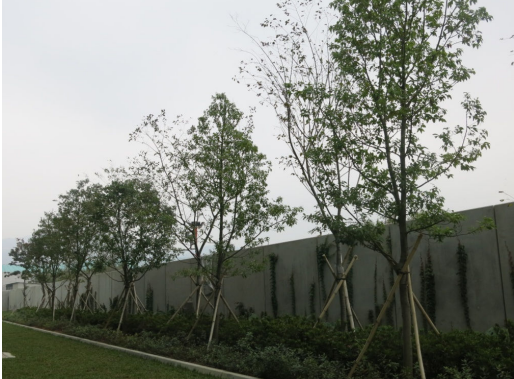
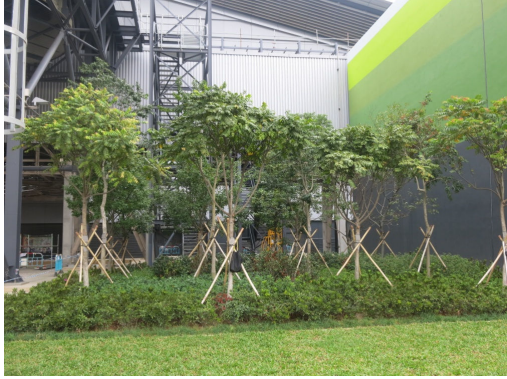
<p>Second batch of compensatory trees has finished.</p>	
<p>5. Photographic Record of the Night-Time Working</p>

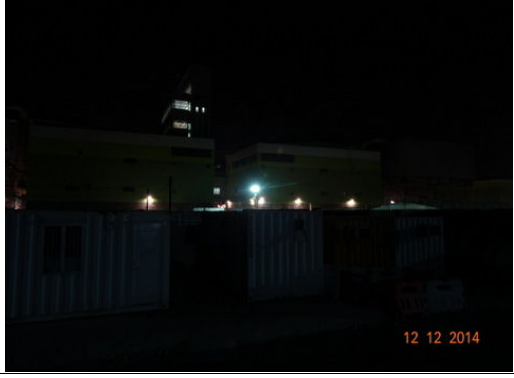
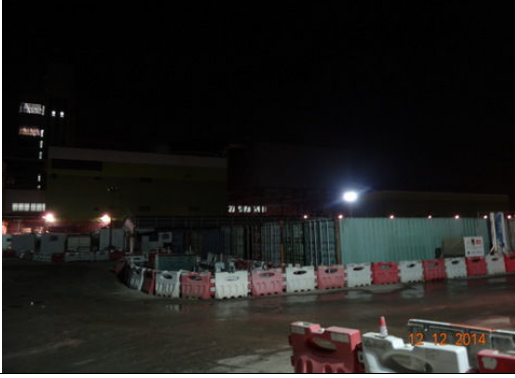
<p>The lighting during night-time working is confined within the working area within the site boundary. Periphery area and the sensitive receivers are not affected by the lighting during night-time working.</p>	<p>The lighting during night-time working is confined within the working area within the site boundary. Periphery area and the sensitive receivers are not affected by the lighting during night-time working.</p>
