Ref No.: 100440EN150128

**Contract No. EP/SP/58/08**  
**Sludge Treatment Facilities**  
**Environmental Monitoring and Audit Report**  
**For**  
**January 2015**

This monthly report reviews the progress of the environmental monitoring and audit work at the site for Contract No. EP/SP/58/08 from 25 December 2014 to 24 January 2015 (the reporting period) and forecasts the activities for February 2015. Since water quality monitoring was not required in the reporting period, no graphical presentation for marine and stream water quality results for the reporting period is included. Findings of Landfill Gas, Ecology and Landscape monitoring are presented in Section 4.

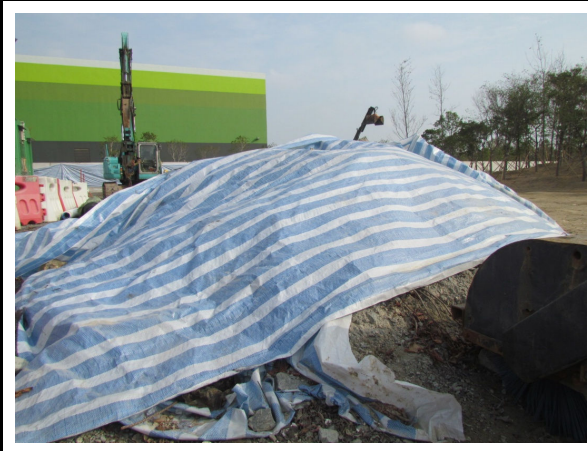
1. Photographic Record of the PFA Treatment

<p>Capping of the PFA is established to prevent spreading in air.</p>	<p>Suitable topsoil has been imported to the site for softscape planting.</p>

Topsoil found within the project site is PFA. Suitable topsoil already imported for planting. All PFA excavated during the tree felling works has been retained in the site confinement. The PFA has been under dehydration and concealed properly to prevent spreading in the air. Backfill of PFA to its original location inside site area is under progress.

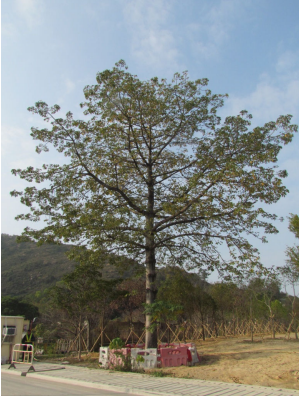
<p>2. Photographic Record of Protection to the Fell / Retained Trees</p>	<p>3. Photographic Record of the Original Transplant Trees Location</p>

<p>T758 is confirmed to be retained on site. Proper tree protection should be applied to protect T758.</p>	<p>Total 13 nos. of transplant trees have been transplanted back to the site in August and September 2013. There have 2 transplant trees found dead in March. Status of the other transplant trees is under close monitoring.</p>
<p>4. Photographic Record of the Compensatory Tree Locations</p>

The Tree felling work approved under the Phase 1 and 2 tree felling application has been completed. Proper procedures of tree felling have been observed. The tree felling works should not cause damages to the existing trees on site. T758 has been confirmed to be retained on site. Proper tree protection should be set up for T758.

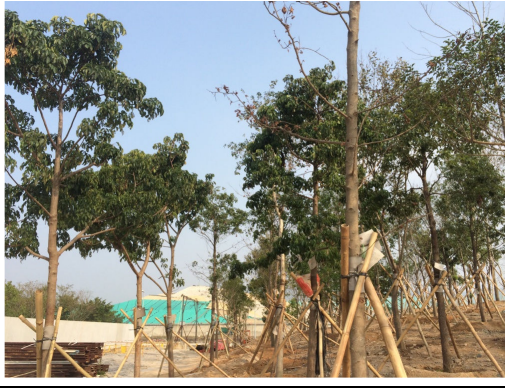
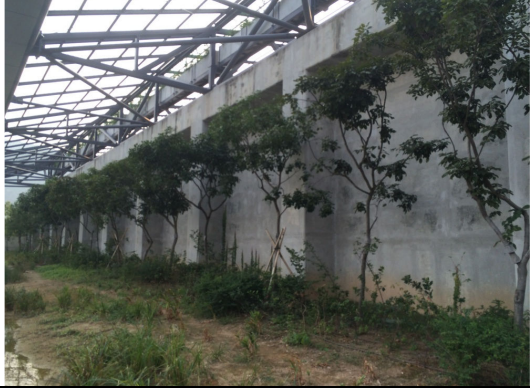
<p>Second batch of compensatory trees has finished.</p>	
<p>5. Photographic Record of the Night-Time Working</p>

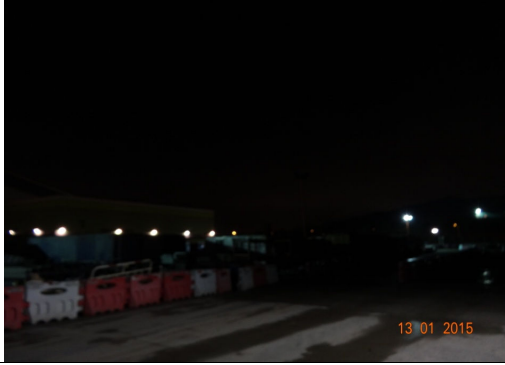
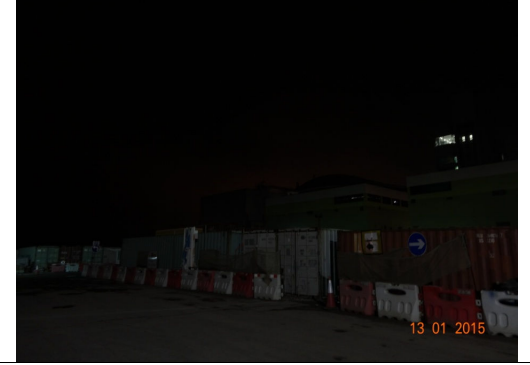
<p>The lighting during night-time working is confined within the working area within the site boundary. Periphery area and the sensitive receivers are not affected by the lighting during night-time working.</p>	<p>The lighting during night-time working is confined within the working area within the site boundary. Periphery area and the sensitive receivers are not affected by the lighting during night-time working.</p>
