***Contract No.: CV/2013/06
Handling of Surplus Public Fill
(2014-2016)***

TUEN MUN AREA 38 FILL BANK

MONTHLY EM&A REPORT NO.31

(JULY 2016)

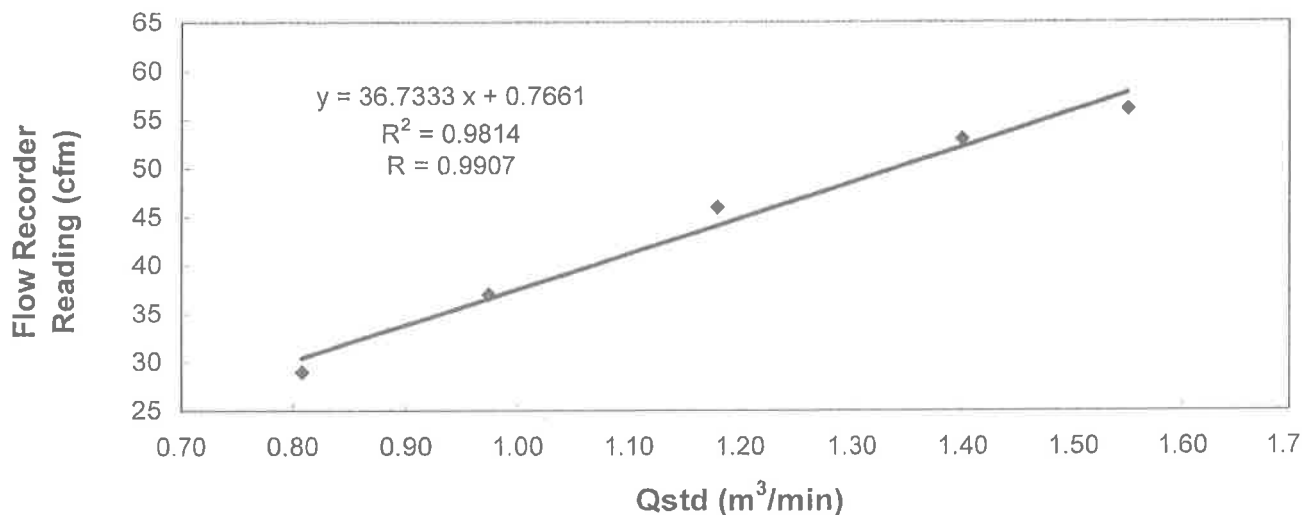
Flow recorder reading (cfm)	56	53	46	37	29
Qstd (Actual flow rate, m ³ /min)	1.55	1.40	1.18	0.97	0.81
Pressure :	763.56 mm Hg		Temp. :	304 K

Sampler 10347 Calibration Curve
Site: Tuen Mun 38 (TM-A1)

Acceptance Criteria : Correlation coefficient (r) of the calibration curve greater than 0.990 after a 5-point calibration

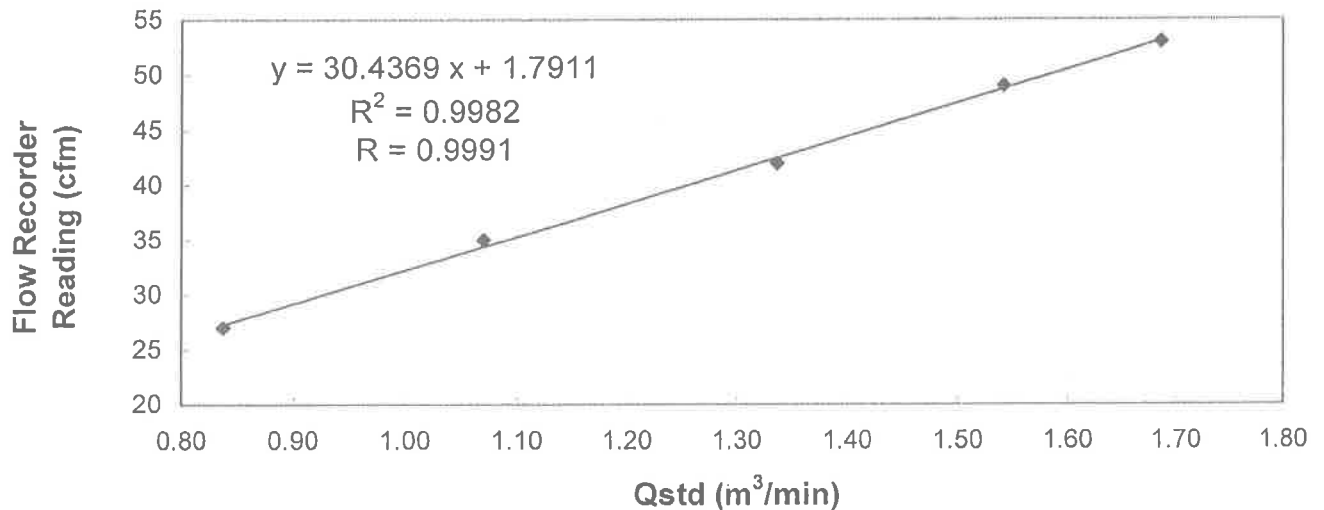
Flow recorder reading (cfm)	53	49	42	35	27
Qstd (Actual flow rate, m ³ /min)	1.69	1.54	1.34	1.07	0.84
Pressure :	763.56 mm Hg			Temp. :	304 K

Sampler 9864 Calibration Curve
Site: Tuen Mun (TM-RA2)

Acceptance Criteria : Correlation coefficient (r) of the calibration curve greater than 0.990 after a 5-point calibration

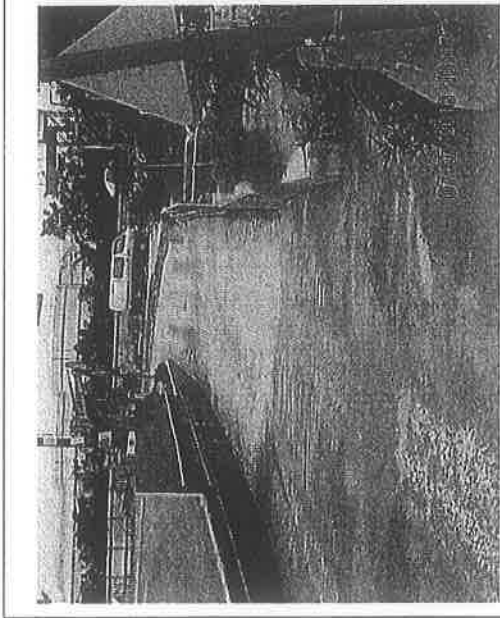
Photo 160707_001 (Wheel washing facilities near weighbridge)

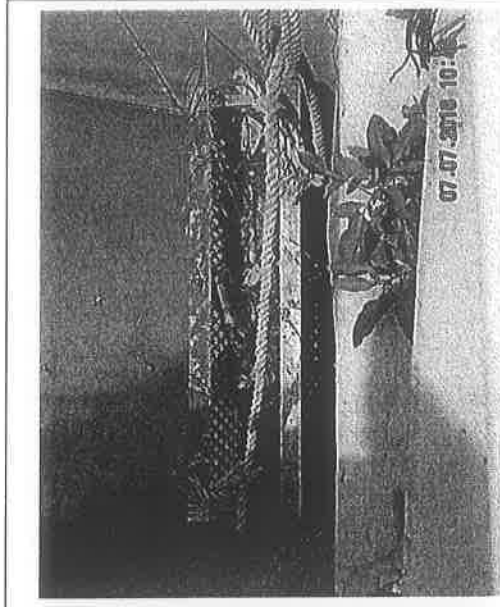
Photo 160707_003 (Main drainage channel)

<i>Date</i>	<i>Key Findings</i>	<i>Action(s) Taken recommended by ET</i>	<i>Action(s) Taken by the Contractor during the site audit</i>	<i>Rectification Status by ET</i>
07 July 2016	Mud and silt was found accumulated inside the main drainage channel. (Previous item)	To clear the accumulated mud and silt properly to avoid any blockage.	---	Follow-up
	Standing water was noted near portable toilet near weighbridge. (New item)	To clear the standing water or apply pesticide to avoid mosquito breeding.	---	Follow-up
	Rubbish, e.g. plastic bottle and boxes, were noted discarded inside the main drainage channel. (New item)	To collect and dispose of the rubbish properly.	---	Follow-up

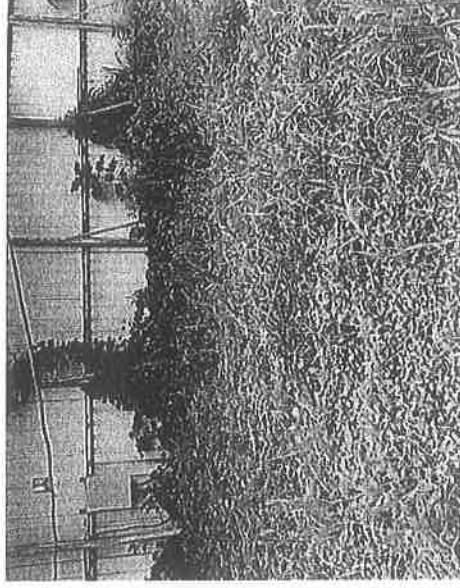
Photo 160714_002 (Portable toilet near weighbridge at site entrance) (Improved)

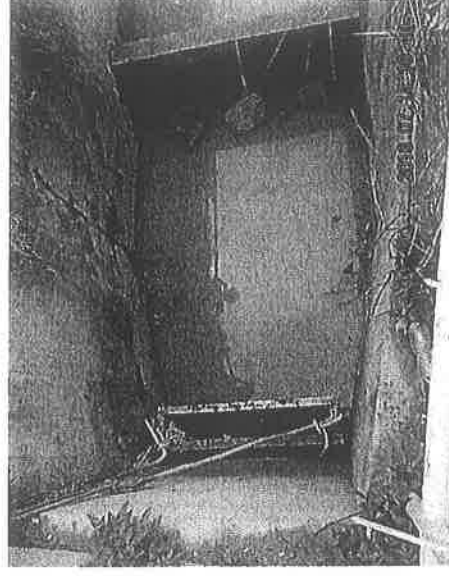
Photo 160714_003 (Main drainage channel) (Improved)

Date	Key Findings	Action(s) Taken recommended by ET	Action(s) Taken by the Contractor during the site audit	Rectification Status by ET
14 July 2016	Mud and silt was found accumulated inside the main drainage channel. (Previous item)	To clear the accumulated mud and silt properly to avoid any blockage.	---	Follow-up
	Standing water was noted near portable toilet near weighbridge. (Previous item)	To clear the standing water or apply pesticide to avoid mosquito breeding.	No standing water was noted beside portable toilet near weighbridge	Closed
	Rubbish, e.g. plastic bottle and boxes, were noted discarded inside the main drainage channel. (Previous item)	To collect and dispose of the rubbish properly.	Rubbish discarded inside the main drainage channel was collected.	Closed
21 July 2016	Mud and silt was found accumulated inside the main drainage channel. (Previous item)	To clear the accumulated mud and silt properly to avoid any blockage.	Mud and silt noted inside the wheel washing facilities near weighbridge were cleared. The performance of wheel washing facilities was noted improved.	Closed

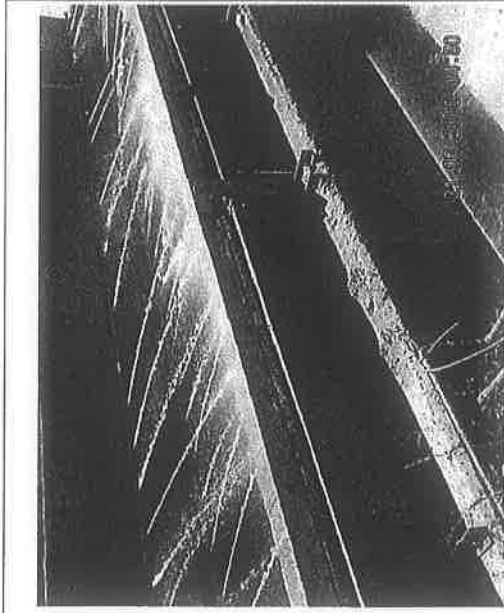
Photo 160721_001 (Wheel washing facilities near weighbridge)

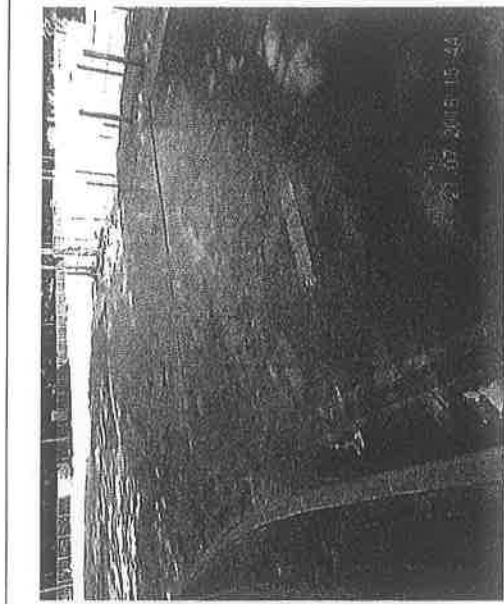
Photo 160721_002 (Site entrance)

Mud and silt were noted on the haul road near site entrance. (New item)	To clear the mud and silt as soon as possible.	---	Follow-up
28 July 2016	Mud and silt were noted on the haul road near site entrance. (Previous item)	To clear the mud and silt as soon as possible.	Mud and silt noted on the haul road near site entrance were cleaned up.	Closed
	Recycling water at B4 wheel washing facilities was noted muddy. (New item)	To treat the recycling water properly, e.g. re-connect to Wetsep, to improve the efficiency of wheel washing facilities.	---	Follow-up

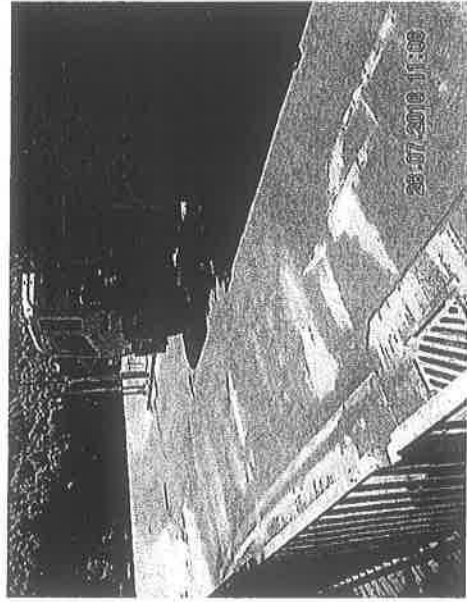
Photo 160728_001 (Site entrance) (Improved)

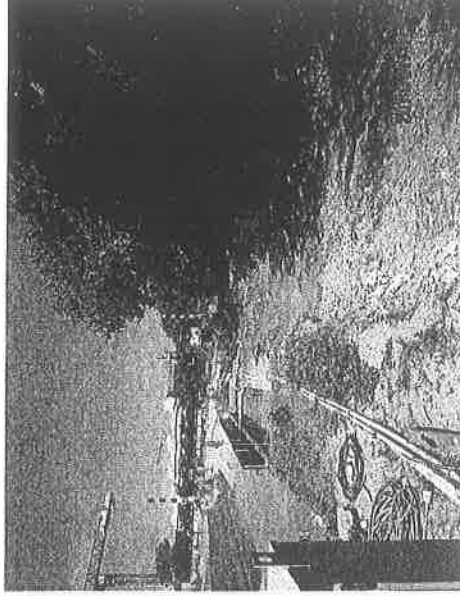
Photo 160728_002 (B4 wheel washing facilities)

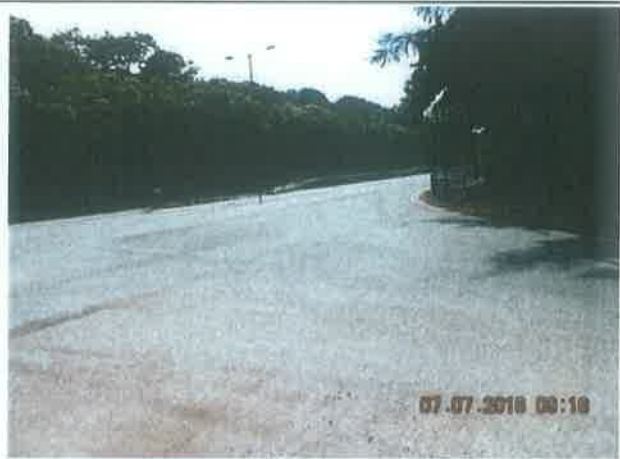
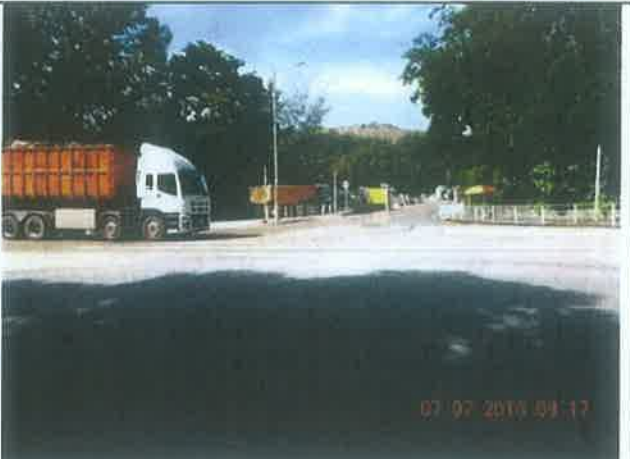
Lung Mun Road

- One complaint received on 30 June 2016 (15:46:15), which was forwarded to ET on 06 July 2016, from public (1823 Case # 2-2418784137) against the rocks and debris deposited on the road surface at the Lung Mun Road. The complainant complained that waste generated caused an environmental nuisance.
