**Contract No.: CV/2013/06
Handling of Surplus Public Fill
(2014-2016)**

TUEN MUN AREA 38 FILL BANK

MONTHLY EM&A REPORT NO.32

(AUGUST 2016)

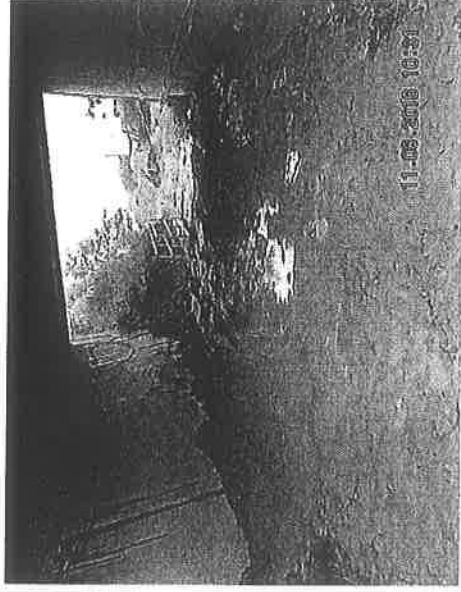
Photo 160811_001 (B4 wheel washing facilities)

Date	Key Findings	Action(s) Taken recommended by ET	Action(s) Taken by the Contractor during the site audit	Rectification Status by ET
11 August 2016	Recycling water at B4 wheel washing facilities was noted muddy. (Previous item)	To treat the recycling water properly, e.g. re-connect to Wetsep, to improve the efficiency of wheel washing facilities.	Recycling water at B4 wheel washing facilities was noted clear.	Closed
	Stockpile of spoil was found under the tripping hall no.2. (Previous item)	To clear the spoil as soon as possible or cover it properly.	Stockpile of spoil found under the tripping hall no.2 was cleared.	Closed
	Rubbish, such as lunch boxes and used plastic bottles, were found discarded inside the main drainage channel. (New item)	To collect and dispose of the rubbish properly.	---	Follow-up
18 August 2016	Rubbish, such as lunch boxes and used plastic bottles, were found discarded inside the main drainage channel. (New item)	To collect and dispose of the rubbish properly.	Rubbish, such as lunch boxes and used plastic bottles, discarded inside the main drainage channel were collected.	Closed

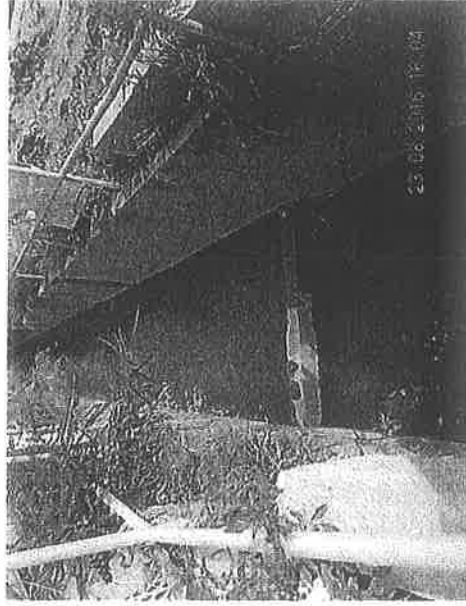
Photo 160823_001 (Main drainage channel)

Mud and silt were found accumulated inside the main drainage channel. (New item)	To clean the accumulated mud properly.	---	Follow-up
23 August 2016	Mud and silt were found accumulated inside the main drainage channel. (Previous item)	To clean the accumulated mud properly.	Mud and silt accumulated inside the main drainage channel were cleared.	Closed
