**Contract No.: CV/2013/06
Handling of Surplus Public Fill
(2014-2016)**

**TUEN MUN AREA 38 FILL BANK
MONTHLY EM&A REPORT NO.41
(FROM 01 TO 11 MAY 2017)**

Report No.: ENA73277

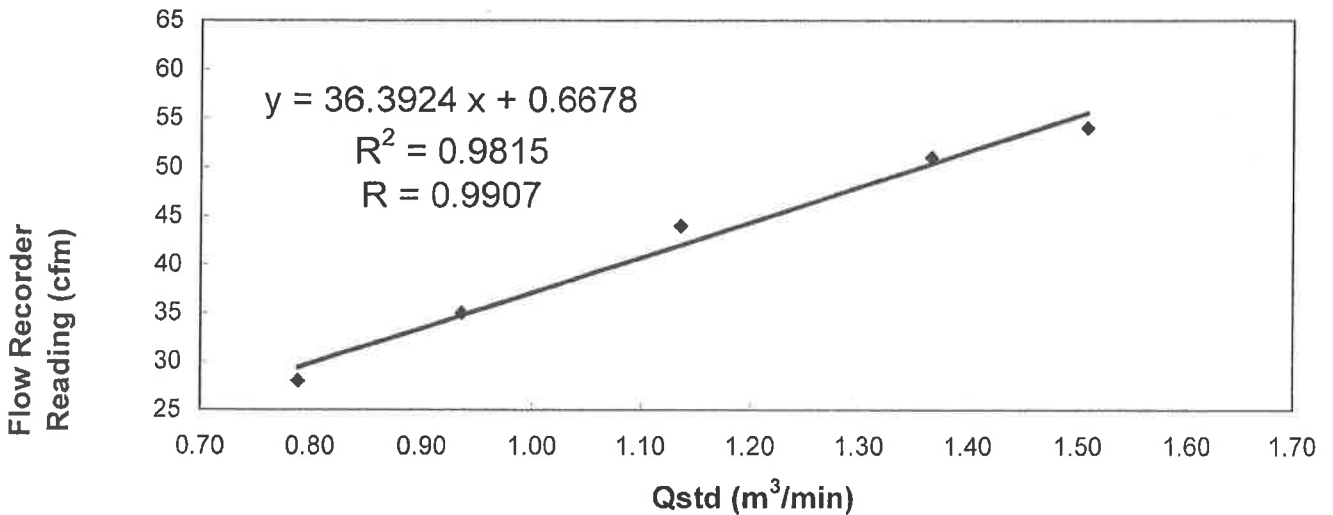
Sampler 10347 Calibration Curve
Site: Tuen Mun 38 (TM-A1)

Acceptance Criteria : Correlation coefficient (r) of the calibration curve greater than 0.990 after a 5-point calibration

The high volume sampler complies* / ~~does not comply*~~ with the specified requirements and is deemed acceptable* / unacceptable* for use.

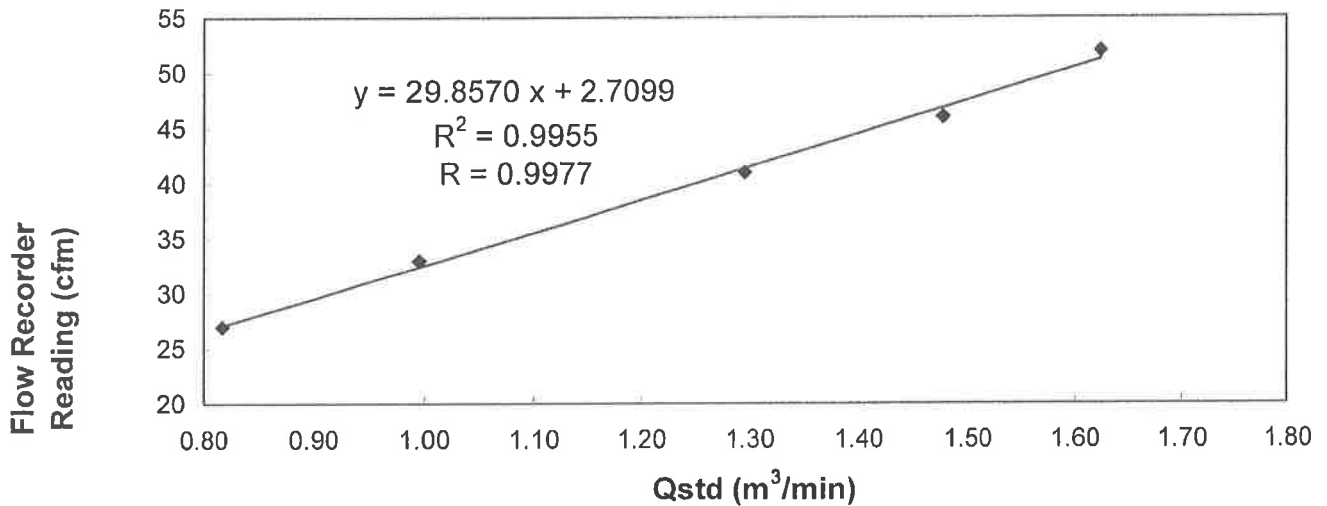
Sampler 9864 Calibration Curve
Site: Tuen Mun (TM-RA2)

Acceptance Criteria : Correlation coefficient (r) of the calibration curve greater than 0.990 after a 5-point calibration

The high volume sampler complies* / ~~does not comply*~~ with the specified requirements and is deemed acceptable* / unacceptable* for use.

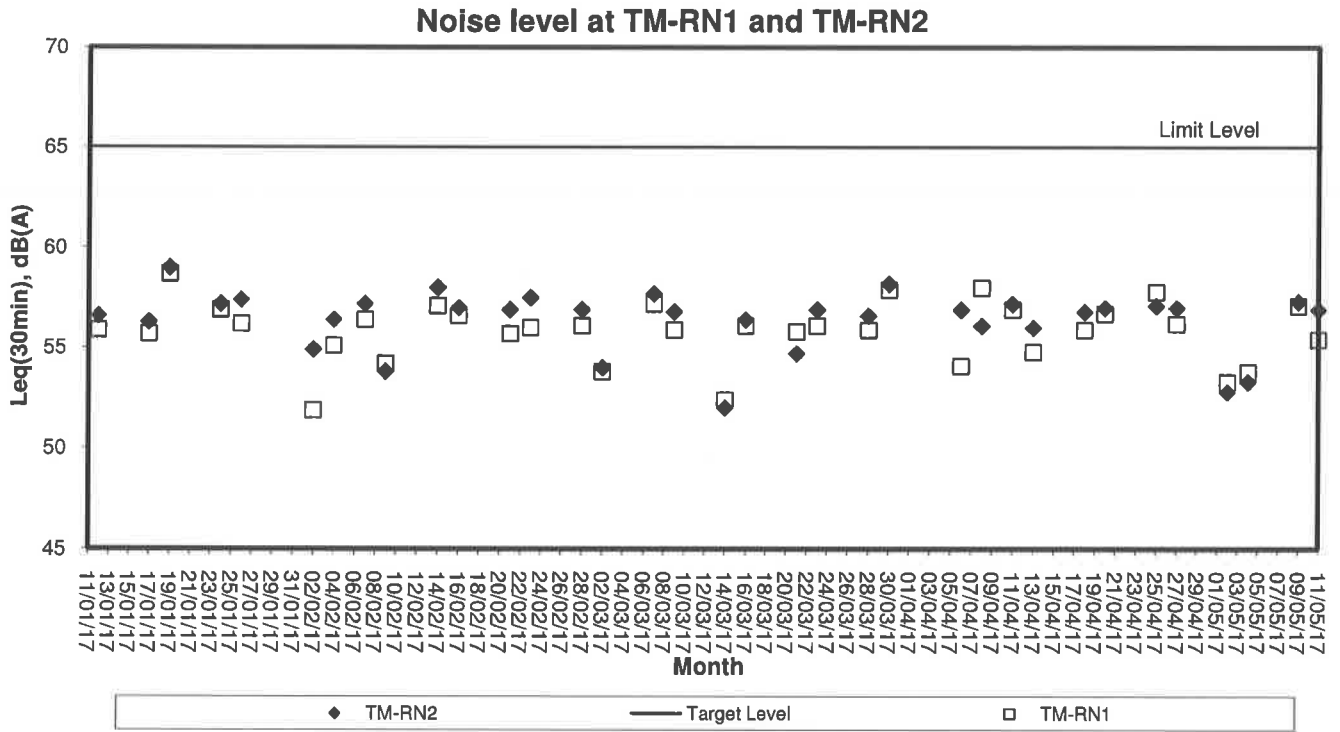
Noise Monitoring (Day-time)

The major sources of noise pollution observed in this reporting period were noise from the traveling dump trucks and from the operation of site machines.

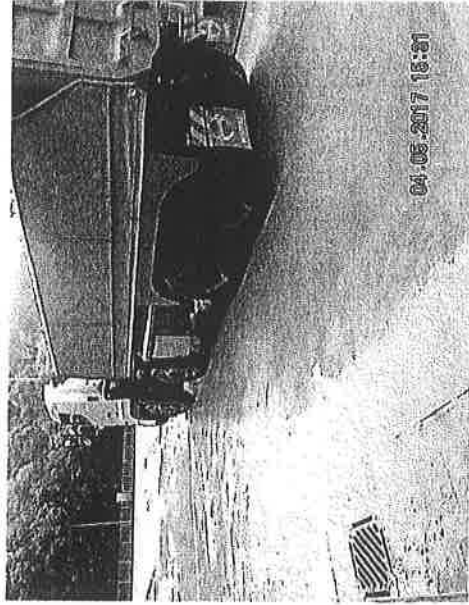
Photo 170504_001 (Public road near site exit) (Improved)

| <i>Date</i> | <i>Key Findings</i> | <i>Action(s) Taken recommended by ET</i> | <i>Action(s) Taken by the Contractor during the site audit</i> | <i>Rectification Status by ET</i> |
|---|--|--|---|---|
| 04 May 2017 | Mud was noted on the public road near site exit. (Previous item) | To clear the mud properly | Mud noted on the public road near site exit was cleared. | Closed |

| Item | Details of defective works or observations | Proposed Follow Up Action | Photo Ref. | Further Action Required (Yes/No) | Target Completion Date |
|---|--|---|---|---|---|
| 1 | Follow-up action to item 2 on 24/04/17, mud noted on the public road near site exit was cleared. | — | 170504_001 | No | --- |

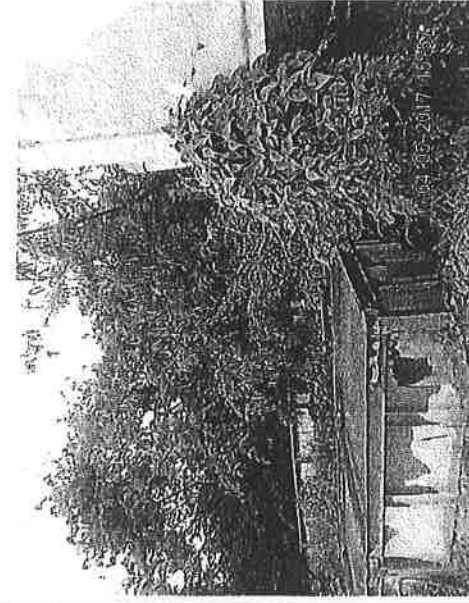
Photo 170504_002 (Wetsep sludge holding tank beside wheel washing facilities B5) (Improved)

| <i>Date</i> | <i>Key Findings</i> | <i>Action(s) Taken recommended by ET</i> | <i>Action(s) Taken by the Contractor during the site audit</i> | <i>Rectification Status by ET</i> |
|---|--|--|---|---|
| | Sludge was noted inside the Wetsep sludge holding tank beside wheel washing facilities B5. (Previous item) | To remove the sludge and maintain the silt removal facilities properly to prevent flooding and overflow. | Sludge inside the Wetsep sludge holding tank beside wheel washing facilities B5 was cleaned. | Closed |
