Contract No. HY/2011/09 HZMB Hong Kong Link Road – Section between HKSAR Boundary and Scenic Hill Revised Monthly EM&A Report for July 2014 (EP-352/2009/C)

Hong Kong-Zhuhai-Macao Bridge

Monthly EM&A Report

July 2014 (Version 2.0)

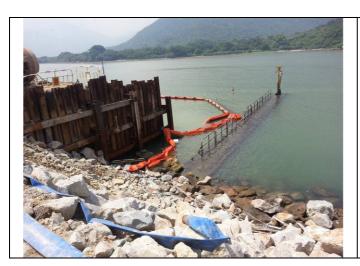
Ref No: 140702-R03

Rectification Actions taken by the Contractor for Environmental Deficiencies Identified during Previous Audit Session
