Contract No. HY/2011/09 Hong Kong-Zhuhai-Macao Bridge Hong Kong Link Road – Section between HKSAR Boundary and Scenic Hill

Submission under Environmental Permit (EP-352/2009/C – Condition 4.4) Monthly EM&A Report – September 2014

We are pleased to verify the captioned Revised Monthly EM&A Report No. 20 (September 2014) in accordance with Condition 4.4 of EP-352/2009/C.

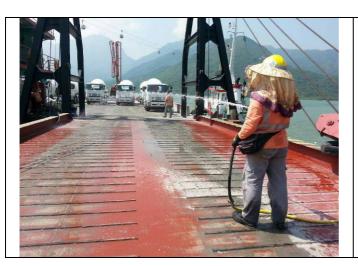
**Ref No:** 140910-R01

# Rectification Actions taken by the Contractor for Environmental Deficiencies Identified during Previous Audit Session
