**Contract No. HY/2011/09 HZMB Hong Kong Link Road –
Section between HKSAR Boundary and Scenic Hill
Quarterly EM&A Report No.7 for September to November 2014 (Revision 1)**

Contract HY/2011/09
Hong Kong-Zhuhai-Macao Bridge
Hong Kong Link Road-Section between
HKSAR Boundary and Scenic Hill

Quarterly EM&A Report

September to November 2014

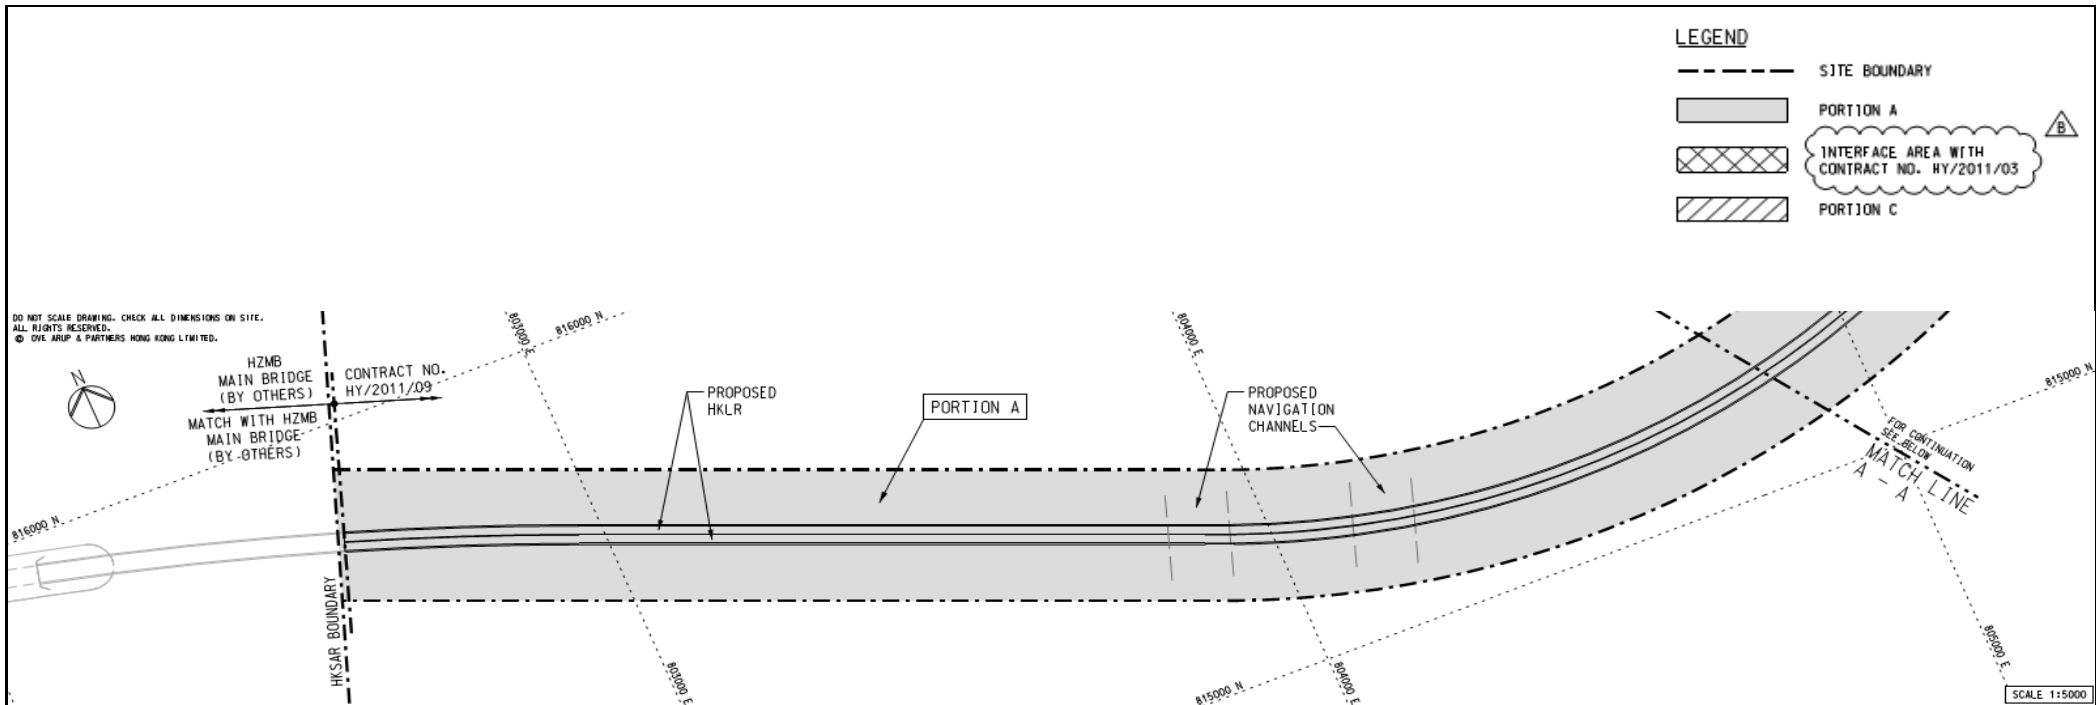
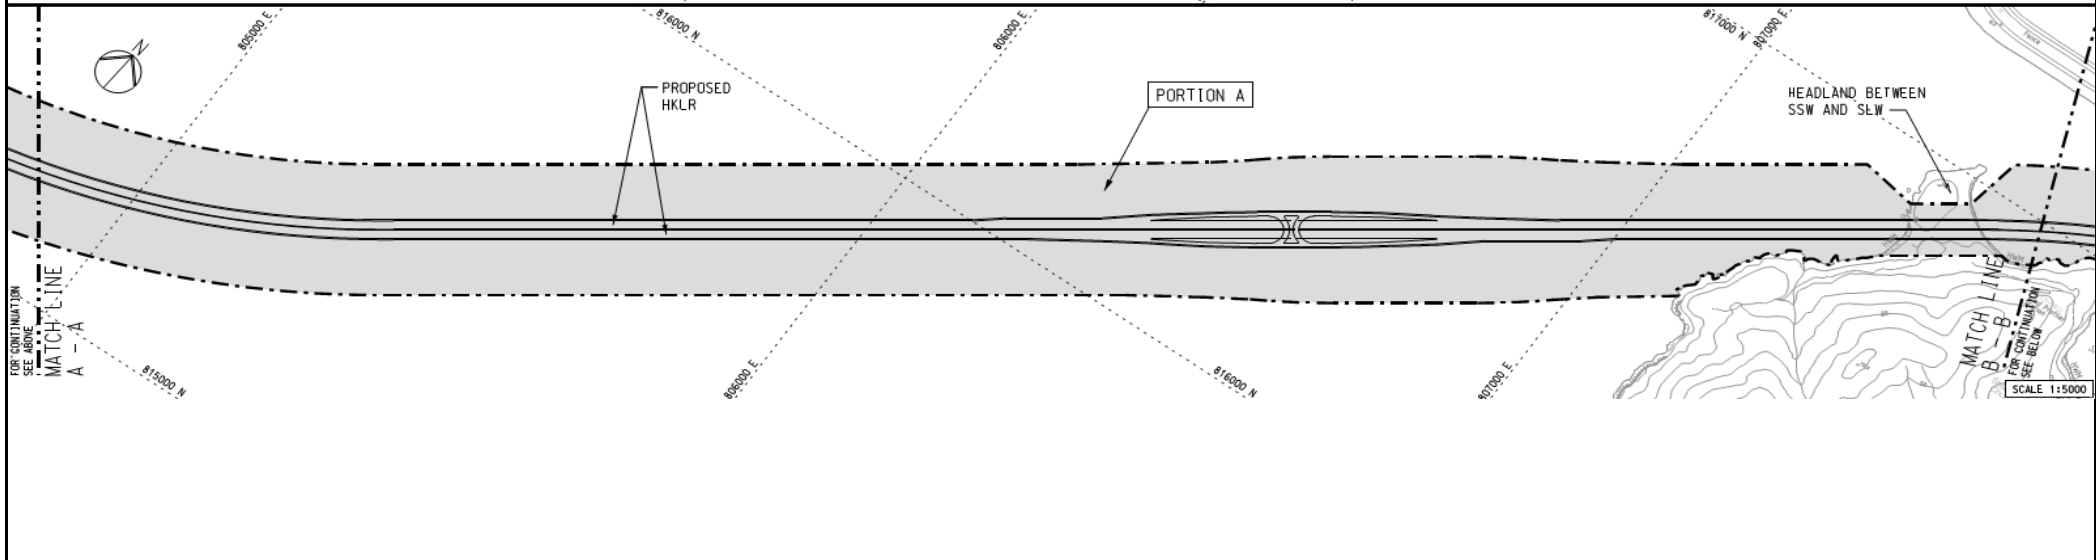
Title	Contract No. HY/2011/09		Scale	N.T.S	Propose No.	MA12014	
	Hong Kong-Zhuhai-Macao Bridge						
	Hong Kong Link Road – Section between HKSAR Boundary and Scenic Hill		Date	May-13	Figure	1b	
	Site Layout Plan (Portion A)

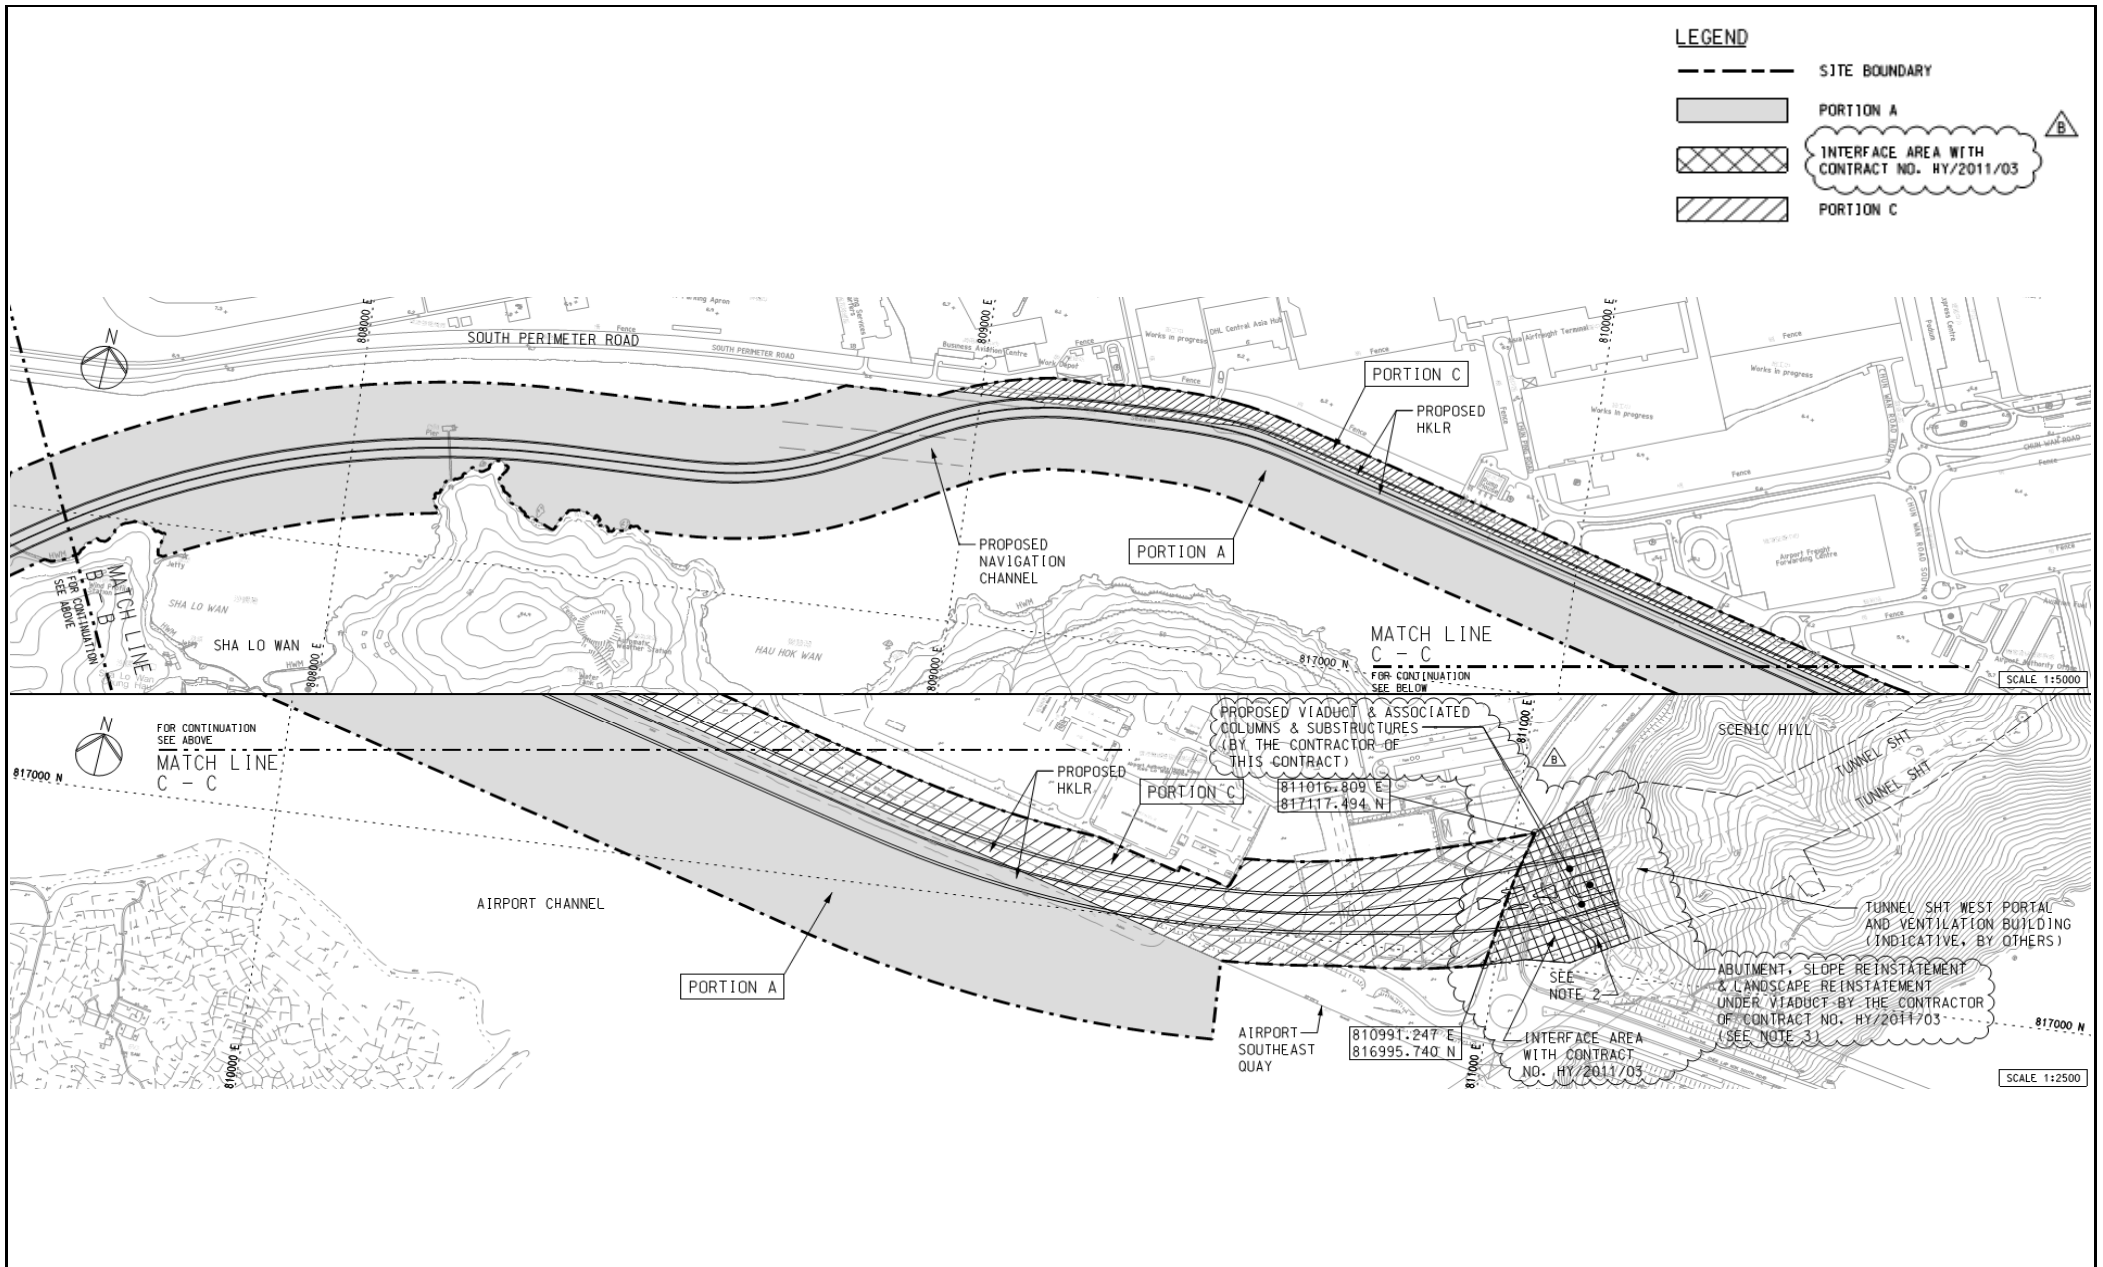
Title	Contract No. HY/2011/09 Hong Kong-Zhuhai-Macao Bridge Hong Kong Link Road – Section between HKSAR Boundary and Scenic Hill Site Layout Plan (Portion A and C)		Scale	N.T.S	Propose No.	MA12014	CINOTECH
	Date	May-13	Figure	1c

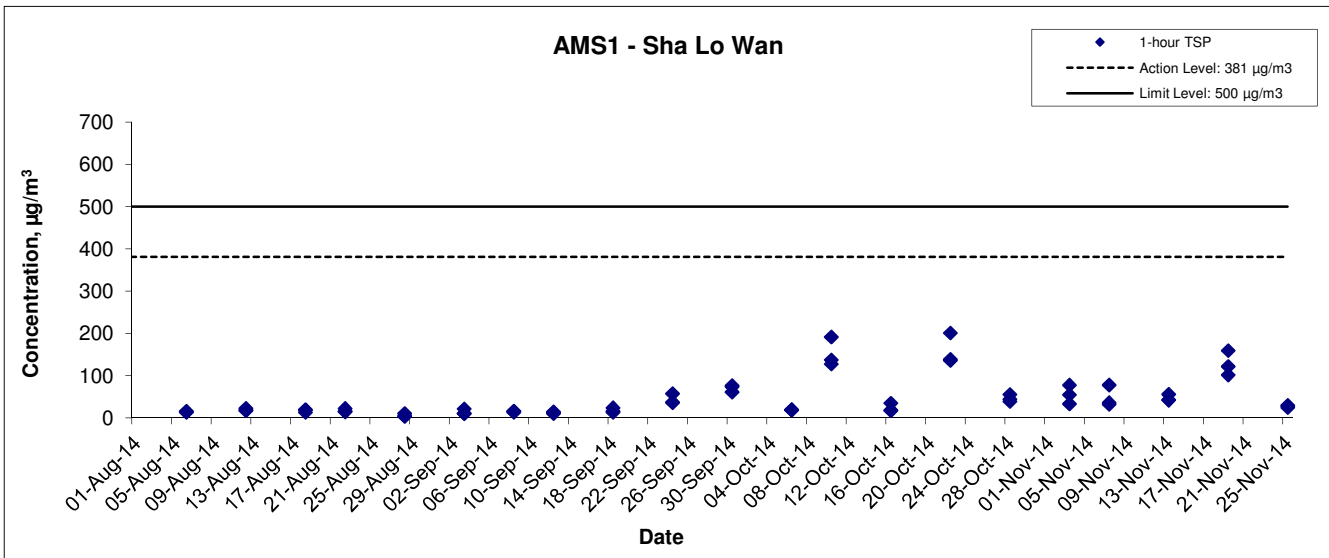
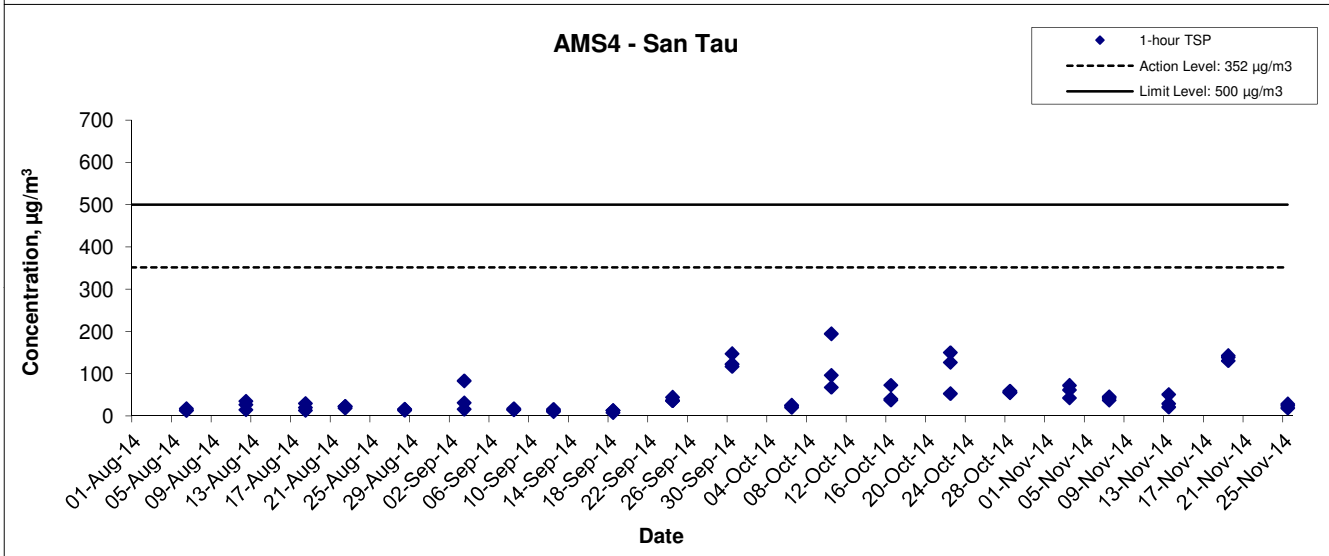
1-hour TSP Concentration Levels

Title Contract No. HY/2011/09 Hong Kong-Zhuhai-Macao Bridge Hong Kong Link Road – Section between HKSAR Boundary and Scenic Hill Graphical Presentation of 1-hour TSP Monitoring Results	Scale N.T.S	Project No. MA12014	
	Date Nov 14	Appendix B

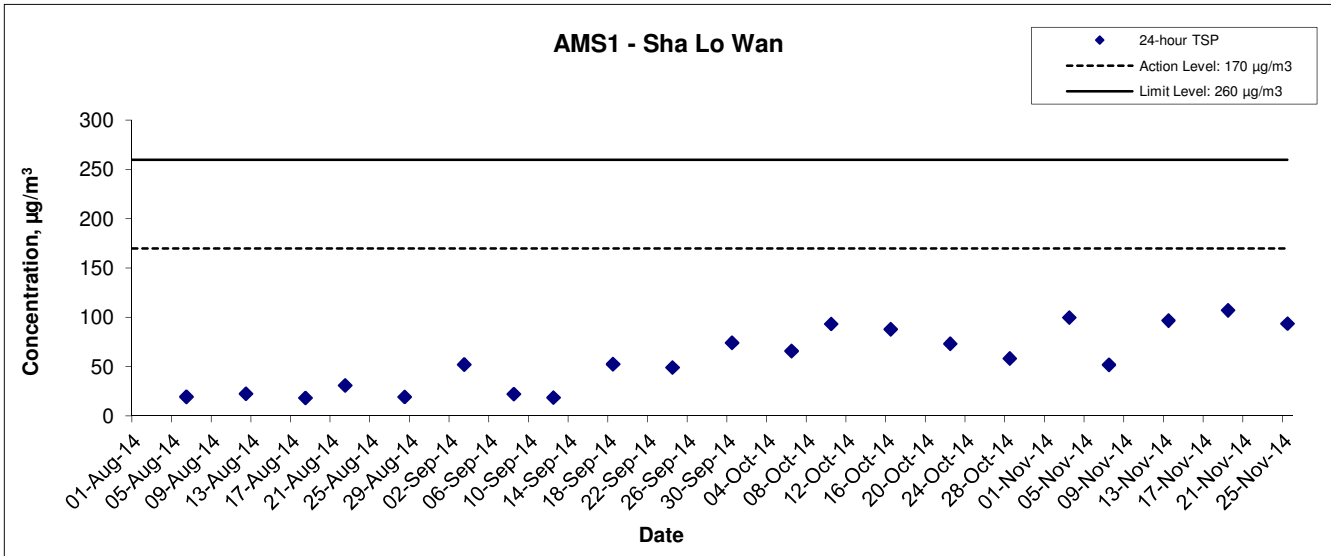
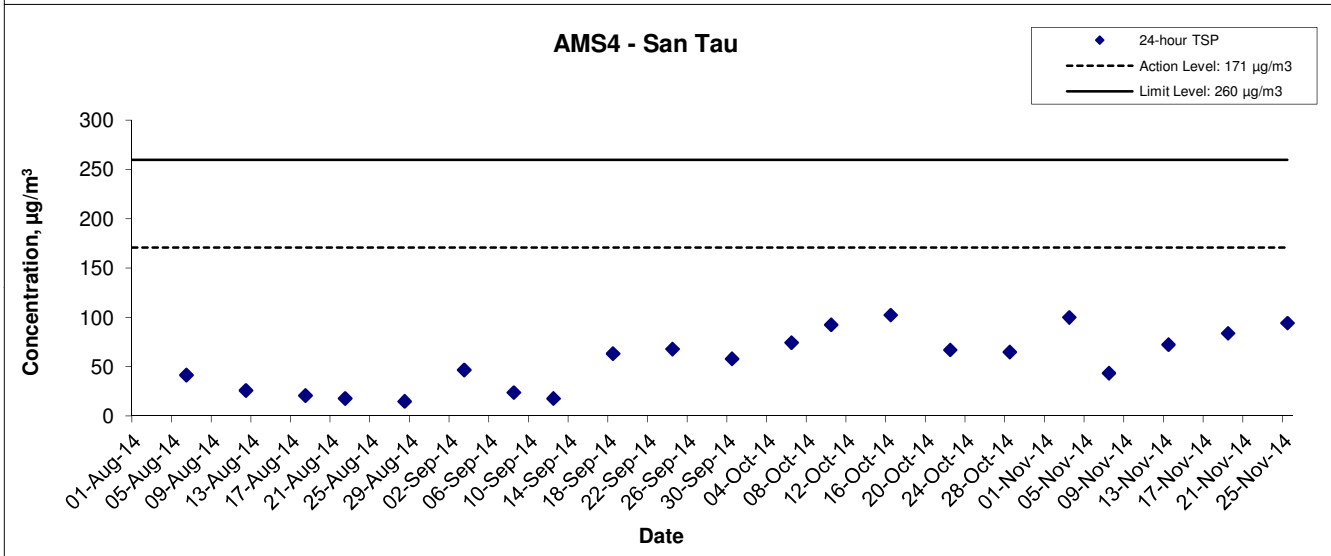
Title Contract No. HY/2011/09 Hong Kong-Zhuhai-Macao Bridge Hong Kong Link Road – Section between HKSAR Boundary and Scenic Hill Graphical Presentation of 24-hour TSP Monitoring Results	Scale N.T.S	Project No. MA12014	CINOTECH
	Date Nov 14	Appendix C

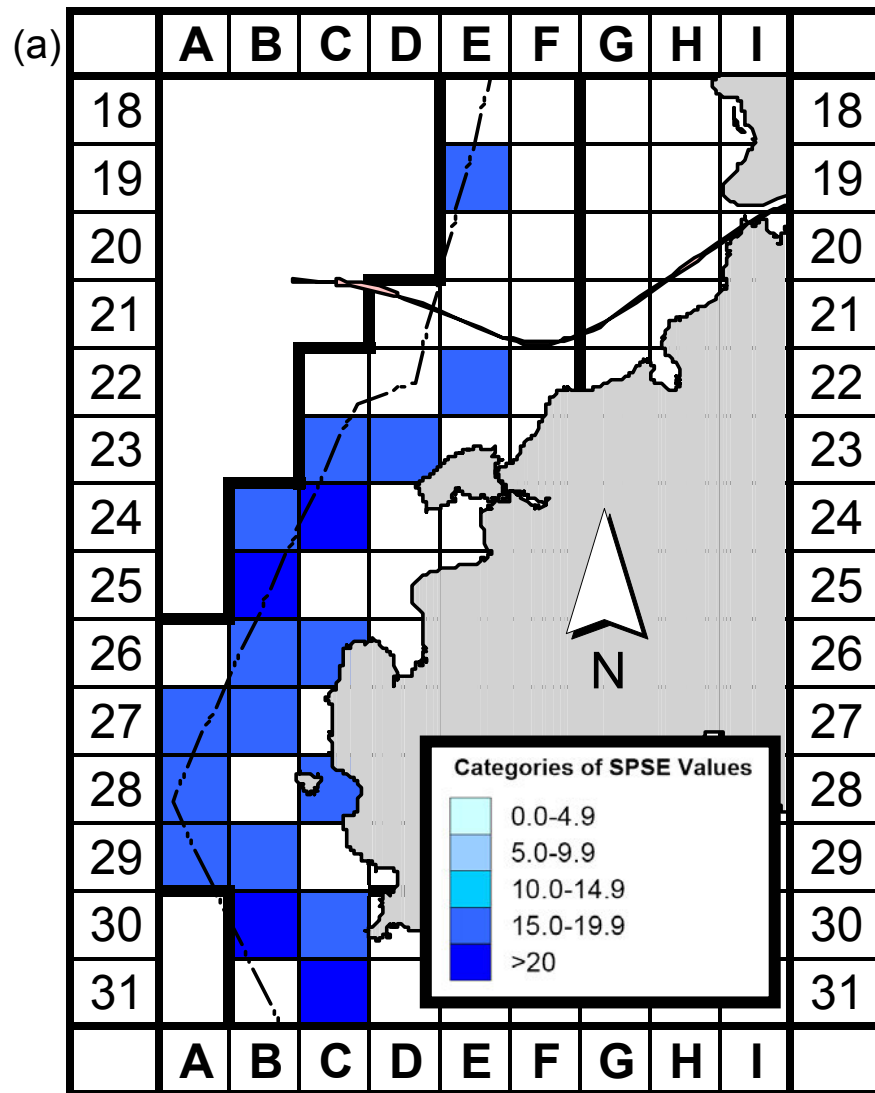
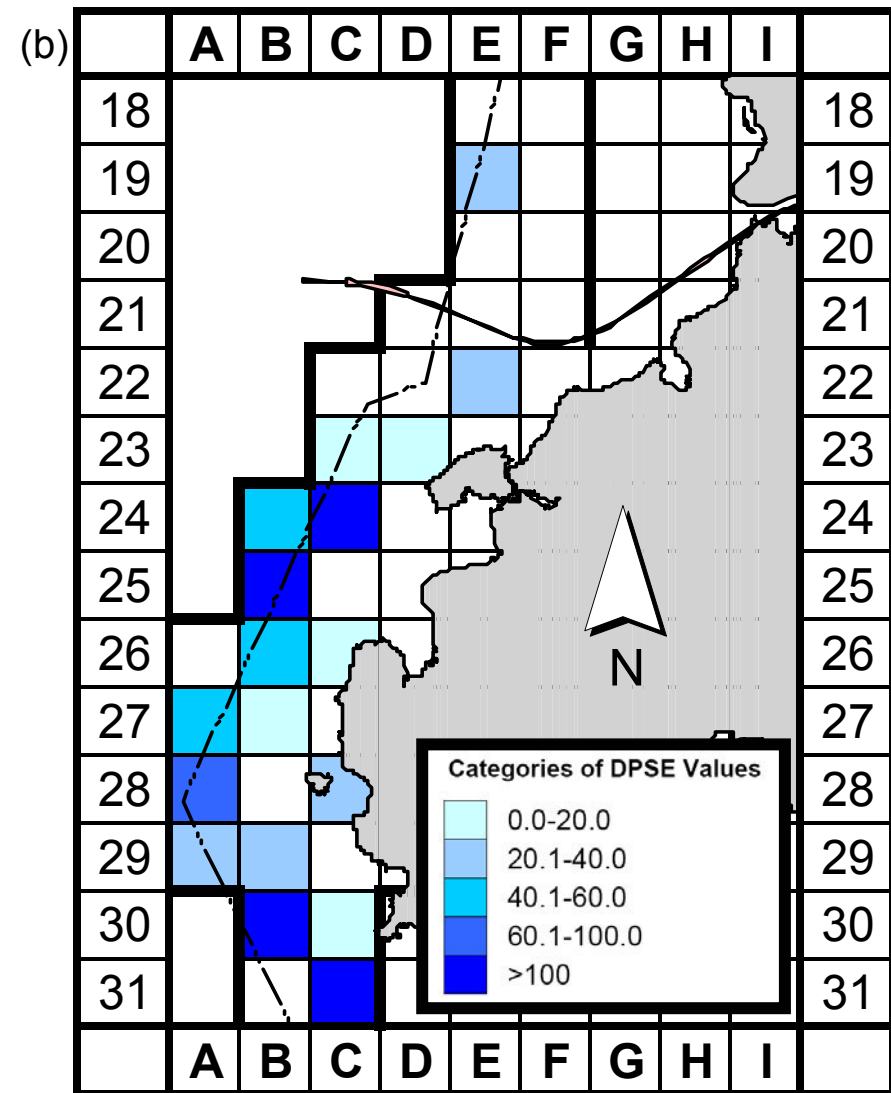
Figure 4a. Sighting density of Chinese white dolphins with corrected survey effort per km² in West Lantau survey area, using data collected during HKLR09 impact monitoring period (Sep-Nov 14) (SPSE = no. of on-effort sightings per 100 units of survey effort)

- 4.22 From September to November 2014, the most heavily utilized habitats by the dolphins were mainly found along the western territorial border off Tai O Peninsula, Peaked Hill and Fan Lau (**Figures 4a and 4b of Appendix F**). Conversely, their densities were much lower in the inshore waters. However, it should be noted that the amount of survey effort collected in each grid during the three-month period was fairly low (6 units of survey effort for most grids), and therefore the habitat use pattern derived from the three-month dataset should be treated with caution. A more complete picture of dolphin habitat use pattern will be presented when more survey effort for each grid will be collected throughout the impact phase monitoring programme.
