Contract No. CV/2012/09
Liantang / Heung Yuen Wai Boundary Control Point
Site Formation and Infrastructures – Contract 3

Environmental Permit No. EP-404/2011/A
Condition 3.4 – Revised Contamination Assessment Plan (CAP)
– Fanling (Rev.3)

**AGREEMENT NO. CE 45/2008 (CE)
LIANTANG/HEUNG YUEN WAI
BOUNDARY CONTROL POINT AND ASSOCIATED WORKS**

**REVISED CONTAMINATION ASSESSMENT PLAN (CAP) –
FANLING**

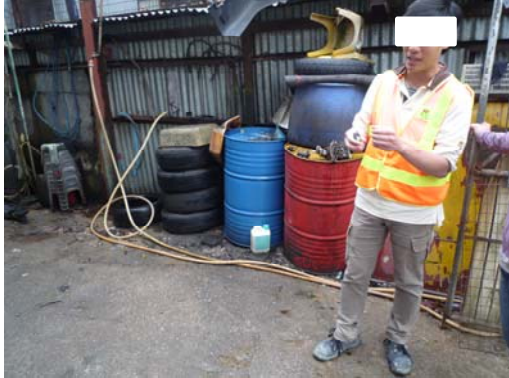
<p>Photo 9 – Car workshop Exit/Entrance</p>	<p>Photo 10 – Vehicle parts observed at car workshop entrance</p>

<p>Photo 11 – Tires and lube oil empty bottles observed at car workshop entrance.</p>	<p>Photo 12 – Chemical waste storage location</p>

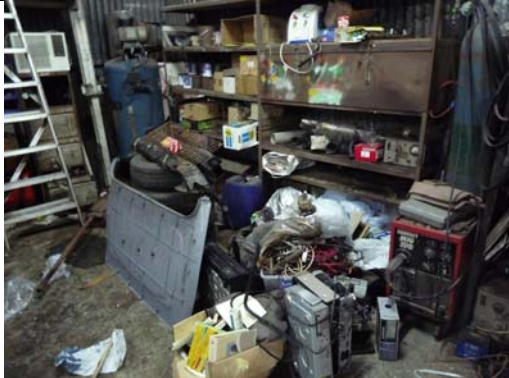
<p>Photo 13 – Oil stain observed at chemical waste storage location</p>	<p>Photo 14 – Oil stain observed at chemical waste storage location</p>

<p>Photo 15 – Lube oil empty bottles temporary storage location</p>	<p>Photo 16 – Work area of car repair and maintenance</p>

- 3.11 According to the site history, there was vehicle repair and maintenance service. Moreover, obvious oil stain was observed at the car workshop boundary near the entrance. In addition, some lube oil empty bottles were disposed in front of the entrance. Furthermore, the site may be contaminated with PCBs as coming from equipment. According to the findings, the chemical analysis is therefore proposed for the car workshop as follows:
