**Environmental Permit No. EP-404/2011/A**  
**Condition 2.16 – Photographic and Cartographic Survey Report**

**Liantang 5\_Photographic and Cartographic Records of graves and well**

Contract No. CV/2013/03 -  
Liantang/Heung Yuen Wai  
Boundary Control Point Site  
Formation and Infrastructure  
Works – Contract 5  
*Cartographic and Photographic  
Survey Report*

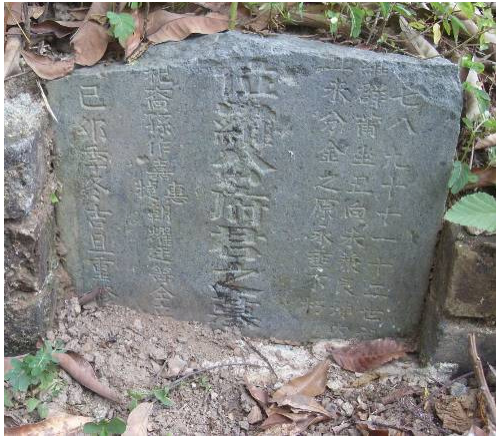
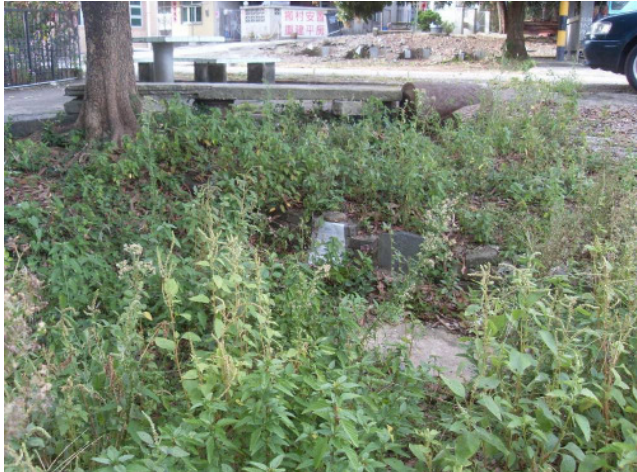
General View

<p>七八九十一十二世祖 維群甫坐五向未兼良坤丙 未分金之原永垂不朽</p> <p>位羅公府君之墓</p> <p>祀裔孫作嘉 捷 朝耀廷等全立 己卯季冬吉日旦重修</p>
Architectural Appraisal: The grave is measured approximately 2m (L) x 2m (W) x 0.5m (H) in size. It has a circular layout and was constructed of bricks with headstone erected in the middle. The upper part of the headstone was broken.

Existing Condition: Poor	
Past and Present Uses: Grave	
Notes on any Modifications: Nil	
Photographic Records:

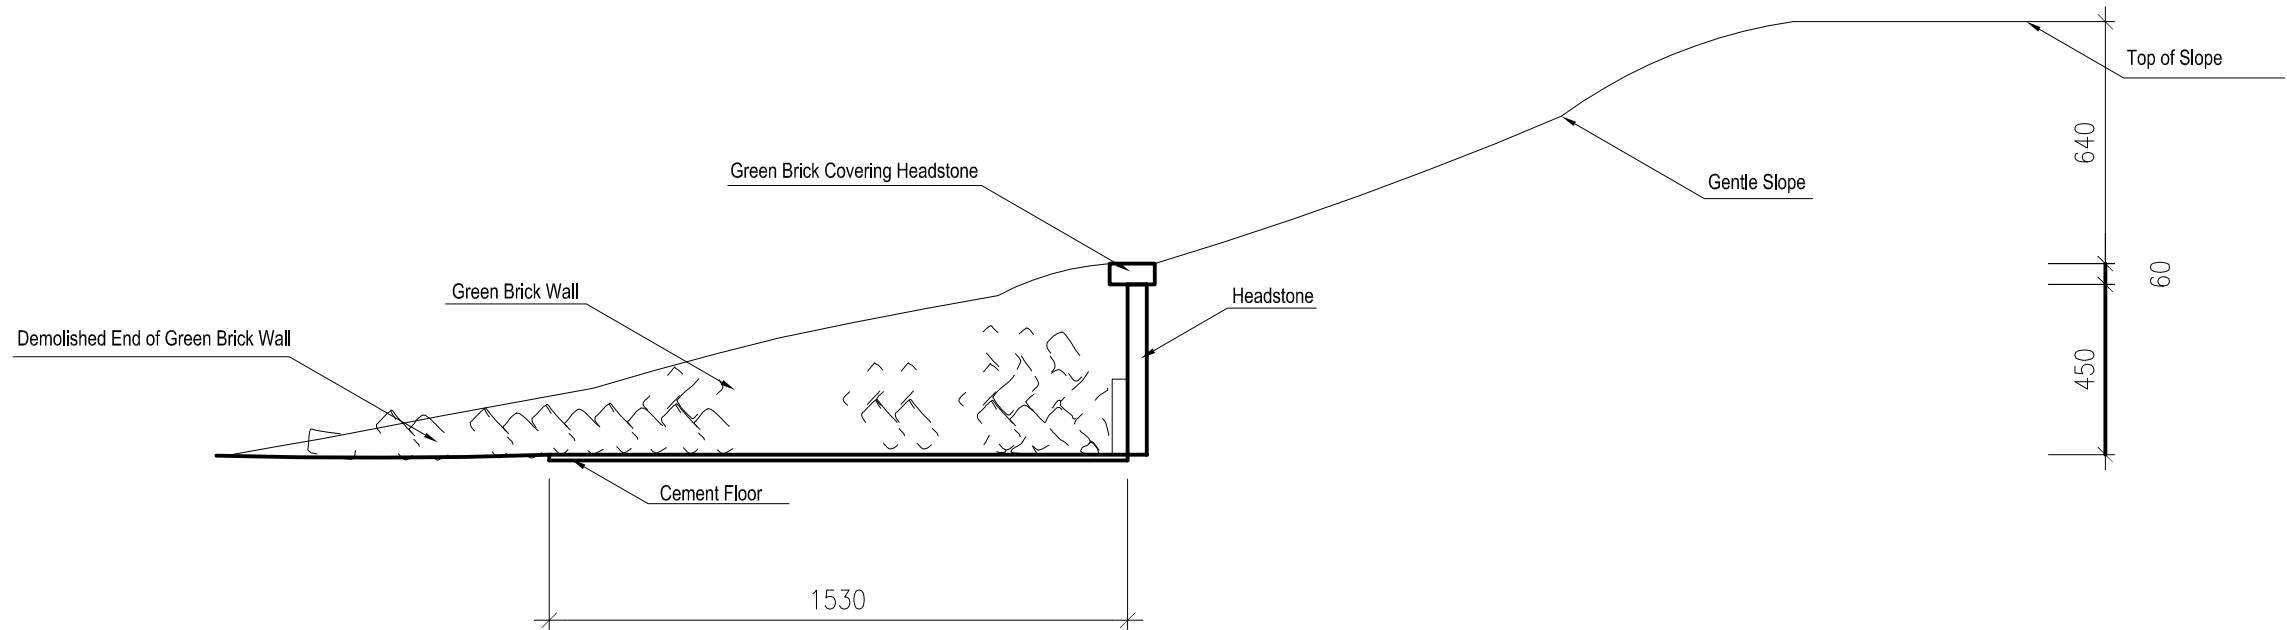
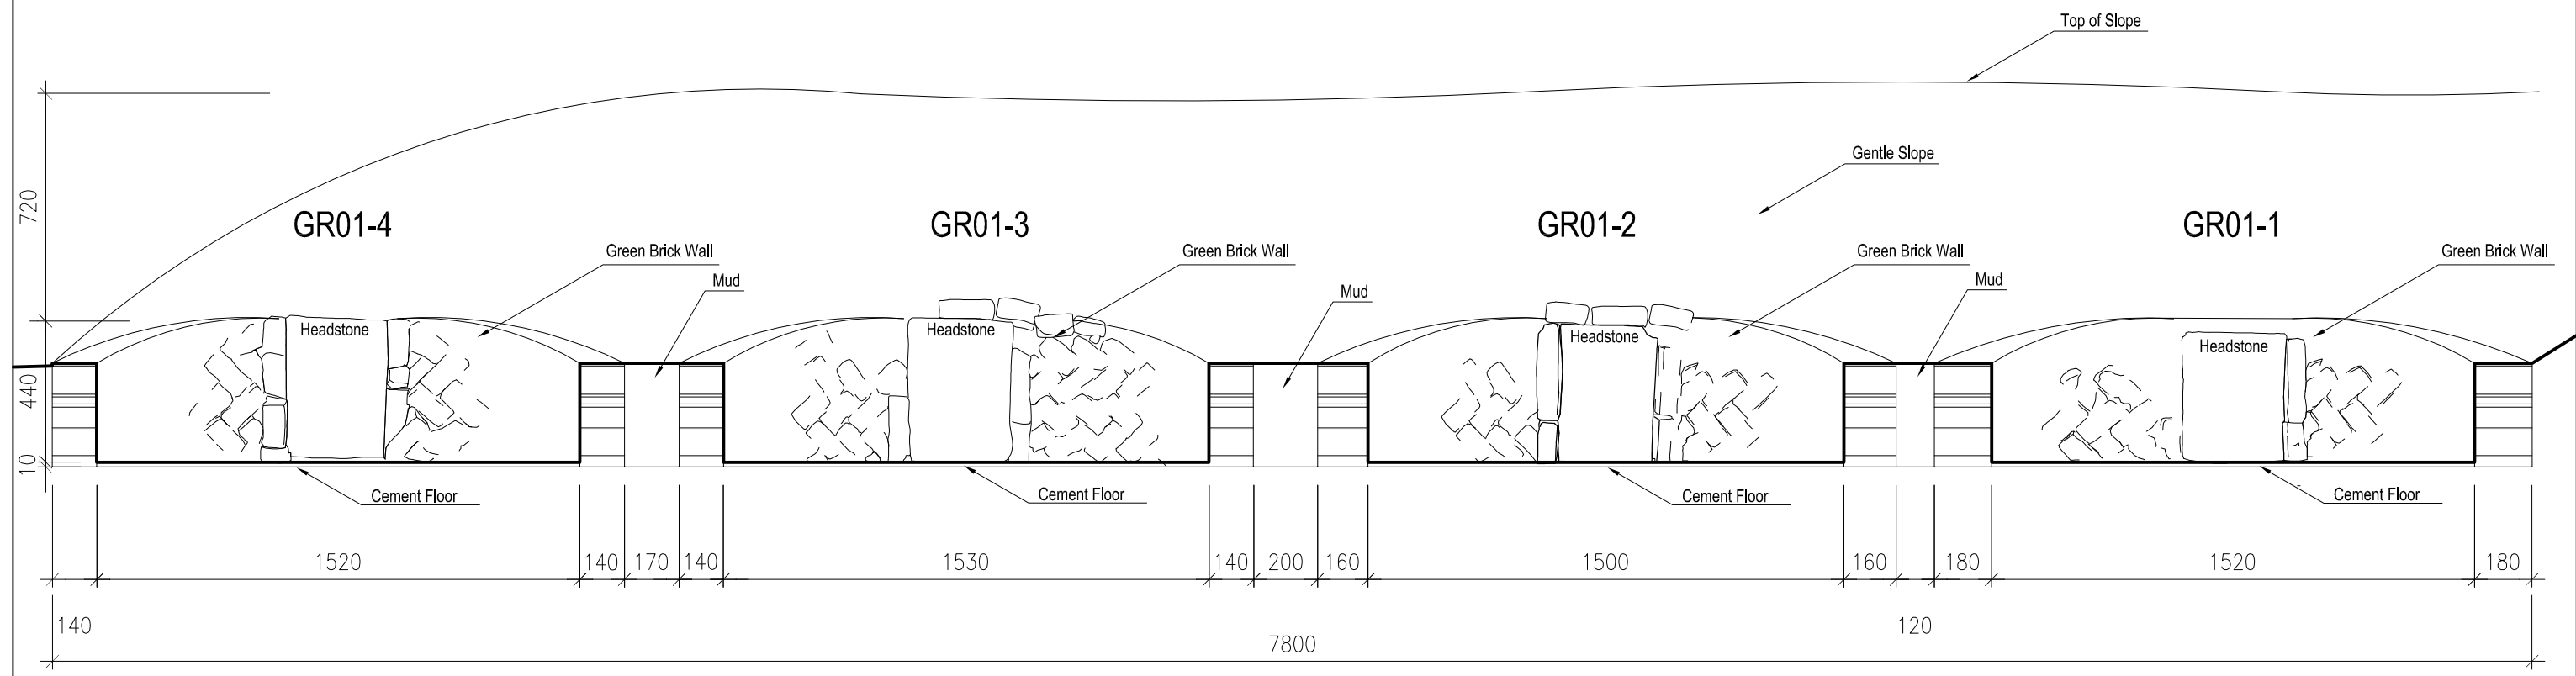
Figure No.:	GR01-D4	Environmental Resources Management 16/F DCH Commercial Centre, 25 Westlands Road, Quarry Bay, Hong Kong
Title:	GR01 A-A' Section and B-B' Section

A-A' Section (1:20)

B-B' Section (1:20)

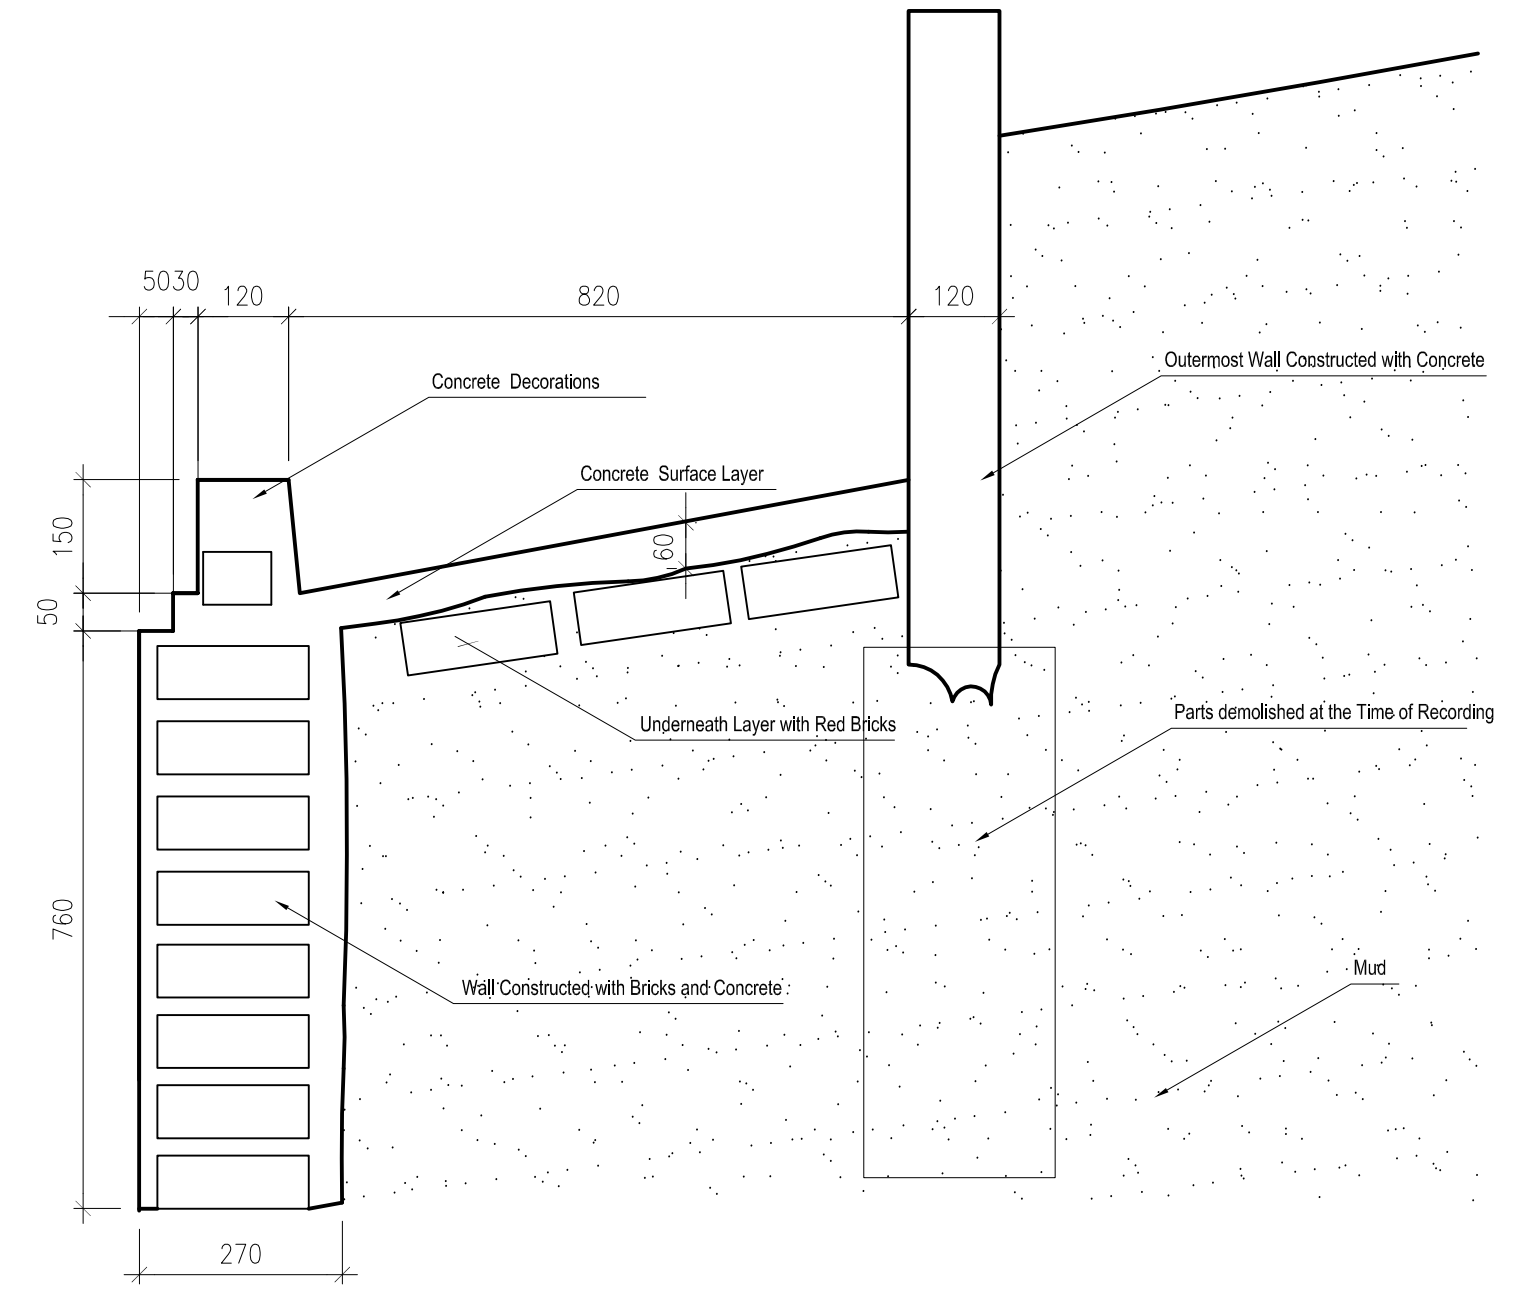
Section Detail of Wall (1:10)

Figure No.: GR05-D6	Environmental Resources Management 16/F DCH Commercial Centre, 25 Westlands Road, Quarry Bay, Hong Kong
Title: GR05 Shrine and Construction Detail of Wall

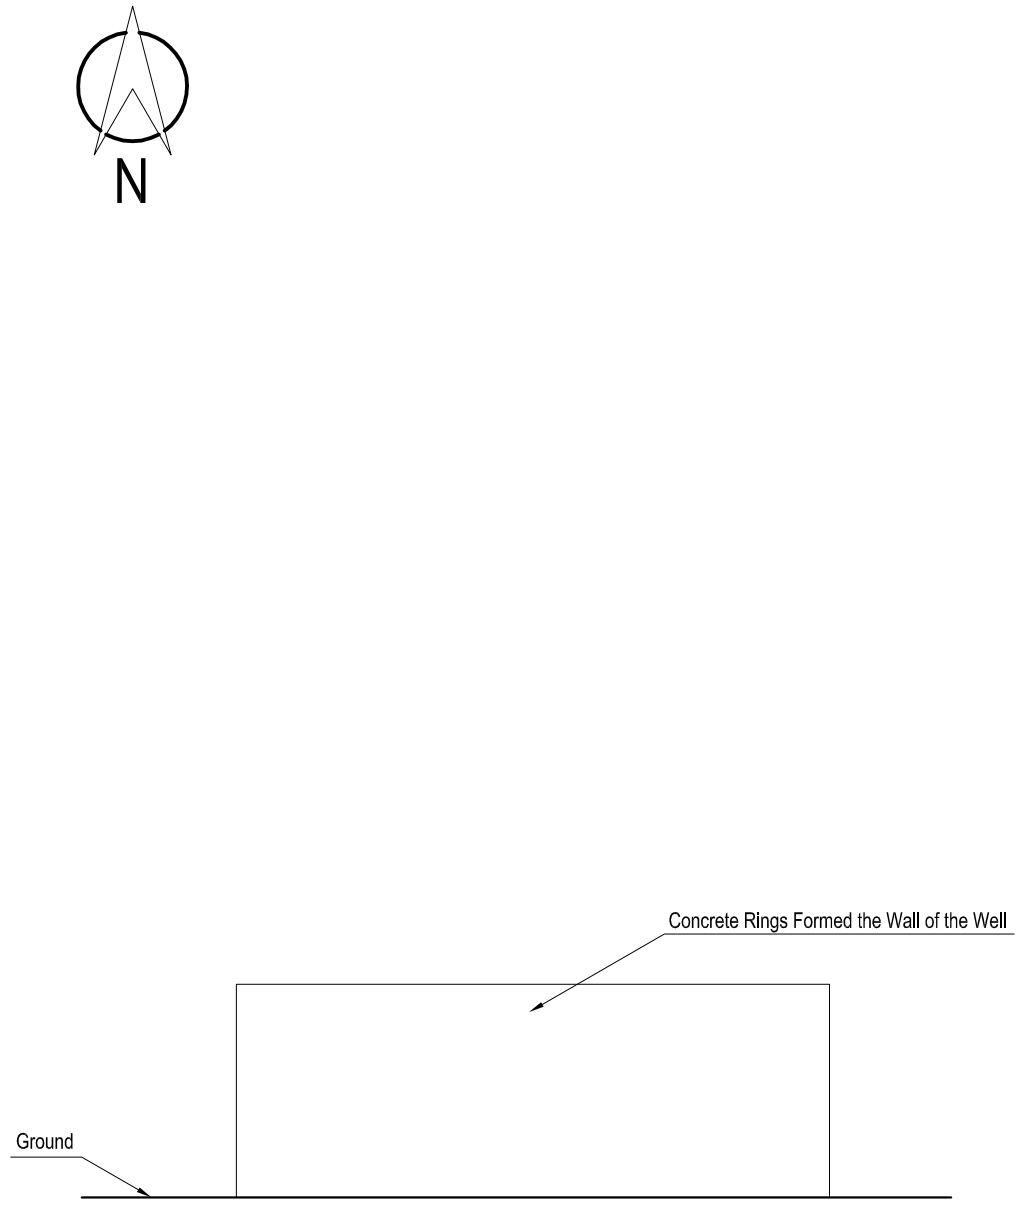
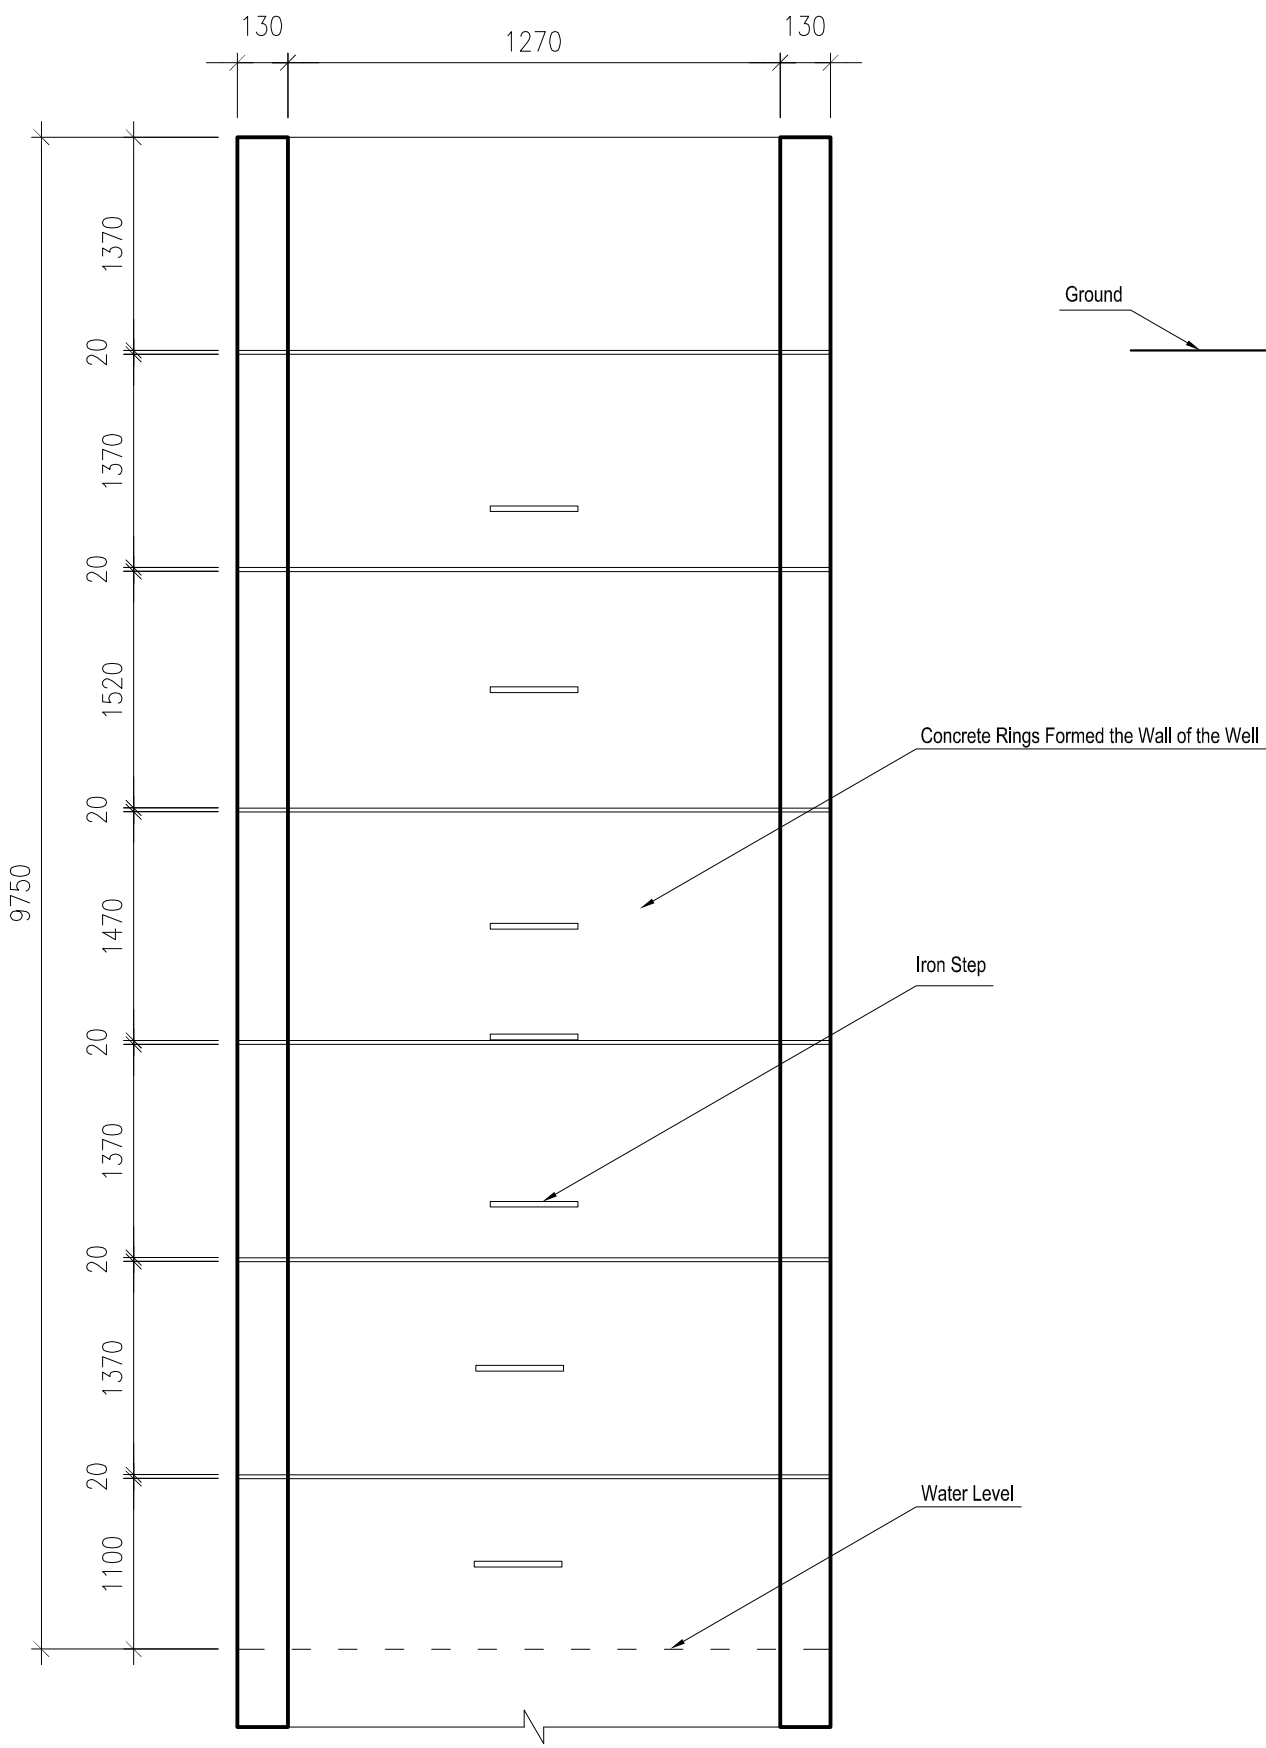
Figure No.:	LF08-D2	Environmental Resources Management 16/F DCH Commercial Centre, 25 Westlands Road, Quarry Bay, Hong Kong
Title:	LF08 Floor Plan, Elevation and A-A' Section

**Elevation (1:20)**

**A - A' Section (1:20)**

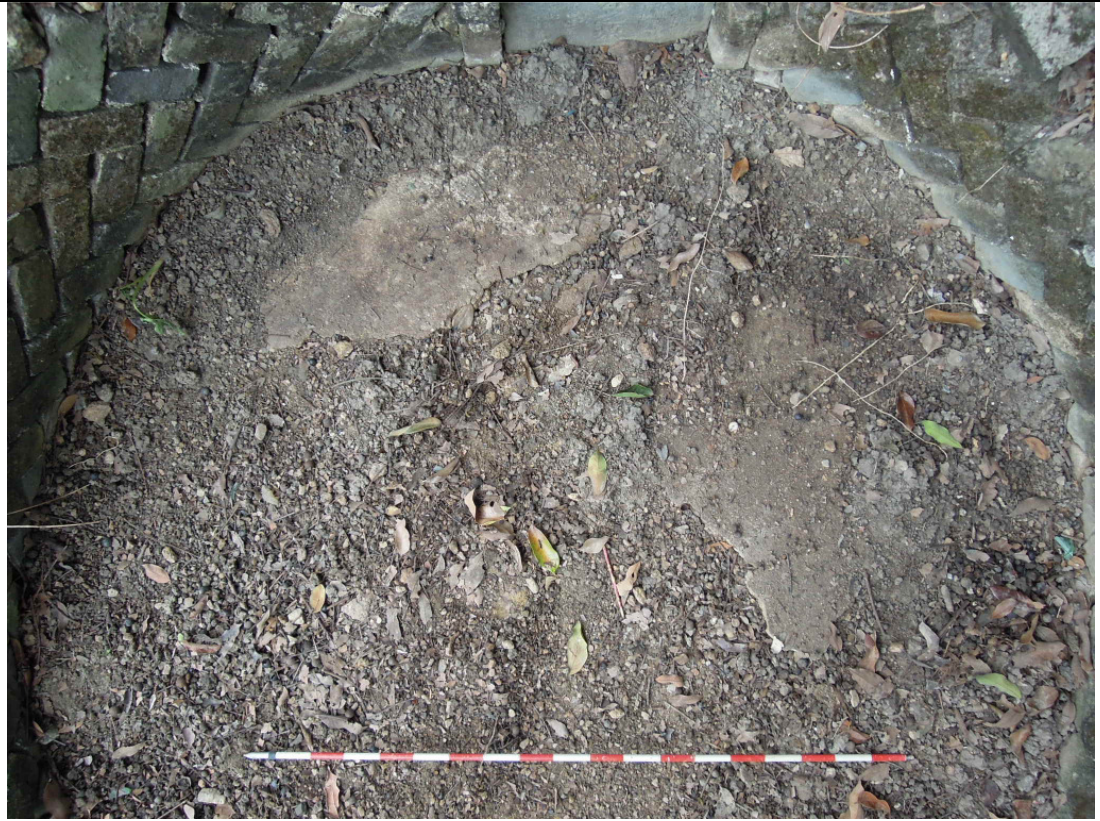
**GR01-2-P6**

Close up of remaining cement slabs on the floor of GR01-2 GR01-2水泥地面殘跡近觀

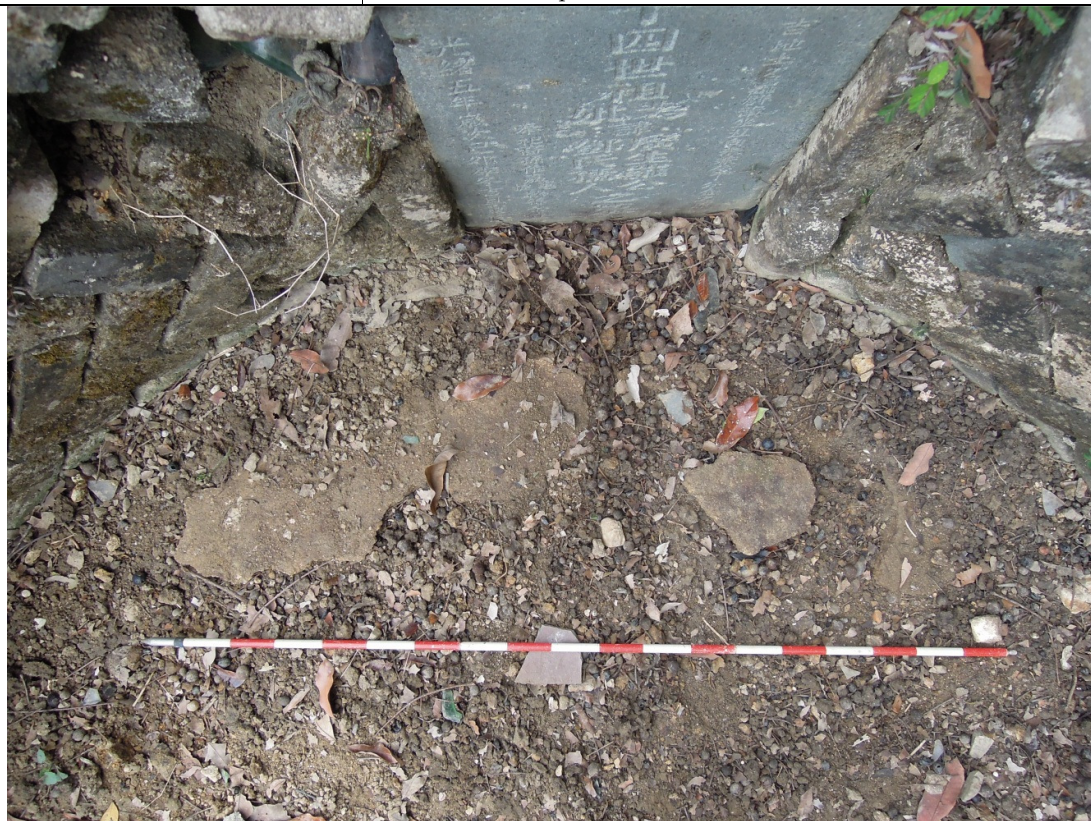
GR01-3-P7

Close up of remaining cement slabs on the floor of GR01-3 GR01-3水泥地面殘跡近觀

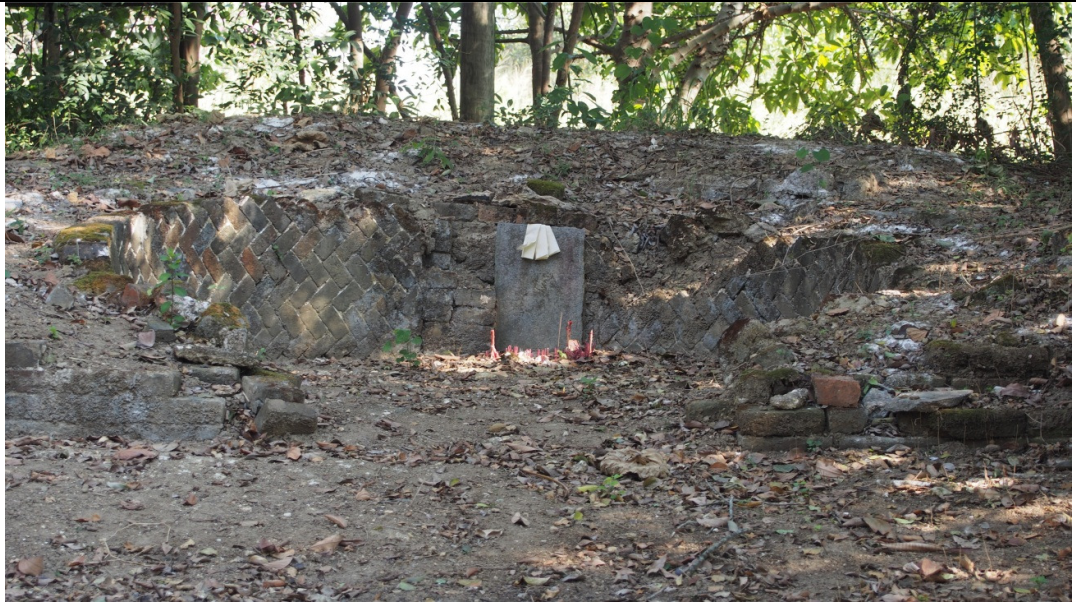
**GR02-1-P3**

Front elevation of GR02-1, showing the wall next to the headstone collapsed and repaired with different arrange of coursework of bricks. GR02-1正視圖，圖中顯示了墓碑旁邊的牆已經倒塌，並以不同的砌磚的方式作修補。

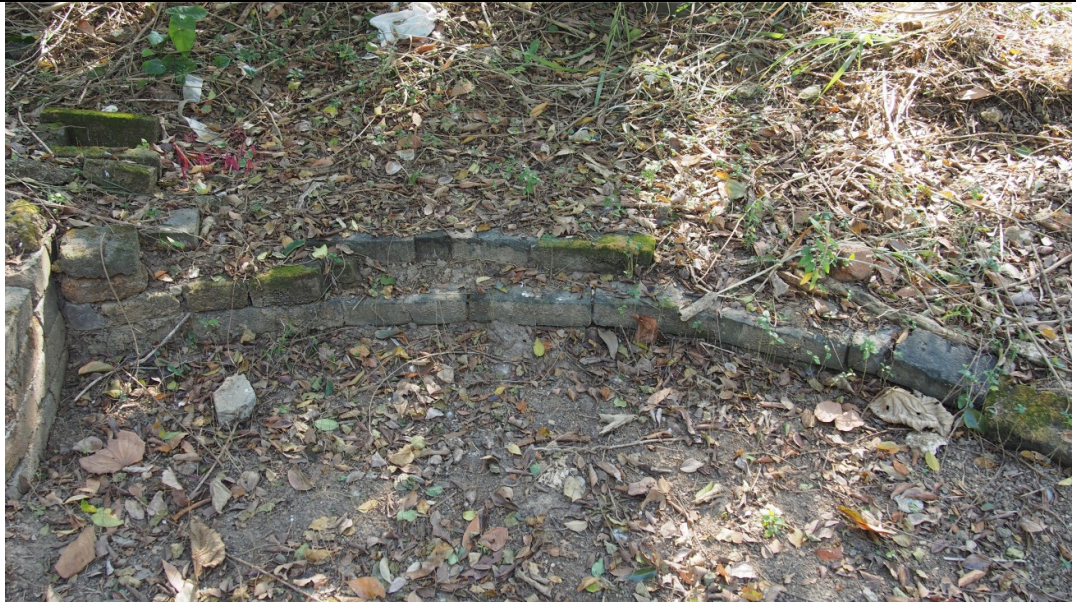
**GR02-1-P15**

Close up of the bottom ring of bricks of GR02-1, which its thickness was of double layer of green bricks.

Most of the bottom ring was destroyed and this is the most integrated part remained. 由雙層青磚組成的環狀底部，大部份結構已受破壞，這段為保存最完整的一段。

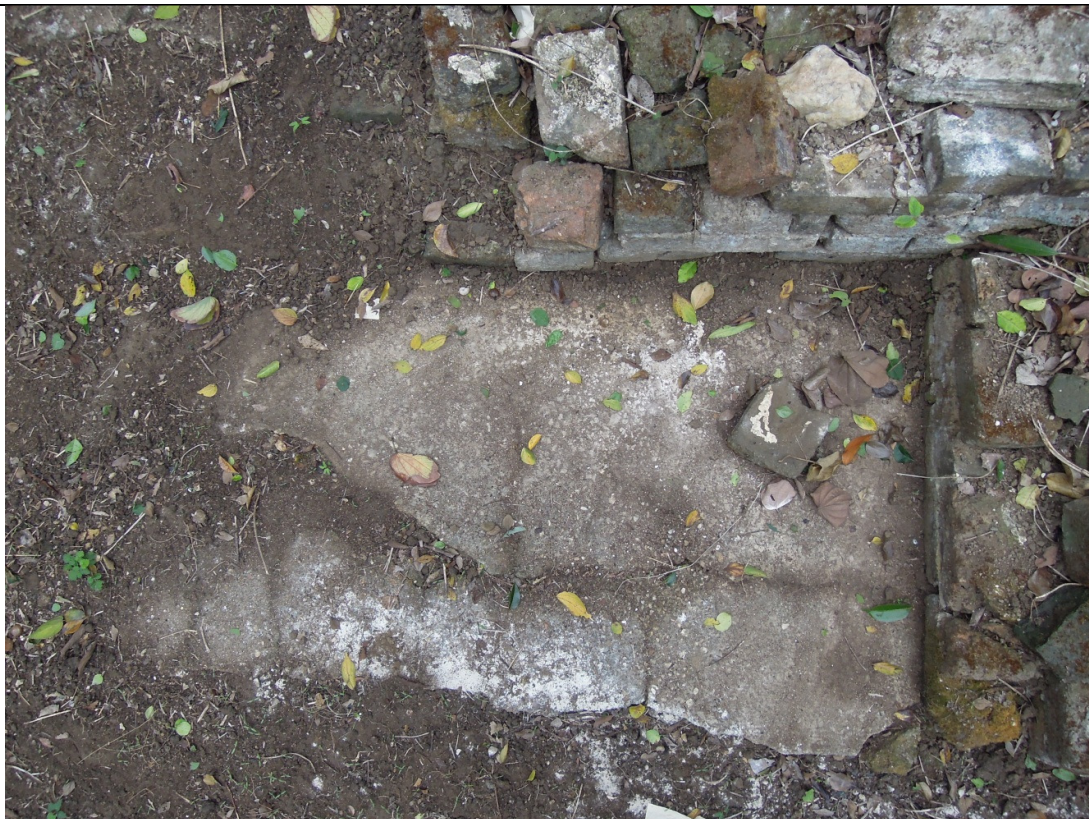
**GR02-2-P12**

Close up of a remains of concrete paving of GR02-2 GR02-2水泥地面殘跡近觀

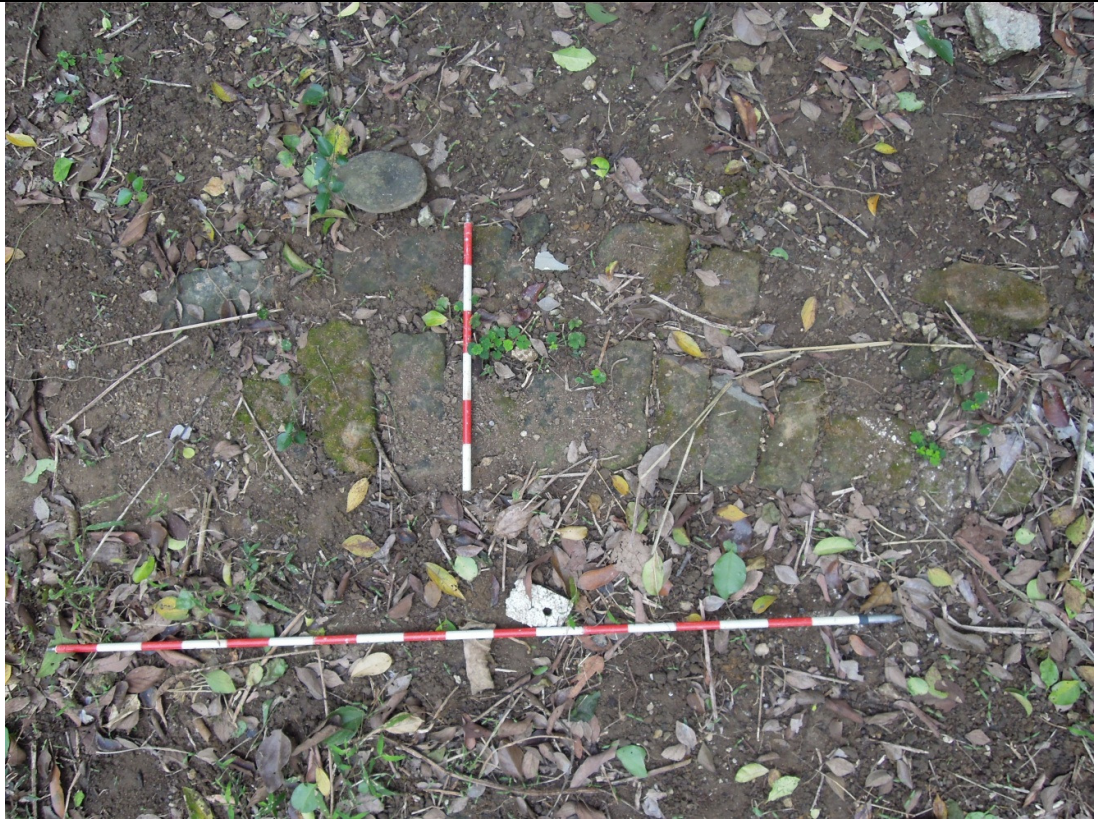
**GR02-2-P13**

Close up of a bottom ring of bricks of GR02-2 GR02-2環形底部的磚壁殘跡近觀

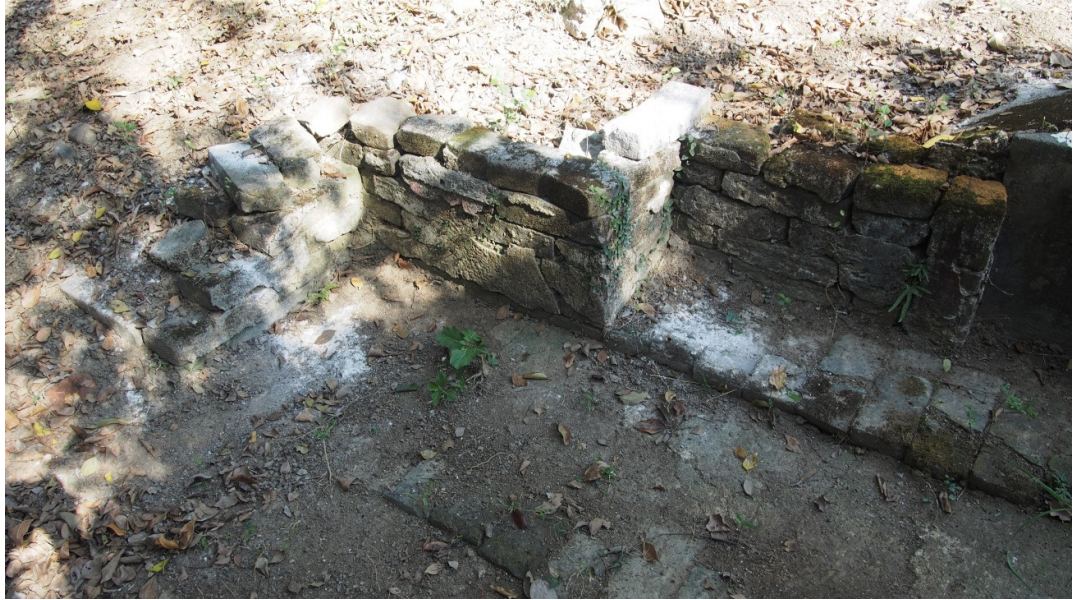
**GR02-3-P8**

Close up of brick wall of GR02-3 on the right, the wall and the floor was originally with mortar/ cement plaster, but now deteriorated. GR02-3右側磚壁的近觀，磚壁及地面原以砂漿/水泥砂漿覆蓋，但現已損壞。

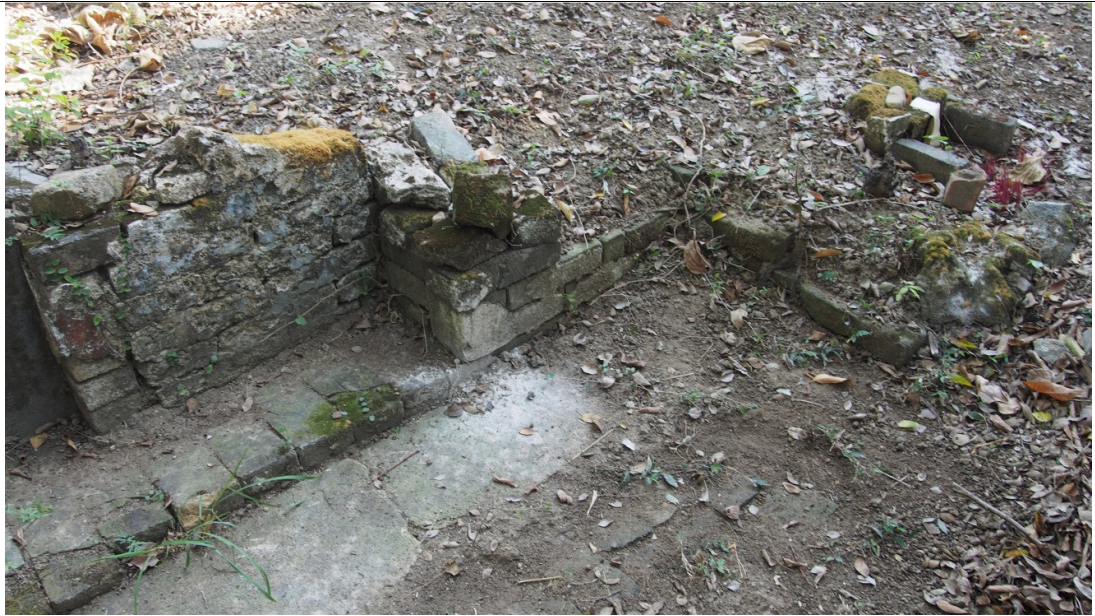
**GR02-3-P9**

Close up of brick wall of GR02-3 on the left, the wall and the floor was originally with mortar/ cement plaster, but now deteriorated. It also shows the shrine at the left of GR02-3. GR02-3左側磚壁的近觀，磚壁及地面原以砂漿/水泥砂漿覆蓋，但現已損壞。圖中亦可見位於GR02-3左側的土地公神位。

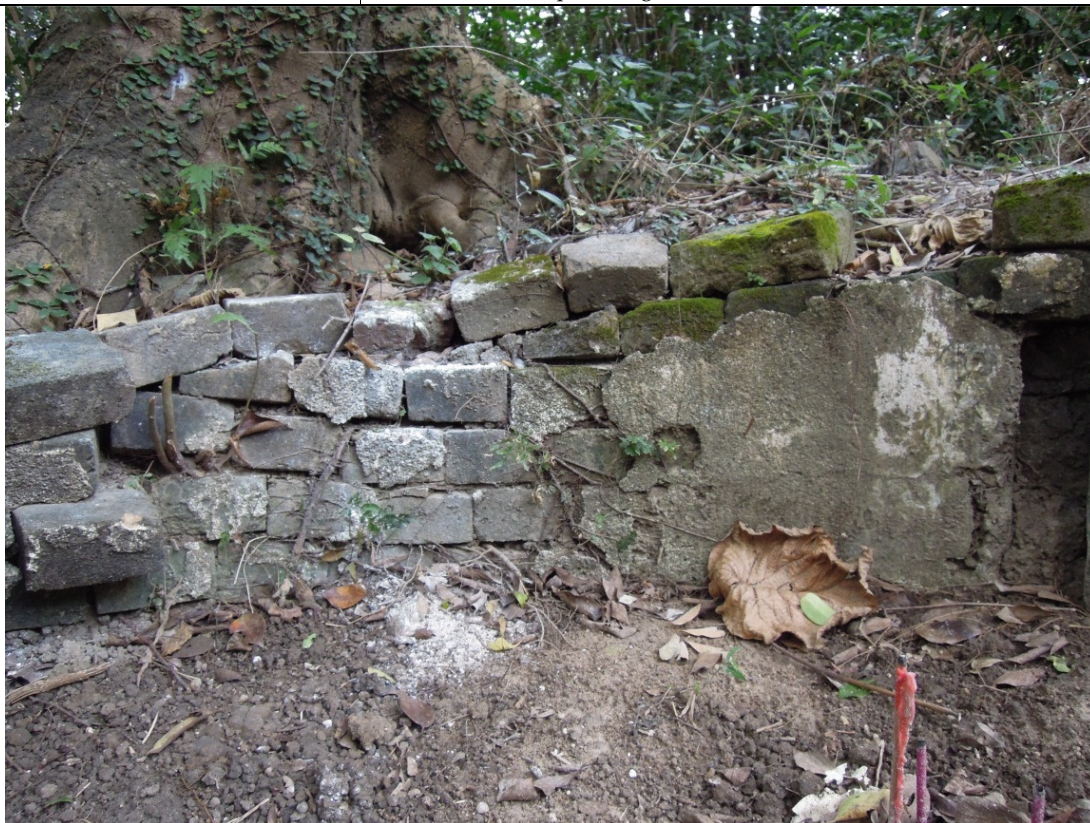
**GR02-4-P5**

Close up of brick wall pattern of GR02-4, showing the wall was originally with cement plastered. GR02-4 磚壁圖案近觀，顯示了磚壁在過往覆蓋有水泥。

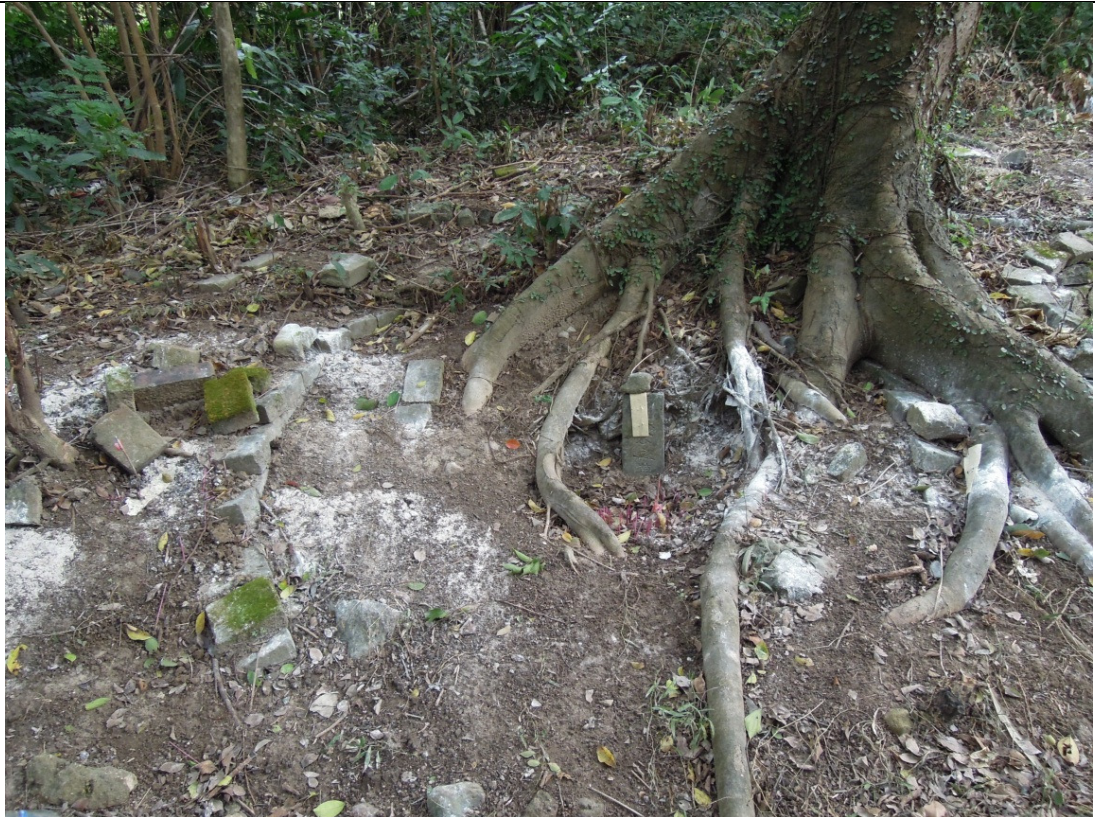
GR02-5-P2

Front view of GR02-5, showing GR02-5 heavily disturbed by tree roots. GR02-5正視圖，顯示了GR02-5被樹

根嚴重破壞。

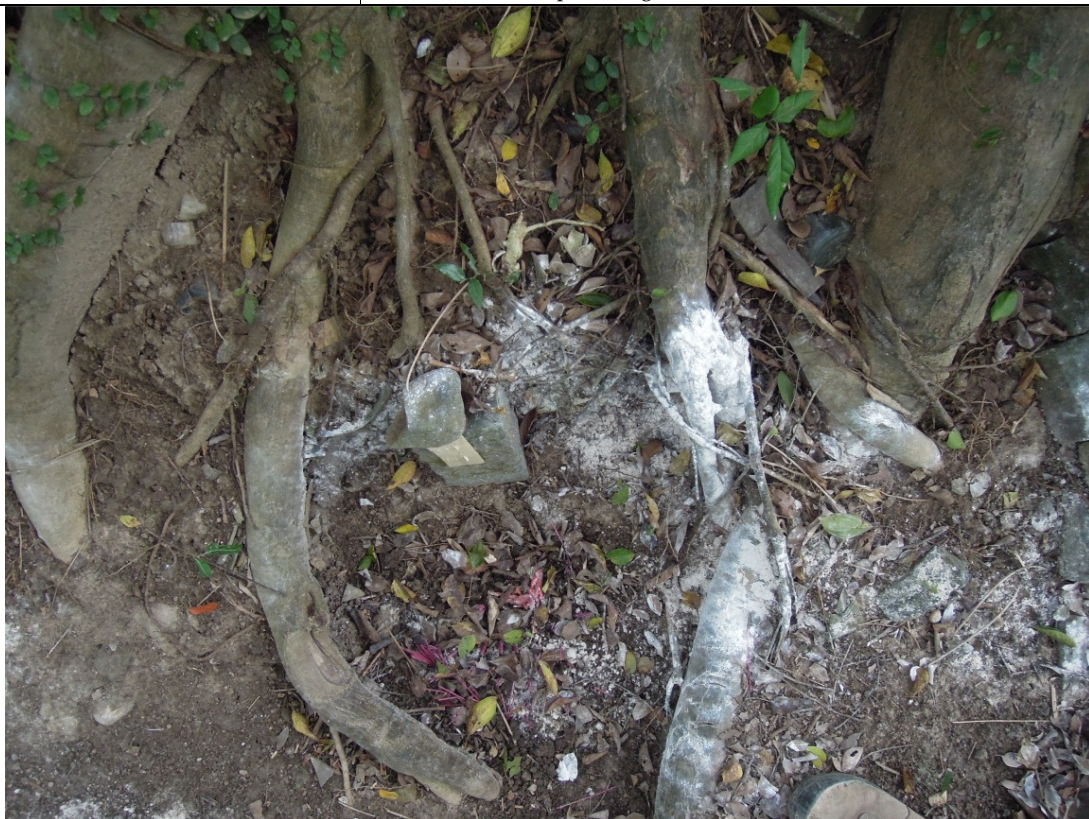
**GR02-5-P4**

View of headstone disturbed heavily by tree roots 上圖顯示墓碑受樹根嚴重破壞

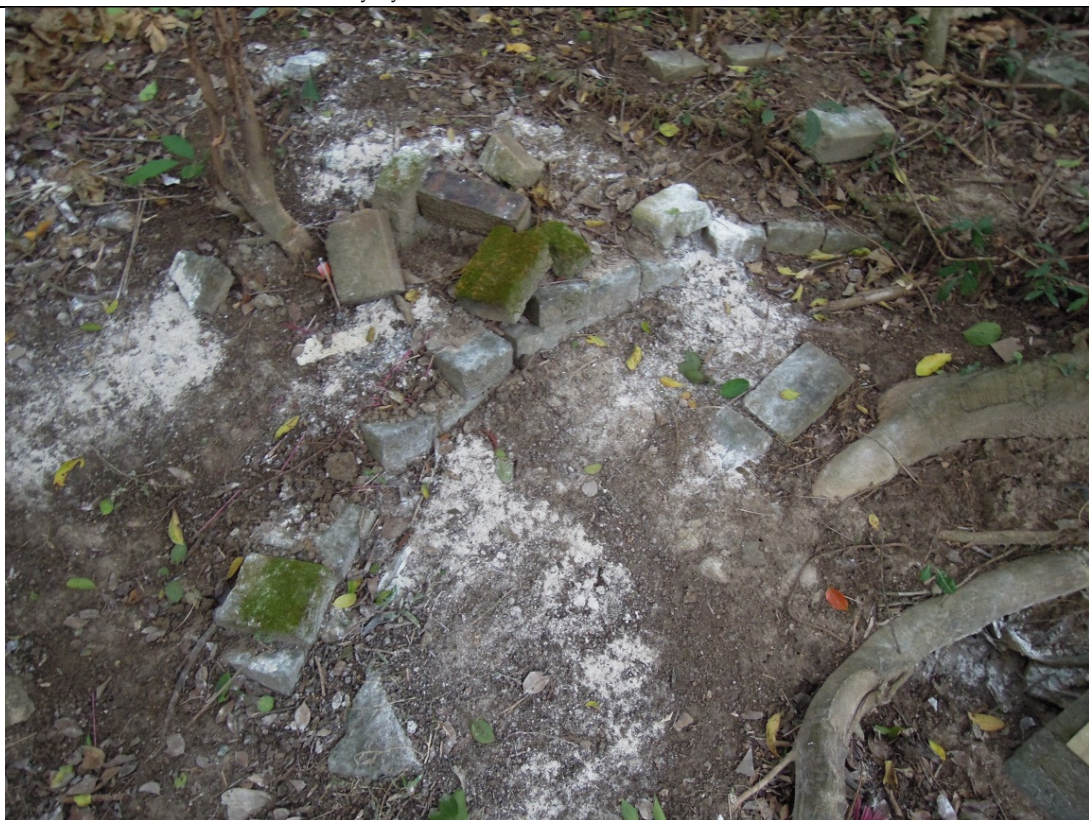
**GR02-5-P5**

Close up of remains of brick wall of GR02-5 GR02-5殘留磚壁的近觀
