Contract No. EP/SP/58/08
Sludge Treatment Facilities
Environmental Monitoring and Audit Report
For
March 2015

This monthly report reviews the progress of the environmental monitoring and audit work at the site for Contract No. EP/SP/58/08 from 25 February 2015 to 24 March 2015 (the reporting period) and forecasts the activities for April 2015. Since water quality monitoring was not required in the reporting period, no graphical presentation for marine and stream water quality results for the reporting period is included. Findings of Landfill Gas, Ecology and Landscape monitoring are presented in Section 4. For radon monitoring, measurement details and results can be referred to the Radon Monitoring Report Ref. No. 100440EN140865(1)A in Appendix 5, Monthly EM&A Report of February 2015.

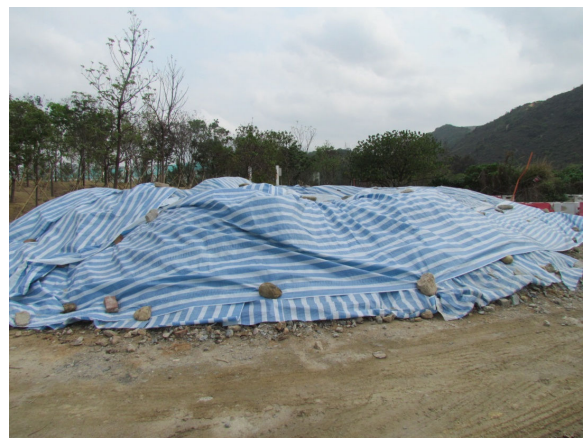
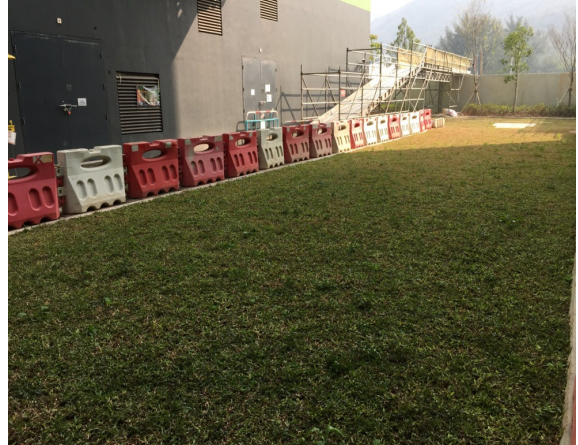
| 1. Photographic Record of the PFA Treatment | |

| 1. Photographic Record of the PFA Treatment | |
|---|--|
| <p>Capping of the PFA is established to prevent spreading in air.</p> | <p>Suitable topsoil has been imported to the site for softscape planting.</p> |

Topsoil found within the project site is PFA. Suitable topsoil already imported for planting. All PFA excavated during the tree felling works has been retained in the site confinement. The PFA has been under dehydration and concealed properly to prevent spreading in the air. Backfill of PFA to its original location inside site area is under progress.

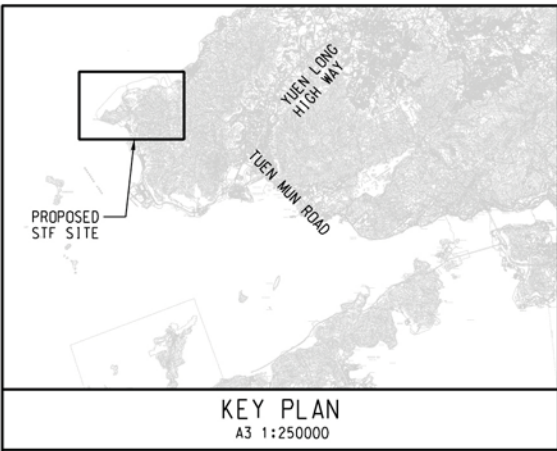
Figure 3.1

Site Layout Plan

The Contractor, VW-VES (HK) Limited, has been awarded a contract by the Environmental Protection Department of the Government of the Hong Kong Special Administrative Region for the Sludge Treatment Facilities. The location of the site is shown in Figure 3.1.

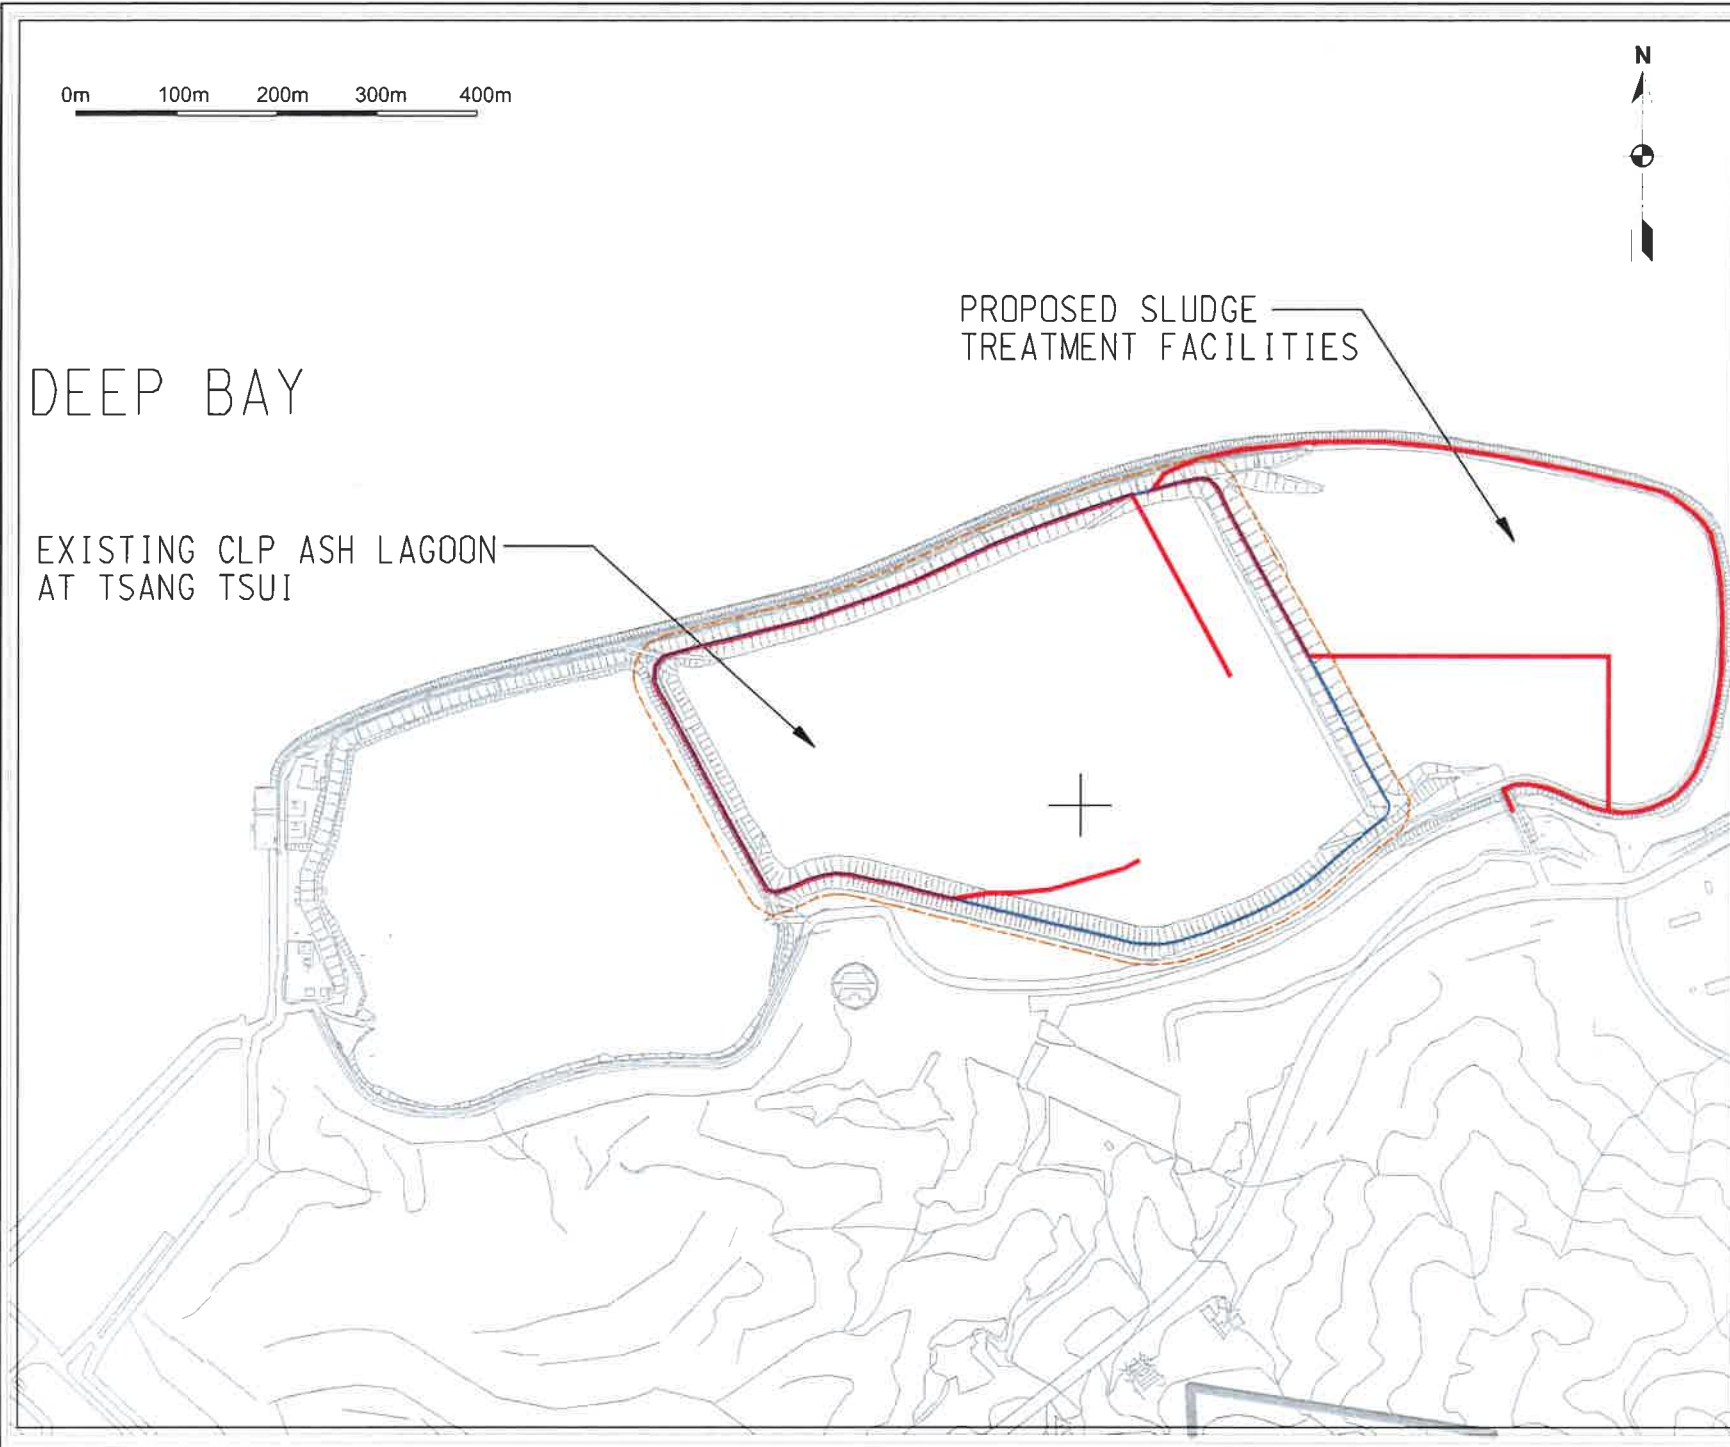
- Notes:
- Survey Route
 - Middle Lagoon Boundary
 - - - 20m from Middle Lagoon Boundary
