# Hong Kong Section of Guangzhou-Shenzhen-Hong Kong Express Rail Link

Environmental Monitoring and Audit Report

February 2014

Environmental Monitoring and Audit Report No. 48  
(Feb 2014)

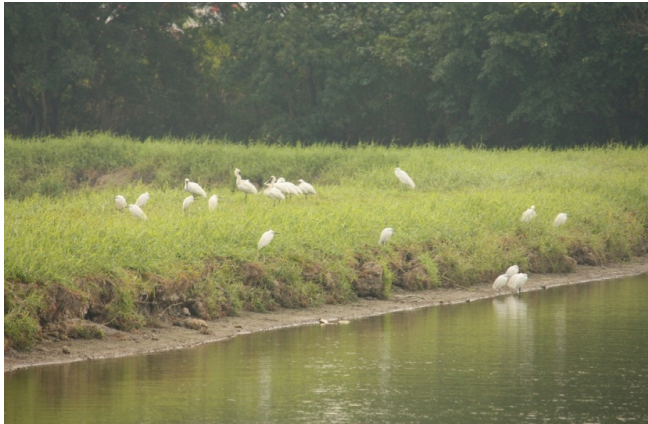
Plate 1 Pond was being ploughed at Point Count Location MPV-1/P4

<b>Date</b>	<b>Weather Conditions</b>	<b>Noticeable Activities in the MPV-1 Survey Site</b>
21 February 2014	Overcast	<ul style="list-style-type: none"> <li>• Ponds were being ploughed at Point Count Locations MPV-1/4</li> <li>• Pond aeration at Point Count Locations MPV-1/P14 and from MPV-1/P16 to MPV-1/P18</li> </ul>

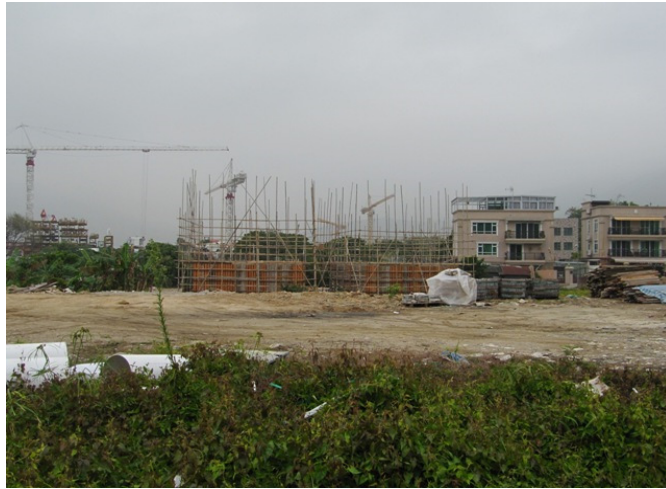
Plate 3 Non Project-related construction works observed near Point Count Location TPP-3/P2

Date of Monitoring	Weather Condition	Noticeable Activities Observed in the TPP-3 Survey Site
21 February 2014	Overcast	<ul style="list-style-type: none"> <li>• Non project-related construction works were observed near Point Count Location TPP-3/P2</li> </ul>

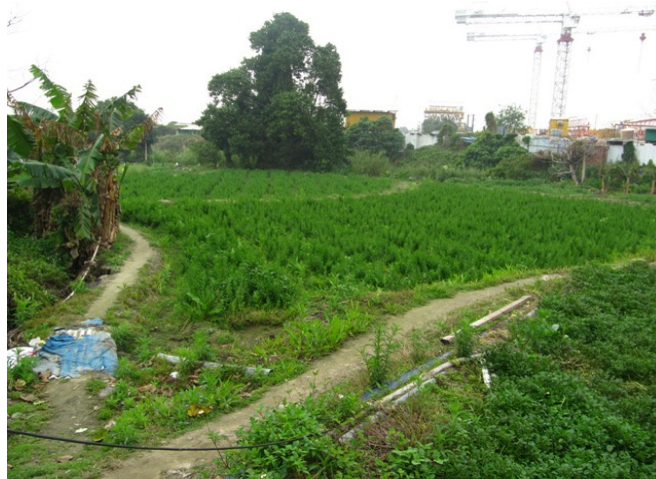
Plate 4 Non Project-related construction works at Point Count Location SSS-3/P6
