Monthly Environmental Monitoring and Audit (EM&A) Report for March 2016

April 2016

Development at West Kowloon Cultural District Monthly Environmental Monitoring and Audit (EM&A) Report for March 2016

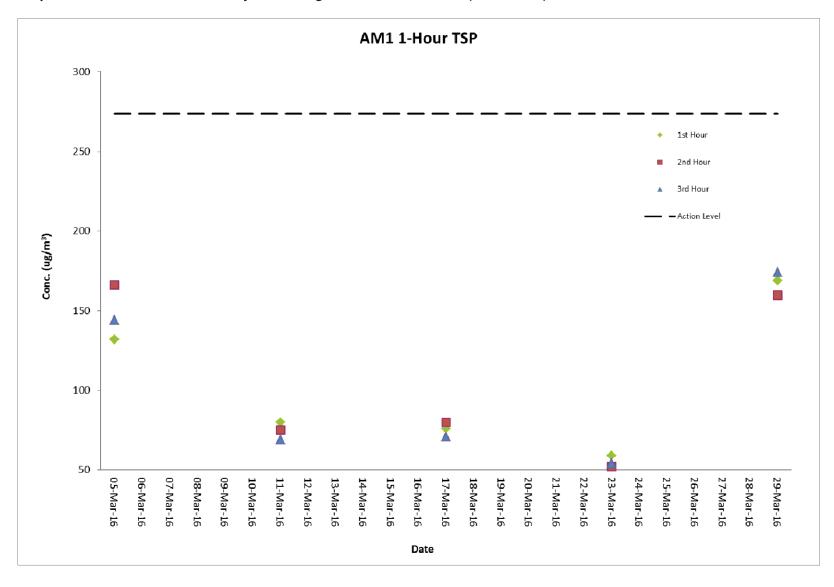
Graphical Presentation of Air Quality Monitoring Result at Station AM1 (1-hour TSP)

Conc. (µg/m³)			Action	Limit		
D . I .	Weather	T '	4 St	and	ard	Level	Level	D 41	
Date	Condition	Time	1 st Hour	2 nd Hour	3 rd Hour	(μg/m³)	(μg/m³)	Min	Max
05-Mar-16	Cloudy	8:00 - 11:00	132	166	144	273.7	500		
11-Mar-16	Cloudy	10:50 - 15:00	80	75	69	273.7	500		
17-Mar-16	Cloudy	10:45 - 16:00	76	80	71	273.7	500	52	174
23-Mar-16	Cloudy	10:48 - 15:00	59	52	54	273.7	500		
29-Mar-16	Fine	10:40 - 15:00	169	160	174	273.7	500

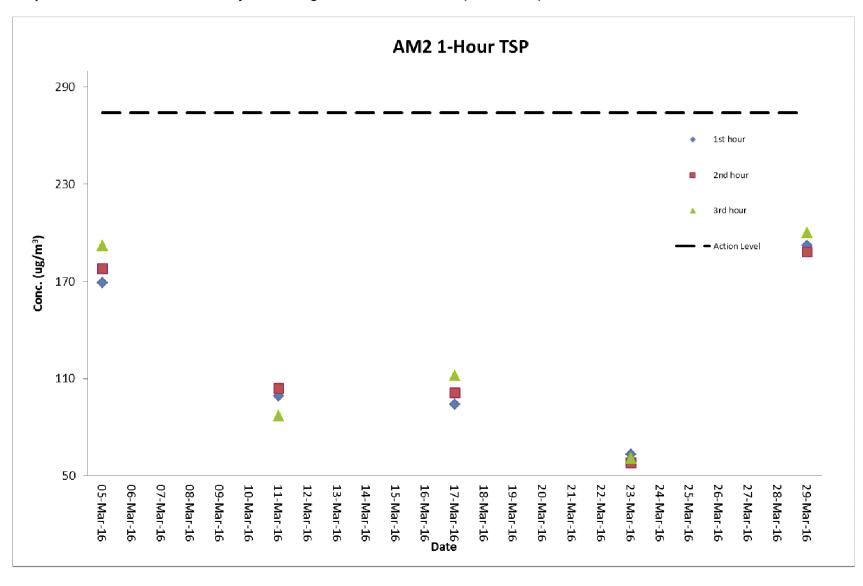
Graphical Presentation of Air Quality Monitoring Result at Station AM2 (1-hour TSP)

Conc. (µg/m³))	Action	Limit		
Date	Weather Condition	Time	1 st Hour	2 nd Hour	3 rd Hour	Level (μg/m³)	Level (μg/m³)	Min	Max
Date	Condition	Tille	1 11001	Z Houi	3 HOUI	(μg/111)	(μg/111)	IVIIII	IVIAX
05-Mar-16	Cloudy	8:10 - 11:10	169	178	192	274.2	500		
11-Mar-16	Cloudy	11:00 - 15:10	99	104	87	274.2	500		
17-Mar-16	Cloudy	10:53 - 16:10	94	101	112	274.2	500	58	200
23-Mar-16	Cloudy	11:00 - 15:10	63	58	61	274.2	500		
29-Mar-16	Fine	10:52 - 16:10	192	188	200	274.2	500

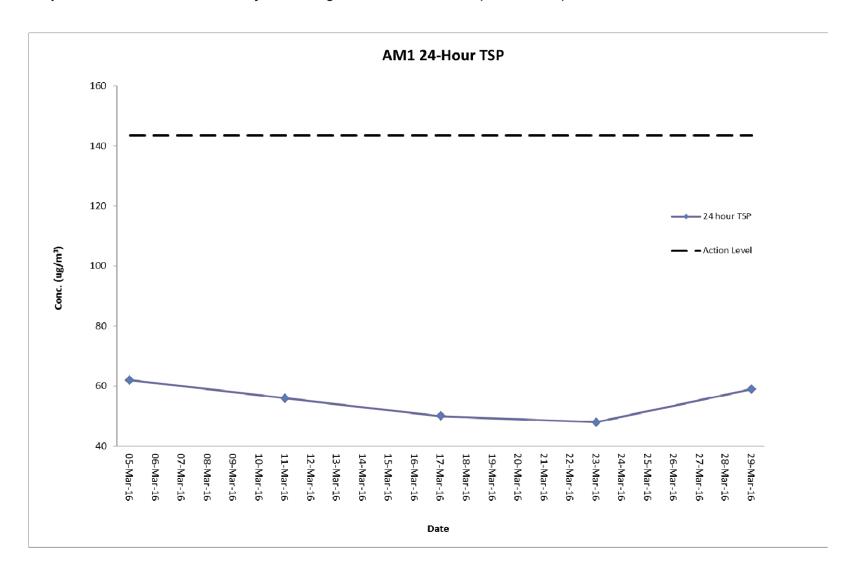
Graphical Presentation of Air Quality Monitoring Result at Station AM1 (24-hour TSP)

Star	rt	Finis	sh	Filter W	eight (g)		d Time ding	Sampling	Flow Rate (m ³ /min)		min) Conc.		Action	Limit	
Date	Time	Date	Time	Initial	Final	Initial	Final	Time (hrs)	Initial	Final	Average	(μg/m³)	Condition	Level	Level
05-Mar-16	08:02	06-Mar-16	08:02	2.7767	2.888	19176.38	19200.38	24	1.25	1.25	1.25	62	Cloudy	143.6	260
11-Mar-16	10:48	12-Mar-16	10:48	2.7895	2.8911	19200.38	19224.38	24	1.25	1.25	1.25	56	Cloudy	143.6	260
17-Mar-16	10:43	18-Mar-16	10:43	2.8007	2.8911	19224.38	19248.38	24	1.25	1.25	1.25	50	Cloudy	143.6	260
23-Mar-16	10:50	24-Mar-16	10:50	2.7907	2.8779	19248.38	19272.38	24	1.25	1.25	1.25	48	Cloudy	143.6	260
29-Mar-16	10:42	30-Mar-16	10:42	2.7842	2.8911	19272.38	19296.38	24	1.25	1.25	1.25	59	Fine	143.6	260

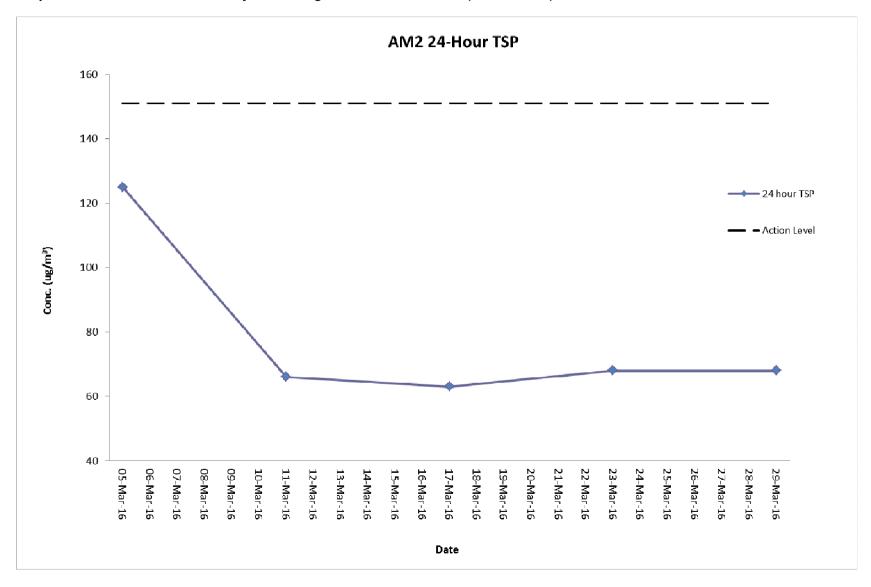
Graphical Presentation of Air Quality Monitoring Result at Station AM2 (24-hour TSP)

Sta	rt	Finis	sh	Filter W	eight (g)		d Time ding	Sampling	Flow Rate (m³/min)		Conc.	Weather	Action	Limit	
Date	Time	Date	Time	Initial	Final	Initial	Final	Time (hrs)	Initial	Final	Average	(μg/m³)	Condition	Level	Level
05-Mar-16	08:13	06-Mar-16	08:13	2.789	3.0048	14879.59	14903.59	24	1.2	1.2	1.2	125	Cloudy	151.1	260
11-Mar-16	11:03	12-Mar-16	11:03	2.7865	2.9009	14903.59	14927.59	24	1.2	1.2	1.2	66	Cloudy	151.1	260
17-Mar-16	10:56	18-Mar-16	10:56	2.822	2.93	14927.59	14951.59	24	1.2	1.2	1.2	63	Cloudy	151.1	260
23-Mar-16	11:05	24-Mar-16	11:05	2.7742	2.8911	14951.59	14975.59	24	1.2	1.2	1.2	68	Cloudy	151.1	260
29-Mar-16	10:55	30-Mar-16	10:55	2.7829	2.9009	14975.59	14999.59	24	1.2	1.2	1.2	68	Fine	151.1	260

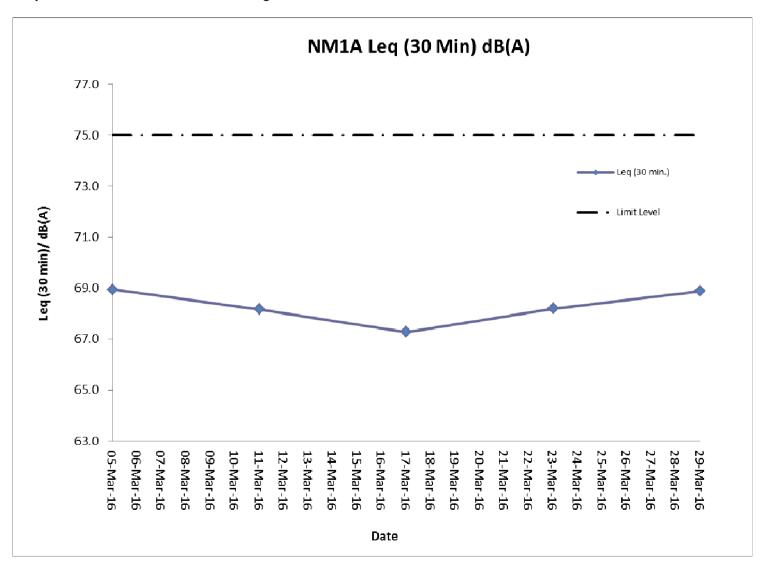
Graphical Presentation Noise Monitoring Result at Station NM1A

Date	Time	Measured L ₁₀ dB(A)	Measured L ₉₀ dB(A)	L _{eq} (30 min.) dB(A)
05-Mar-16	09:17	68.2	62.3	
05-Mar-16	09:22	68.5	62.3	
05-Mar-16	09:27	67.6	62.2	69.0
05-Mar-16	09:32	68.6	63.6	
05-Mar-16	09:37	68.8	62.7	
05-Mar-16	09:42	68.7	63.5	
11-Mar-16	15:50	68.0	63.4	
11-Mar-16	15:55	67.9	62.4	
11-Mar-16	16:00	67.5	62.0	68.2
11-Mar-16	16:05	67.9	62.7	
11-Mar-16	16:10	67.7	63.5	
11-Mar-16	16:15	67.4	62.9	
17-Mar-16	13:00	64.9	60.9	
17-Mar-16	13:05	66.2	61.1	
17-Mar-16	13:10	66.8	62.4	67.3
17-Mar-16	13:15	66.7	61.9	
17-Mar-16	13:20	66.9	62.4	
17-Mar-16	13:25	67.2	63.9	
23-Mar-16	15:50	66.9	62.5	
23-Mar-16	15:55	67.7	63.3	
23-Mar-16	16:00	65.8	61.9	68.2
23-Mar-16	16:05	66.9	62.9	
23-Mar-16	16:10	67.9	63.4	
23-Mar-16	16:15	67.9	63.8	
29-Mar-16	14:45	66.0	62.7	
29-Mar-16	14:50	67.9	63.4	
29-Mar-16	14:55	67.9	63.4	68.9
29-Mar-16	15:00	68.0	63.9	
29-Mar-16	15:05	69.2	64.0	
29-Mar-16	15:10	68.0	63.8

The station set-up of a free-field measurement at Station NM1A.
