# Civil Engineering and Development Department

**Contract No. ST/2013/01**  
**Sha Tin New Town Stage II**  
**Road T3 and Associated Roadworks –**  
**Remaining Works, Phase III**  
Monthly EM&A Report  
(Version 1.0)  
December 2014

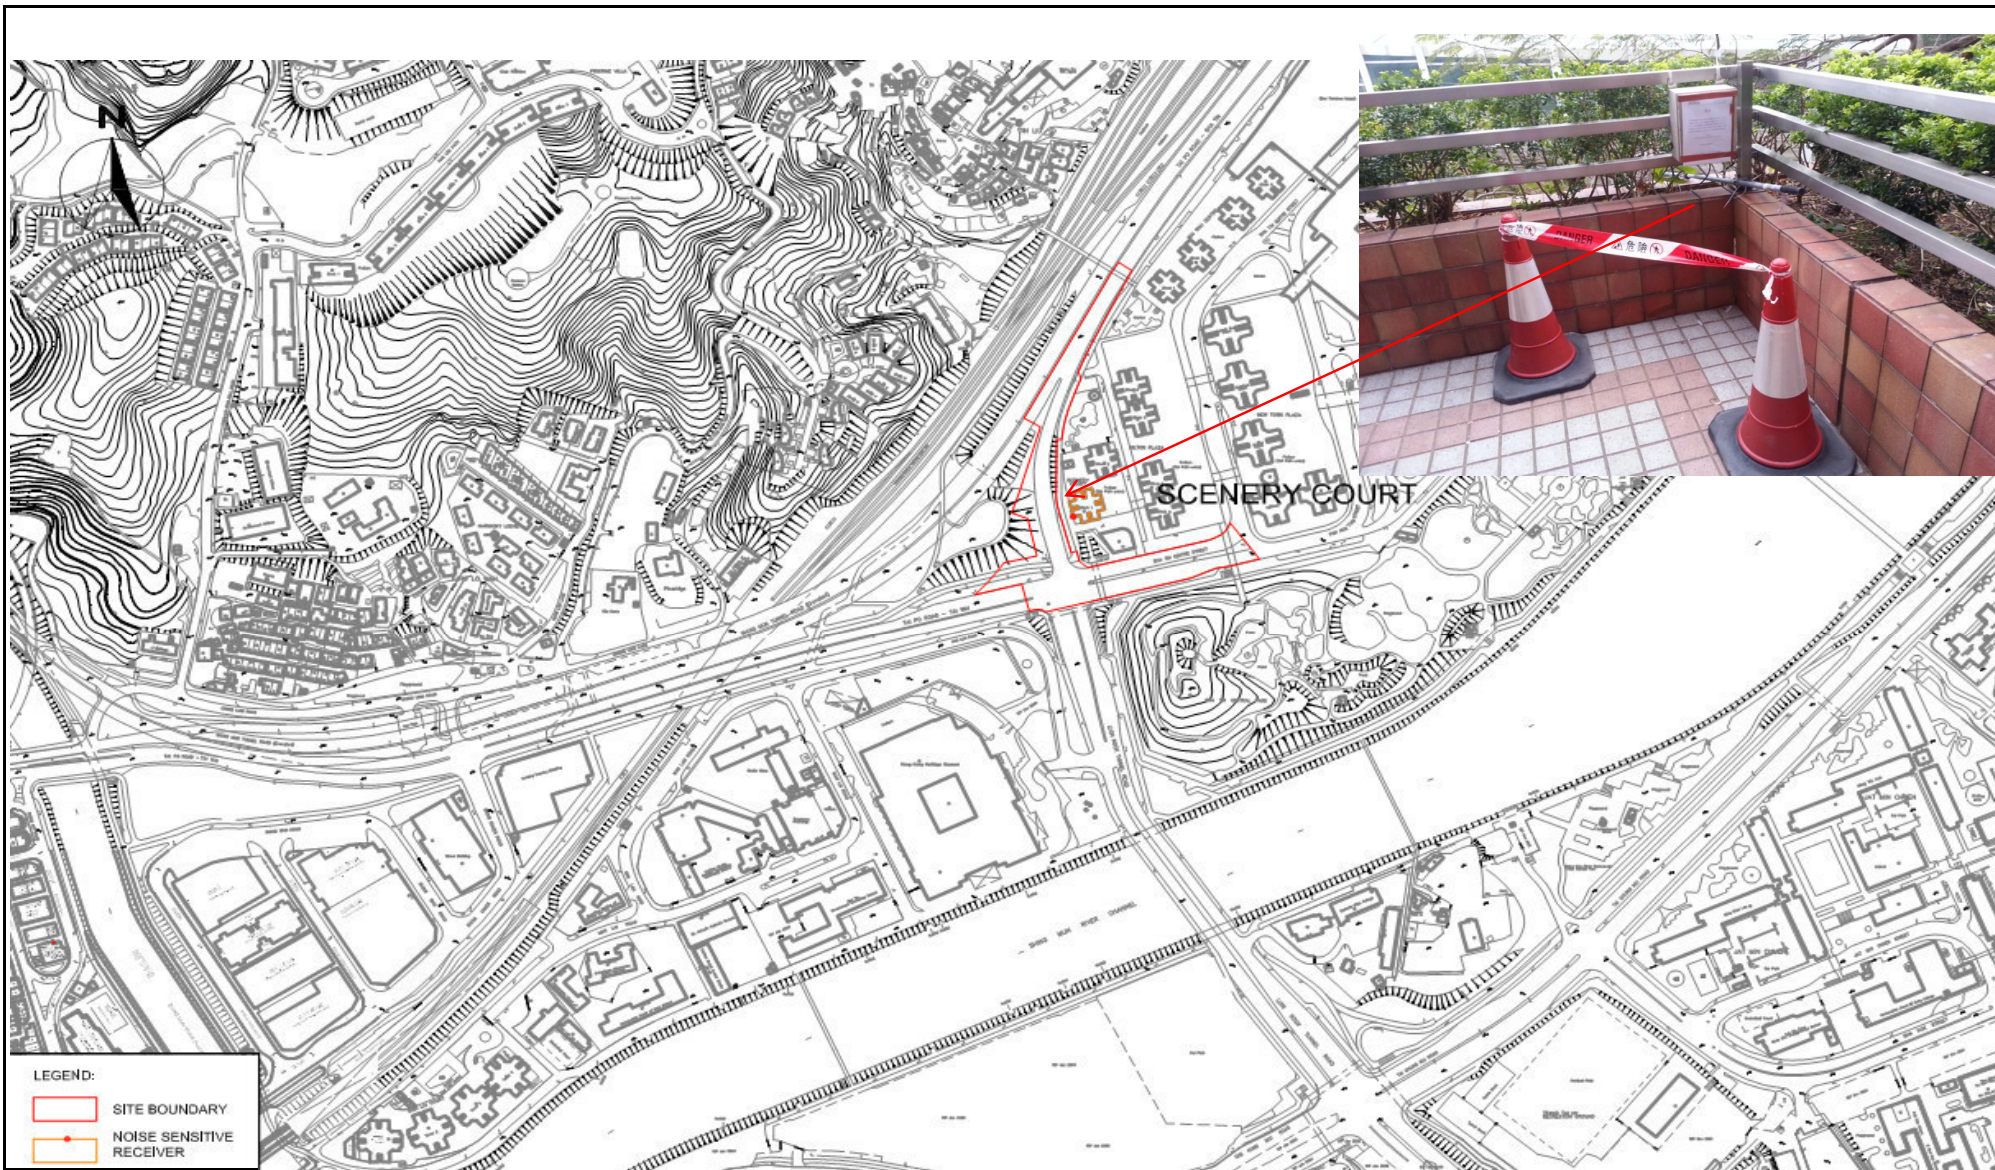
Title	Contract No. ST/2013/01 -	Scale	Project	CINOTECH
	Sha Tin New Town Stage II - Road T3 and Associated Roadworks – Remaining Works, Phase III	N.T.S	No. MA13058	
	Location of Noise Monitoring Station at Scenery Court	Date	Figure	
		Feb-14	1

- 1.3 Cinotech Consultants Limited was commissioned by the CEDD to undertake the Environmental Monitoring and Audit (EM&A) works for the Project.
- 1.4 The site layout plan and the location of noise monitoring station are shown in **Figure 1**.

- 2.2 Noise monitoring was conducted at one designated monitoring station as presented in **Table 2.1**. **Figure 1** shows the location of the monitoring station.
