# **Entrusted Portion of Widening of Tolo Highway / Fanling Highway between Island House Interchange and Fanling Stage 2**

Monthly EM&A Report

April 2015

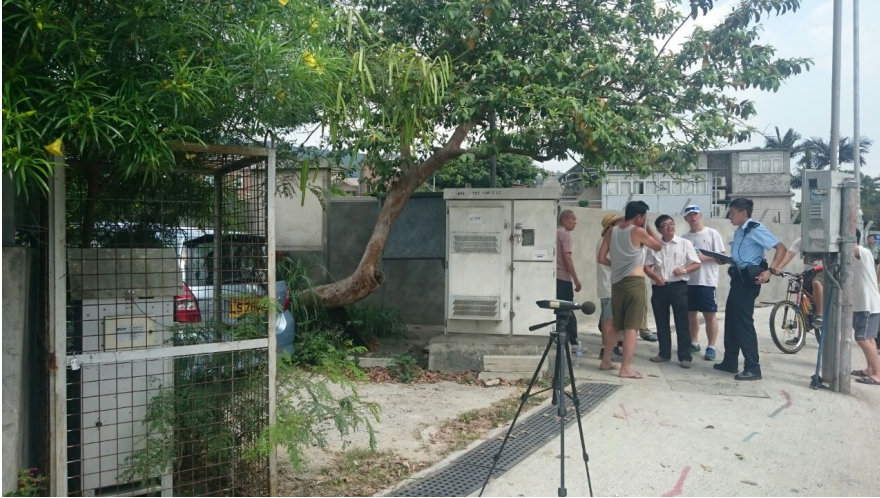
Photo 1: Local residents protesting against police force (Date: 30 April 2015)

<b>Action taken / to be taken</b>	The exceedance would due to public interruption which is out of the control of the contractor. As such, if similar incidents happen in future, the result would be considered invalid and re-monitoring would be arranged.
<b>Remarks</b>	-

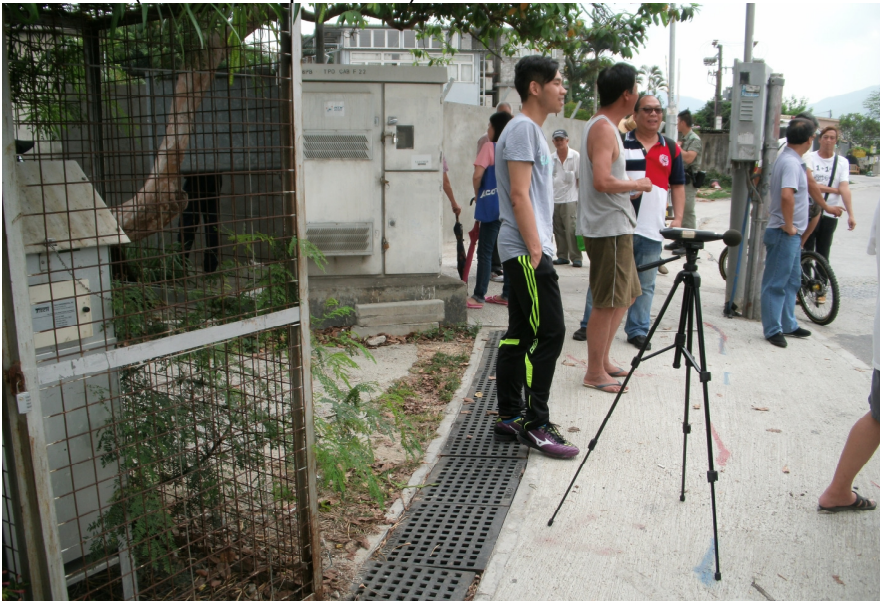
Photo 2: Local residents protesting against police force near the noise meter (Date: 30 April 2015)

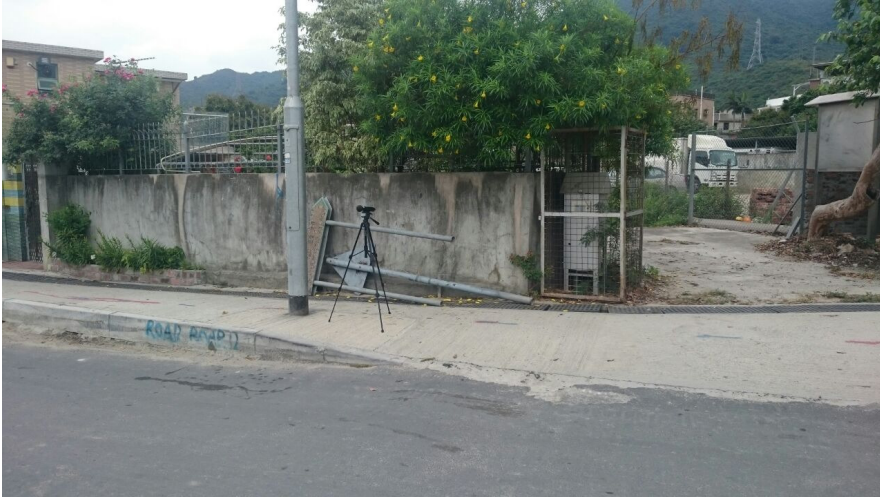
Photo 3: Re-Monitoring taking place on 6 May 2015 (Date: 6 May 2015)
