# Sun Fook Kong – Bestwise Joint Venture

**Contract No. DC/2009/10  
HATS Stage 2A – Upgrading  
Works at Stonecutters Island Sewage  
Treatment Works - Main Pumping Station,  
Sedimentation Tanks and Ancillary Facilities**

**Monthly Environmental  
Monitoring and Audit Report  
January 2019**

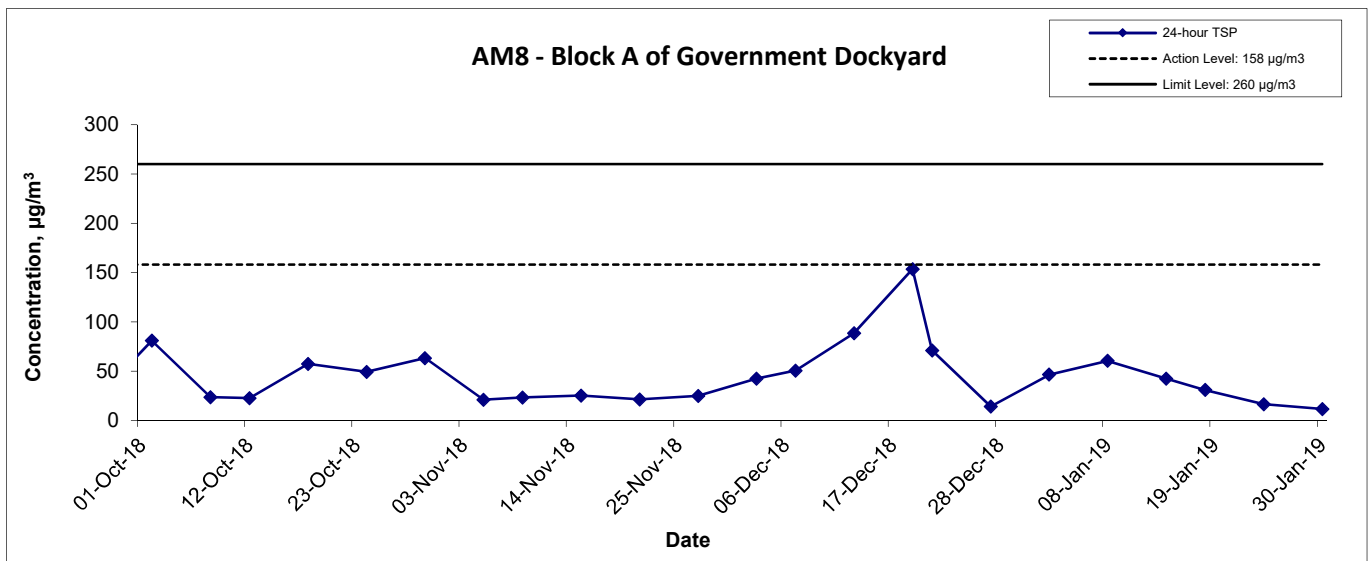
### 24-hr TSP Concentration Levels

Title Contract No. DC/2009/10 HATS 2A – Upgrading Works at SCISTW– Main Pumping Station, Sedimentation Tanks and Ancillary Graphical Presentation of 24-hour TSP Monitoring Results	Scale N.T.S	Project No. MA11007	
	Date Jan 19	Appendix D
