# Contract No. DE/2018/17 Enhancement of Deodourisation System at Stonecutters Island Sewage Treatment Works

Monthly Environmental Monitoring and Audit Report July 2021

(Version 1.0)

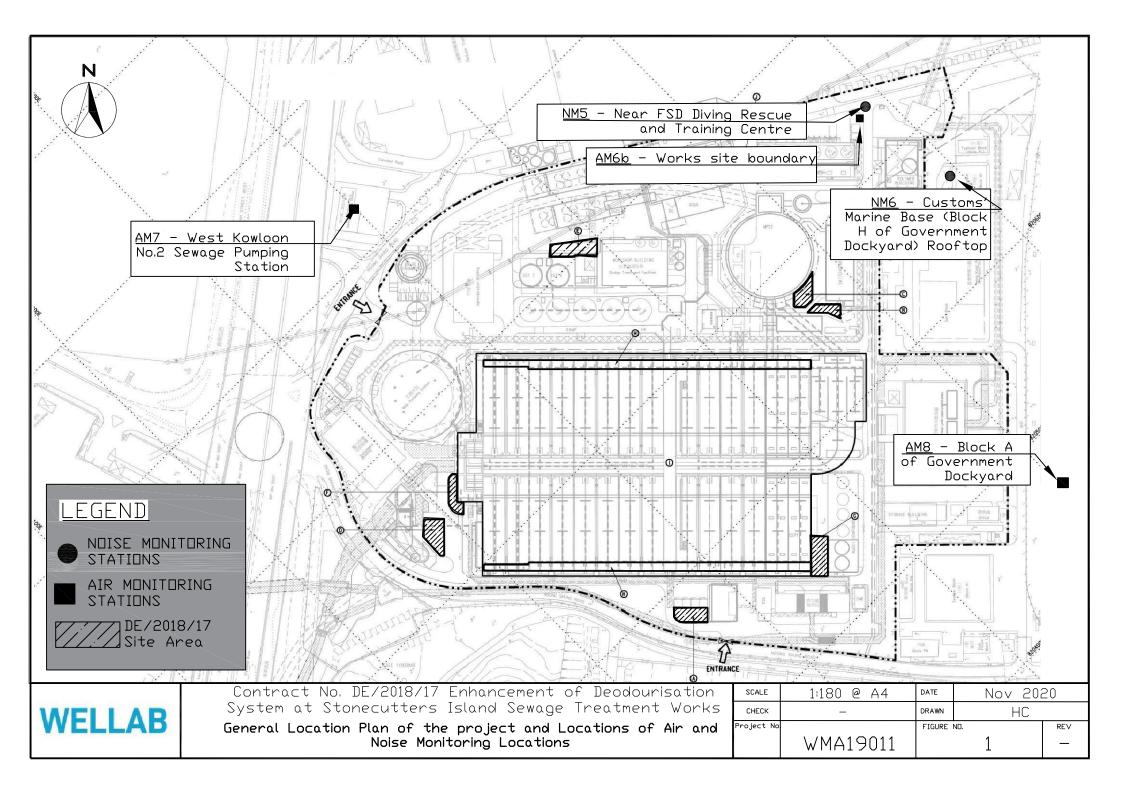
- 1.4 Wellab Limited was commissioned by BSJV to undertake the Environmental Monitoring and Audit (EM&A) works for the project and was appointed as the Environmental Team (ET) of the Project under Condition 2.1 of the EP. The date of commencement of EM&A works is 2<sup>nd</sup> September 2019. The Project cover the environmental monitoring works at monitoring stations AM6b, AM7, AM8, NM5 and NM6. The general location plan of the Project is shown in **Figure 1**.

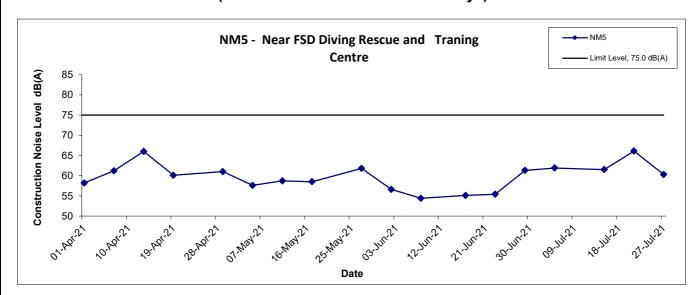
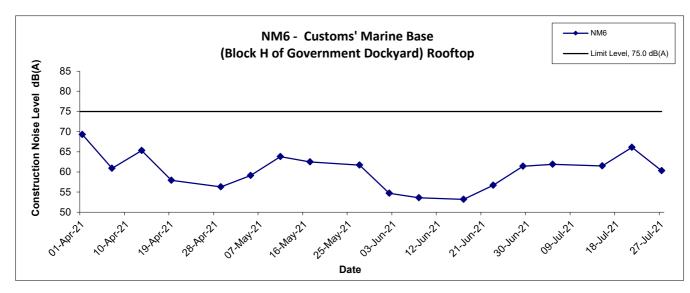
Title	Contract No. DE/2018/17	Scale		Project	
	Enhancement of Deodourisation System at Stonecutters Island		N.T.S	No. WMA1901	
	Sewage Treatment Works				WELLAB匯力
		Date		Appendix _	consulting . testing . research
	Graphical Presentation of Noise Monitoring Result		Jul 21	E

### **Noise Levels**

# (0700-1900 hrs on Normal Weekdays)
