**Appendix H**  
**Investigation Report**

**Report No.** 003  
**Monitoring Date** 29 April 2022

Harbour Area Treatment Scheme Stage 2A (Operational Phase)  
Investigation Report on Action Level or Limit Level Non-compliance

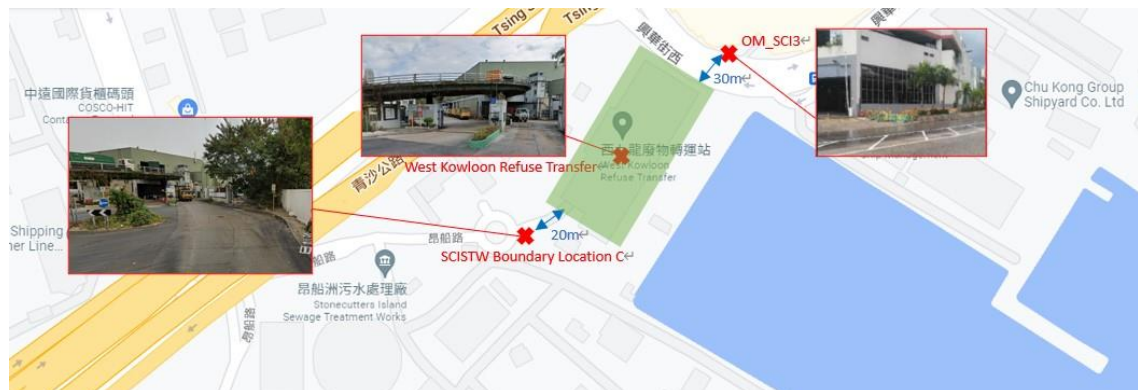
- Investigation was conducted by DSD to identify the reason / source of exceedance. It was noted that West Kowloon Refuse Transfer Station is located next to the SCISTW. In Hong Kong, a total of seven Refuse Transfer Stations (RTS) is currently in operation. Throughput of West Kowloon Transfer Station is about 2,700 tonnes per day which has the largest throughput among the seven RTS and resulted in high frequency of refuse vehicles going in and out Ngong Shung Road.
- SCISTW Boundary Location C is a monitoring point in front of the West Kowloon Refuse Transfer Station. OM\_SCI3 and WKTS is only separated by Hing Wah Street West only. Therefore, the odour at these two points were largely related to the West Kowloon Refuse Transfer Station. The following diagram shown the location and distance between the corresponding monitoring point and West Kowloon Transfer Station:

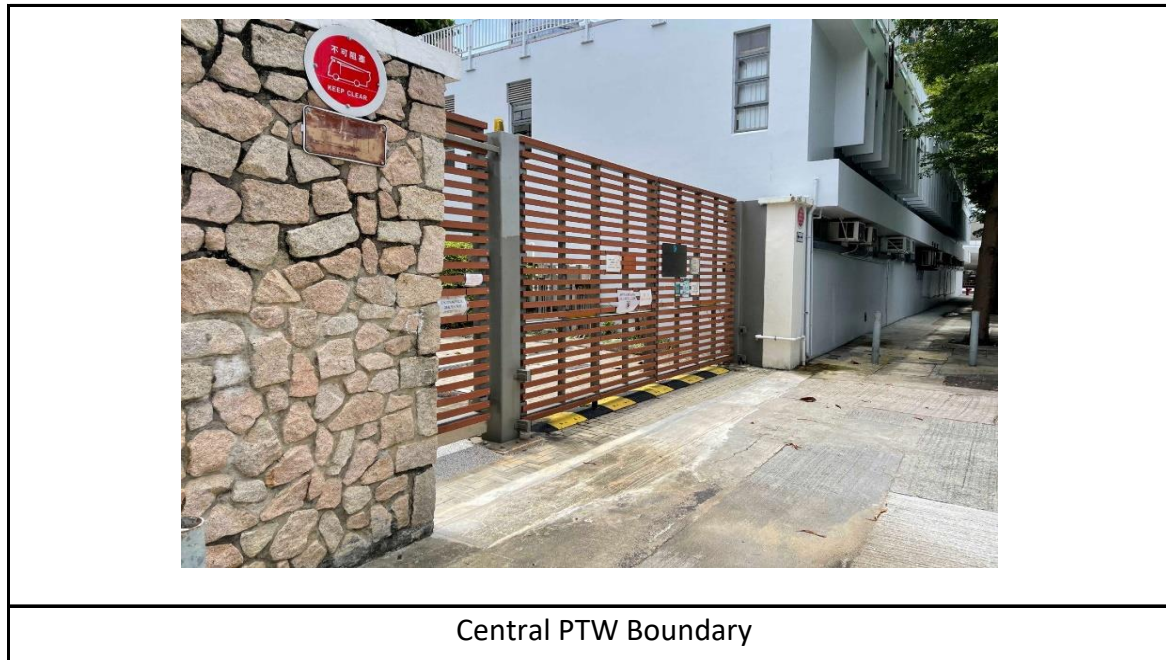
**Field Record and Photo Record for Additional Odour Patrol on 18<sup>th</sup> May 2022**

Location ID	Panellist	Weather	Time	Temperature (°C)	Relative Humidity (%)	Wind Speed (m/s)	Wind Direction	Odour Intensity	Duration of Odour	Direction from Source	On-Site Observation	
											Odour Characteristics	Potential Odour Source
Central PTW Boundary	1	Sunny	1155	26.1	38	0.7	NW	1	Continuous	Downwind	Sewage	Sewage Treatment Plant
	2							1				
	3							1

- To confirm the findings and conclusion, additional odour patrol at Central PTW Boundary was conducted on 18<sup>th</sup> May 2022. The field record and photo record during the patrol are attached in **Annex 1**. On 18<sup>th</sup> May 2022, the odour intensity was 1 for all three panelists. The odour level was acceptable and thus the exceedance recorded on 29<sup>th</sup> April 2022 was considered as an occasional case. The operators are reminded to maintain the equipment and plants in good condition and have a close monitoring on the performance of the deodorization units.
