# Hong Kong Section of Guangzhou-Shenzhen-Hong Kong Express Rail Link

Environmental Monitoring and Audit Report

December 2015

Environmental Monitoring and Audit Report No. 70  
(December 2015)

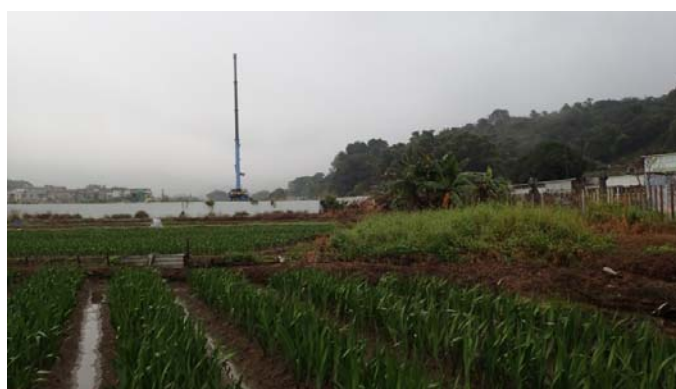
Plate 6 Project-related construction works observed near Point Count Location TUW-1/P4
