Hong Kong Section of Guangzhou-Shenzhen-Hong Kong Express Rail Link

Environmental Monitoring and Audit Report

November 2016

Environmental Monitoring and Audit Report No. 81
(November 2016)

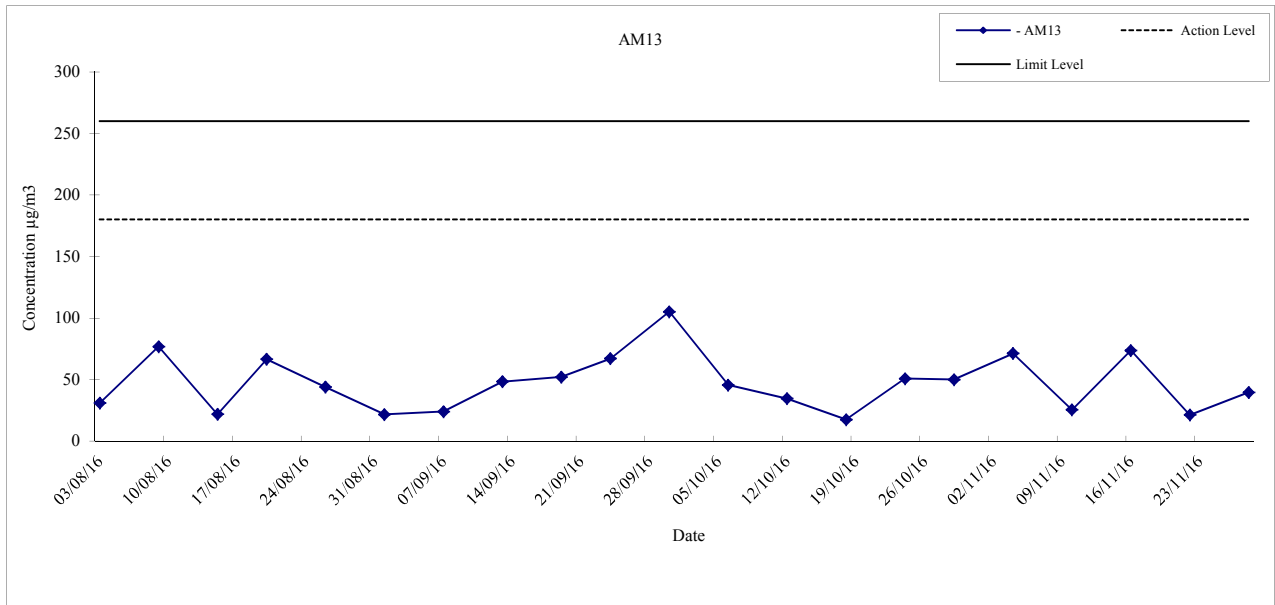
Hong Kong Section of Guangzhou-Shenzhen-Hong Kong Express Rail Link Graphical Presentation of 24-hour TSP Monitoring Result for Location AM13 and AM14	Date	2016
		APPENDIX	F
