Hong Kong Section of Guangzhou-Shenzhen-Hong Kong Express Rail Link

Environmental Monitoring and Audit Report

February 2017

Environmental Monitoring and Audit Report No. 84
(February 2017)

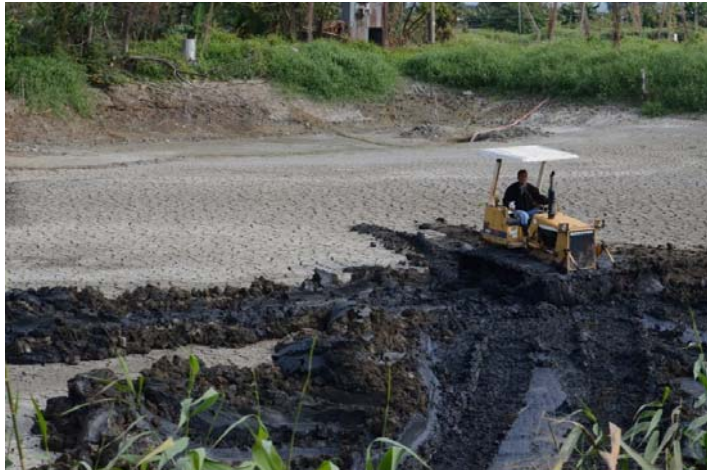
Plate 4 Pond was observed to be drained and site levelling works was being conducted at Point Count Location MPV-1/P3 (non-project related)

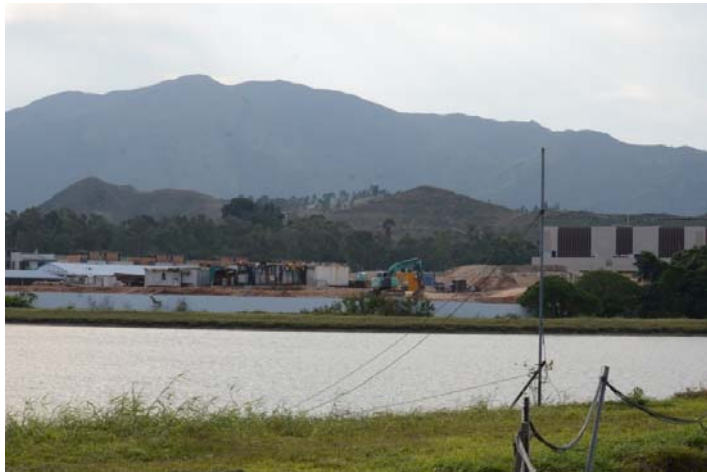
Date	Weather Conditions	Noticeable Activities Observed in the vicinity of MPV-1 Survey Site
9 February 2017	Overcast	<ul style="list-style-type: none"> • Overhead nets were observed at Point Count Location MPV-1/P2 • Ponds were observed to be drained and site levelling works are being conducted at Point Count Location MPV-1/P3 (Plate 4, Appendix H refers) (non-project related) and partially drained at Point Count Location MPV-1/P8 • Overhead wires were observed at Point Count Locations MPV-1/P8, MPV-1/P9 and MPV-1/P10 • Project-related works were observed at MPV-1/P6 (Plate 5, Appendix H refers)

Plate 5 Project-related works observed at Point Count Location MPV-1/P6

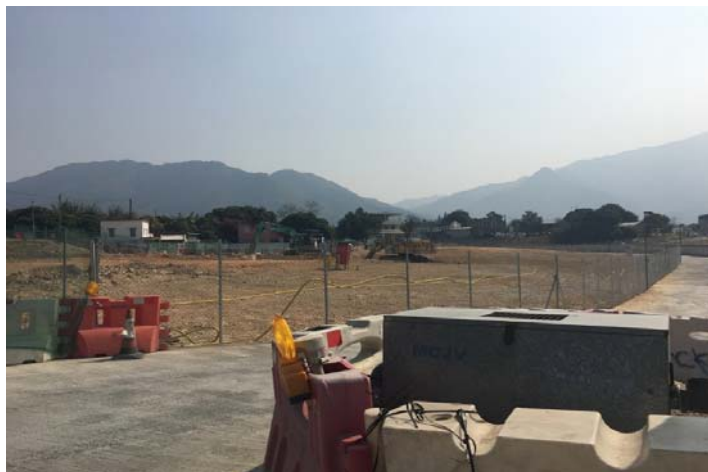
Date of Monitoring	Weather Condition	Noticeable Activities Observed in the vicinity of SSS-1 Survey Site
9 February 2017	Sunny	<ul style="list-style-type: none"> Project-related construction works for SSS/ERS were observed near Point Count Location SSS-1/P1 (Plate 8, Appendix H refers)

Plate 8 Project-related construction works for SSS/ERS were observed near Point Count Location SSS-1/P1

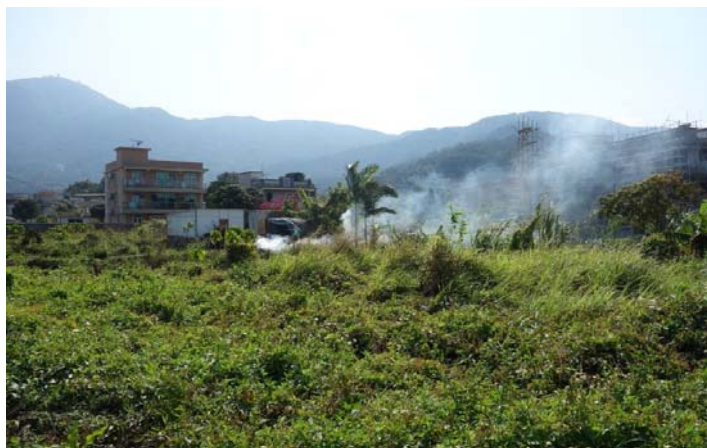
Plate 11 Open burning of grass was observed near Point Count Location SSS-3/P10

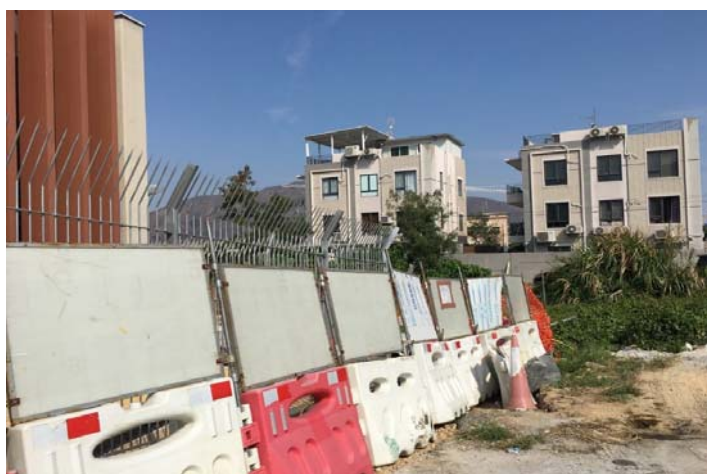
2. The access to Point Count Locations SSS-3/P6 was blocked due to project related work, therefore, the number of species recorded at Point Count Locations could not fully reflect the actual on-site condition.

Plate 12 The access to Point Count Location SSS-3/P6 was blocked due to project-related works

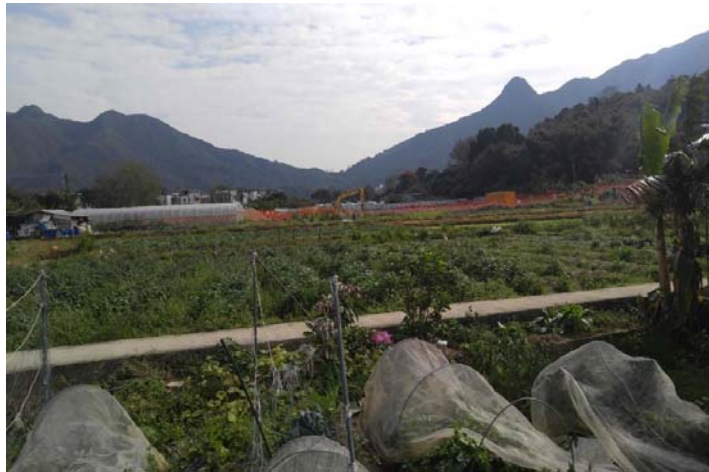
Plate 14 Project-related excavation works observed near Point Count Location TUW-1/P4
