**Shatin to Central Link –
Tai Wai to Hung Hom Section and
Mong Kok East to Hung Hom Section**

Monthly EM&A Report No. 33

[Period from 1 to 31 May 2015]

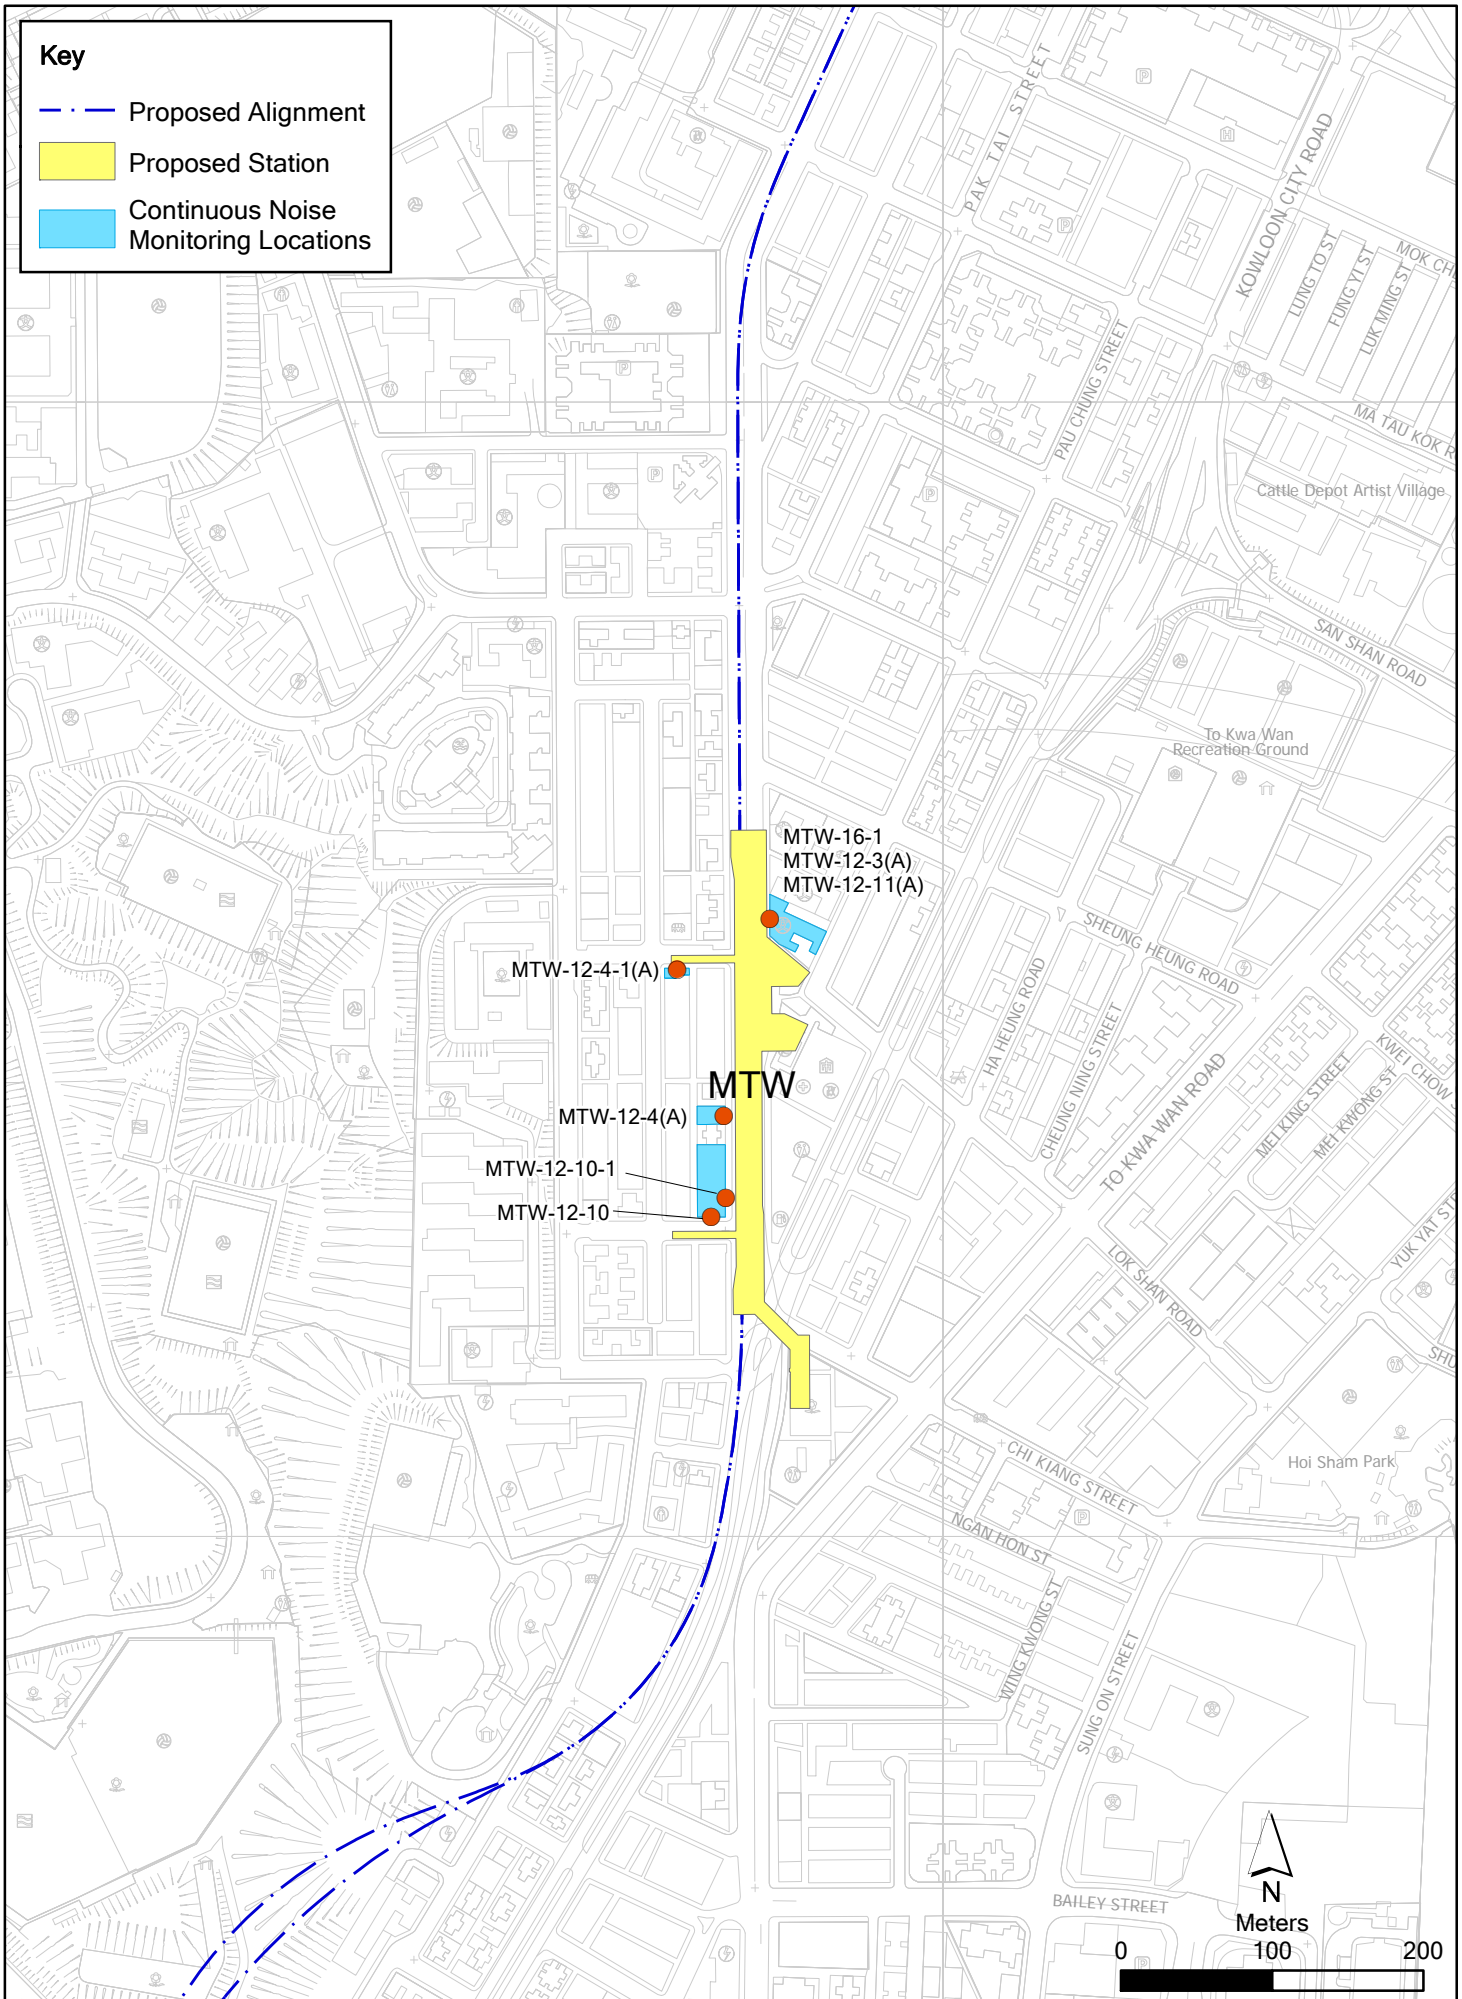
Figure 2.2b

Continuous Noise Monitoring Locations
