Contract No. HY/2011/09
Hong Kong-Zhuhai-Macao Bridge
Hong Kong Link Road – Section between HKSAR Boundary and Scenic Hill

Submission under Environmental Permit (EP-352/2009/D – Condition 4.4)
Monthly EM&A Report – January 2017

**Contract No. HY/2011/09 HZMB Hong Kong Link Road –
Section between HKSAR Boundary and Scenic Hill
Revised Monthly EM&A Report for January 2017 (EP-352/2009/D)**

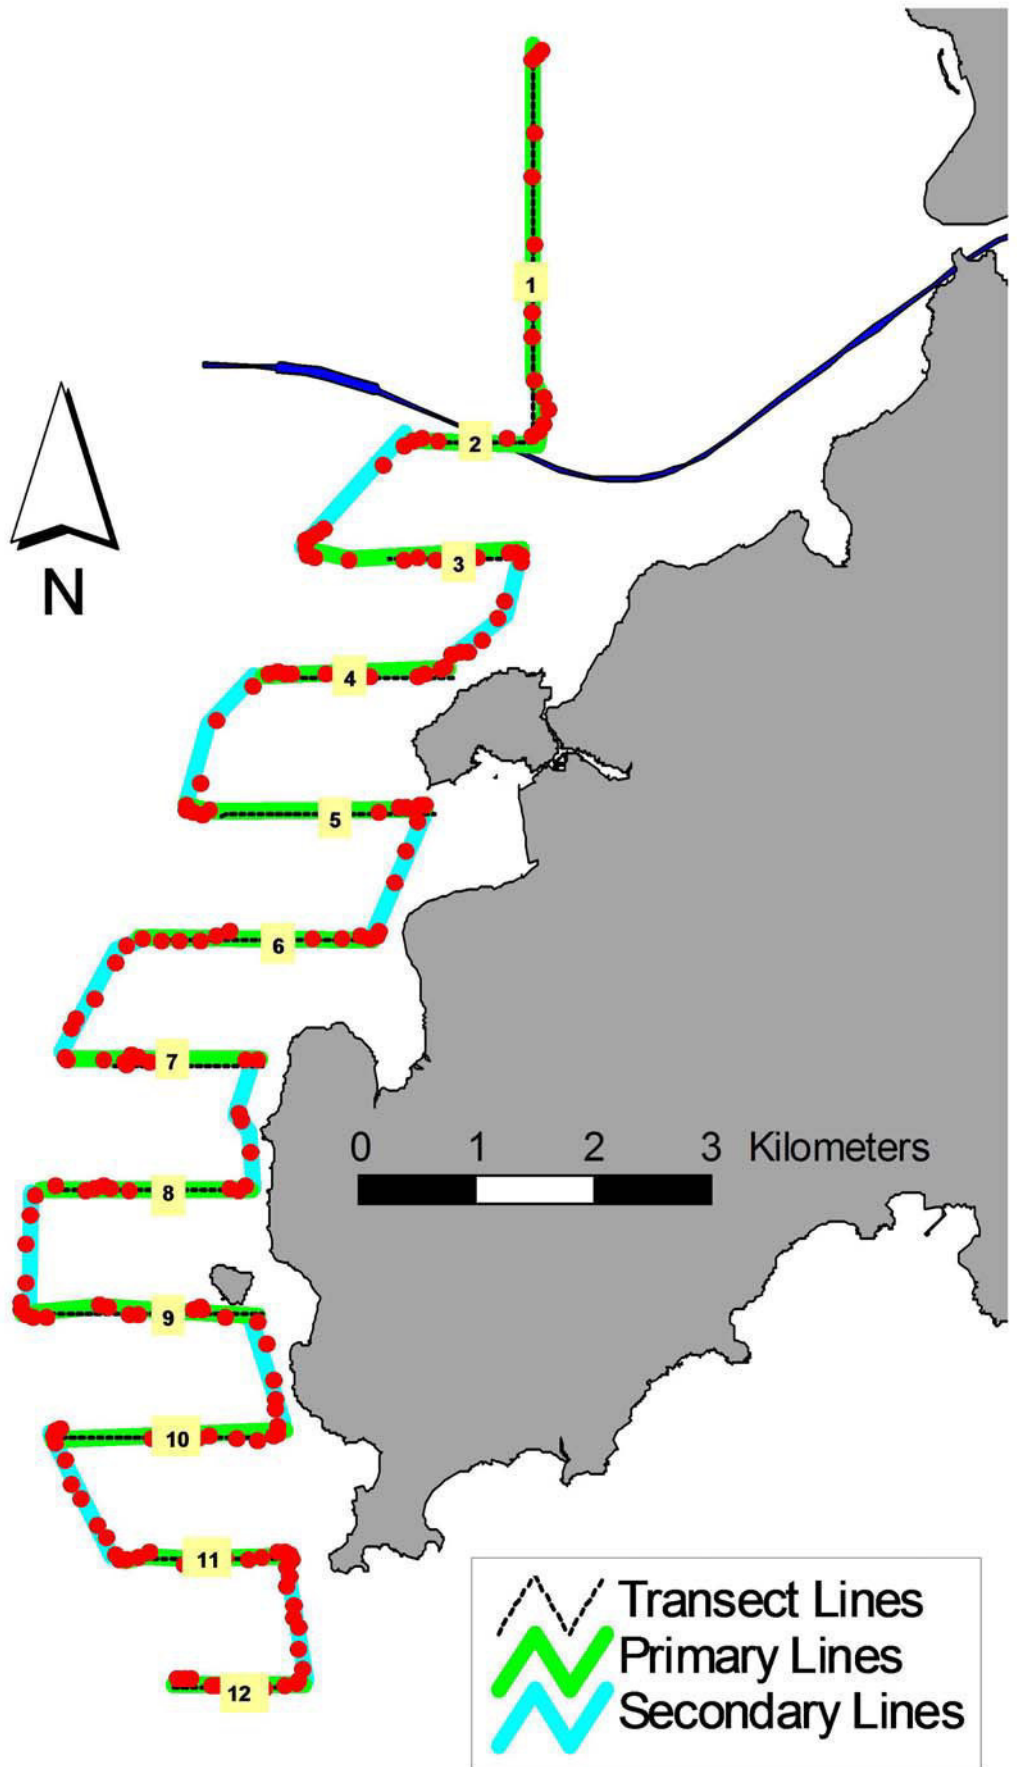
Figure 2. Survey Route on January 3rd, 2017 (note: red dots represent the tracked positions of survey boat logged continuously by GPS throughout the course of the survey)

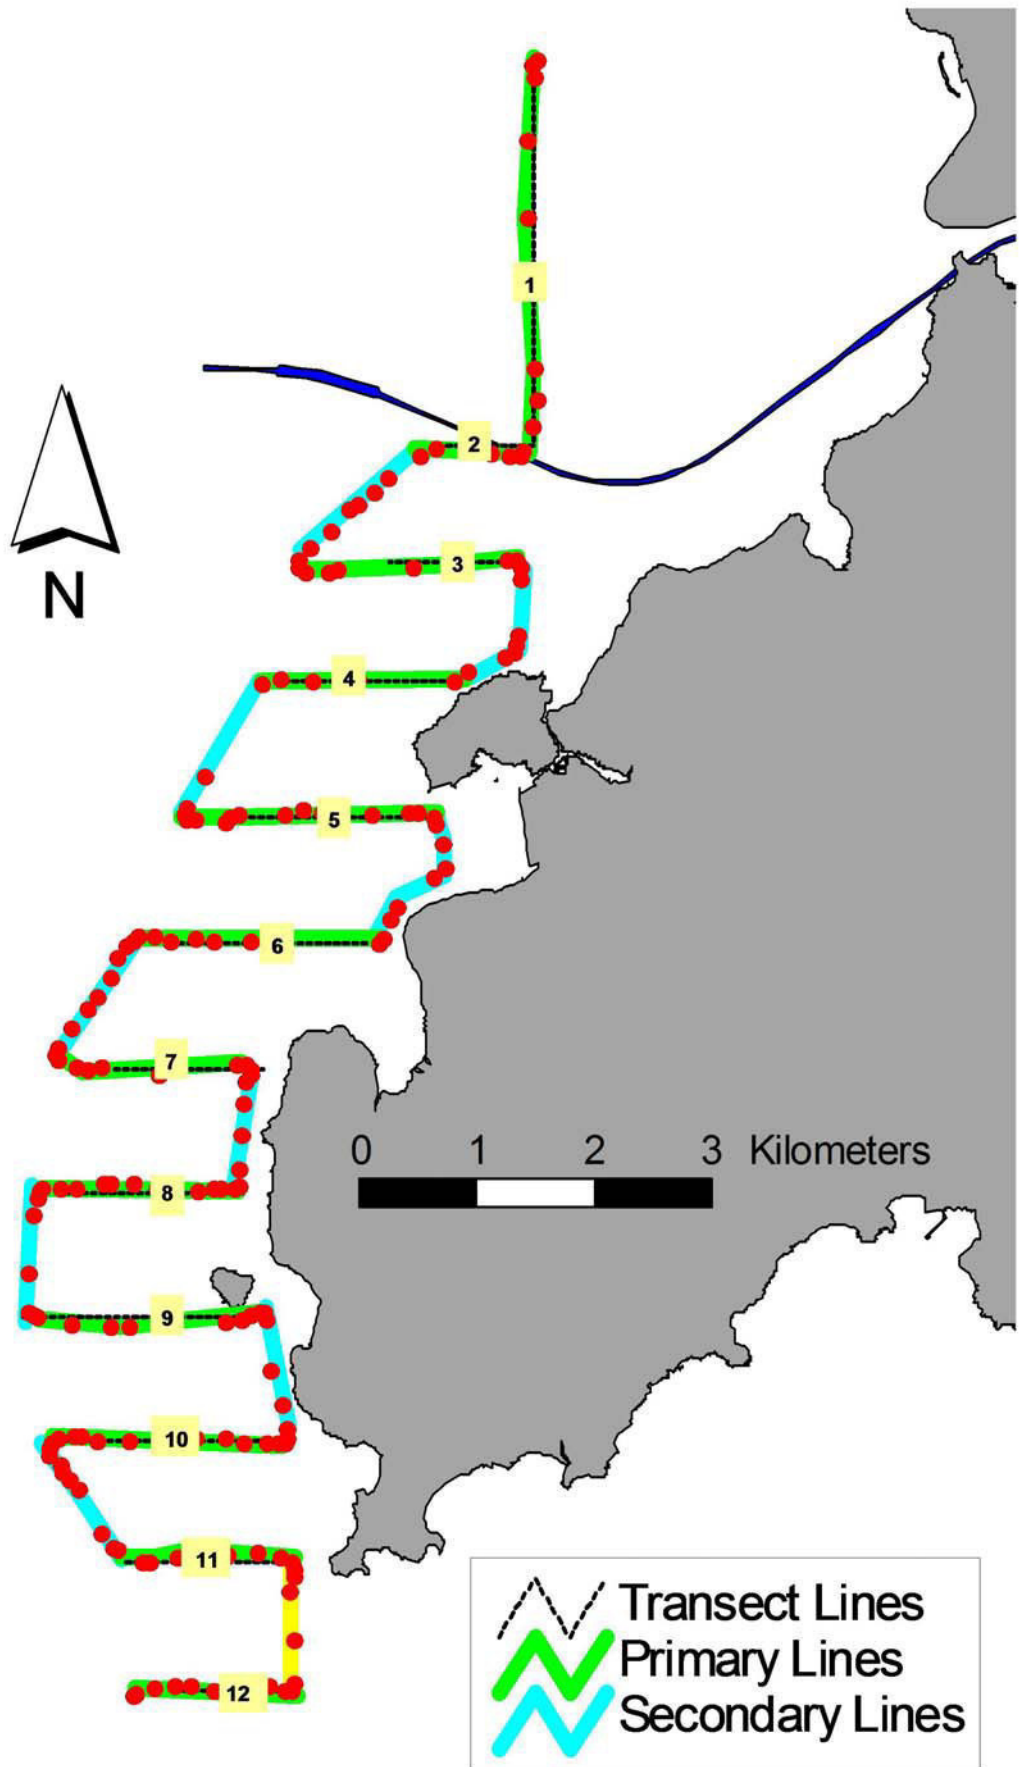
Figure 3. Survey Route on January 9th, 2017 (note: red dots represent the tracked positions of survey boat logged continuously by GPS throughout the course of the survey)

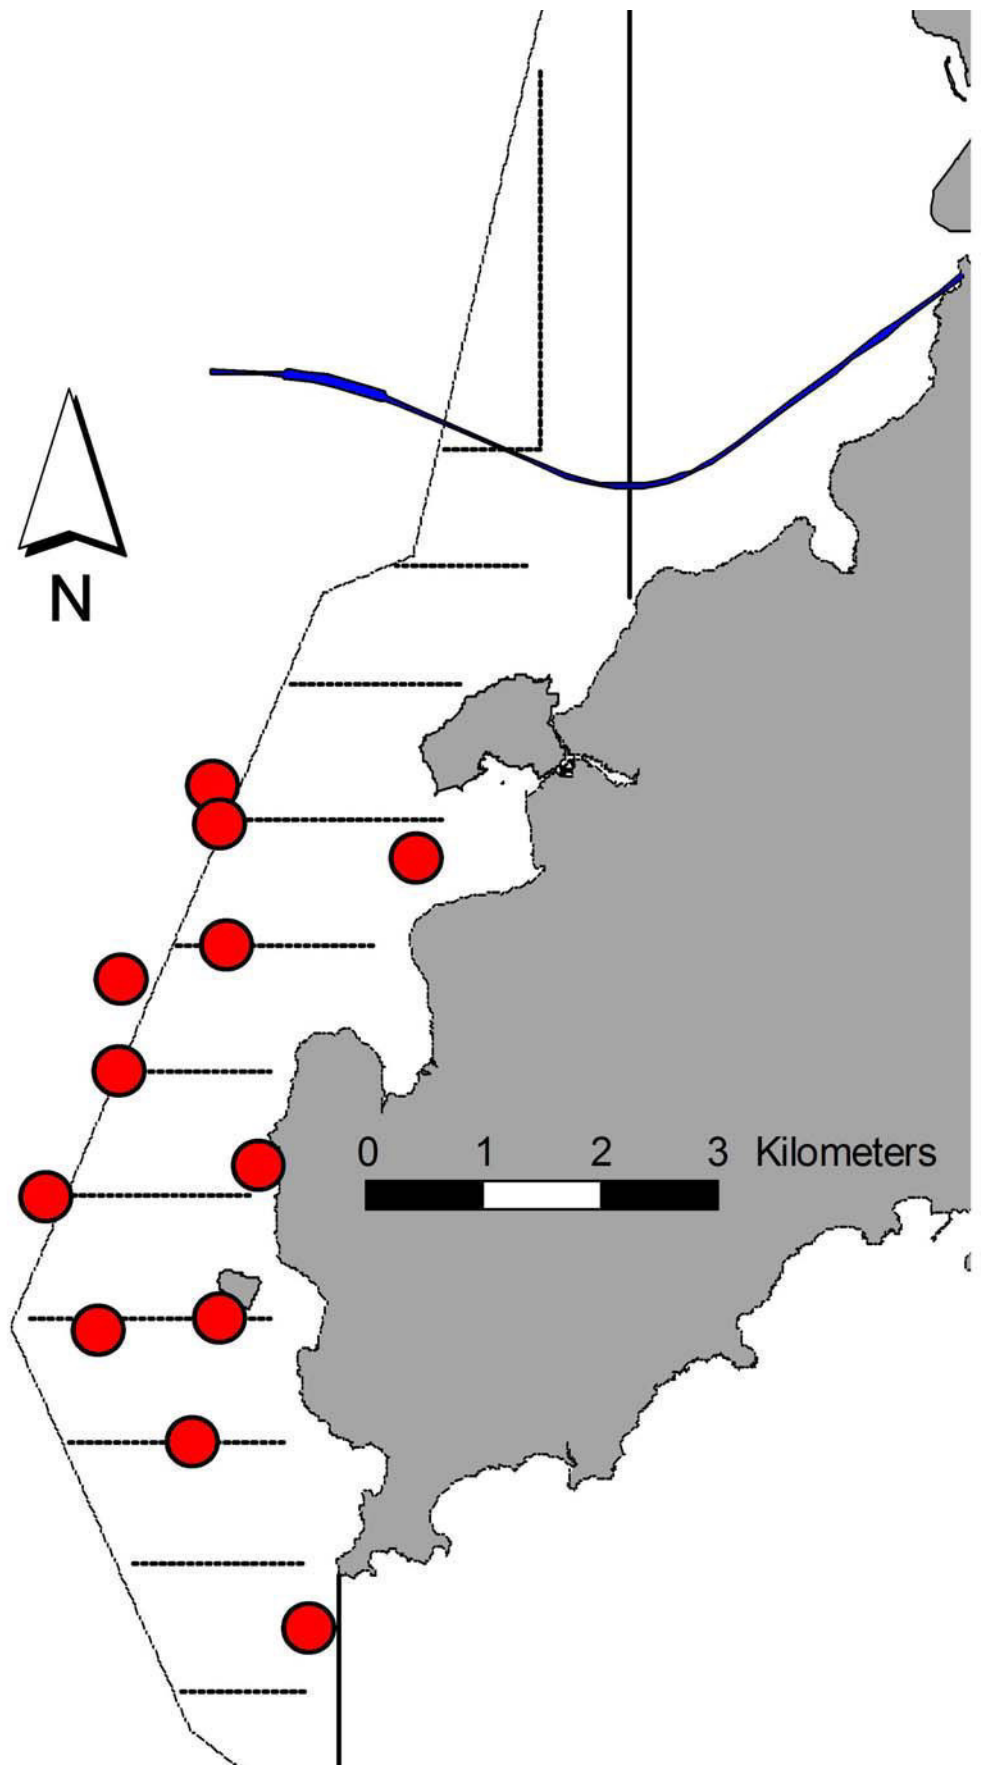
Figure 4. Distribution of Chinese White Dolphin Sighting during January 2017 HKLR09 Monitoring Surveys

- 6.12 Nine of 12 dolphin groups were small in size with only 1-3 animals each, while the other three groups were moderate to large in size with 6-12 animals per group.
- 6.13 During this month of dolphin monitoring, marine construction activities have continued under this contract. However, no adverse impact on Chinese white dolphins was noticeable from general observations.
- 6.14 Evaluation of impacts on dolphins due to construction work will be conducted in the quarterly EM&A report.
- 6.15 Detailed monitoring methodology and results can be found in **Appendix I**.

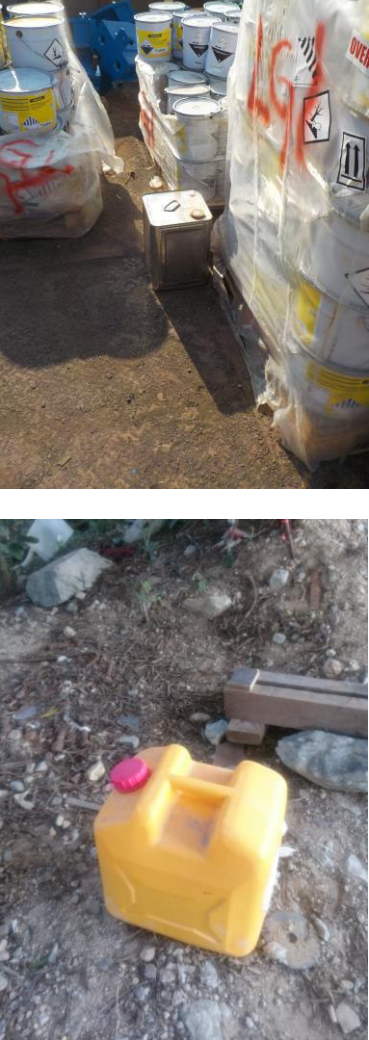
<p>Ref No: 170103-R01</p> <p>Impact: Waste / Chemical Management (F8,9)</p> <p>Details: Drip trays should be provided to the chemical containers at P68 and Portion A (P102).</p>

170117-R03	Dusty material should be cleared at P56.	Rectification/improvement was observed during the follow-up audit session on 24 January 2017.
<i>Noise</i>	N/A ⁽¹⁾	N/A ⁽¹⁾	N/A ⁽¹⁾
<i>Waste / Chemical Management</i>	170103-R01	Drip trays should be provided to the chemical containers at P68 and Portion A (P102).	Rectification/improvement was observed during the follow-up audit session on 10 January 2017.
	170103-R02	Accumulated waste should be cleared at P83.	Rectification/improvement was observed during the follow-up audit session on 10 January 2017.
	170110-R03	Accumulated waste at P113 should be cleared.	Rectification/improvement was observed during the follow-up audit session on 17 January 2017.
	170110-R05	Chemical container at P72 should be provided with drip tray.	Rectification/improvement was observed during the follow-up audit session on 17 January 2017.
	170117-R01	Drip trays at P47, 53, 55, 56 should be plugged or provided.	Rectification/improvement was observed during the follow-up audit session on 24 January 2017.

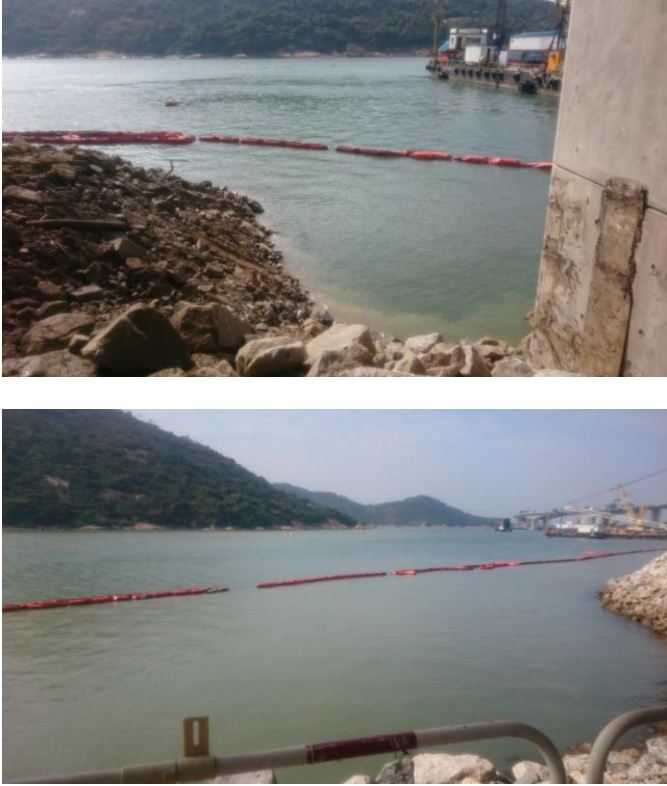
<p>Ref No: 170110-R02</p> <p>Impact: Water Quality (B25)</p> <p>Details: Silt curtain at P82, 88 should be well maintained.</p>

Parameters	Date	Observations and Recommendations	Follow-up
<i>Water Quality</i>	170110-R02	Silt curtain at P82, 88 should be well maintained.	Rectification/improvement was observed during the follow-up audit session on 24 January 2017.
	170117-R05	Silt curtain should be maintained at P88.	Rectification/improvement was observed during the follow-up audit session on 24 January 2017.
	170124-R03	Silt curtain should be provided at P82.	Rectification/improvement was observed during the follow-up audit session on 2 February 2017.
<i>Ecology</i>	N/A ⁽¹⁾	N/A ⁽¹⁾	N/A ⁽¹⁾
<i>Air Quality</i>	170110-R01	Stockpile of dusty material should be covered with impervious sheet at P102.	Rectification/improvement was observed during the follow-up audit session on 17 January 2017.
	170110-R04	Water spraying should be provided to concrete breaking works at P75.	Rectification/improvement was observed during the follow-up audit session on 17 January 2017.

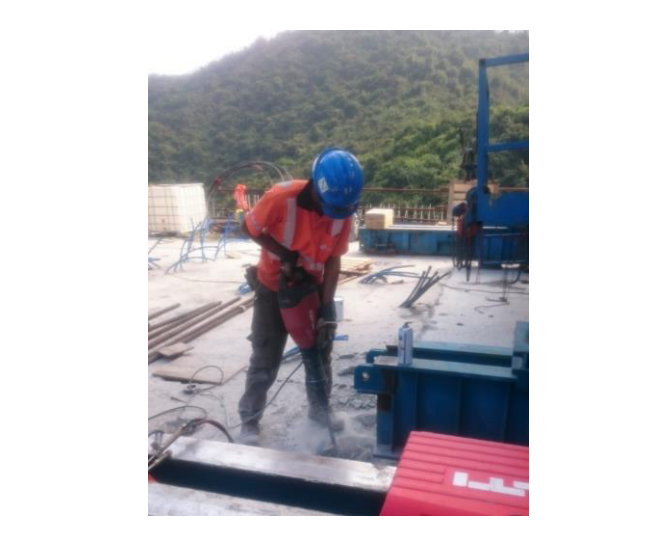
<p>Ref No: 170110-R04</p> <p>Impact: Air Quality (D15)</p> <p>Details: Water spraying should be provided to concrete breaking works at P75.</p>

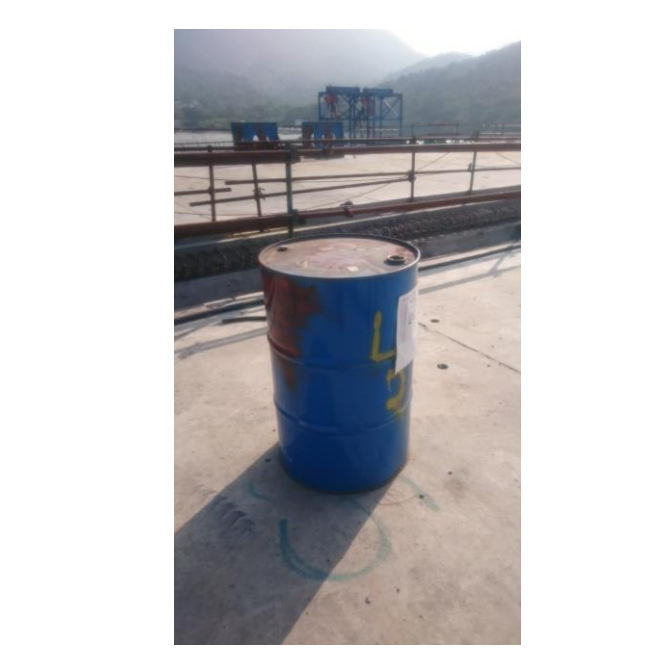
<p>Ref No: 170110-R05</p> <p>Impact: Waste / Chemical Management (F8)</p> <p>Details: Chemical container at P72 should be provided with drip tray.</p>

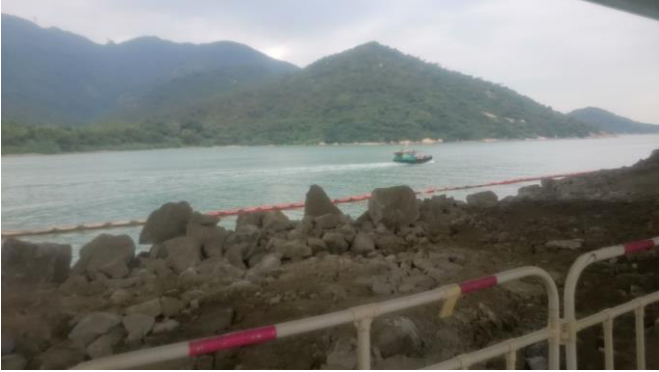
<p>Ref No: 170110-R01</p> <p>Impact: Air Quality (D7)</p> <p>Details: Stockpile of dusty material should be covered with impervious sheet at P102.</p> <p>Follow-up: Stockpile of dusty material was removed at P102.</p>
