**Contract No. HY/2011/03**

**Hong Kong-Zhuhai-Macao Bridge Hong Kong Link Road  
Section between Scenic Hill and Hong Kong Boundary Crossing  
Facilities**

**Monthly EM&A Report No.57 (June 2017)**

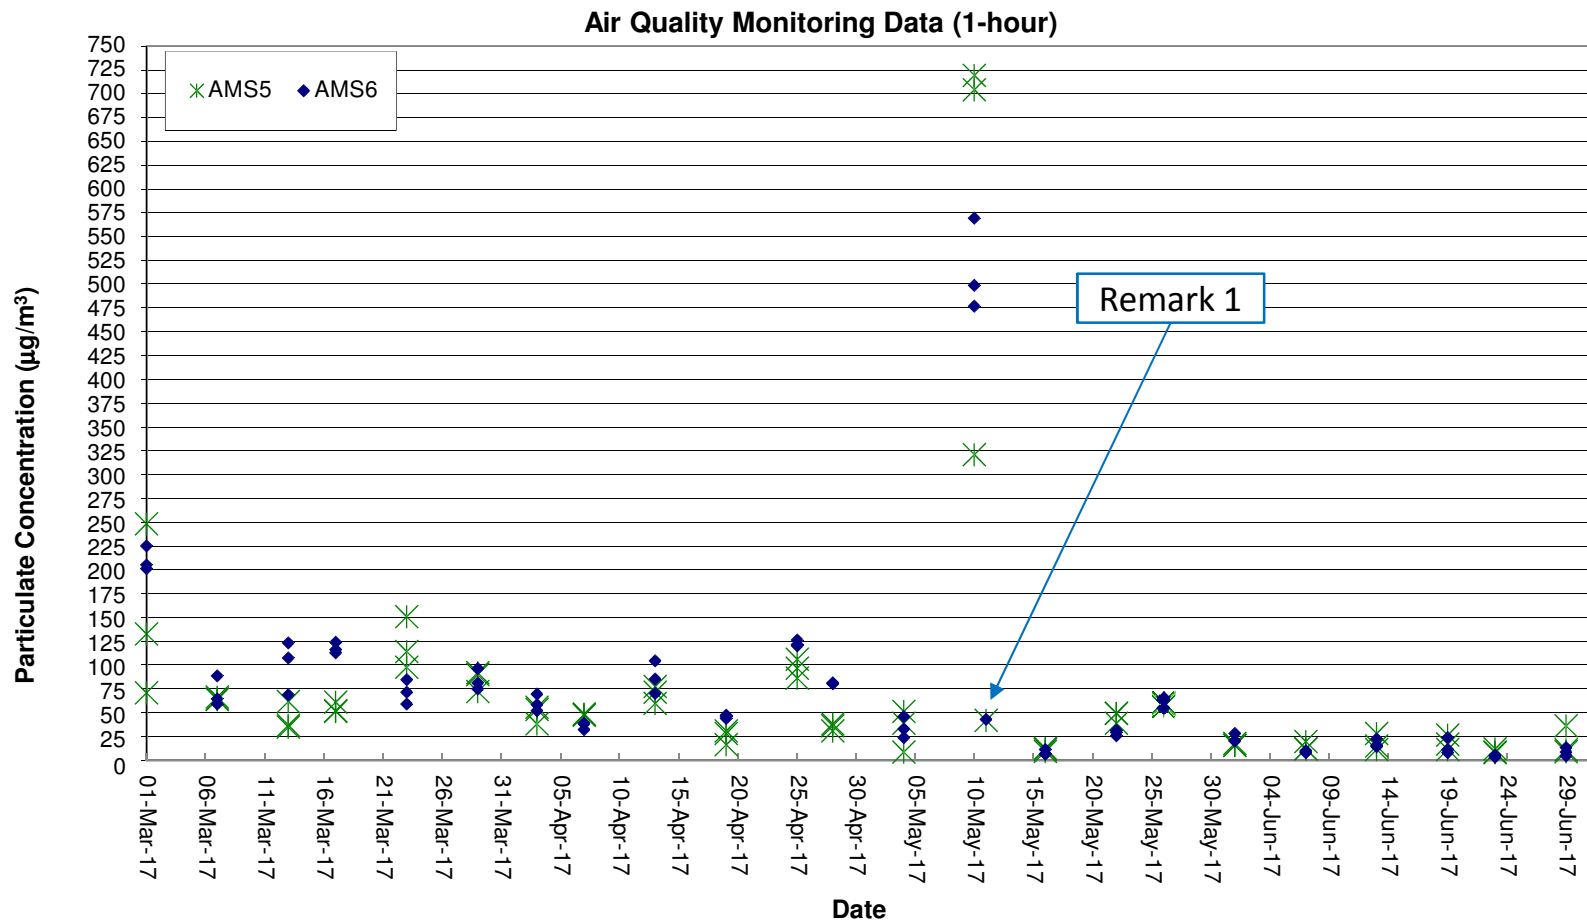
Graphical Plot of 1-hour TSP at AMS5 and AMS6

1) Due to the Action/Limit level exceedances of 1-hr TSP were recorded at AMS5 and AMS6 on 10 May 2017, an additional 1-hr TSP monitoring was conducted on 11 May 2017 at AMS5 and AMS6 respectively.

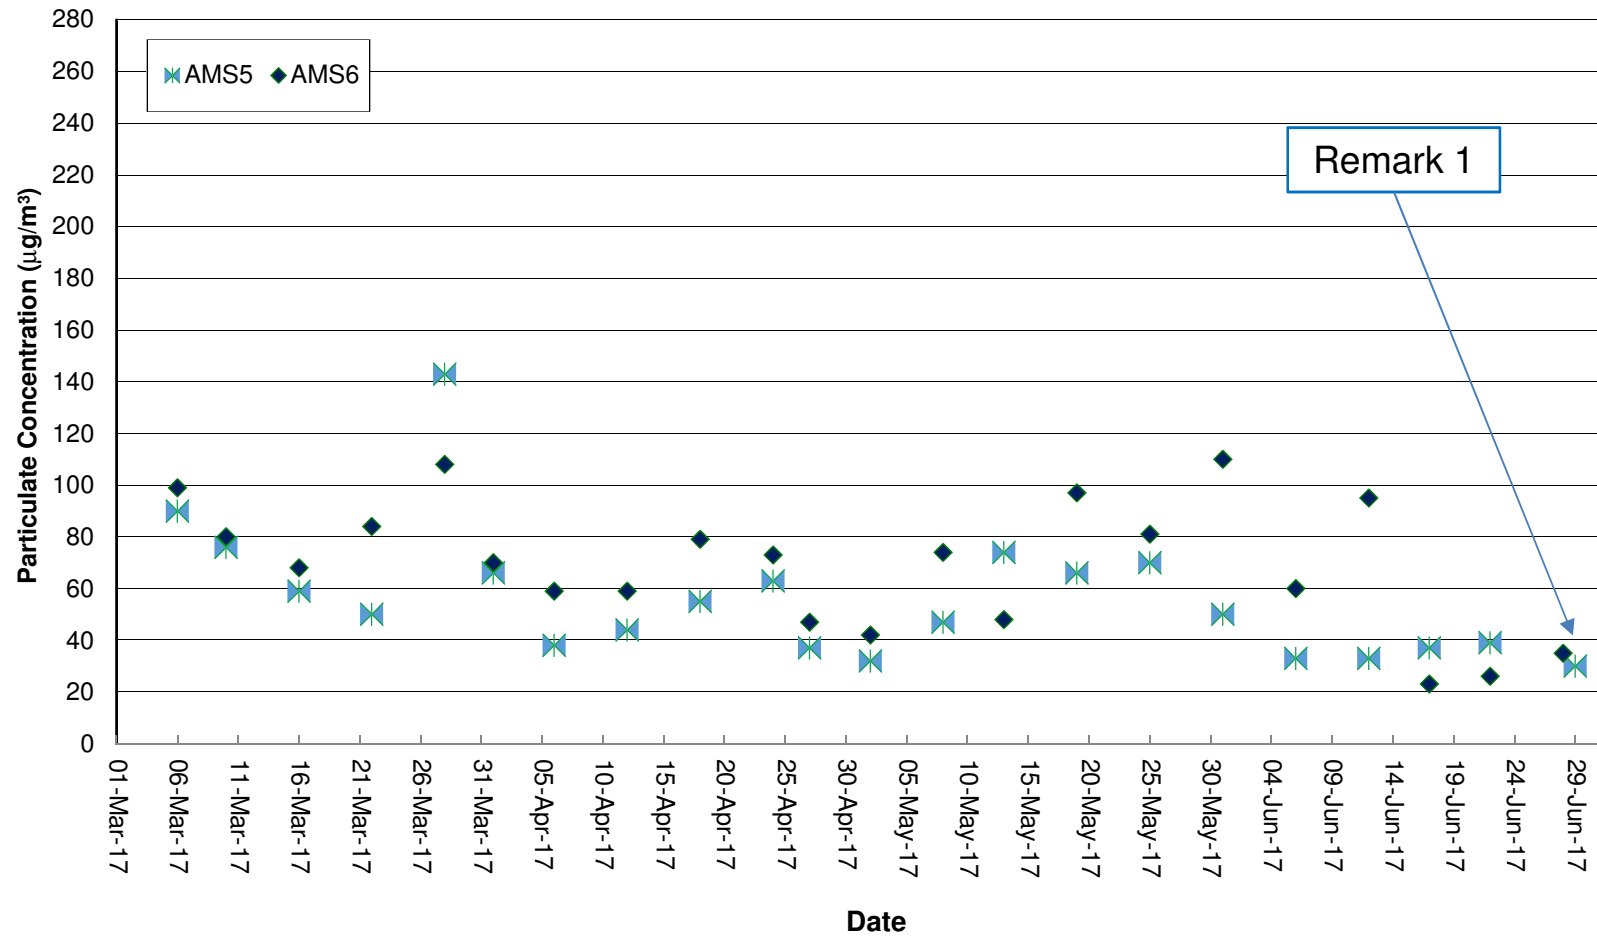
Graphical Plot of 24-hour TSP at AMS5 and AMS6

- 1) Due to power supply failure, the 24-hour TSP monitoring at AMS5 was rescheduled from 28 June 2017 to 29 June 2017.

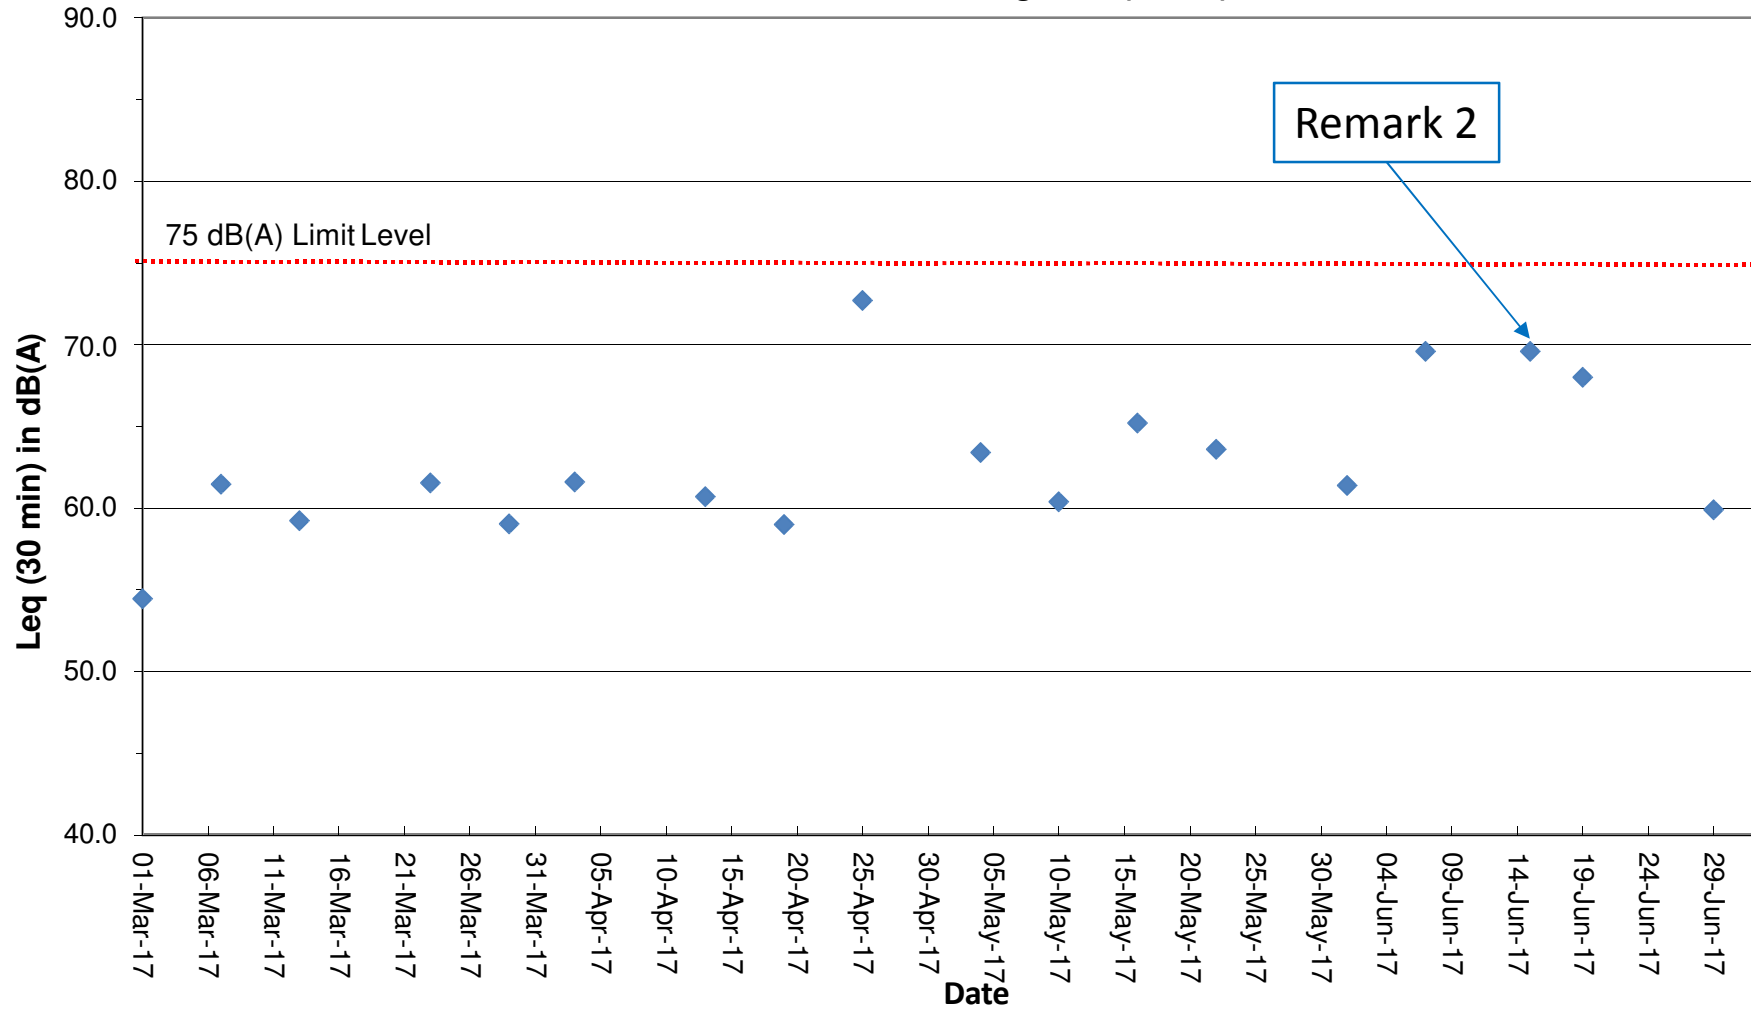
## Graphical Plot of Noise Levels at NMS5

- (1) A facade correction of +3 dB(A) was applied to the measured noise level.
- (2) Due to weather condition, the noise monitoring schedule was rescheduled from 13 June 2017 to 15 June 2017.

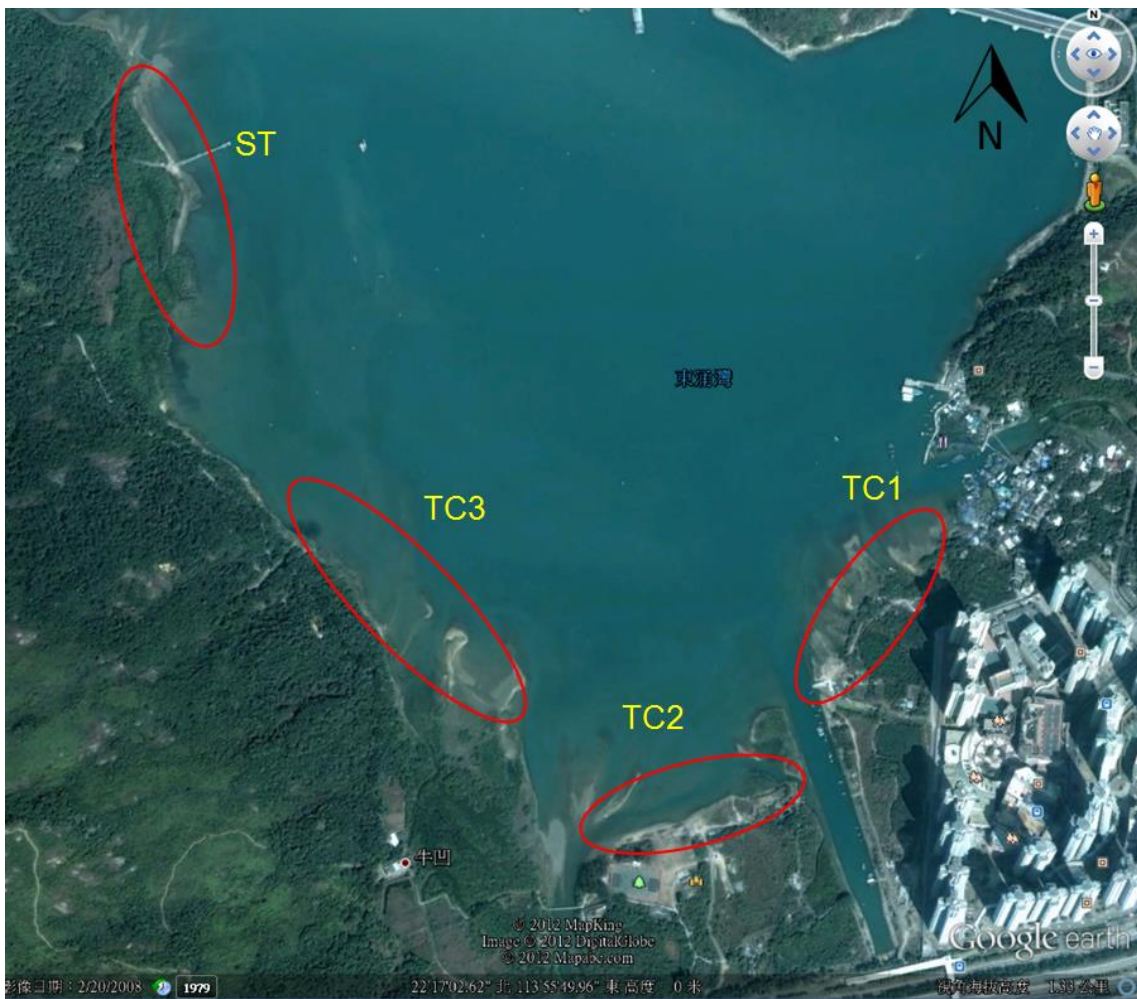
**Figure 2.1.** Locations of sampling zones. The study site was divided into three sampling zones (TC1, TC2, TC3) in Tung Chung Bay and one zone in San Tau (ST) (map generated from Google Map).

- 6.3.1 In order to collect baseline information of mudflats in the study site, the study site was divided into three sampling zones (labeled as TC1, TC2, TC3) in Tung Chung Bay and one zone in San Tau (labeled as ST) (**Figure 2.1 of Appendix I**). The horizontal shoreline of sampling zones TC1, TC2, TC3 and ST were about 250 m, 300 m, 300 m and 250 m respectively (**Figure 2.2 of Appendix I**). Survey of horseshoe crabs, seagrass beds and intertidal communities were conducted in every sampling zone. The present survey was conducted in June 2017 (totally 5 sampling days between 2<sup>nd</sup> and 11<sup>th</sup> June 2017).

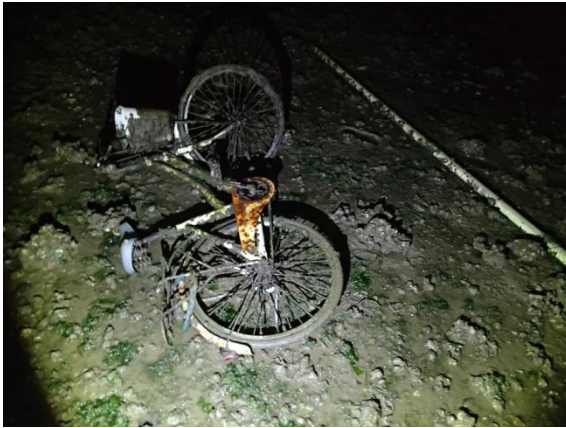
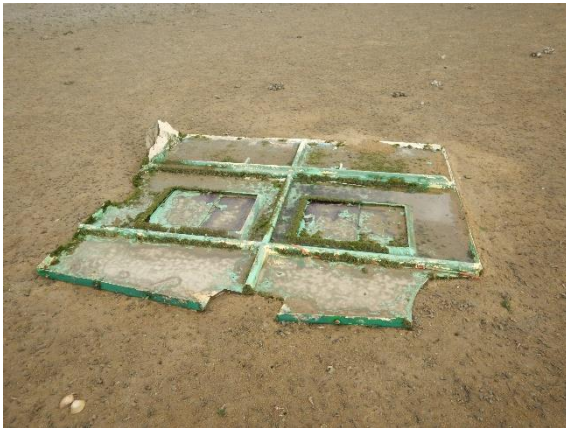
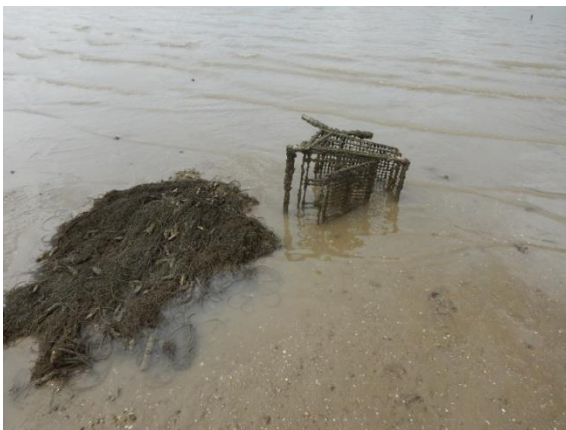
**Figure 2.3.** *Examples of photographic record of the big trashes found on the mudflat.*

- 6.3.2 Since the field survey of Jun. 2016, increasing number of trashes and even big trashes (**Figure 2.3 of Appendix I**) were found in every sampling zone. It raised a concern about the solid waste dumping and current-driven waste issues in Tung Chung Wan. Respective measures (e.g. manual clean-up) should be implemented by responsible units.

- 6.3.4 In present survey (Jun. 2017), a big horseshoe crab was tangled by a trash gill net in ST mudflat (**Figure 2.3 of Appendix I**). It was released to sea once after photo recording. The horseshoe crab of such size should be inhabiting sub-tidal environment while it forages on intertidal shore occasionally during high tide period. If it is tangled by the trash net for few days, it may die due to starvation or overheat during low tide period. These trash gill nets are definitely 'fatal trap' for the horseshoe crabs and other marine life. Manual clean-up should be implemented as soon as possible by responsible units.

bike

boat wreckage

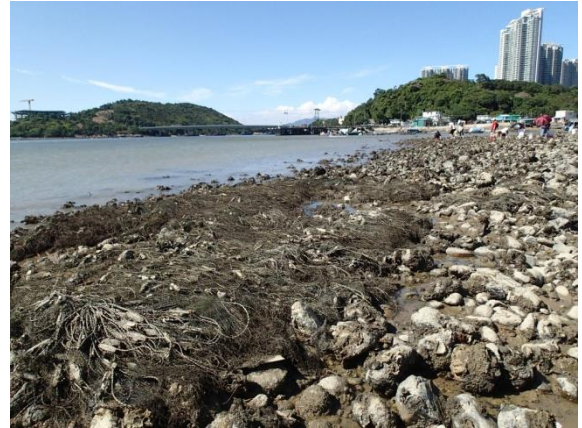
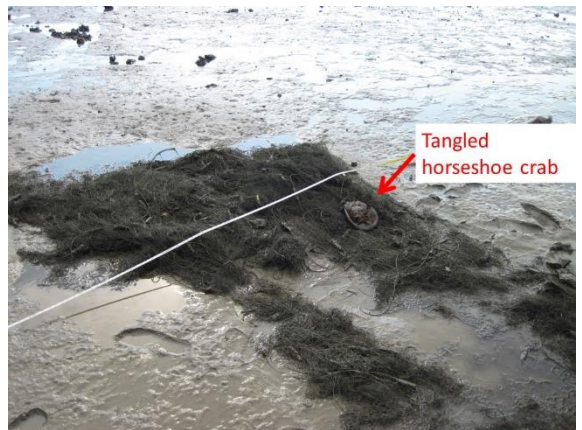
trash gill net

trash gill net and hand trolley

a tangled horseshoe crab on a trash net

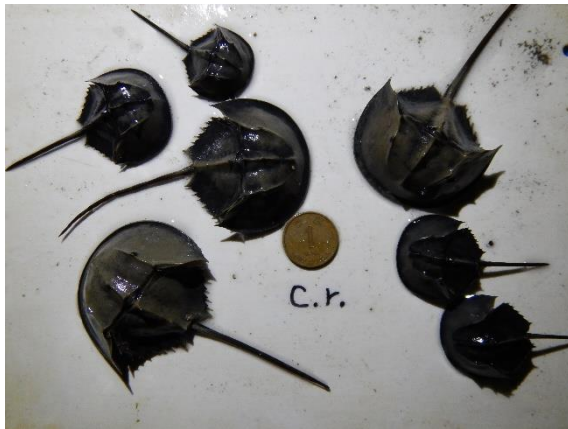
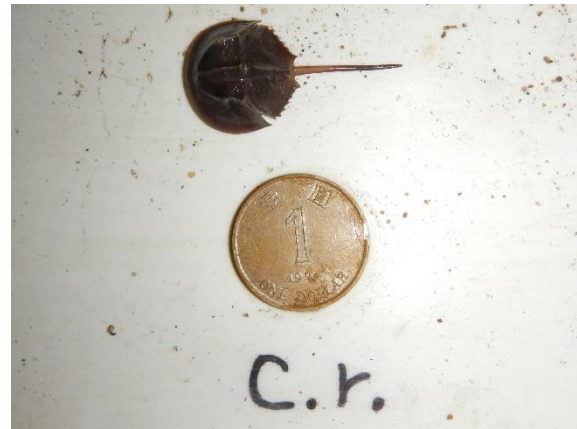
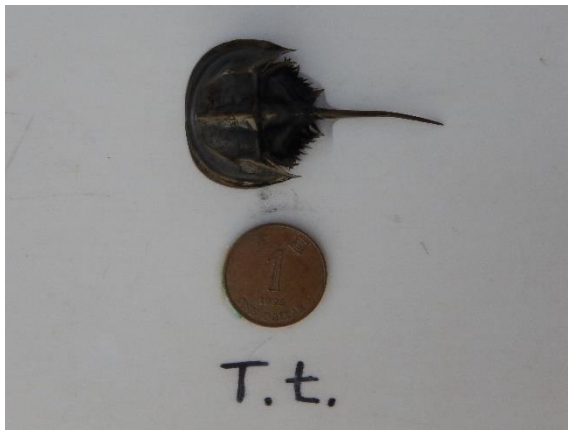
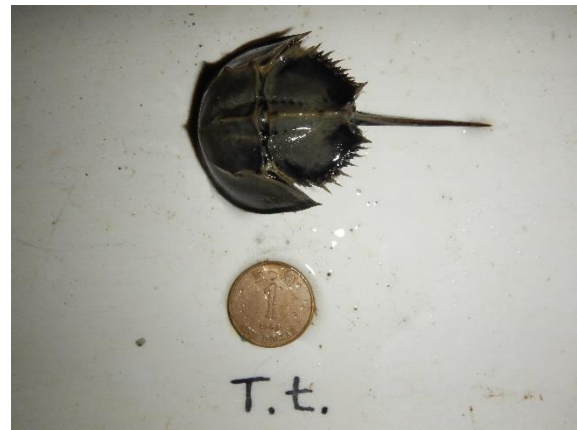
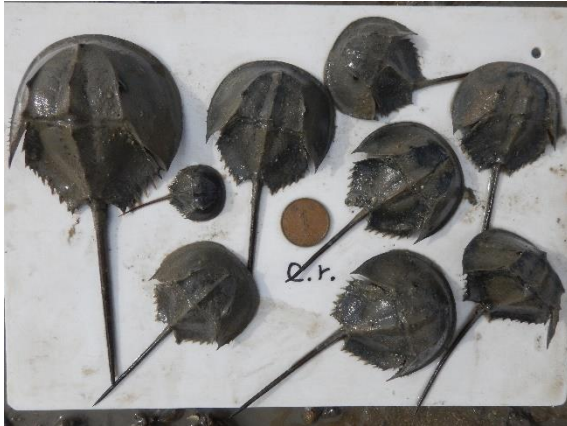
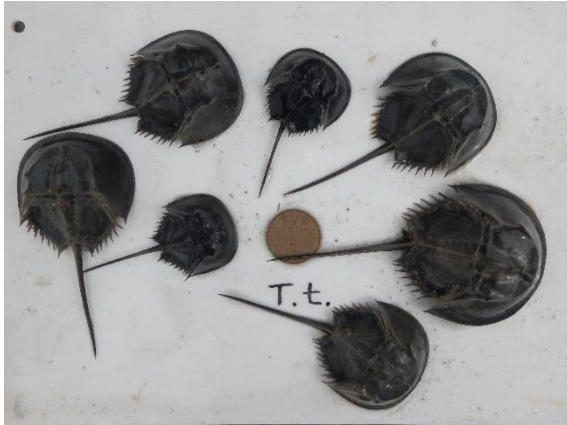
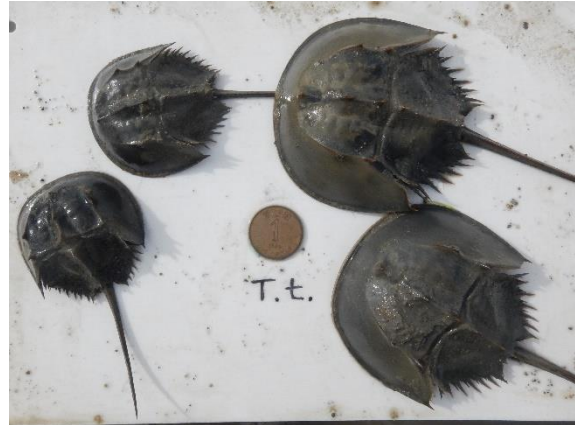
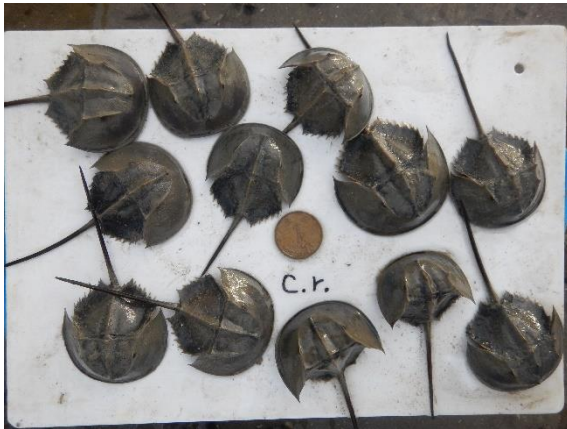
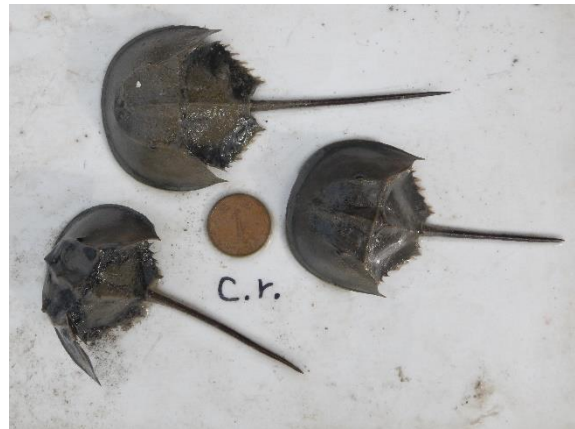
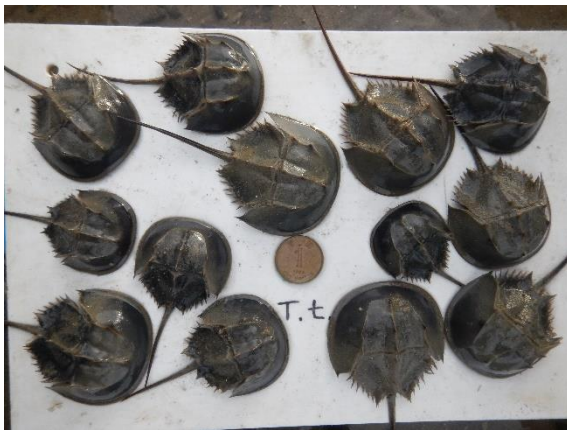
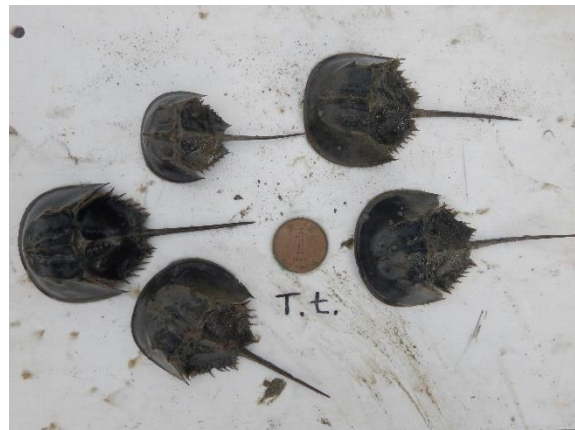
**Figure 3.1.** Examples of photographic records of horseshoe crab (Jun. 2017)

- 6.5.1 In the present survey, two species of horseshoe crab *Carcinoscorpius rotundicauda* (total 133 ind.) and *Tachypleus tridentatus* (total 125 ind.) were recorded. For one sight record, grouping of 2-20 individuals was observed at same locations with similar substratum (fine sand or soft mud, slightly submerged). Photo records were shown in **Figure 3.1 of Appendix I** while the complete survey records were listed in **Annex II of Appendix I**. Besides, one tiny individual (prosomal width ~8 mm) was found in TC3 but identification to species was not possible. Hence this record was excluded from the data analysis.

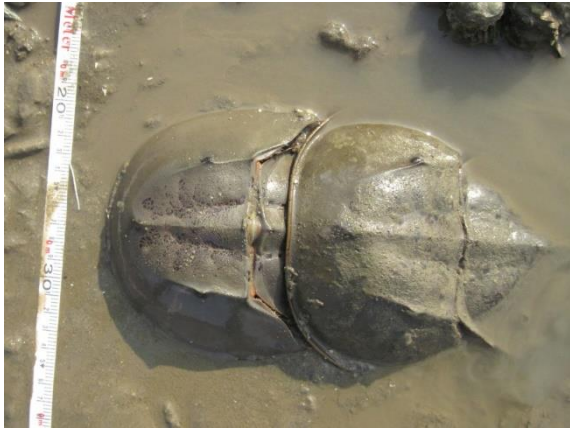
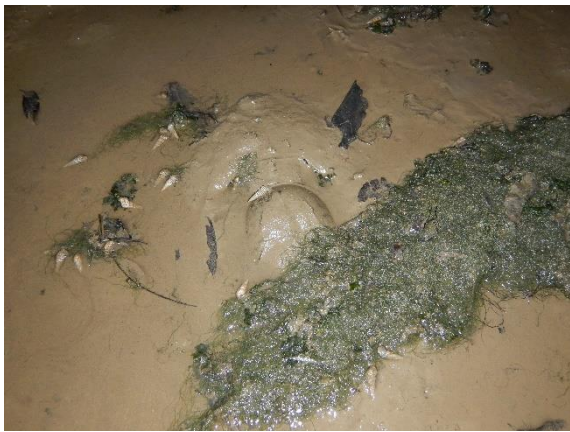
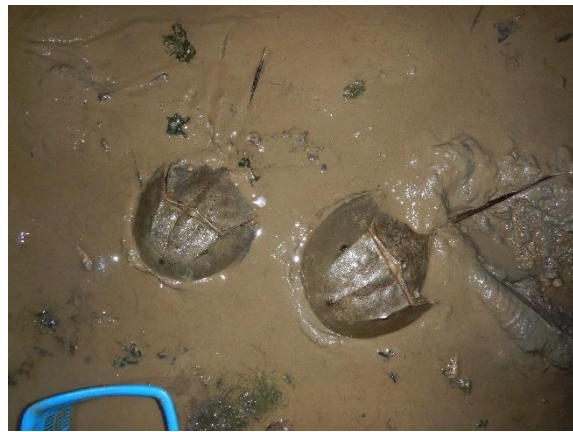
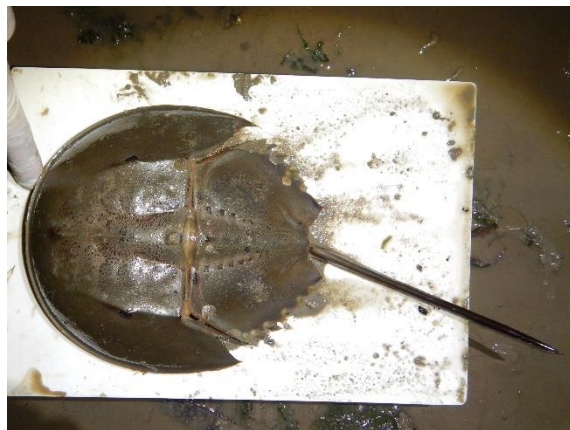
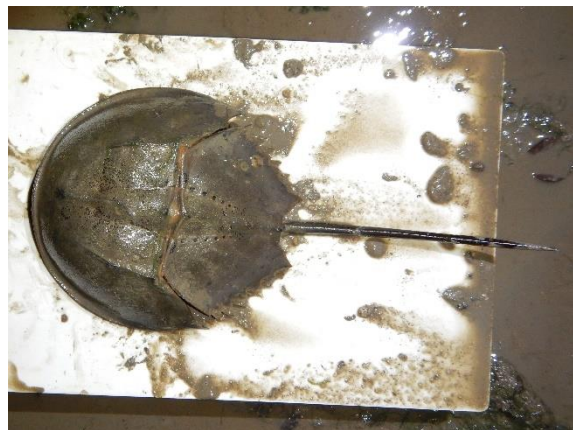
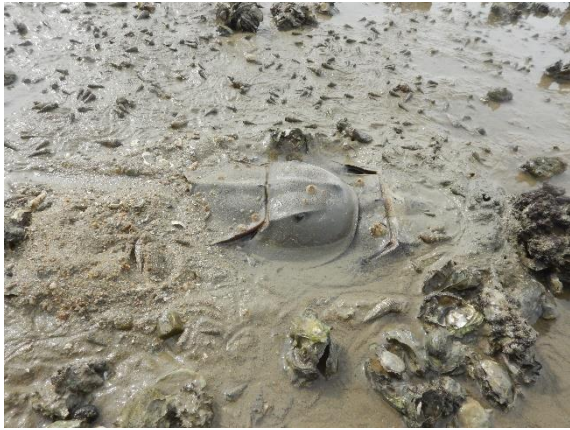
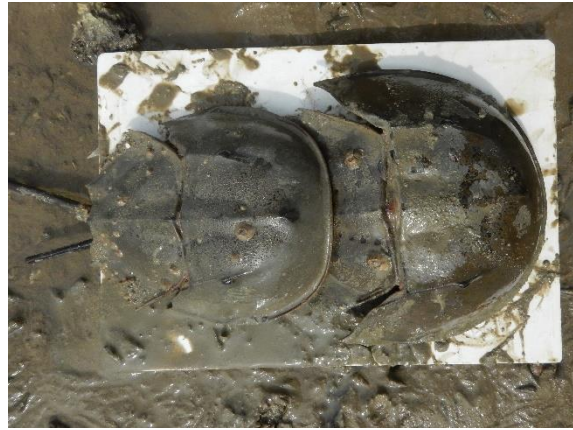
Figure 3.2. Photographic records of mating pair of *Carcinoscorpius rotundicauda*

- 6.5.4 In the previous survey of Mar. 2015, there was one important finding that a mating pair of *Carcinoscorpius rotundicauda* was found in ST (prosomal width: male 155.1 mm, female 138.2 mm) (**Figure 3.2 of Appendix I**). It indicated the importance of ST as a breeding ground of horseshoe crab. In the present survey (Jun. 2017), mating pairs of *Carcinoscorpius rotundicauda* were also found in TC2 (prosomal width: male 175.27 mm, female 143.51 mm) and TC3 (prosomal width: male 182.08 mm, female 145.63 mm) (**Figure 3.2 of Appendix I**). It indicated that breeding of horseshoe crab could occur along the coast of Tung Chung Wan rather than ST only, as long as suitable substratum was available. The mating pairs were found nearly burrowing in soft mud at low tidal level (0.5-1.0 m above C.D.). The smaller male was holding the opisthosoma (abdomen carapace) of larger female from behind.

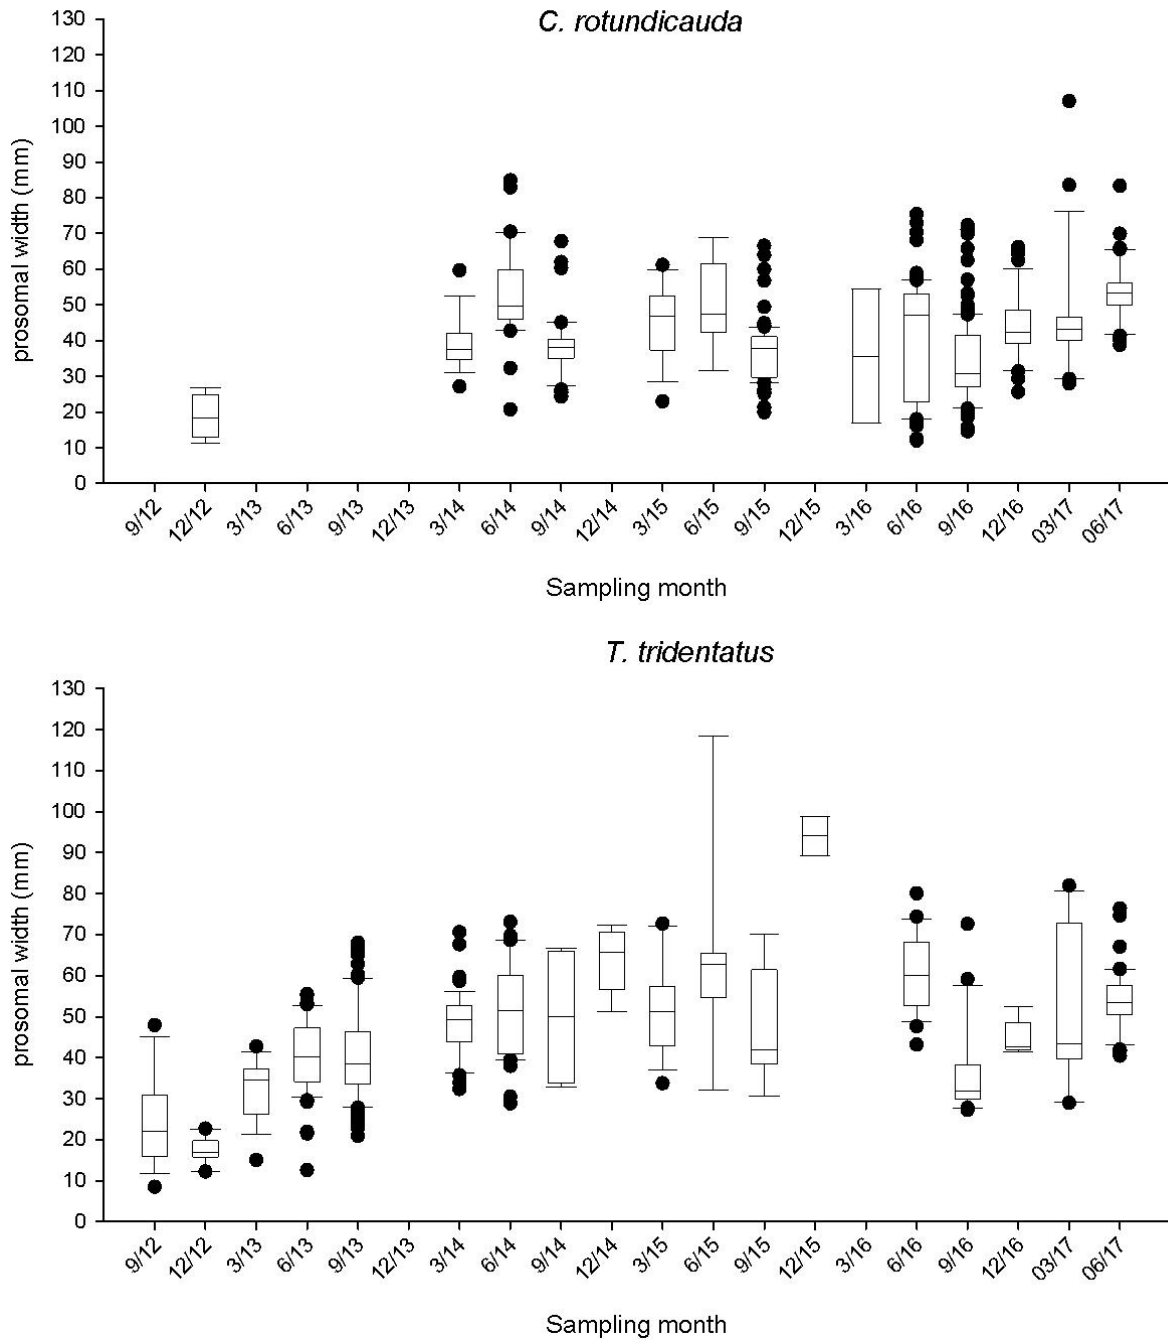
**Figure 3.7.** Box plot of prosomal width of horseshoe crab in the sampling zone ST along the sampling months. (The box represents 50% of the sample (upper to lower quartile) with a middle line showing the median value. The upper whisker and lower whisker showed the 25% of sample above upper quartile and below the lower quartile respectively. The black circle dots showed the data of outlier.)

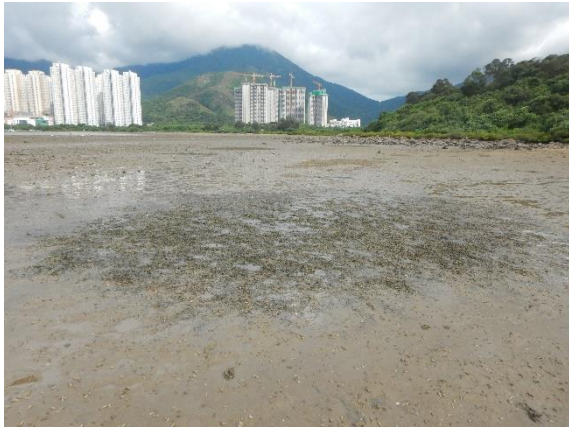
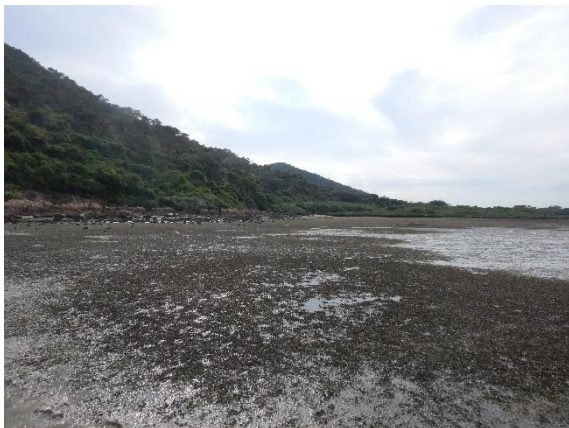
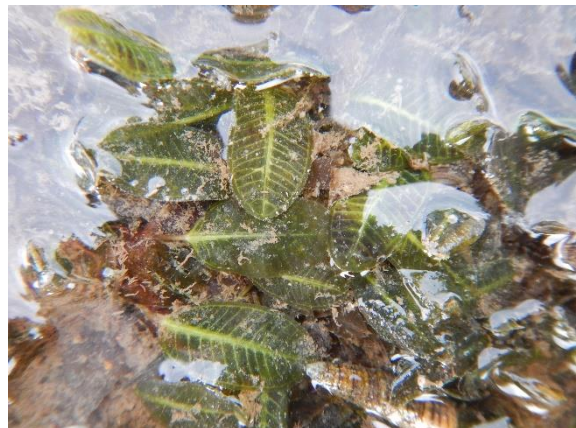
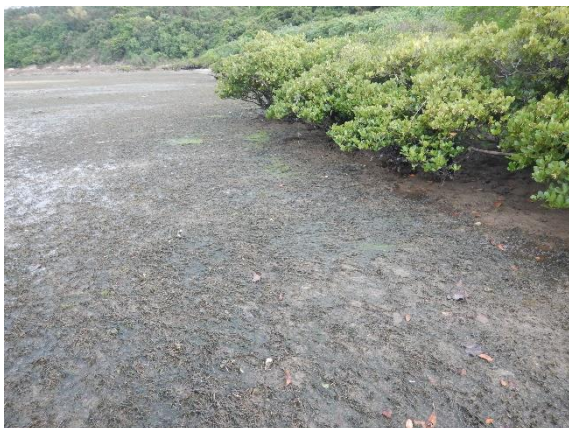
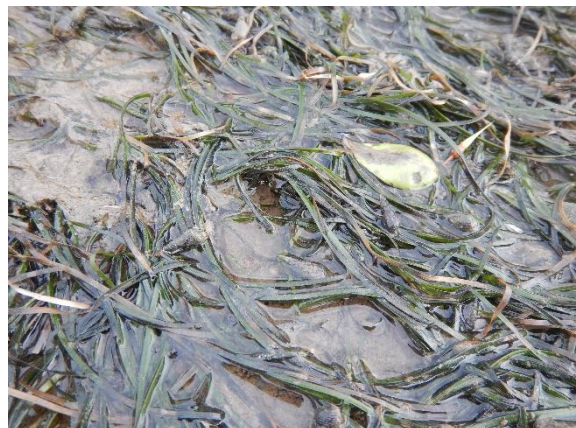
**Figure 3.8.** Examples of photographic records of seagrass beds survey (Jun. 2017)

- 6.5.24 In the present survey, seagrass species *Halophila ovalis* and *Zostera japonica* were recorded in TC3 and ST. Photo records were shown in **Figure 3.8 of Appendix I** while the complete records of seagrass beds survey were shown in **Annex III of Appendix I**.

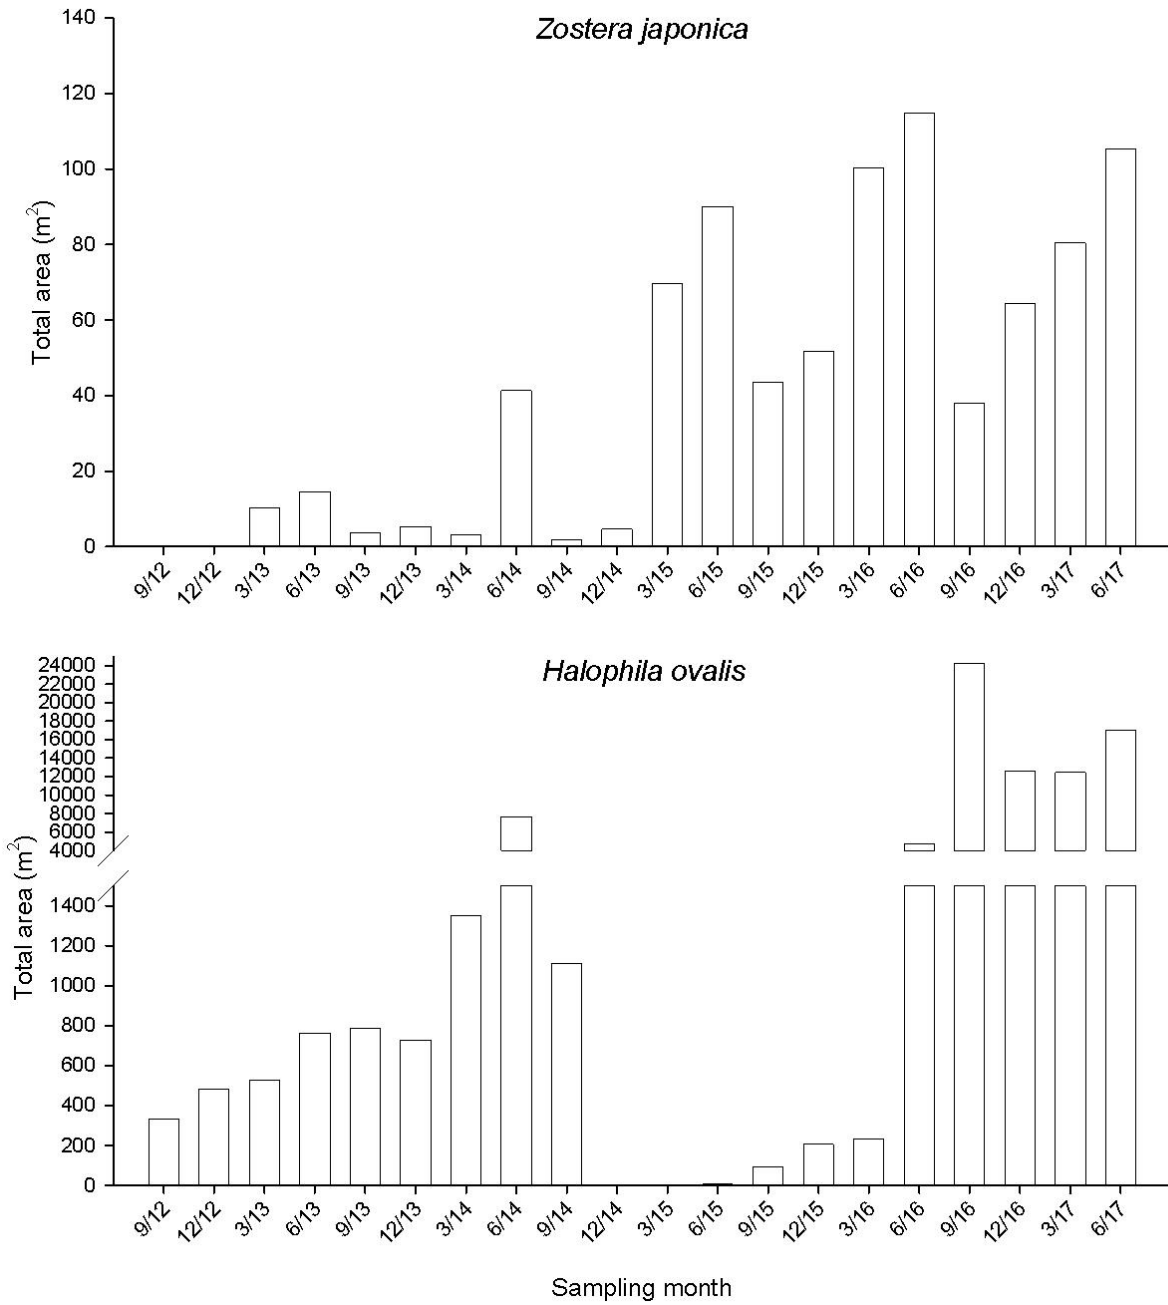
**Figure 3.9.** Temporal changes of estimated total area of seagrass beds in ST

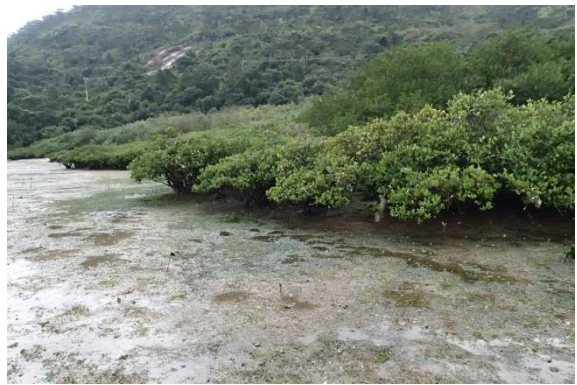
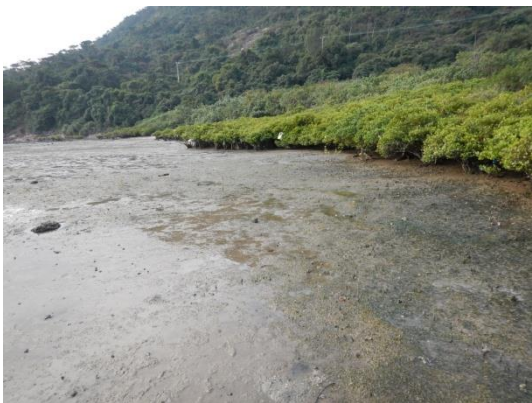
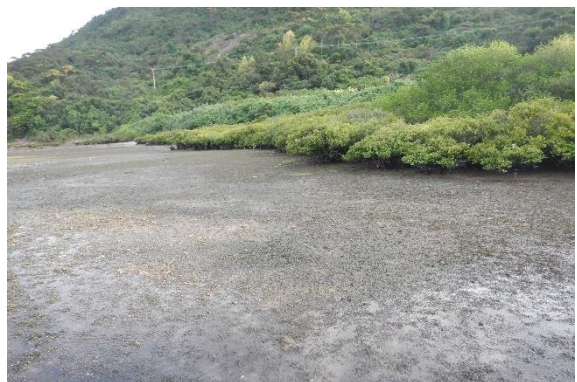
**Figure 3.10.** Comparison of pictures taken in different sampling months shows the disappearance and recolonization of seagrass beds.

**Mar. 2016**

**Dec. 2016**

**Jun. 2017**

- 6.5.31 In Dec. 2014, all the seagrass patches of *Halophila ovalis* disappeared in ST. **Figure 3.10 of Appendix I** shows the difference of the original seagrass beds area nearby the mangrove vegetation at high tidal level between Jun. 2014 and Dec. 2014. Such rapid loss would not be seasonal phenomenon because the seagrass beds at higher tidal level (2.0 m above C.D.) were present and normal in December 2012 and 2013. According to Fong (1998), similar incident had occurred in ST in the past. The original seagrass area had declined significantly during the commencement of the construction and reclamation works for the international airport at Chek Lap Kok in 1992. The seagrass almost disappeared in 1995 and recovered gradually after the completion of reclamation works. Moreover, incident of rapid loss of seagrass area was also recorded in another intertidal mudflat in Lai Chi Wo in 1998 with unknown reason. Hence *Halophila ovalis* was regarded as a short-lived and r-strategy seagrass that could colonize areas in short period but disappears quickly under unfavorable conditions (Fong, 1998).

6.5.36 **Figure 3.10 of Appendix I** shows the recolonization of seagrass bed area in ST from Dec. 2014 to Jun. 2017. From Mar. to Jun. 2015, 2-3 small patches of *Halophila ovalis* were newly found coinhabiting with another seagrass species *Zostera japonica*. But its total patch area was still very low relative to the previous records. The recolonization rate was low while cold weather and insufficient sunlight were possible factors between Dec. 2014 and Mar. 2015. Moreover, it would need to compete with seagrass *Zostera japonica* for substratum and nutrient. Since *Zostera japonica* had extended and had covered the original seagrass bed of *Halophila ovalis* at certain degree. From Jun. 2015 to Mar. 2016, the total seagrass area of *Halophila ovalis* had increased rapidly from 6.8 m<sup>2</sup> to 230.63 m<sup>2</sup>. It had recolonized its original patch locations and covered *Zostera japonica*. In Jun. 2016, the total seagrass area increased sharply to 4707.3 m<sup>2</sup>. Similar to the previous records of Mar to Jun. 2014, the original patch area increased further to a horizontally long strand. Another large seagrass beds colonized the lower tidal zone (1.0-1.5 m above C.D.). In Sep. 2016, this patch extended much and covered significant soft mud area of ST, resulting in sharp increase of total area (24245 m<sup>2</sup>). It indicated the second extensive colonization of this *r*-strategy seagrass. In Dec. 2016, this extensive seagrass patch decreased in size and had separated into few, undistinguishable patches. Moreover, the horizontal strand nearby the mangrove vegetation decreased in size (**Figure 3.10 of Appendix I**). The total seagrass bed decreased to 12550 m<sup>2</sup>. In Mar. 2017, the seagrass bed area remained stable (12438 m<sup>2</sup>) while the vegetation coverage decreased clearly (20-50%). It was once predicted that the seagrass bed area would continue to decrease, similar to the record in Sep-Dec. 2014. However, it increased in both area (17046.5 m<sup>2</sup>) and vegetation coverage (80-100%) in Jun. 2017 (present survey).

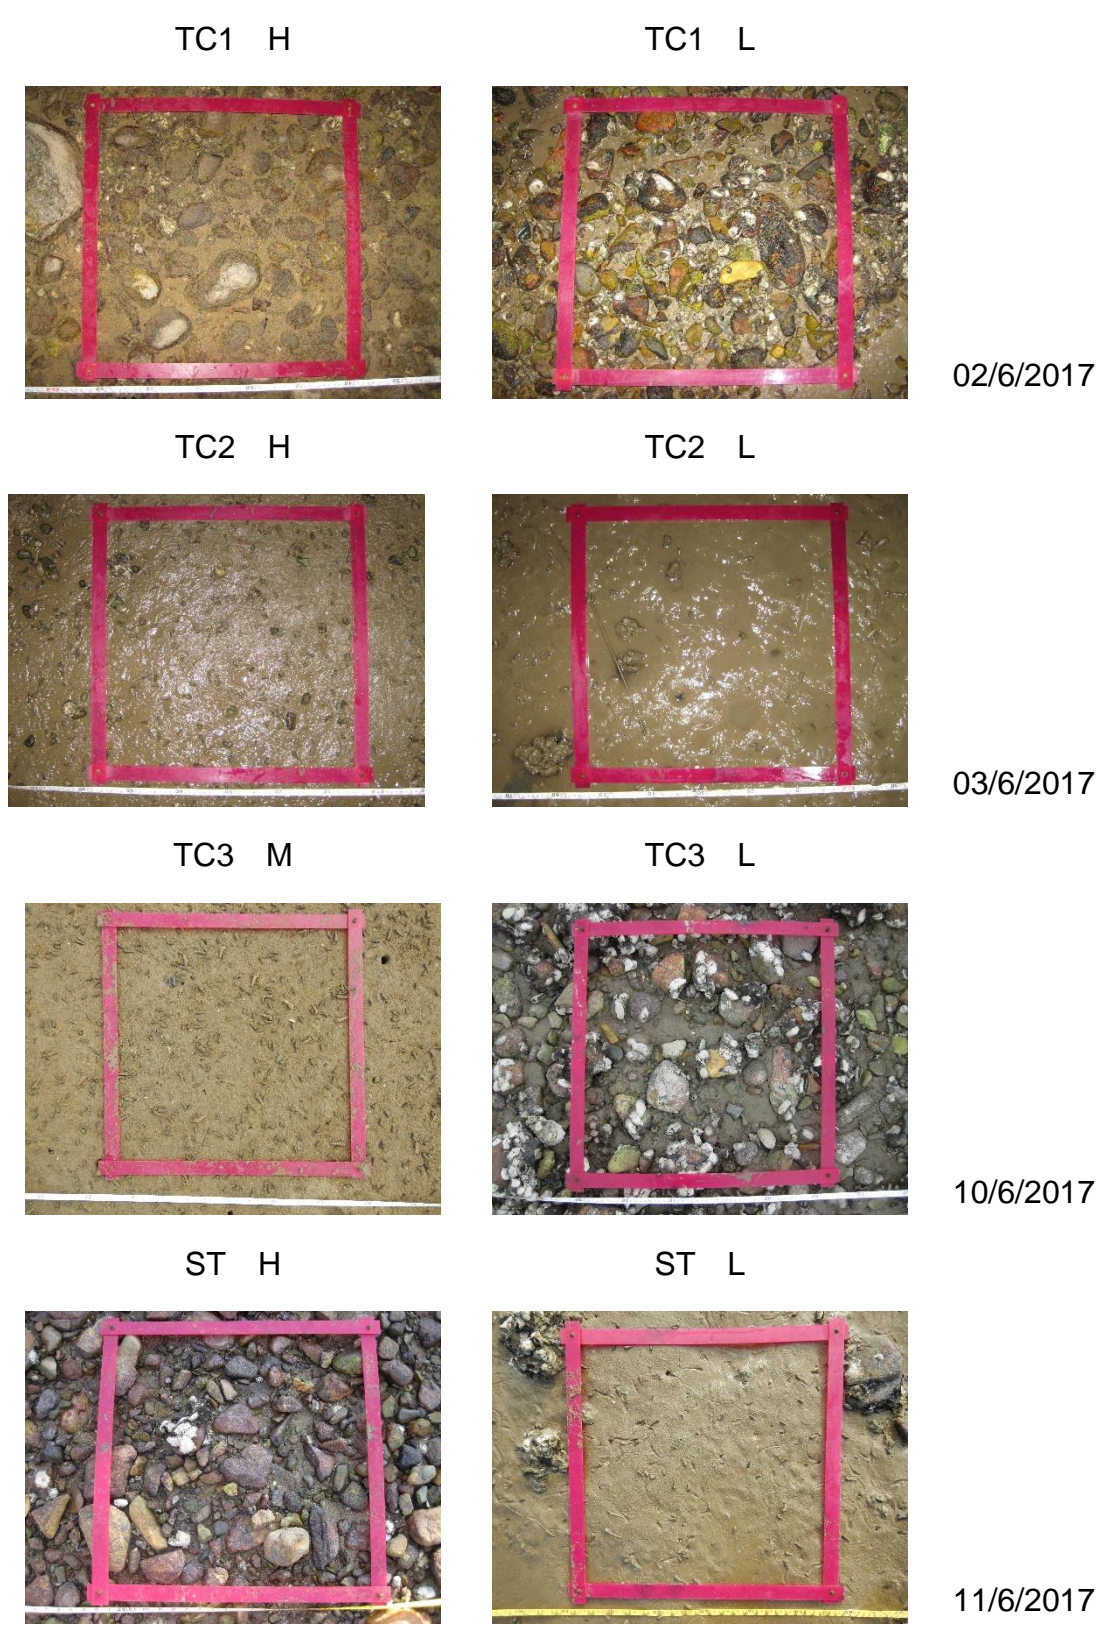
**Figure 3.11.** *Examples of photographic records of quadrat for intertidal soft shore community survey (H: 2.0 m above C.D.; M: 1.5 m above C.D.; L: 1.0 m above C.D.)*

Sampling zone	Tidal level	Percentage		
		Gravels and Boulders	Sands	Soft mud
TC1	H	80	20	
	M	80		20
	L	70	20	10
TC2	H	30	60	10
	M	30	30	40
	L	20	10	70
TC3	H		100	
	M	10	90	
	L	90		10
ST	H	100		
	M	80	20	
	L	30	40	30

H: 2.0 m above C.D.; M: 1.5 m above C.D.; L: 1.0 m above C.D.
