Contract No. HY/2011/09
Hong Kong-Zhuhai-Macao Bridge
Hong Kong Link Road – Section between HKSAR Boundary and Scenic Hill

Submission under Environmental Permit (EP-352/2009/D – Condition 4.4)
Monthly EM&A Report – July 2017

**Contract No. HY/2011/09 HZMB Hong Kong Link Road –
Section between HKSAR Boundary and Scenic Hill
Revised Monthly EM&A Report for July 2017 (EP-352/2009/D)**

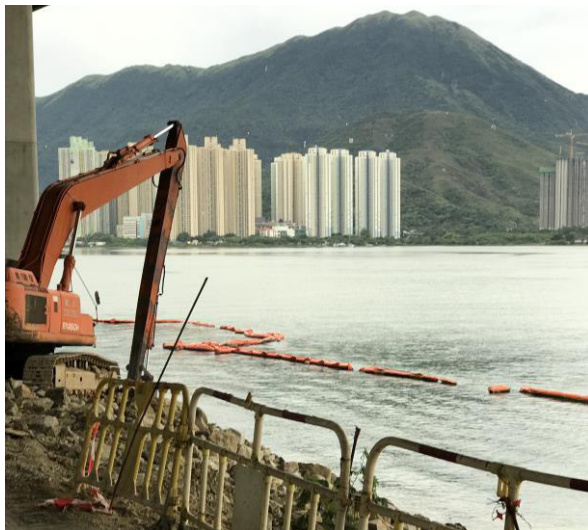
Ref No: 170704-R04

Parameters	Date	Observations and Recommendations	Follow-up
Water Quality	170704-R04	Silt curtain at P98 should be maintained.	Rectification/improvement was observed during the follow-up audit session on 11 July 2017.
	170718-R02	Silt curtain at P86, 91 should be properly maintained.	Rectification/improvement was observed during the follow-up audit session on 25 July 2017.
	170718-R03	Sandbag should be properly banded along SE Quay site boundary to prevent site runoff discharge to the sea.	Rectification/improvement was observed during the follow-up audit session on 25 July 2017.
Ecology	N/A ⁽¹⁾	N/A ⁽¹⁾	N/A ⁽¹⁾
Air Quality	170704-R02	Surfaces at P40 should be sprayed with water during breaking works.	Rectification/improvement was observed during the follow-up audit session on 11 July 2017.
	170711-R01	Dusty material at P40 should be removed or covered by impervious sheet.	Rectification/improvement was observed during the follow-up audit session on 25 July 2017.

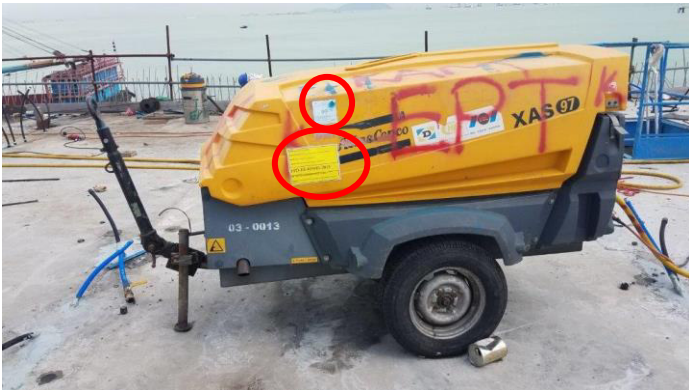
<p>Ref No: 170627-R01</p> <p>Impact: Air Quality (D26); Noise (E8)</p> <p>Details: NRMM and NEL labels should be provided to the equipment at P60.</p> <p>Follow-up: NRMM and NEL labels were provided to the equipment at P60.</p>

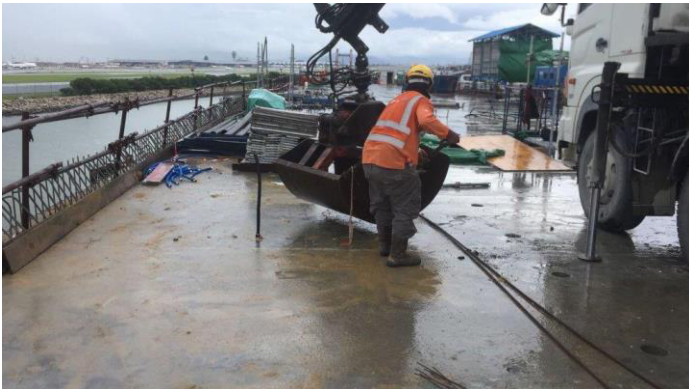
<p>Ref No: 170627-R02</p> <p>Impact: Waste / Chemical Management (F1i,iii)</p> <p>Details: Housekeeping should be enhanced at P63.</p> <p>Follow-up: Housekeeping was enhanced at P63.</p>

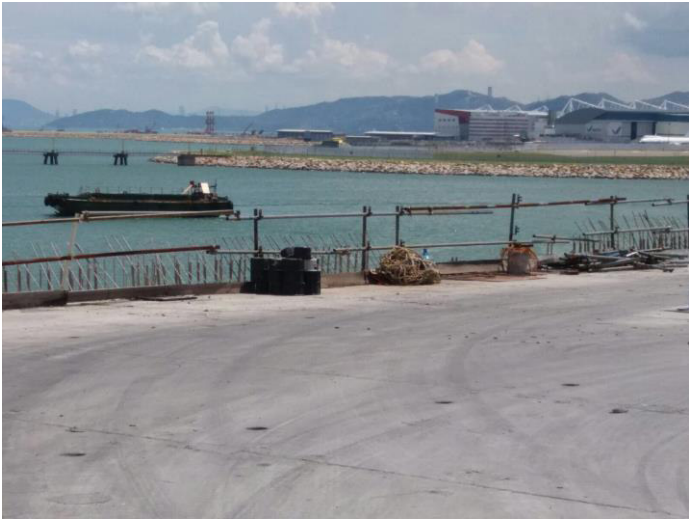
<p>Ref No: 170627-R03</p> <p>Impact: Air Quality (D7)</p> <p>Details: Dusty material should be covered by impervious sheet or removed at P68.</p> <p>Follow-up: Dusty material at P68 was removed.</p>

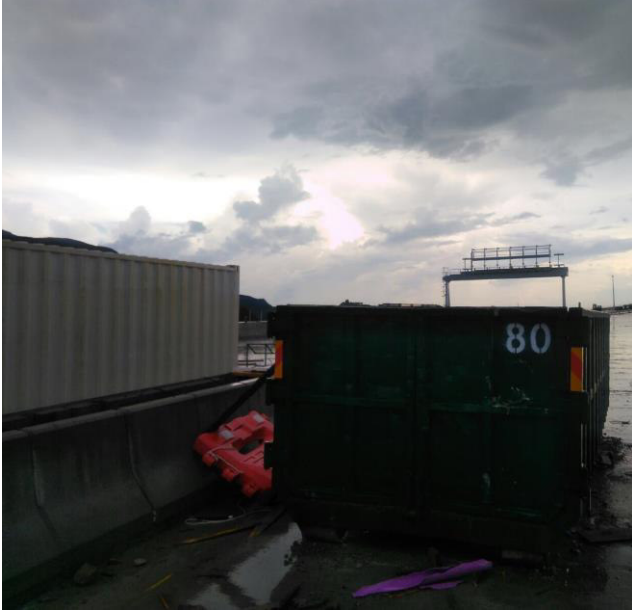
<p>Ref No: 170704-R01</p> <p>Impact: Waste / Chemical Management (F4ii)</p> <p>Details: Housekeeping should be enhanced at P35 to avoid accumulated construction waste.</p> <p>Follow-up: Accumulated construction waste at P35 was cleared.</p>

Noise	N/A ⁽¹⁾	N/A ⁽¹⁾	N/A ⁽¹⁾
Waste / Chemical Management	170704-R01	Housekeeping should be enhanced at P35 to avoid accumulated construction waste.	Rectification/improvement was observed during the follow-up audit session on 11 July 2017.
	170704-R03	Drip tray at P47, 57 should be plugged.	Rectification/improvement was observed during the follow-up audit session on 11 July 2017.
	170711-R02	Chemical containers at P44, 51, 53 should be provided with proper chemical label, drip tray and with proper chemical container.	Rectification/improvement was observed during the follow-up audit session on 25 July 2017.
	170711-R03	Housekeeping at P50, 53 and Portion A P82 should be enhanced.	Rectification/improvement was observed during the follow-up audit session on 25 July 2017.
	170718-R01	Housekeeping at P82-83 should be enhanced.	Rectification/improvement was observed during the follow-up audit session on 25 July 2017.
