Contract No. HY/2011/03

**Hong Kong-Zhuhai-Macao Bridge Hong Kong Link Road
Section between Scenic Hill and Hong Kong Boundary Crossing
Facilities**

Monthly EM&A Report No.59 (Aug 2017)

14 September 2017

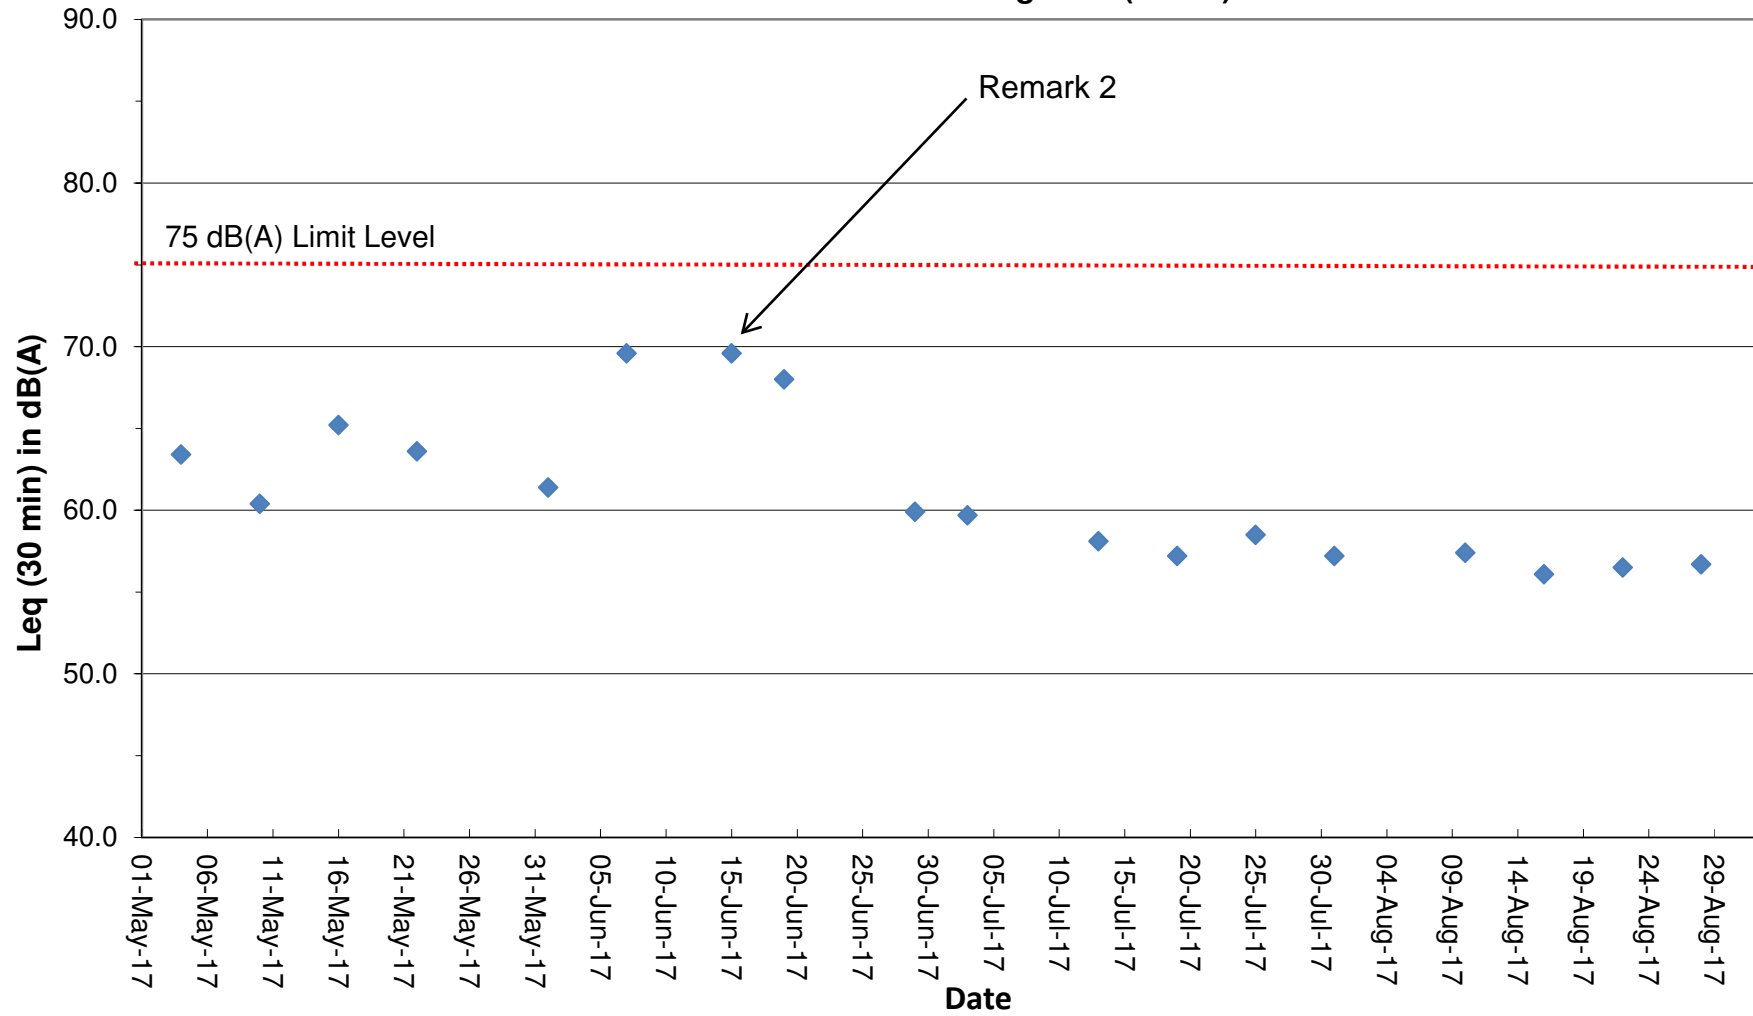
Graphical Plot of Noise Levels at NMS5

- (1) A facade correction of +3 dB(A) was applied to the measured noise level.
- (2) Due to weather condition, the noise monitoring schedule was rescheduled from 13 June 2017 to 15 June 2017.
