Contract No. HY/2011/03

**Hong Kong-Zhuhai-Macao Bridge Hong Kong Link Road
Section between Scenic Hill and Hong Kong Boundary Crossing
Facilities**

Monthly EM&A Report No.60 (September 2017)

12 October 2017

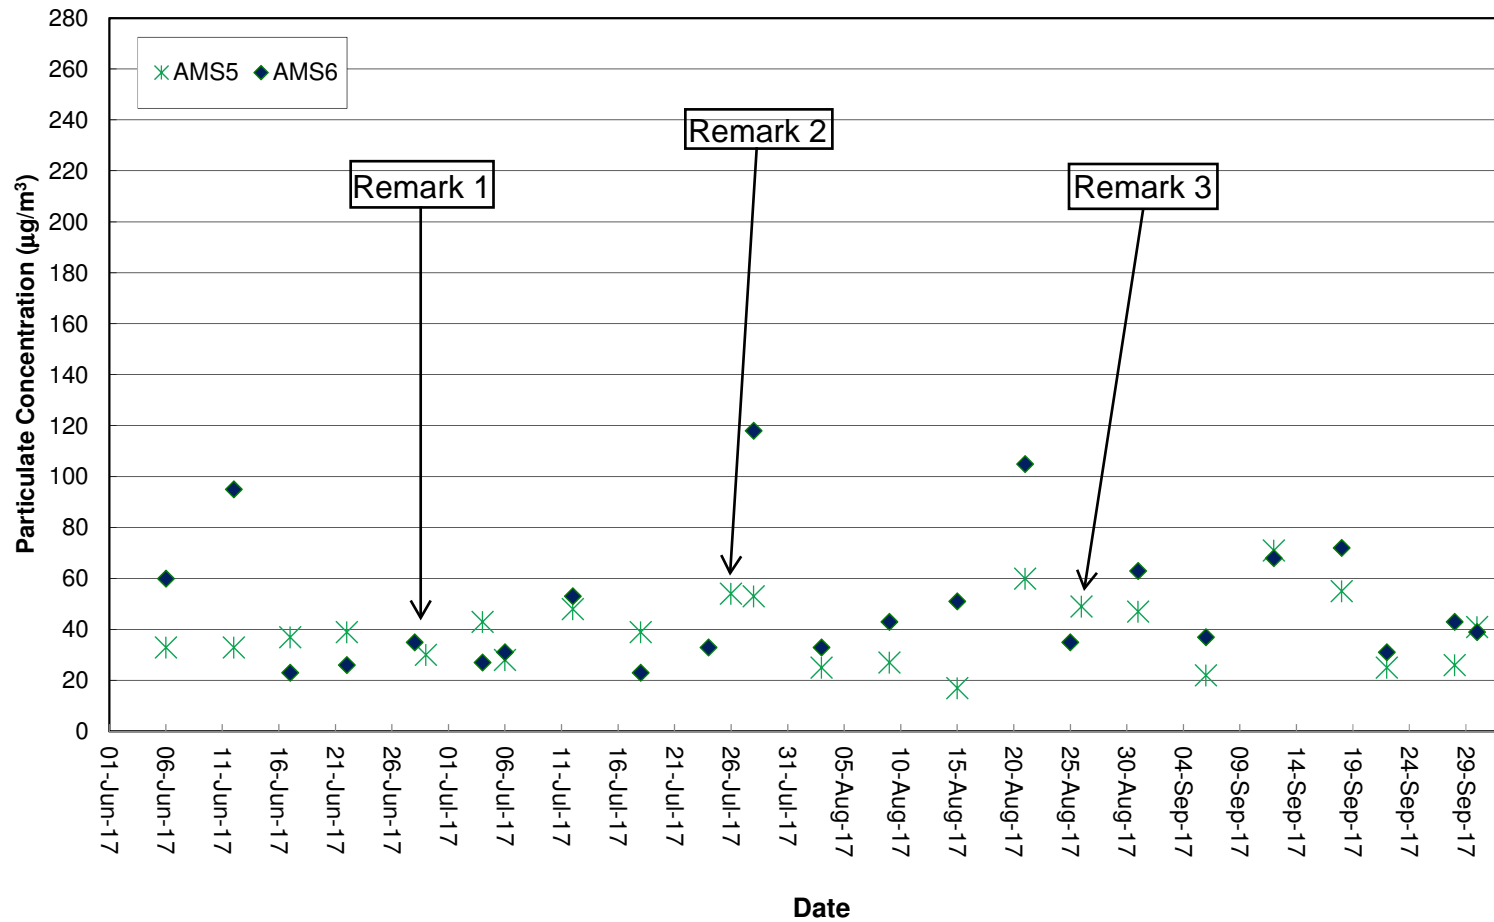
Graphical Plot of 24-hour TSP at AMS5 and AMS6

- 1) Due to power supply failure, the 24-hour TSP monitoring at AMS5 was rescheduled from 28 June 2017 to 29 June 2017.
- 2) Due to motor failure, the 24-hour TSP monitoring at AMS5 was rescheduled from 24 July 2017 to 26 July 2017.
- 3) The 24-hour TSP monitoring at AMS5 was rescheduled from 25 August 2017 to 26 August 2017 due to power outage of Ma Wan Chung Village caused by seawater engulfment.

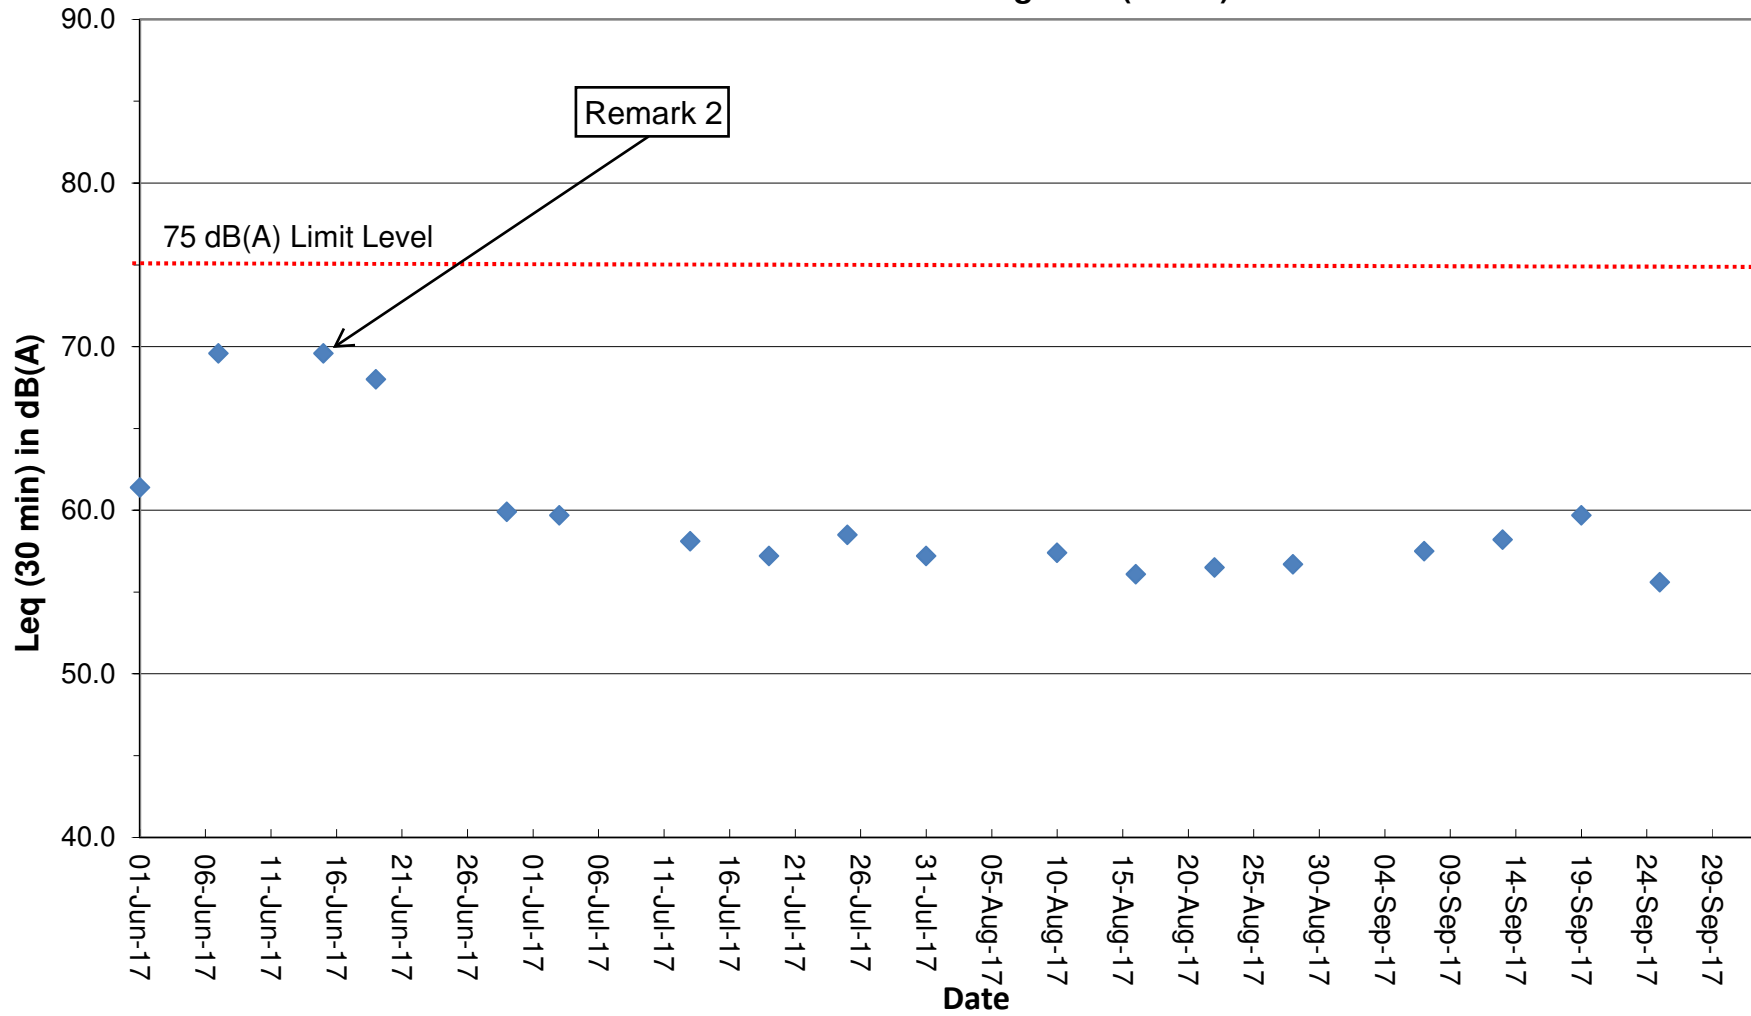
Graphical Plot of Noise Levels at NMS5

- (1) A facade correction of +3 dB(A) was applied to the measured noise level.
- (2) Due to weather condition, the noise monitoring schedule was rescheduled from 13 June 2017 to 15 June 2017.

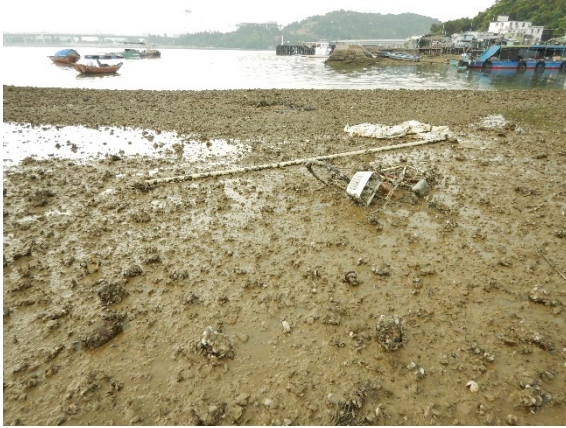
broken bike and plastic waste

- 6.3.2 Since the field survey of Jun. 2016, increasing number of trashes and even big trashes (**Figure 2.3 of Appendix I**) were found in every sampling zone. It raised a concern about the solid waste dumping and current-driven waste issues in Tung Chung Wan. Respective measures (e.g. manual clean-up) should be implemented by responsible units.

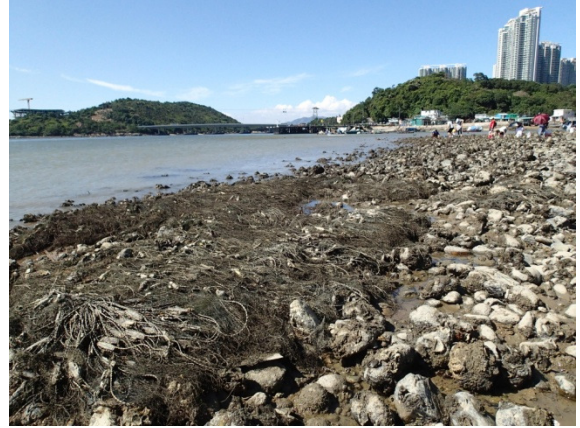
trash gill net

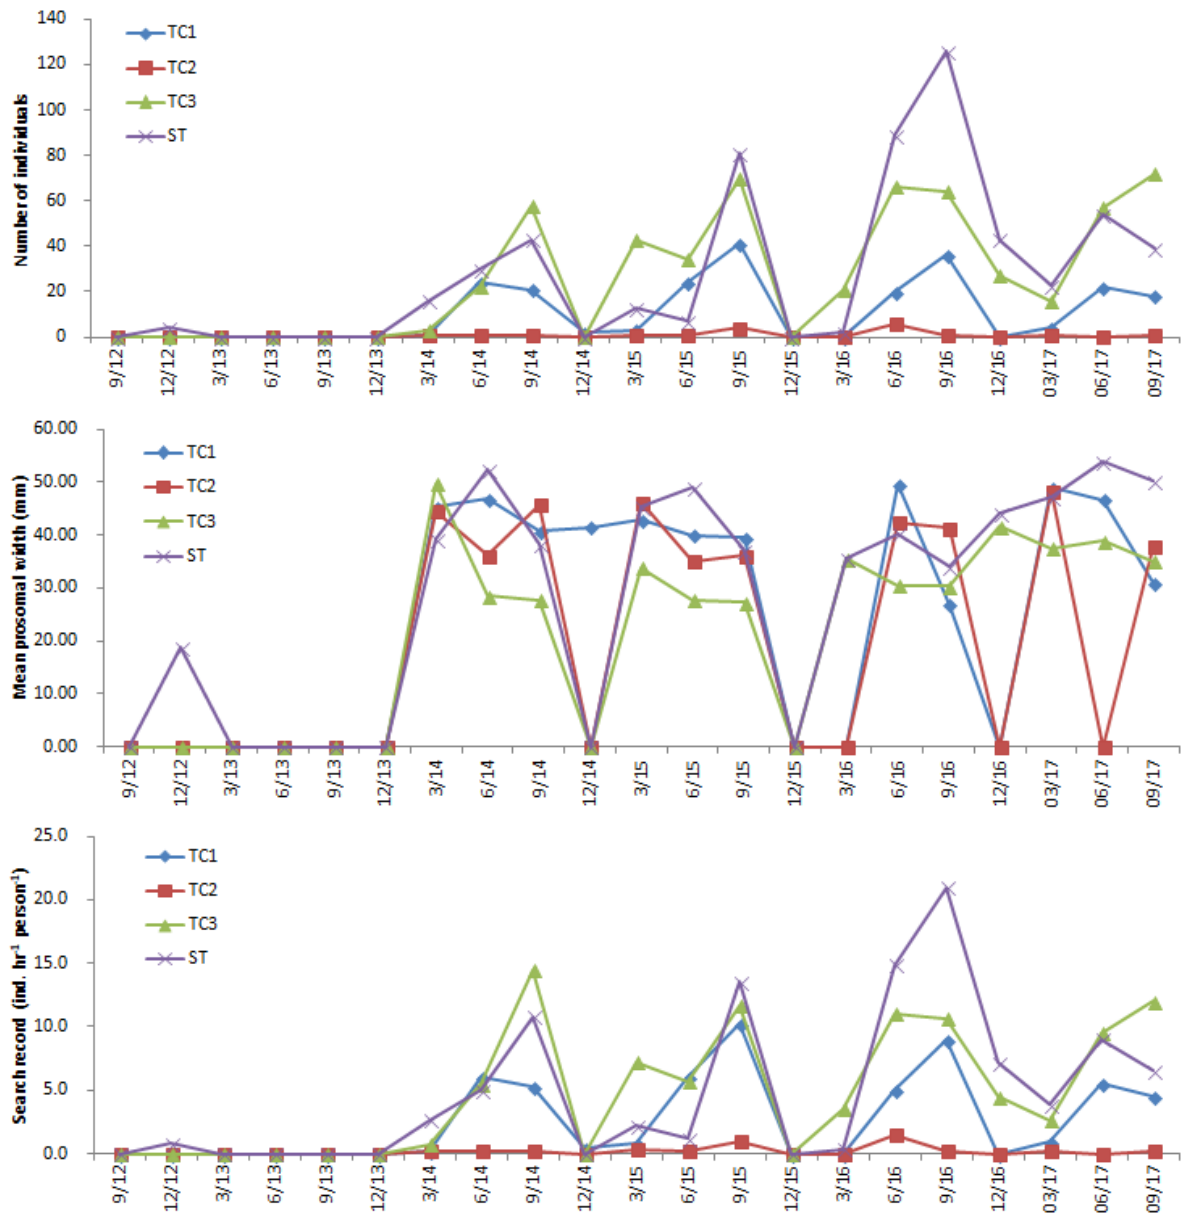
Figure 3.4. Changes of number of individuals, mean prosomal width and search record of horseshoe crab *Carcinoscorpius rotundicauda* in every sampling zone along the sampling months

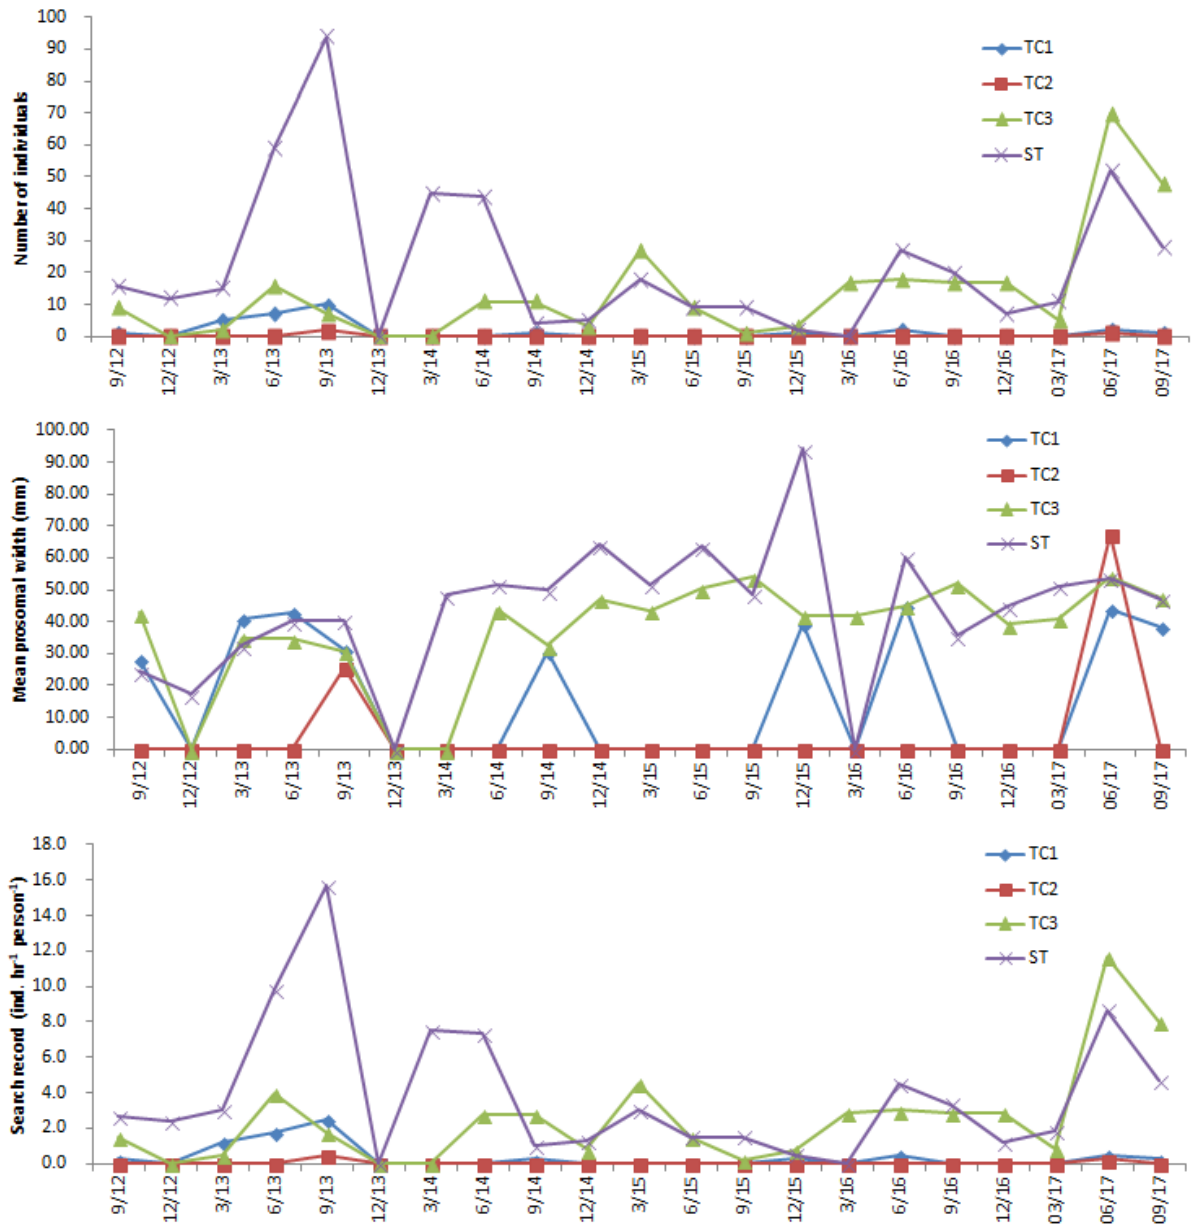
Figure 3.5. Changes of number of individuals, mean prosomal width and search record of horseshoe crab *Tachypleus tridentatus* in every sampling zone along the sampling months

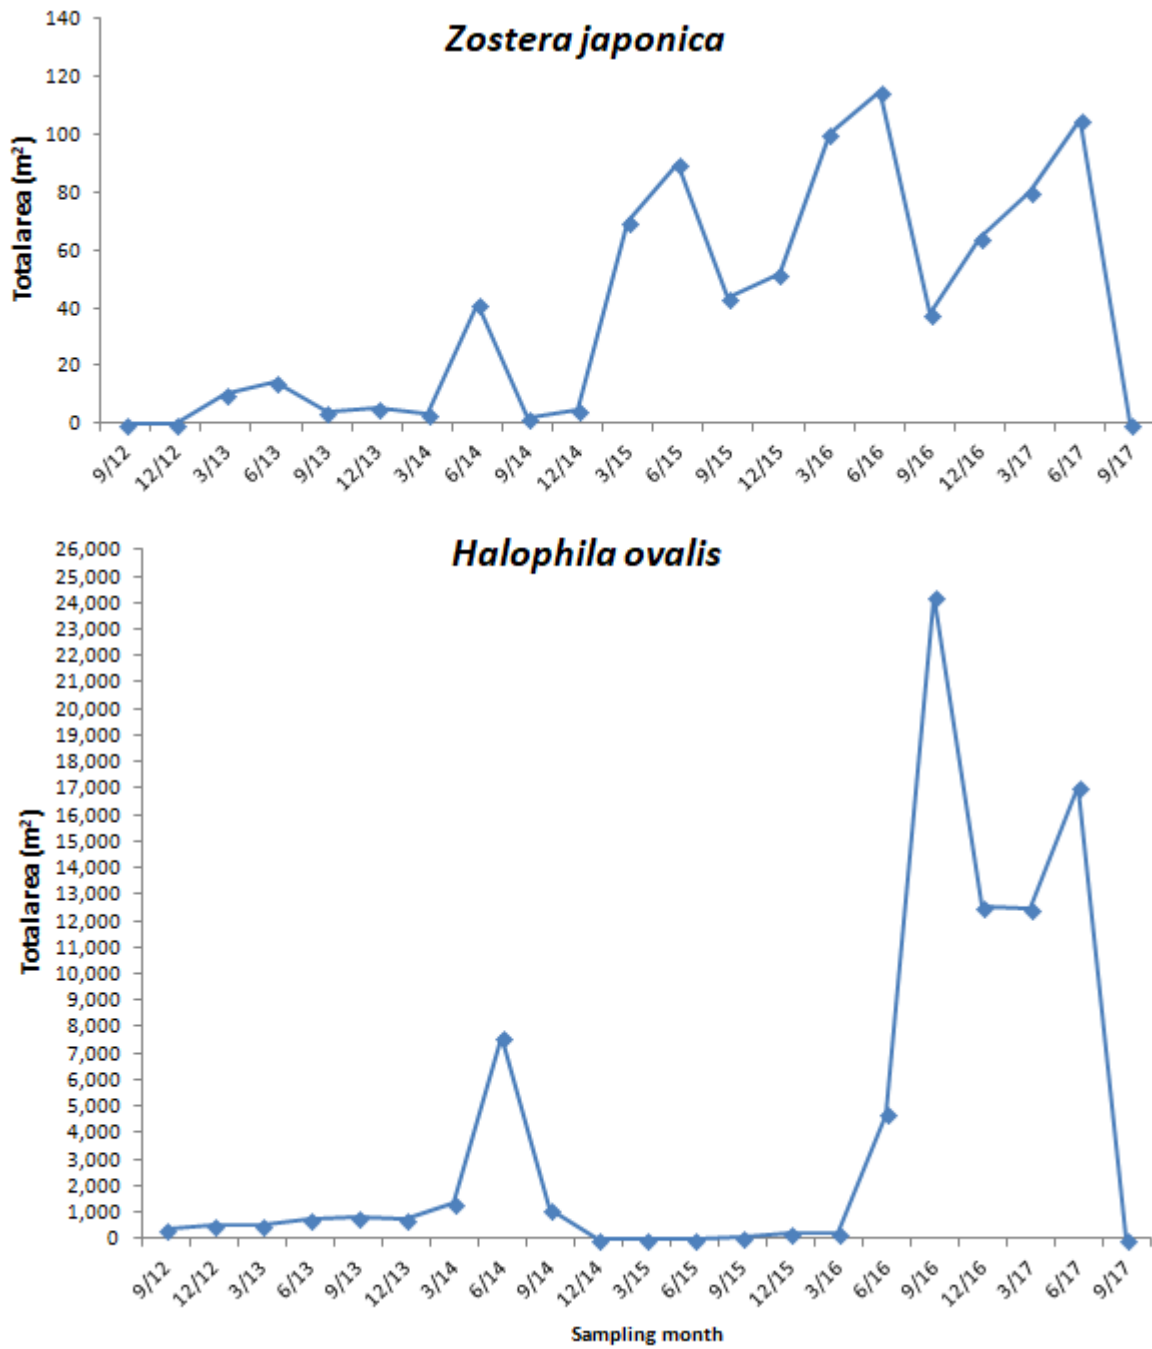
Figure 3.10. Temporal changes of estimated total area of seagrass beds in ST
