Contract No. HY/2011/03

**Hong Kong-Zhuhai-Macao Bridge Hong Kong Link Road
Section between Scenic Hill and Hong Kong Boundary Crossing
Facilities**

Monthly EM&A Report No.73 (October 2018)

13 November 2018

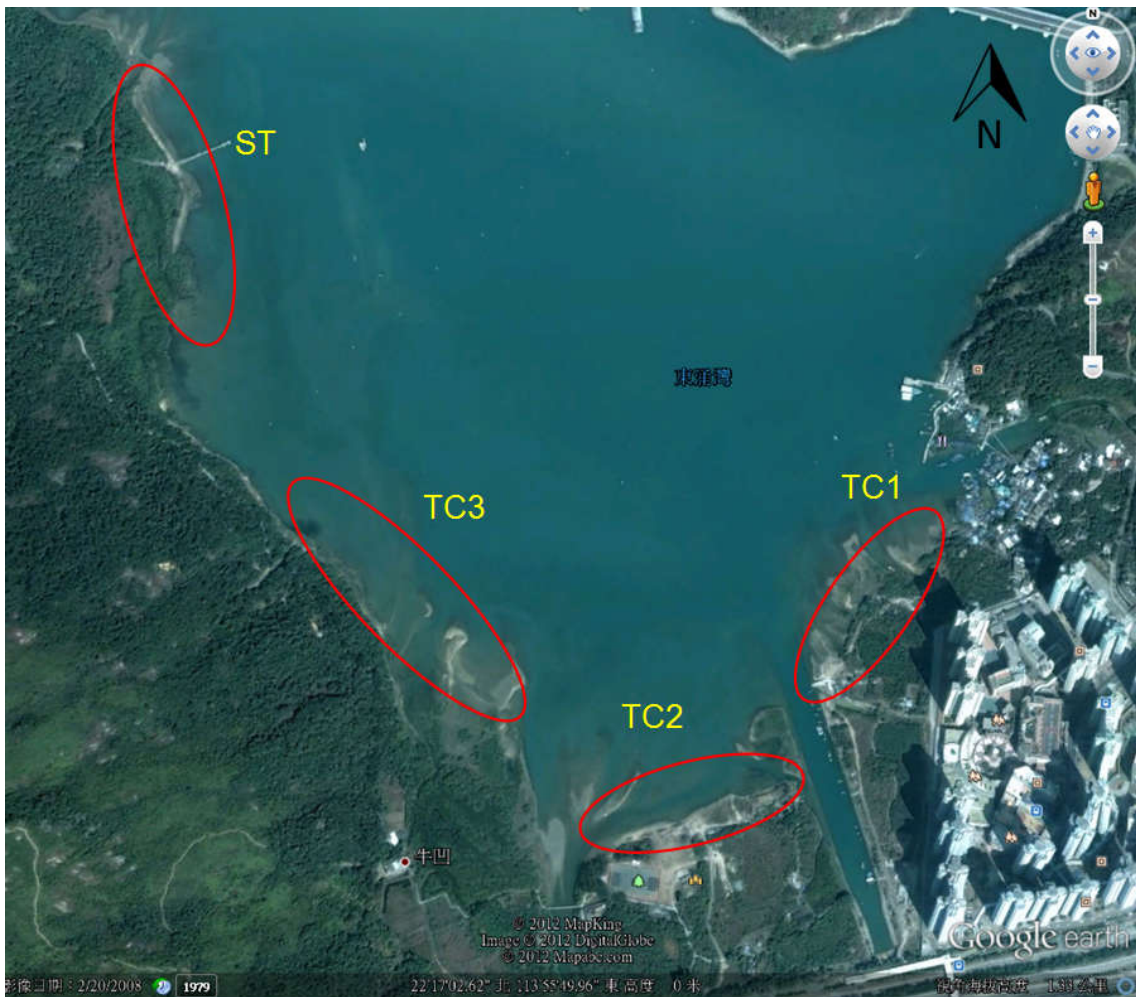
Figure 2.1. Locations of sampling zones. The study site was divided into three sampling zones (TC1, TC2, TC3) in Tung Chung Bay and one zone in San Tau (ST) (map generated from Google Map).

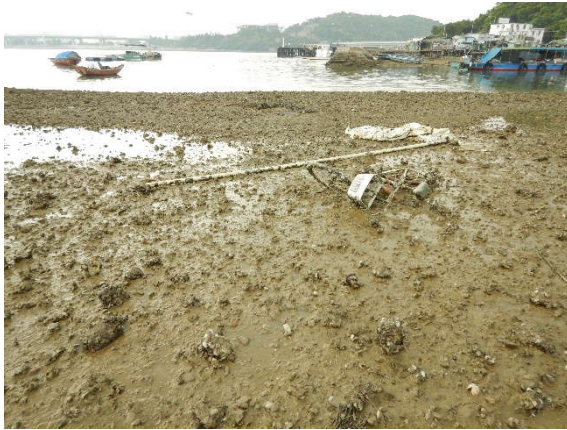
broken bike and plastic waste

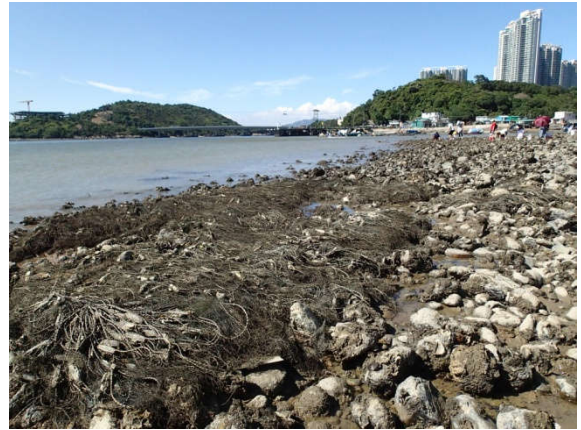
trash gill net

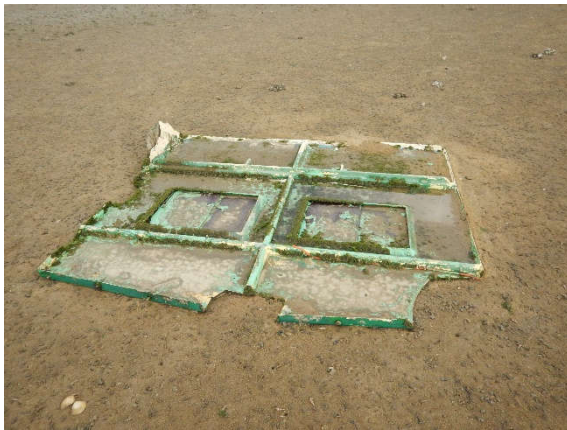
TC3

boat wreckage

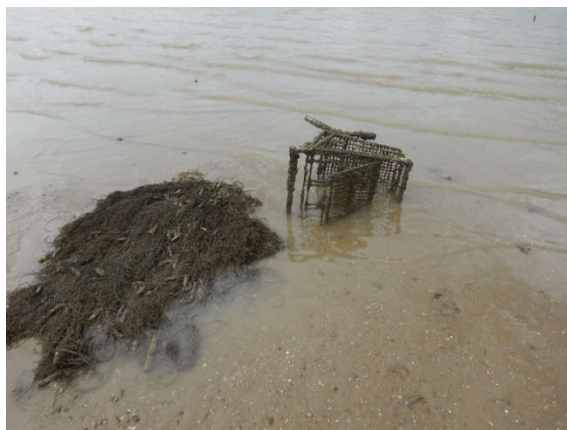
ST

trash gill net and hand trolley

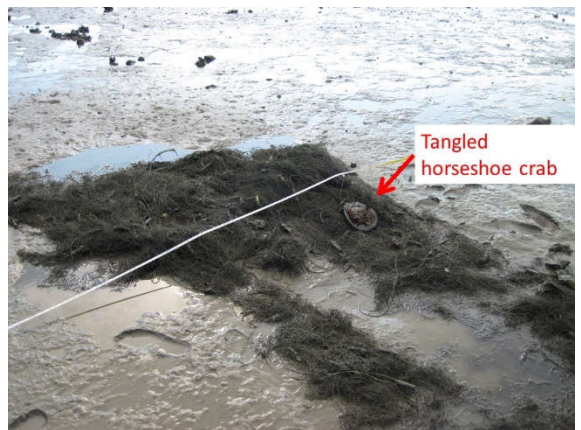
Figure 2.3. *Examples of photographic record of the big trashes found on the mudflat.*

a tangled horseshoe crab on a trash net

(record in Jun. 2017)

- 6.2.4 In Jun. 2017, a big horseshoe crab was tangled by a trash gill net in ST mudflat (**Figure 2.3 of Appendix I**). It was released to sea once after photo recording. The horseshoe crab of such size should be inhabiting sub-tidal environment while it forages on intertidal shore occasionally during high tide period. If it is tangled by the trash net for few days, it may die due to starvation or overheat during low tide period. These trash gill nets are definitely 'fatal trap' for the horseshoe crabs and other marine life. Manual clean-up should be implemented as soon as possible by responsible government agency units.

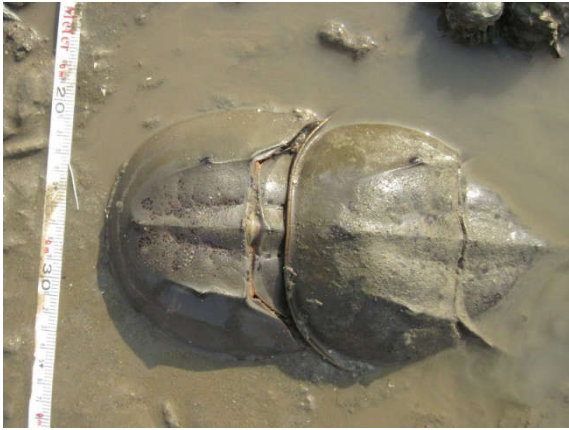
Mar. 2015 - ST

Figure 3.2. Photographic records of mating pair of *Carcinoscorpius rotundicauda*

- 6.4.4 In the previous survey of Mar. 2015, there was one important finding that a mating pair of *Carcinoscorpius rotundicauda* was found in ST (prosomal width: male 155.1 mm, female 138.2 mm) (**Figure 3.2 of Appendix I**). It indicated the importance of ST as a breeding ground of horseshoe crab. In Jun. 2017, mating pairs of *Carcinoscorpius rotundicauda* were also found in TC2 (male 175.27 mm, female 143.51 mm) and TC3 (male 182.08 mm, female 145.63 mm) (**Figure 3.2 of Appendix I**). In Dec. 2017 and Jun. 2018, one mating pair was of *Carcinoscorpius rotundicauda* was found in TC3 (Dec. 2017: male 127.80 mm, female 144.61 mm; Jun. 2018: male 139 mm, female 149 mm). **Figure 3.2 of Appendix I** shows the photographic records of all mating pairs found. The recorded mating pairs were found nearly burrowing in soft mud at low tidal level (0.5-1.0 m above C.D.). The smaller male was holding the opisthosoma (abdomen carapace) of larger female from behind. These mating pairs indicated that breeding of horseshoe crab could be possible along the coast of Tung Chung Wan rather than ST only, as long as suitable substratum was available. Based on the frequency of encounter, the shoreline between TC3 and ST should be more suitable mating ground. Moreover suitable breeding period was believed in wet season (Mar - Sep.) because tiny individuals (i.e. newly hatched) were usually recorded in Jun. and Sep. every year. In present survey (Sep. 2018), two newly hatched individuals were also found in TC1 and TC2 (prosomal width 6.00-6.87 mm) (**Figure 3.4 of Appendix I**) while species identification was not possible.

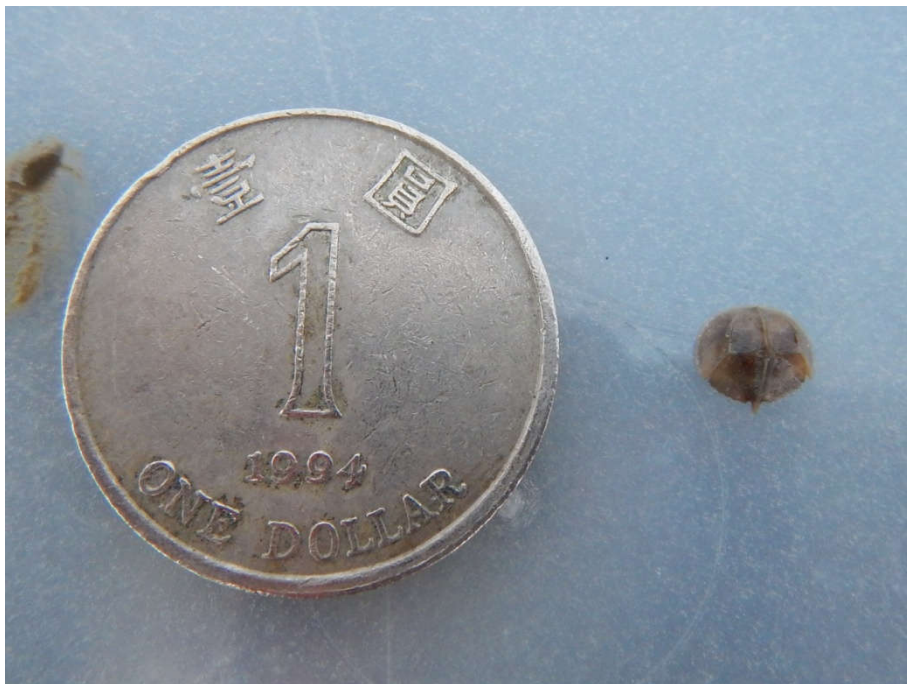
TC2

Figure 3.4. *Photographic records of newly hatched individuals of horseshoe crab (Sep. 2018)*

- 6.4.13 Throughout the monitoring period, the search record of horseshoe crab declined obviously during dry season especially December (**Figures 3.4 and 3.5 of Appendix I**). 4 individuals of *Carcinoscorpius rotundicauda* and 12 individuals of *Tachypleus tridentatus* were found only. In Dec. 2013, no individual of horseshoe crab was found. In Dec. 2014, 2 individuals of *Carcinoscorpius rotundicauda* and 8 individuals of *Tachypleus tridentatus* were found only. In Dec. 2015, 2 individuals of *Carcinoscorpius rotundicauda*, 6 individuals of *Tachypleus tridentatus* and one newly hatched, unidentified individual were found only. The horseshoe crabs were inactive and burrowed in the sediments during cold weather (<15 °C). Similar results of low search record in dry season were reported in a previous territory-wide survey of

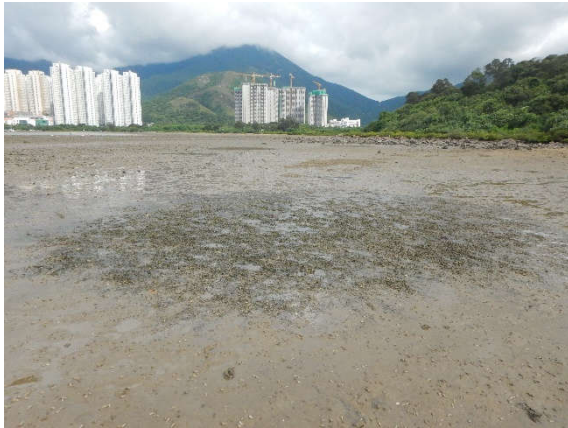
TC3 single patch of *Halophila ovalis*

Figure 3.9. Examples of photographic records of seagrass beds (record in Jun. 2017)

- 6.4.23 Since the commencement of the EM&A monitoring programme, two species of seagrass *Halophila ovalis* and *Zostera japonica* were recorded in TC3 and ST (**Figure 3.9 of Appendix I**). In general, *Halophila ovalis* was occasionally found in TC3 in few, small to medium patches. But it was commonly found in ST in medium to large seagrass bed. Moreover it had sometimes grown extensively and had covered significant mudflat area at 0.5-2.0 m above C.D. between TC3 and ST. Another seagrass species *Zostera japonica* was found in ST only. It was relatively lower in vegetation area and was co-existing with *Halophila ovalis* nearby the mangrove strand at 2.0 m above C.D...

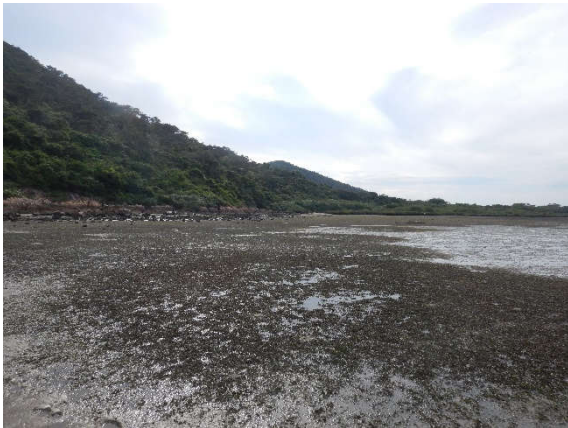
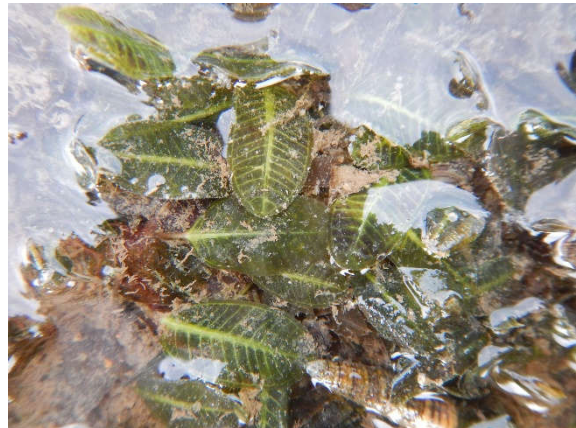
TC3 - ST extensive patch of *Halophila ovalis*

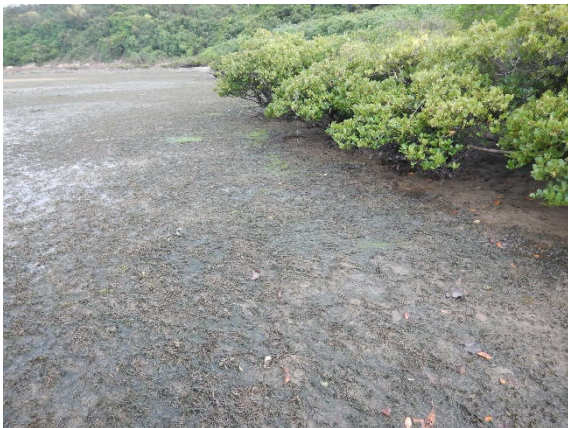
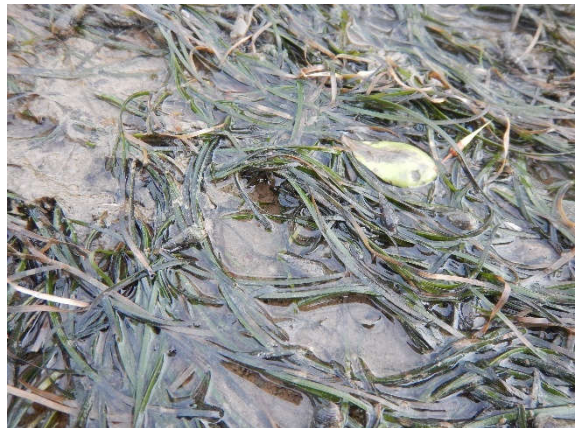
ST medium, horizontal patch of *Zostera japonica*

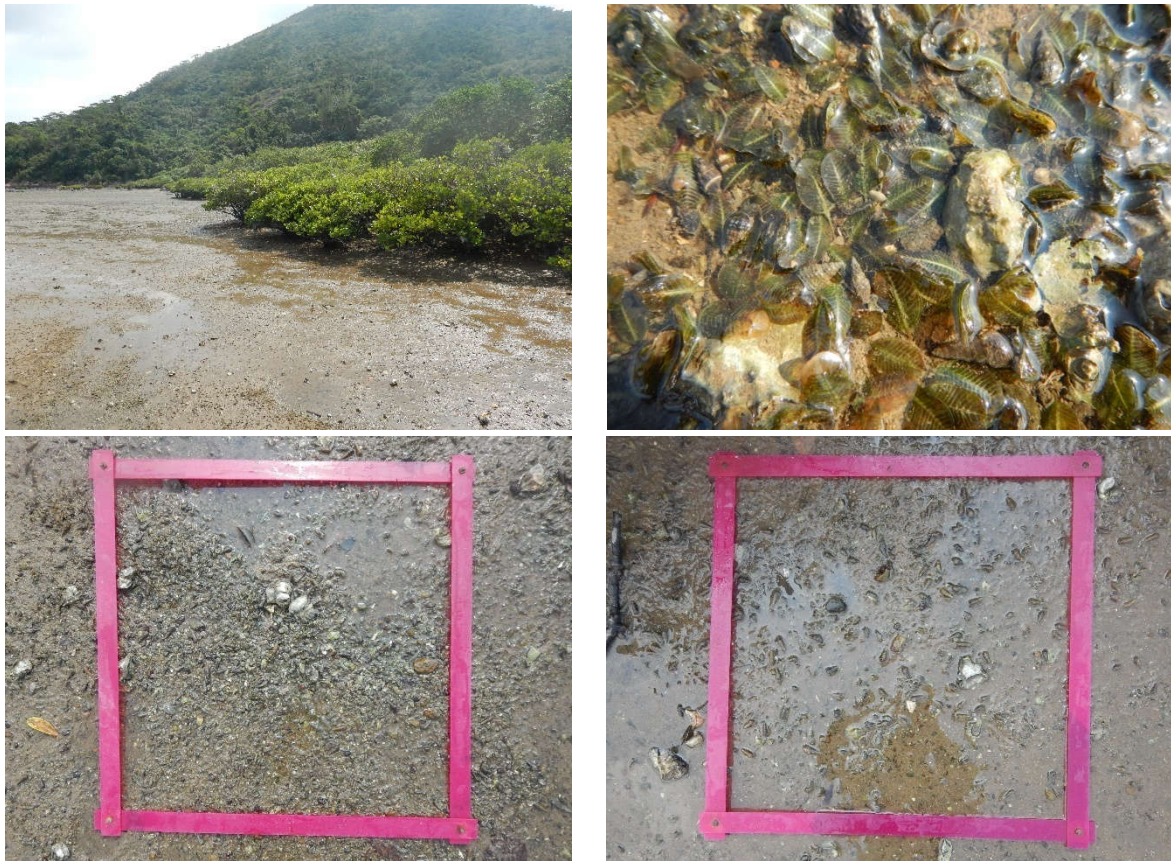
ST small, horizontal patch of *Halophila ovalis*

Figure 3.10. *Photographic record of seagrass beds in present survey.*
