Contract No. HY/2011/03

**Hong Kong-Zhuhai-Macao Bridge Hong Kong Link Road
Section between Scenic Hill and Hong Kong Boundary Crossing
Facilities**

Monthly EM&A Report No.81 (June 2019)

12 July 2019

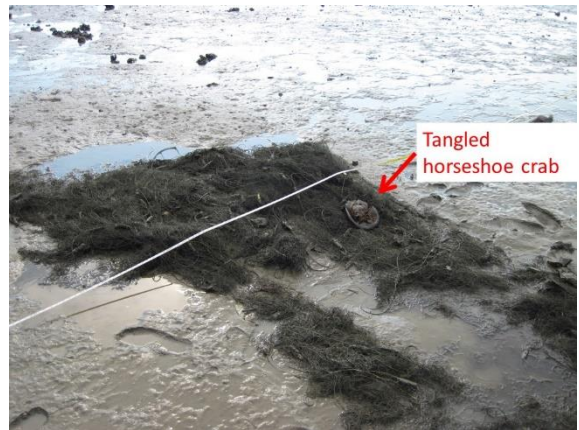
- 6.3.2 Since the field survey of June 2016, increasing number of trashes and even big trashes (**Figure 2.3 of Appendix I**) were found in every sampling zone. It raised a concern about the solid waste dumping and current-driven waste issues in Tung Chung Way. Respective measures (e.g. manual clean-up) should be implemented by responsible governmental agency units.

A tangled horseshoe crab on a trash net
(record in June 2017)

Figure 2.3. *Examples of photographic record of the big trashes found on the mudflat.*

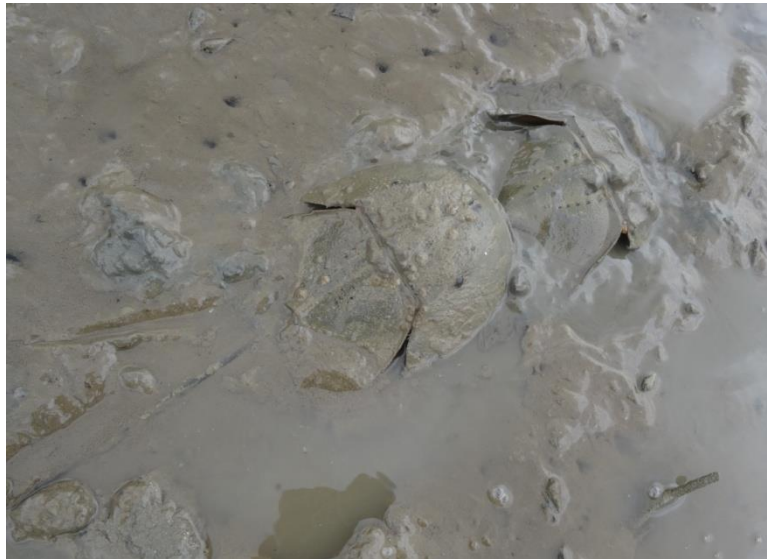
- 6.5.4 Despite of mating pairs, 3 large individuals with average body size 190mm were found in TC3 and one large individual with body size 180mm was noted in ST (**Figure 3.4 of Appendix I**). Based on its size, it indicated that individuals of prosomal width larger than 100 mm would progress its nursery stage from intertidal habitat to sub-tidal habitat of Tung Chung Wan. This large individual might move onto intertidal shore occasionally during high tide for foraging and breeding. Because it should be inhabiting sub-tidal habitat most of the time. This record is excluded from the data analysis to avoid mixing up with juvenile population living on intertidal habitat.

Large individual of *Tachypleus tridentatus* at TC3 (large individual (>100 mm) of horseshoe crabs records was excluded from data analysis)
