**Contract No. HY/2013/04 Hong Kong-Zhuhai-Macao Bridge (HZMB)
Hong Kong Boundary Crossing Facilities – Infrastructure Works Stage II
(Southern Portion)**

Monthly EM&A Report for August 2019 (Revision 1)

**Contract No. HY/2013/04 – HZMB HKBCF – Infrastructure Works Stage II
(Southern Portion)
Monthly Environmental Monitoring & Audit Report for August 2019 (Revision 1)**

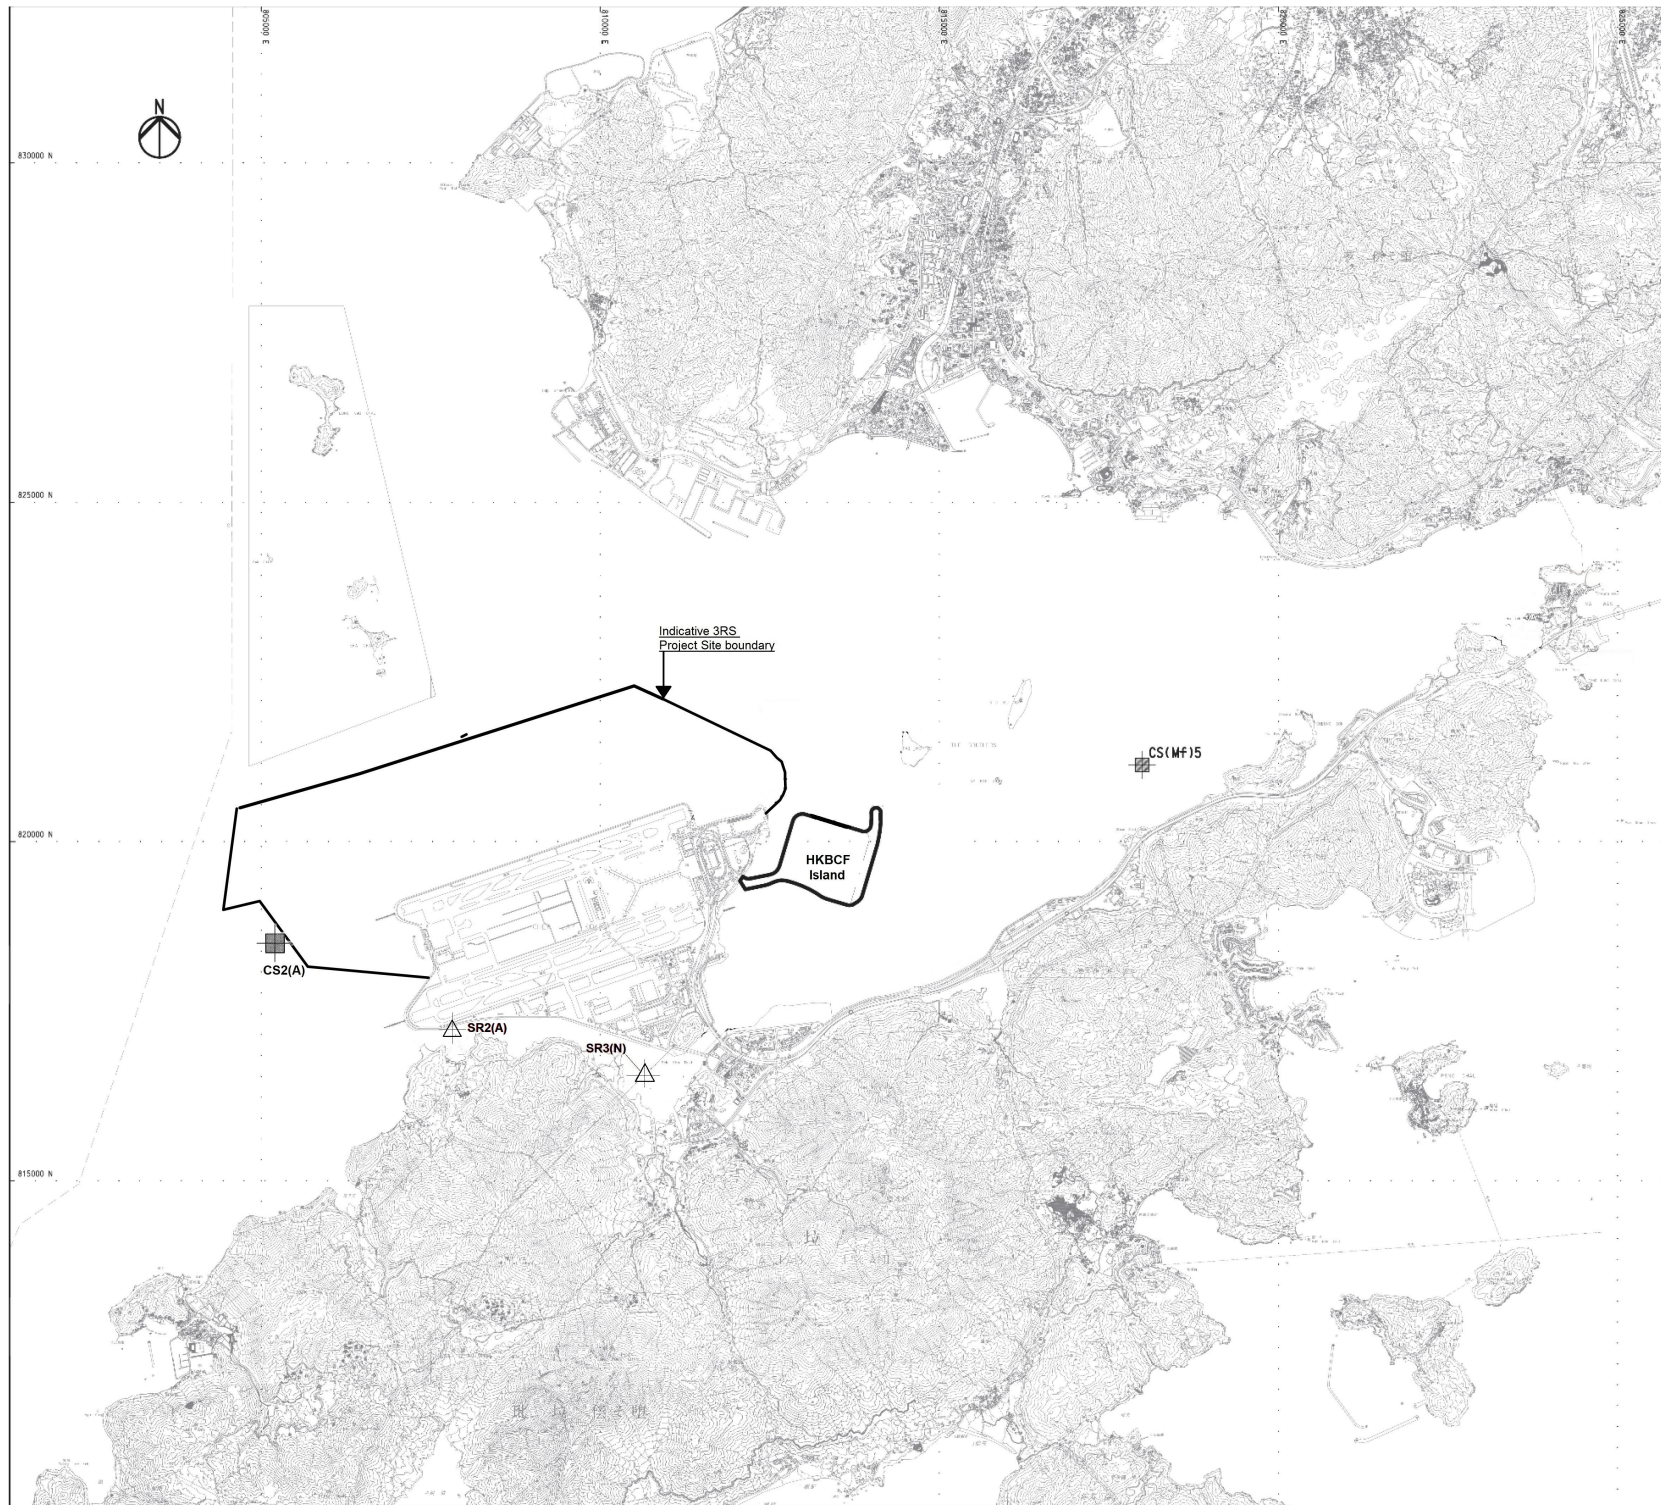
FIGURE 4.1— LOCATION OF WATER QUALITY MONITORING STATIONS

Station	East	North
SR2(A)	807810	817189
SR3(N)	810689	816591
CS2(A)	805232	818606
CS(Mf)5	817990	821129
