Contract No. HY/2011/03

**Hong Kong-Zhuhai-Macao Bridge Hong Kong Link Road
Section between Scenic Hill and Hong Kong Boundary Crossing
Facilities**

Quarterly EM&A Report No. 29 (September 2019 to November 2019)

17 February 2020

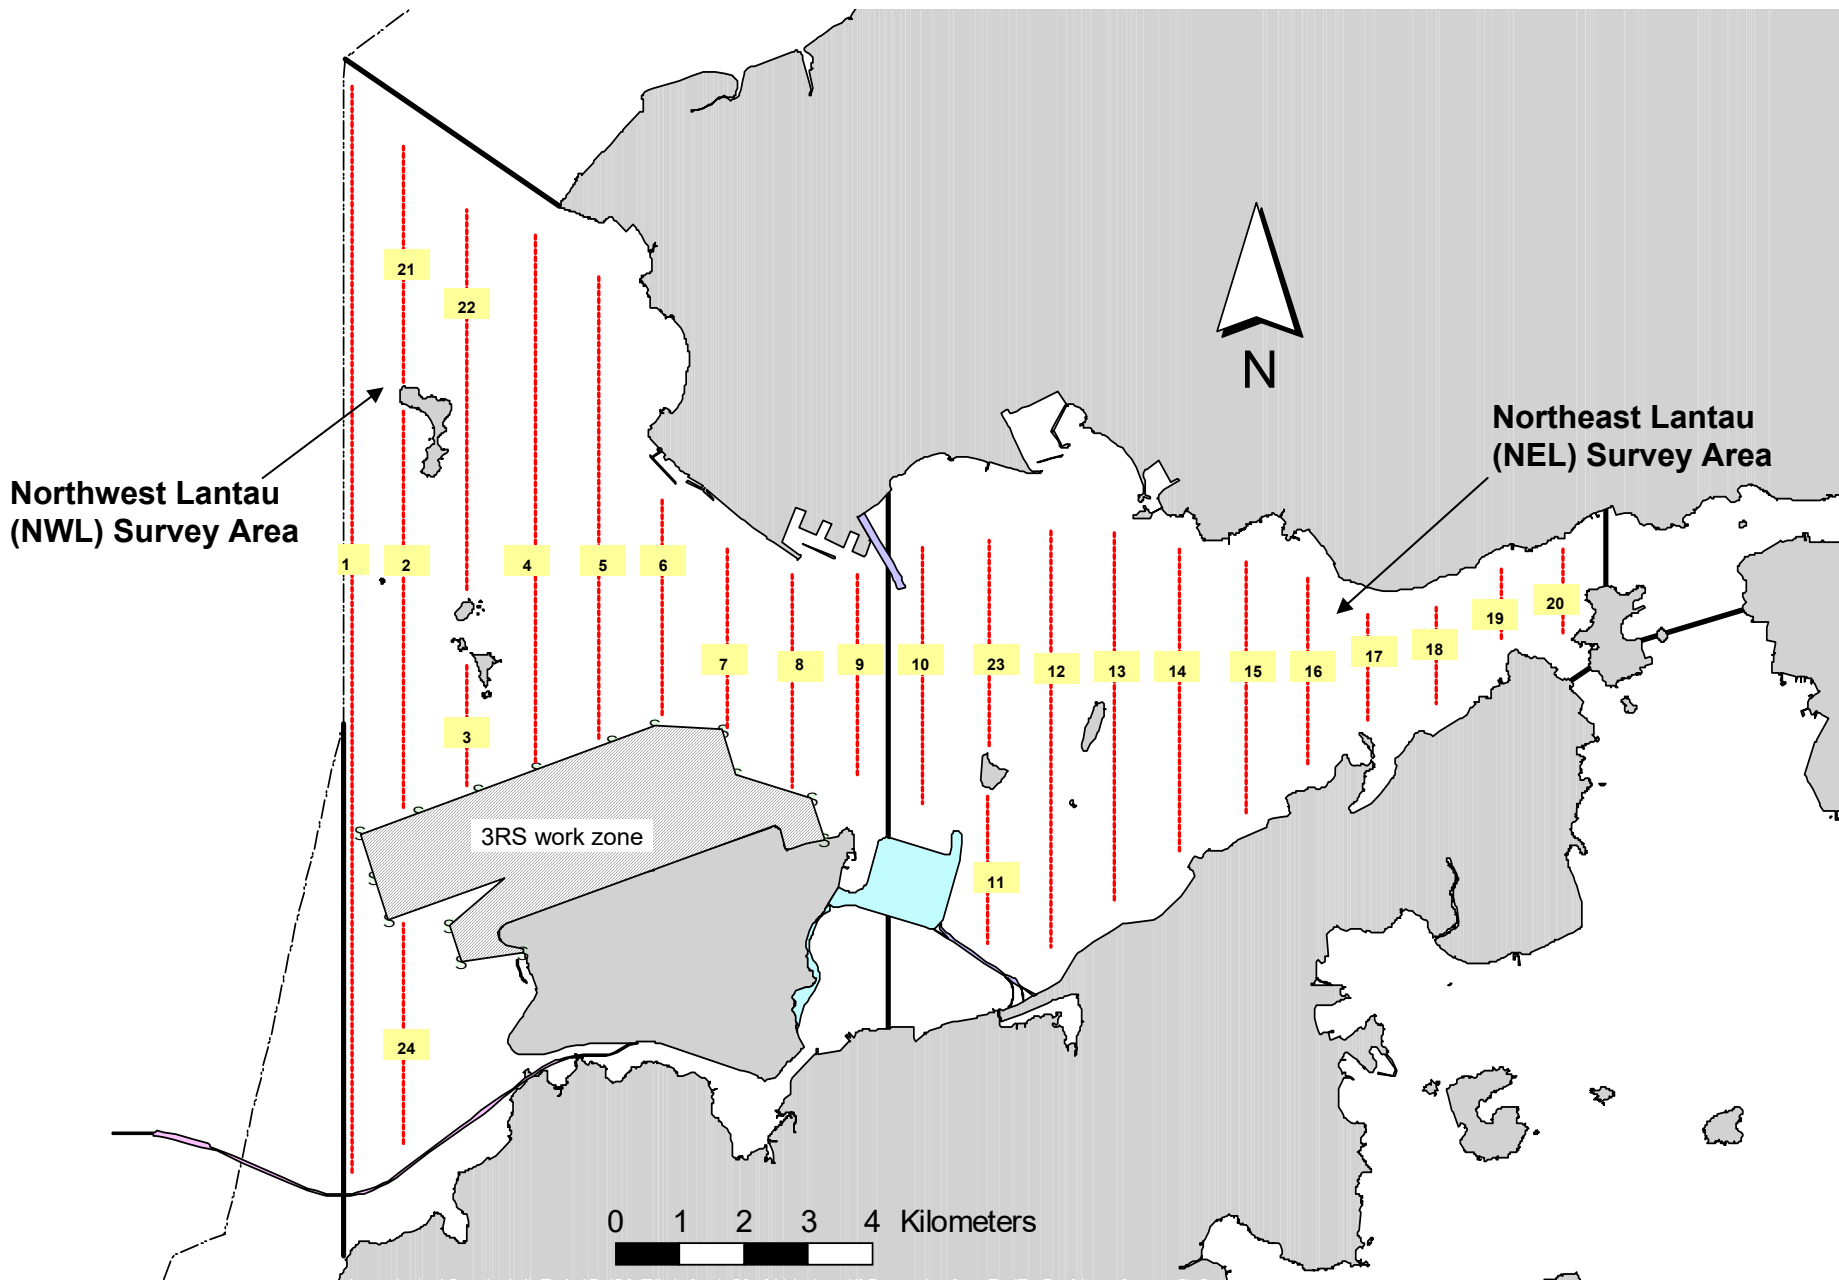
Figure 2.2. Transect Line Layout in Northwest and Northeast Lantau Survey Areas

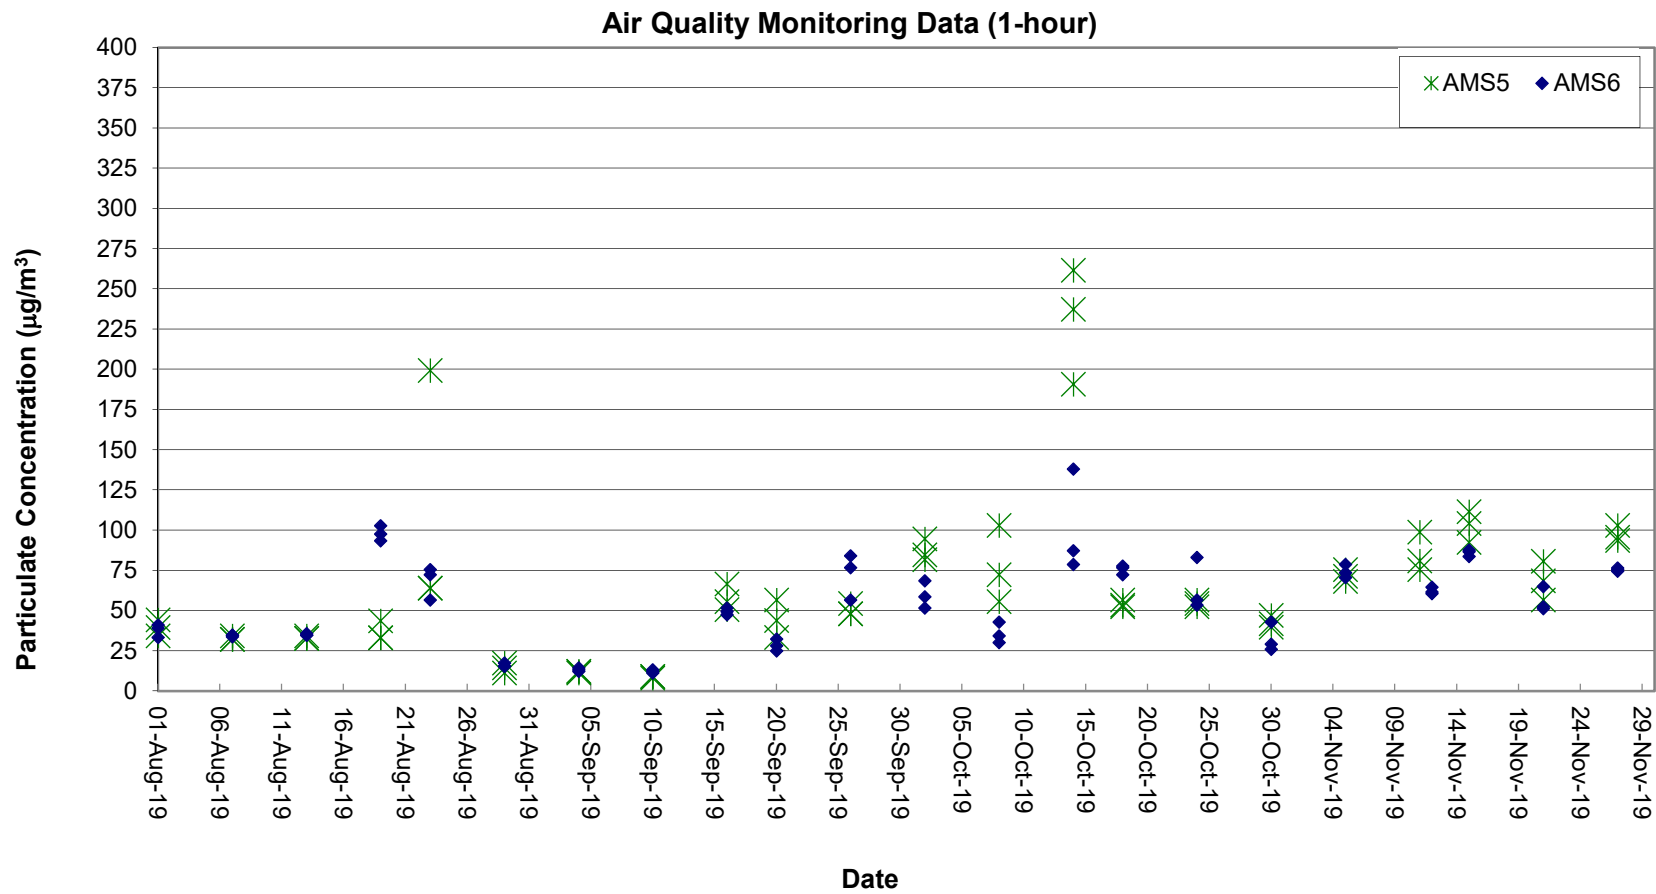
Graphical Plot of 1-hour TSP at AMS5 and AMS6

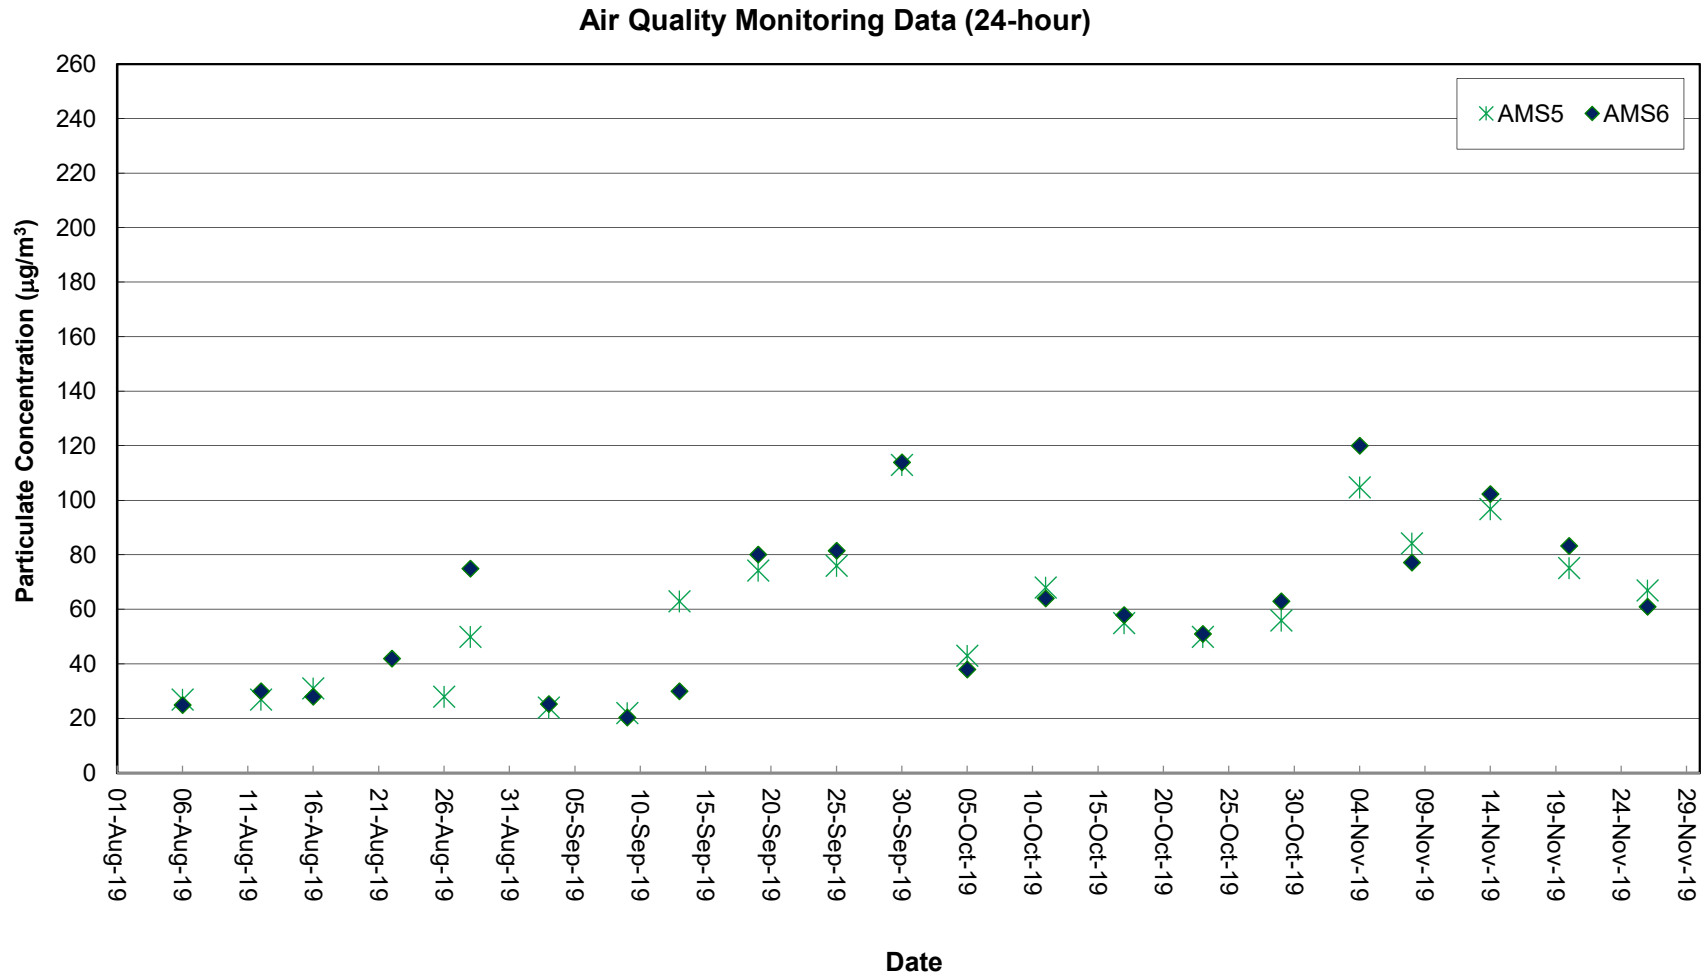
Graphical Plot of 24-hour TSP at AMS5 and AMS6

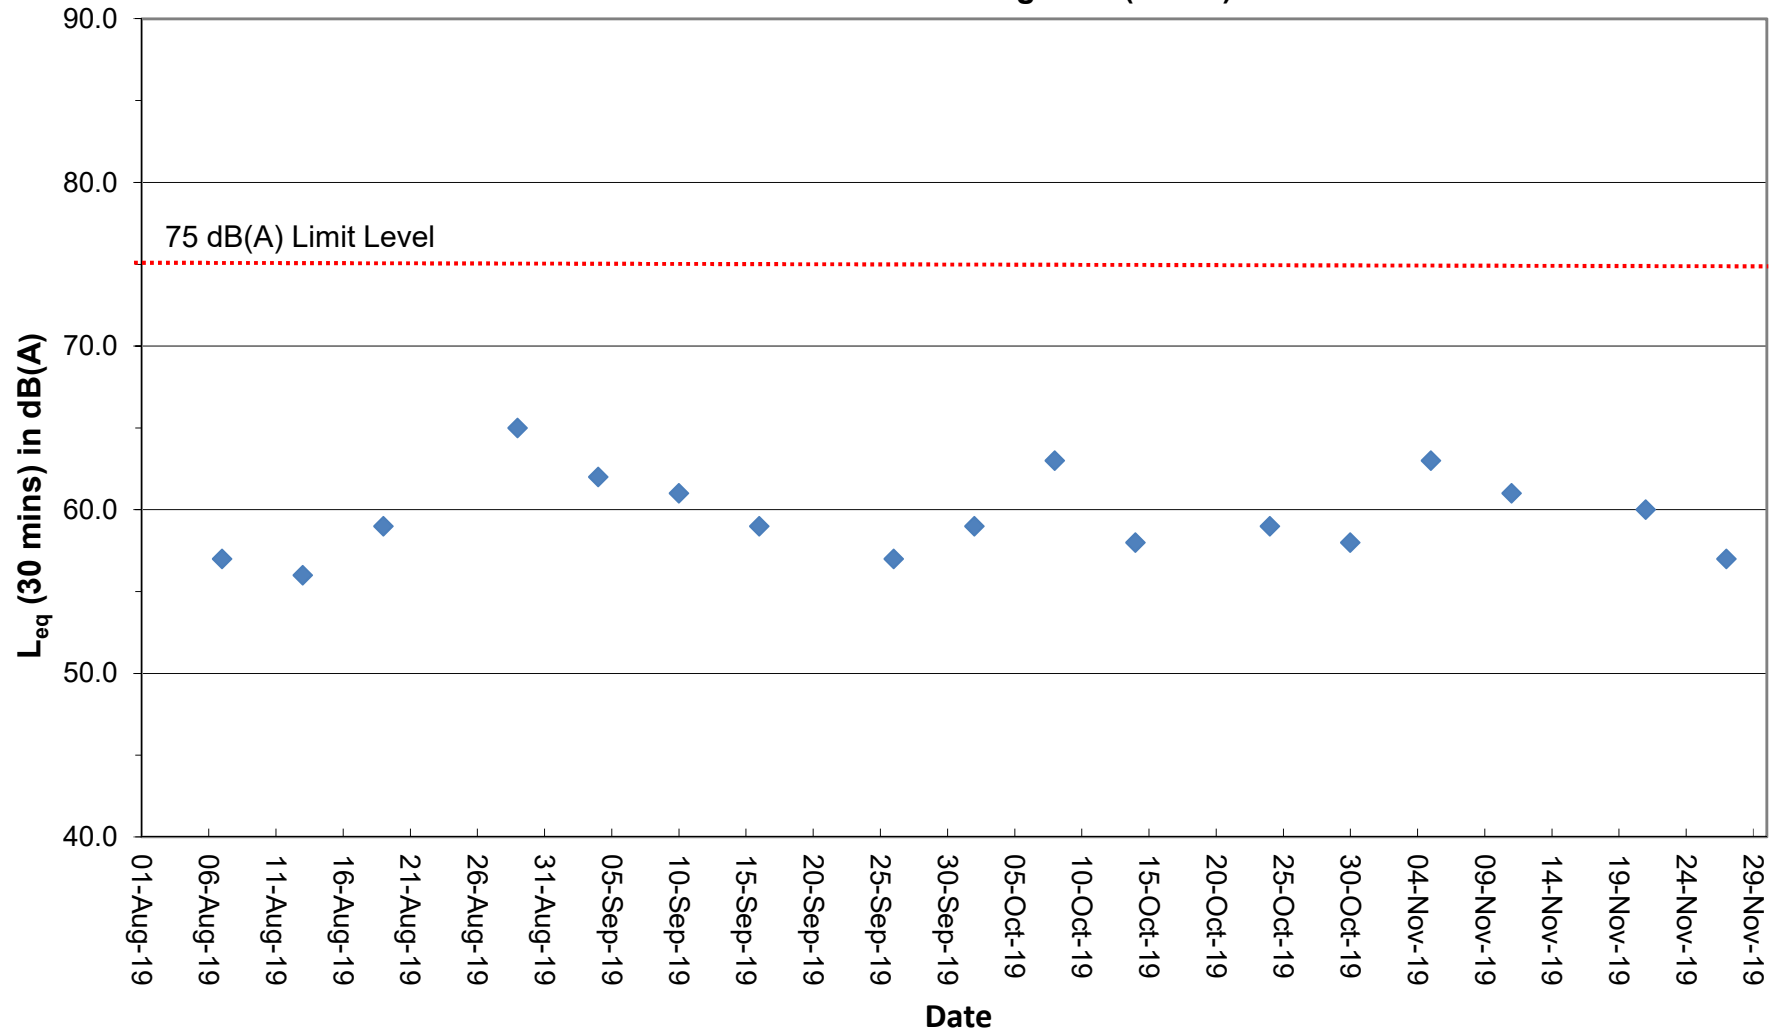
Continuous Noise Monitoring Data (NMS5)

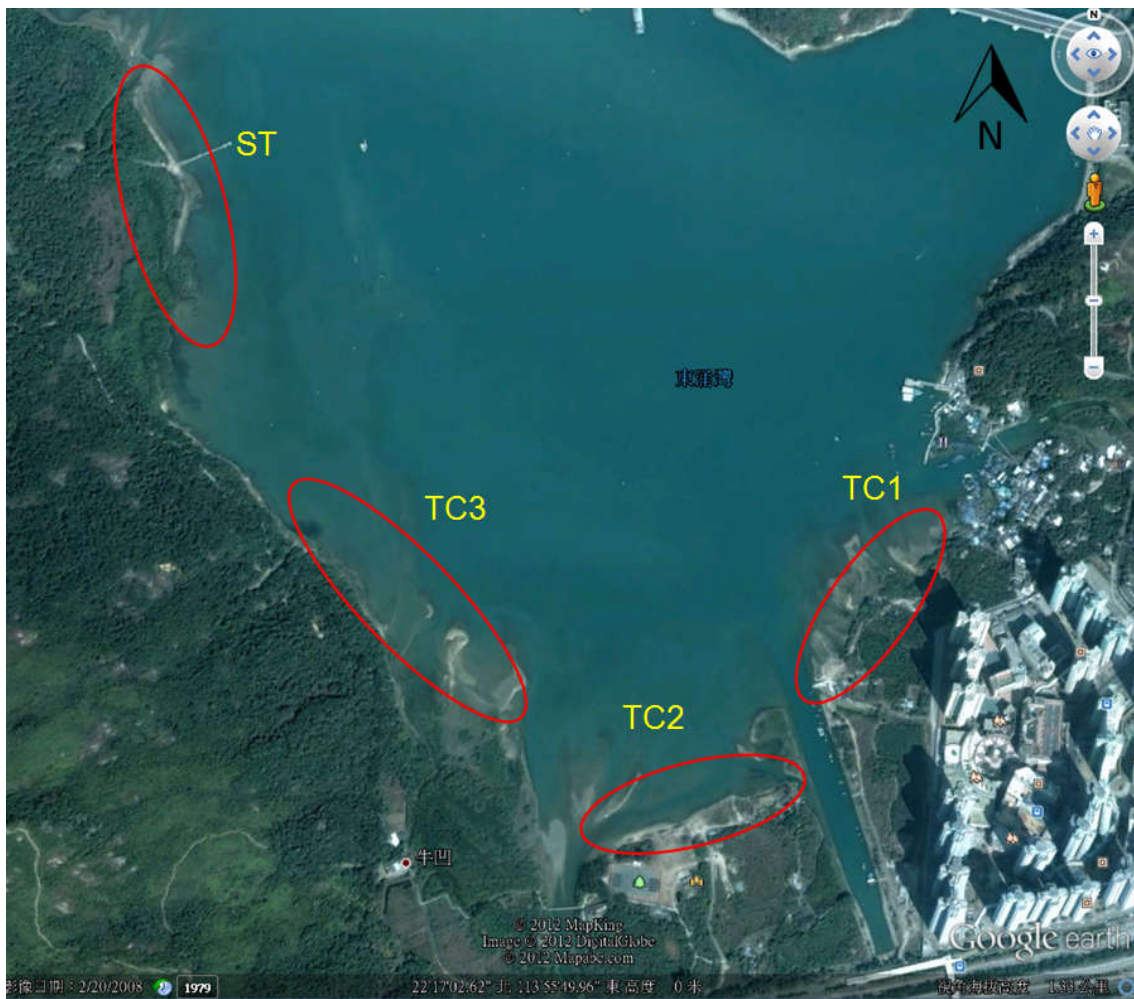
Figure 2.1 Locations of sampling zones. The study site was divided into three sampling zones (TC1, TC2, TC3) in Tung Chung Bay and one zone in San Tau (ST) (map generated from Google Map).

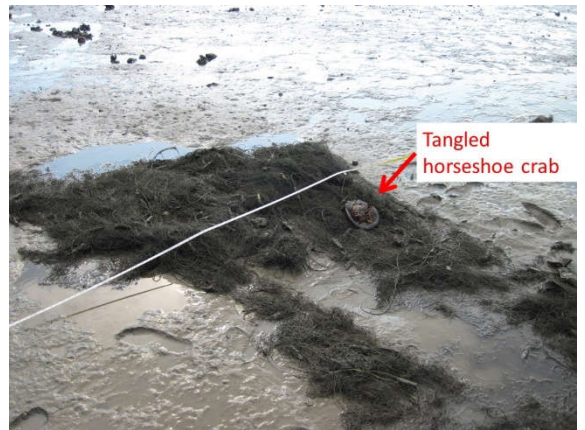
A tangled horseshoe crab on a trash net
(record in June 2017)

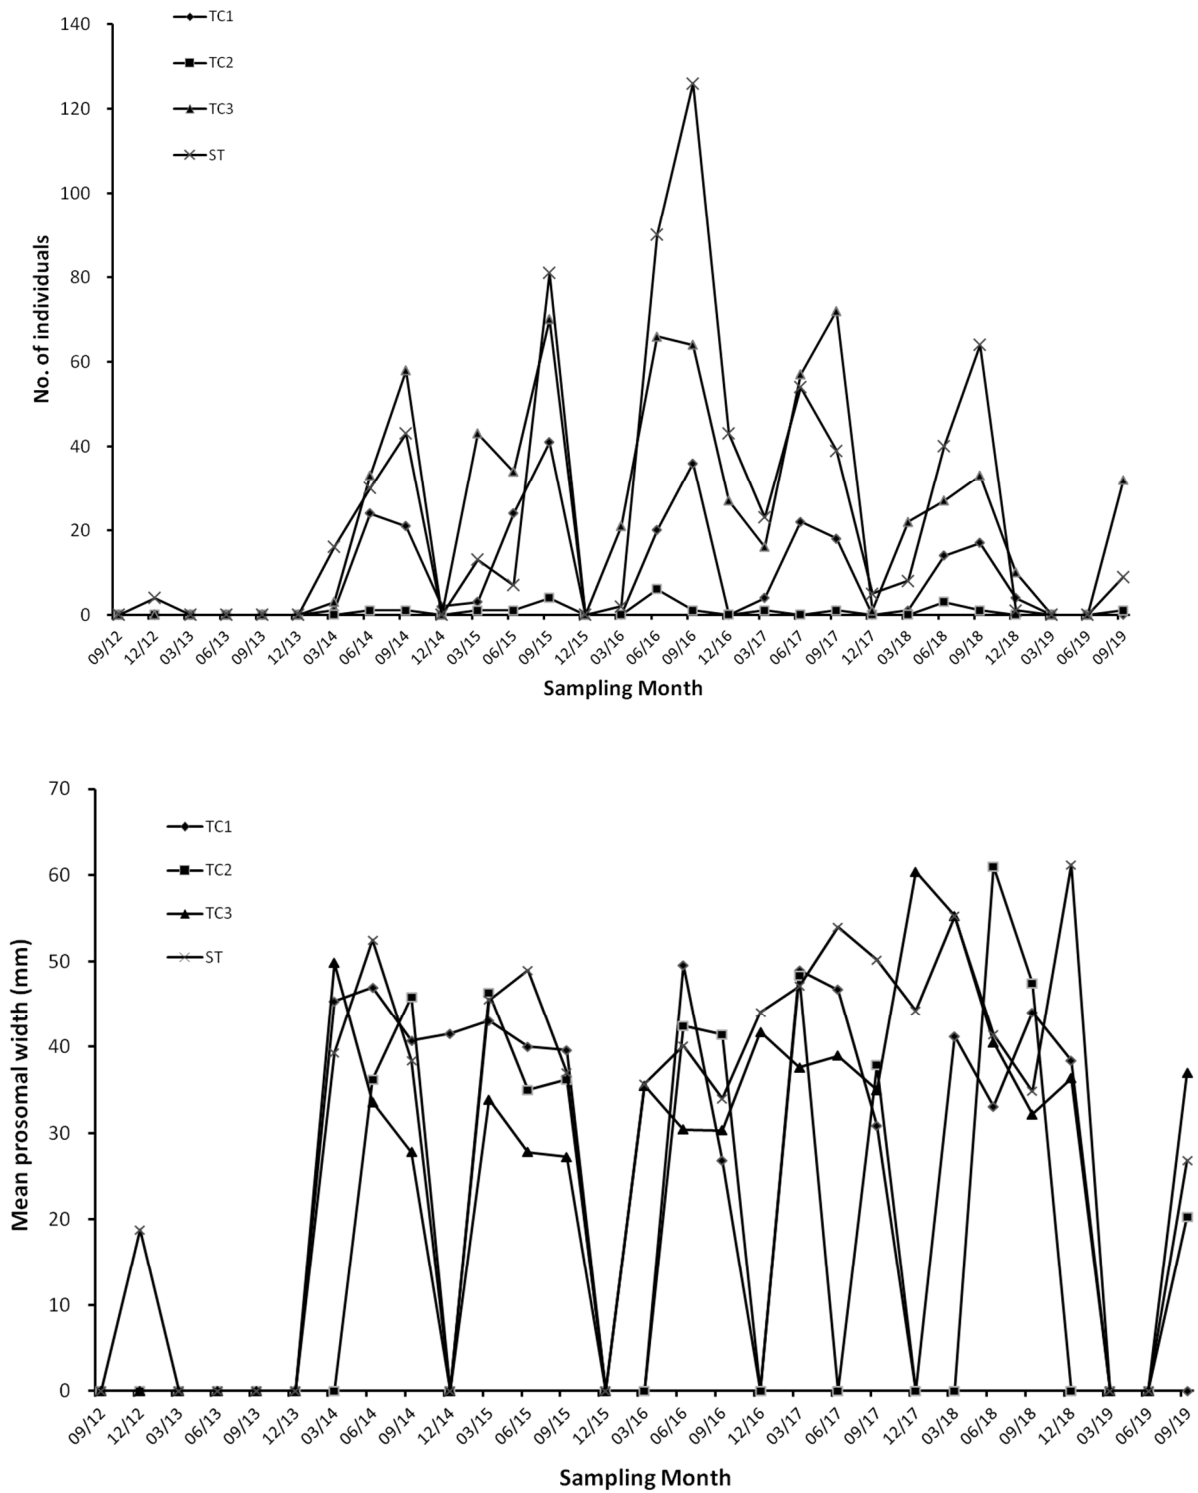
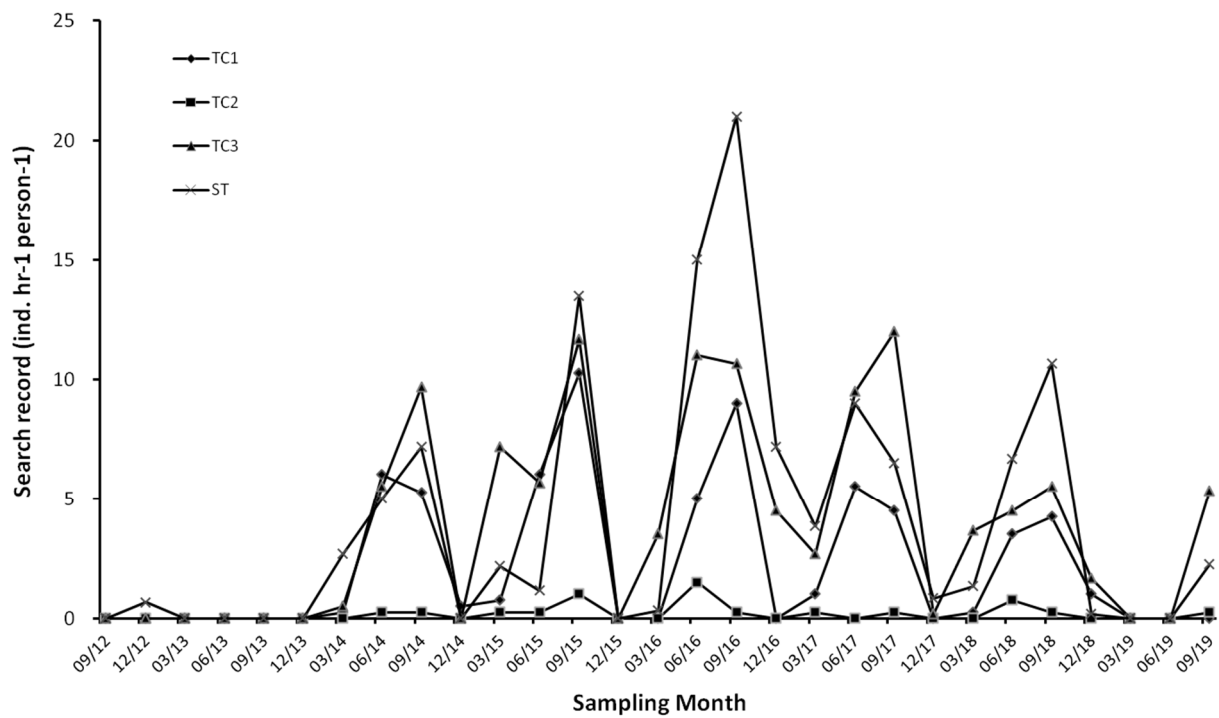
Figure 3.5 Changes of number of individuals mean prosomal width and search record of horseshoe crab *Carcinoscorpius rotundicauda* in every sampling zone along the sampling months

Figure 3.5 (Cont'd) Changes of number of individuals mean prosomal width and search record of horseshoe crab *Carcinoscorpius rotundicauda* in every sampling zone along the sampling months

- 3.6.29 Throughout the monitoring period, the search records of horseshoe crabs were fluctuated and at moderate – very low level in June (**Figures 3.5 and 3.6 of Appendix O**). Low – Very low search record was found in June 2013, totally 82 individuals of *Tachypleus tridentatus* and 0 ind. of *Carcinoscorpius rotundicauda* were found in TC1, TC3 and ST. Compare with the search record of June 2013, the numbers of *Tachypleus tridentatus* were gradually decreased in June 2014 and 2015 (55 ind. in 2014 and 18 ind. in 2015); the number of *Carcinoscorpius rotundicauda* raise to 88 and 66 individuals. in June 2014 and 2015 respectively. In June 2016, the search record increased about 3 times compare with June 2015. In total, 182 individuals of *Carcinoscorpius rotundicauda* and 47 individuals. of *Tachypleus tridentatus* were noted, respectively. Then, the search record was similar to June 2016. The number of recorded *Carcinoscorpius rotundicauda*(133 ind.) slightly dropped in June 2017. However, that of *Tachypleus tridentatus* rapidly increased (125 ind.). In June 2018, the search record was low to moderate while the numbers of *Tachypleus tridentatus* dropped sharply (39 ind.). In March 2019, 3 individuals of *Carcinoscorpius rotundicauda* were observed in TC2. However, all of them were large individuals (prosomal width >100mm), their records are excluded from the data analysis to avoid mixing up with the juvenile population living on intertidal habitat. Throughout the monitoring period, similar distribution of horseshoe crabs population were found in March. Most of the horseshoe crabs were found in TC3 and ST.

- 3.6.30 The search record of horseshoe crab declined obviously in all sampling zones during dry season especially December (**Figures 3.5 and 3.6 of Appendix O**) throughout the monitoring period. Very low – low search record was found in December from 2012 to 2015 (0-4 ind. of *Carcinoscorpius rotundicauda* and 0-12 ind. of *Tachypleus tridentatus*). The horseshoe crabs were inactive and burrowed in the sediments during cold weather (<15 °C). Similar results of low search record in dry season were reported in a previous territory-wide survey of horseshoe crab. For example, the search records in Tung Chung Wan were 0.17 ind. hr⁻¹person⁻¹ and 0.00 ind. hr⁻¹ person⁻¹ in wet season and dry season respectively (details see Li, 2008). Compare with the search record of December from 2012 to 2015, which of December 2016 were much higher relatively. There were totally 70 individuals of *Carcinoscorpius rotundicauda* and 24 individuals of *Tachypleus tridentatus* in TC3 and ST. Since the survey was carried in earlier December with warm and sunny weather (~22 °C during dawn according to Hong Kong Observatory database, Chek Lap Kok station on 5 December 2016), the horseshoe crab was more active (i.e. move onto intertidal shore during high tide for foraging and breeding) and easier to be found. In contrast, there was no search record in TC1 and TC2 because the survey was conducted in mid-December with colder and cloudy weather (~20 °C during dawn on 19

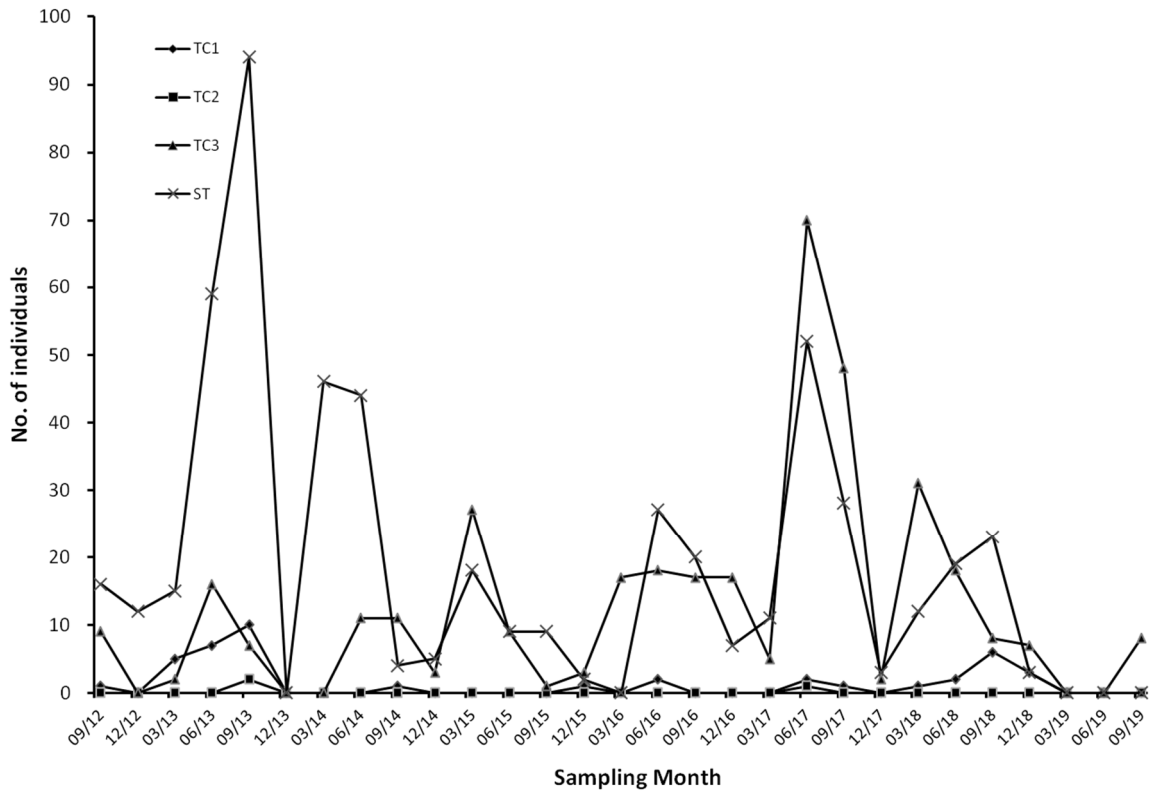
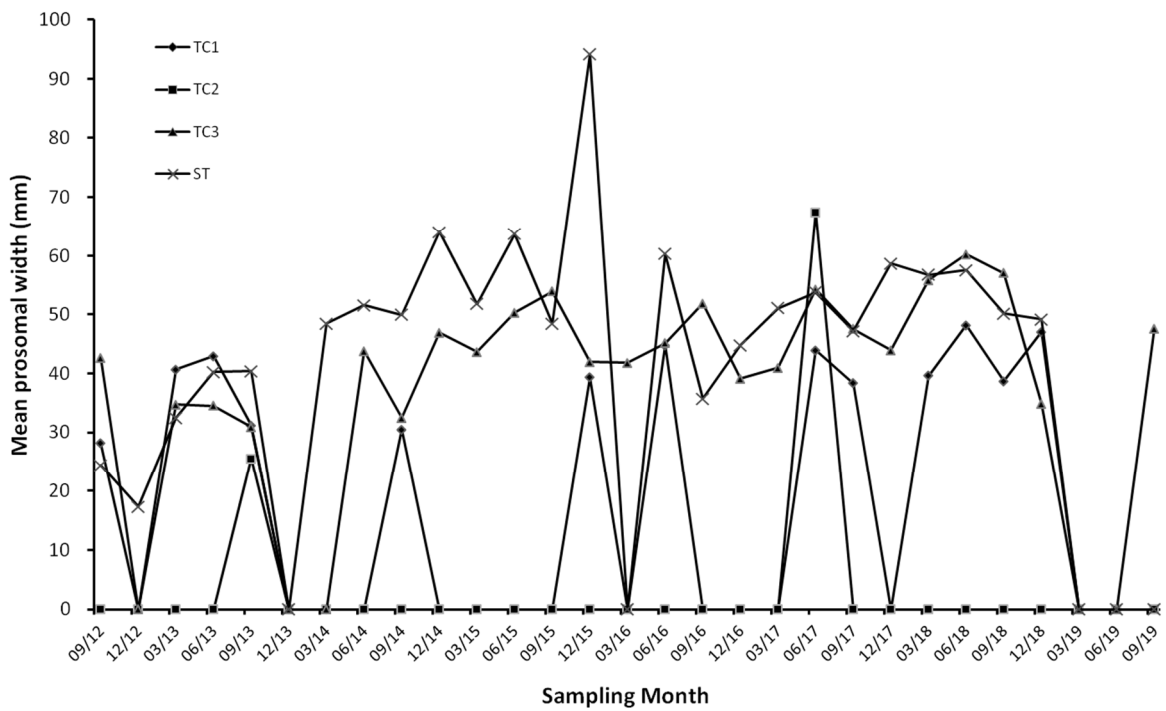
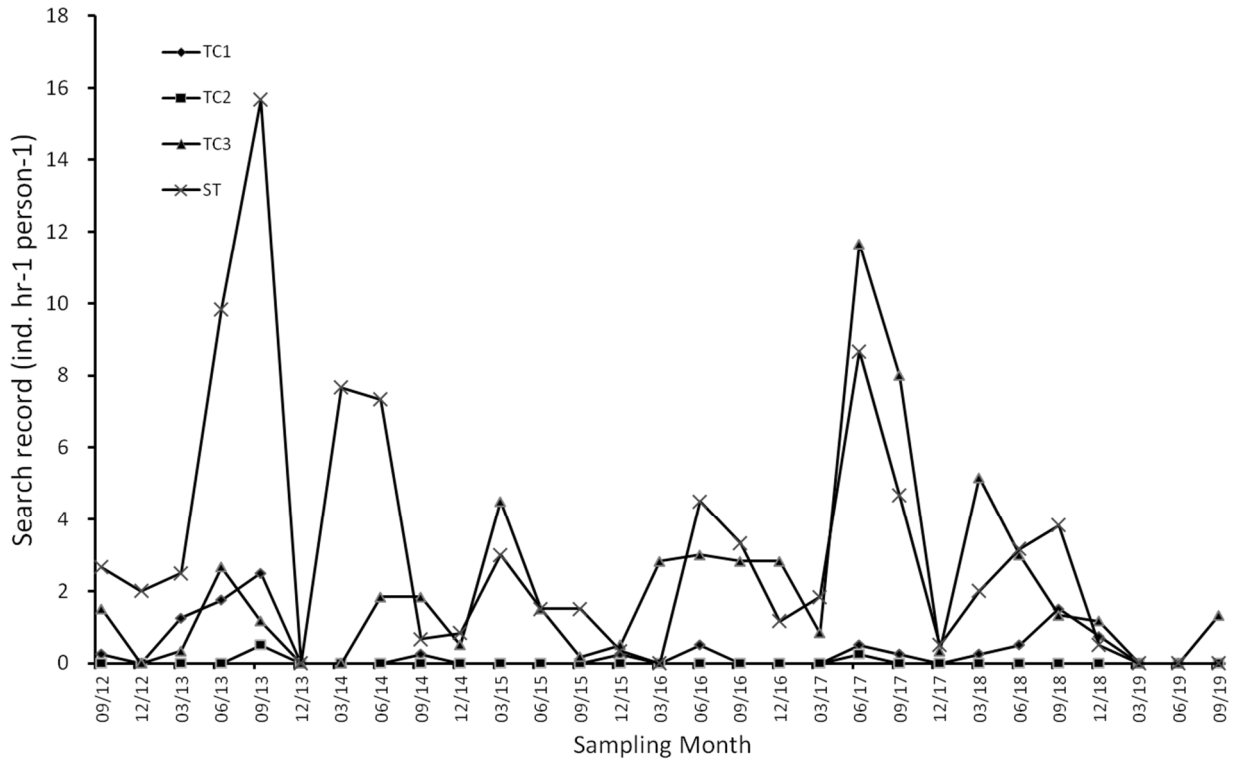
Figure 3.6 Changes of number of individuals mean prosomal width and search record of horseshoe crab *Tachypleus tridentatus* in every sampling zone along the sampling months

Figure 3.6 (Cont'd) Changes of number of individuals mean prosomal width and search record of horseshoe crab *Tachypleus tridentatus* in every sampling zone along the sampling months

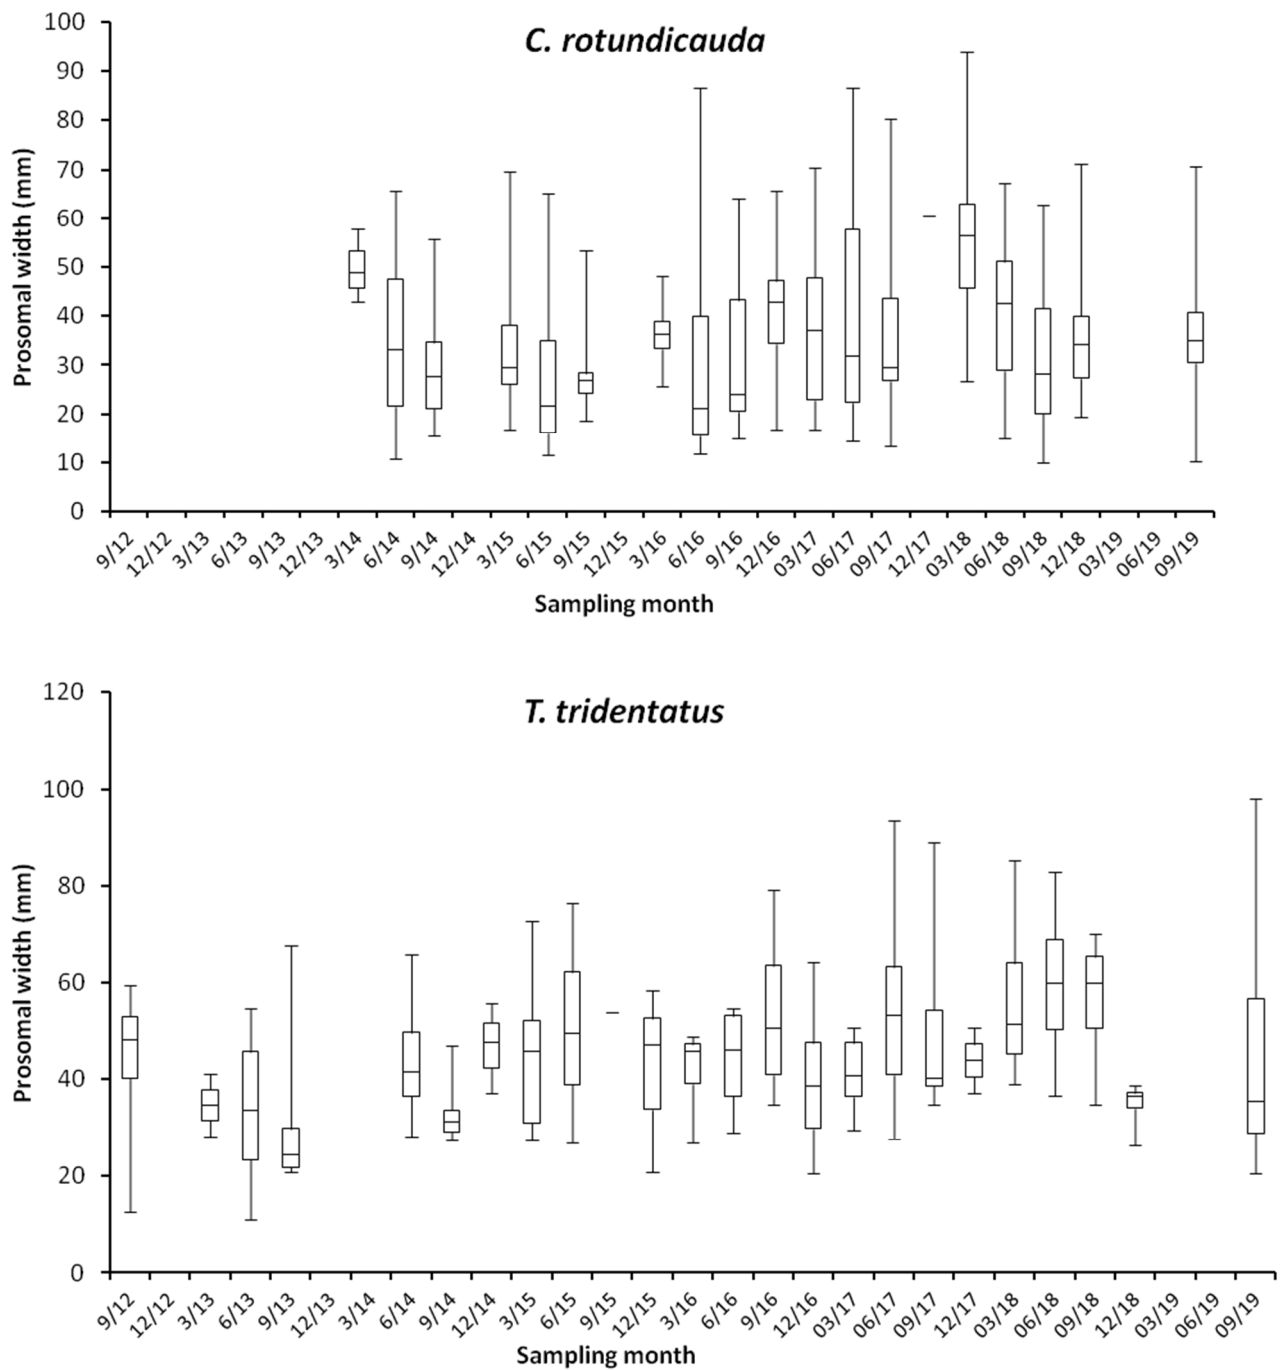
Figure 3.7 Box plot of prosomal width of horseshoe crab in the sampling zone TC3 along the sampling months. (The box represents 50% of the sample (upper to lower quartile) with a middle line showing the median value. The upper whisker and lower whisker showed the 25% of sample above upper quartile and below the lower quartile respectively)

- 3.6.34 **Figure 3.7 of Appendix O** shows the changes of prosomal width of *Carcinoscorpius rotundicauda* and *Tachypleus tridentatus* in TC3. As mentioned above, *Carcinoscorpius rotundicauda* was rarely found between September 2012 and December 2013 hence the data were lacking. In March 2014, the major size (50% of individual records between upper (top box) and lower quartile (bottom box)) ranged 40 – 60 mm while only few individuals were found. From March 2014 to September 2018, the median prosomal width (middle line of whole box) and major size (whole box) decreased after March of every year. It was due to more small individuals found in June indicating new rounds of spawning. Also, there were slight increasing trends of body size from June to March of next year since 2015. It indicated a stable growth of individuals. Focused on larger juveniles (upper whisker), the size range was quite variable (prosomal width 60 – 90 mm) along the sampling months. Juveniles reaching this size might gradually migrate to sub-tidal habitats.

- 3.6.35 For *Tachypleus tridentatus*, the major size ranged 20-50 mm while the number of individuals fluctuated from September 2012 to June 2014. Then a slight but consistent growing trend was observed from September 2014 to June 2015. The prosomal width increased from 25 – 35 mm

to 35 – 65 mm. As mentioned, the large individuals might have reached a suitable size for migrating from the nursery soft shore to subtidal habitat. It accounted for the declined population in TC3. From March to September 2016, slight increasing trend of major size was noticed again. From December 2016 to June 2017, similar increasing trend of major size was noted with much higher number of individuals. It reflected new round of spawning. In September 2017, the major size decreased while the trend was different from previous two years. Such decline might be the cause of serial cyclone hit between June and September 2017 (to be discussed in the 'Seagrass survey' section). From December 2017 to September 2018, increasing trend was noted again. Across the whole monitoring period, the larger juveniles (upper whisker) usually reached 60 – 80 mm in prosomal width, even 90 mm occasionally. Juveniles reaching this size might gradually migrate to sub-tidal habitats.

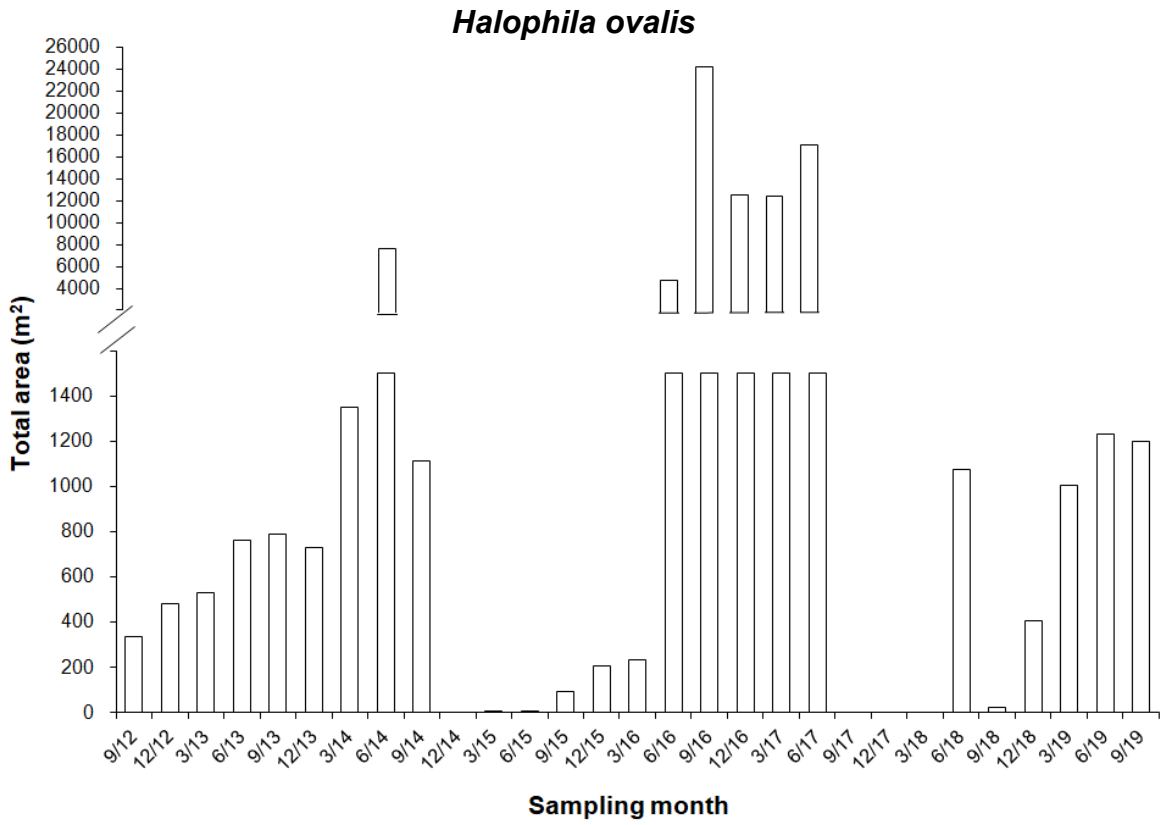
Figure 3.11 Temporal changes of estimated total area of seagrass beds in ST

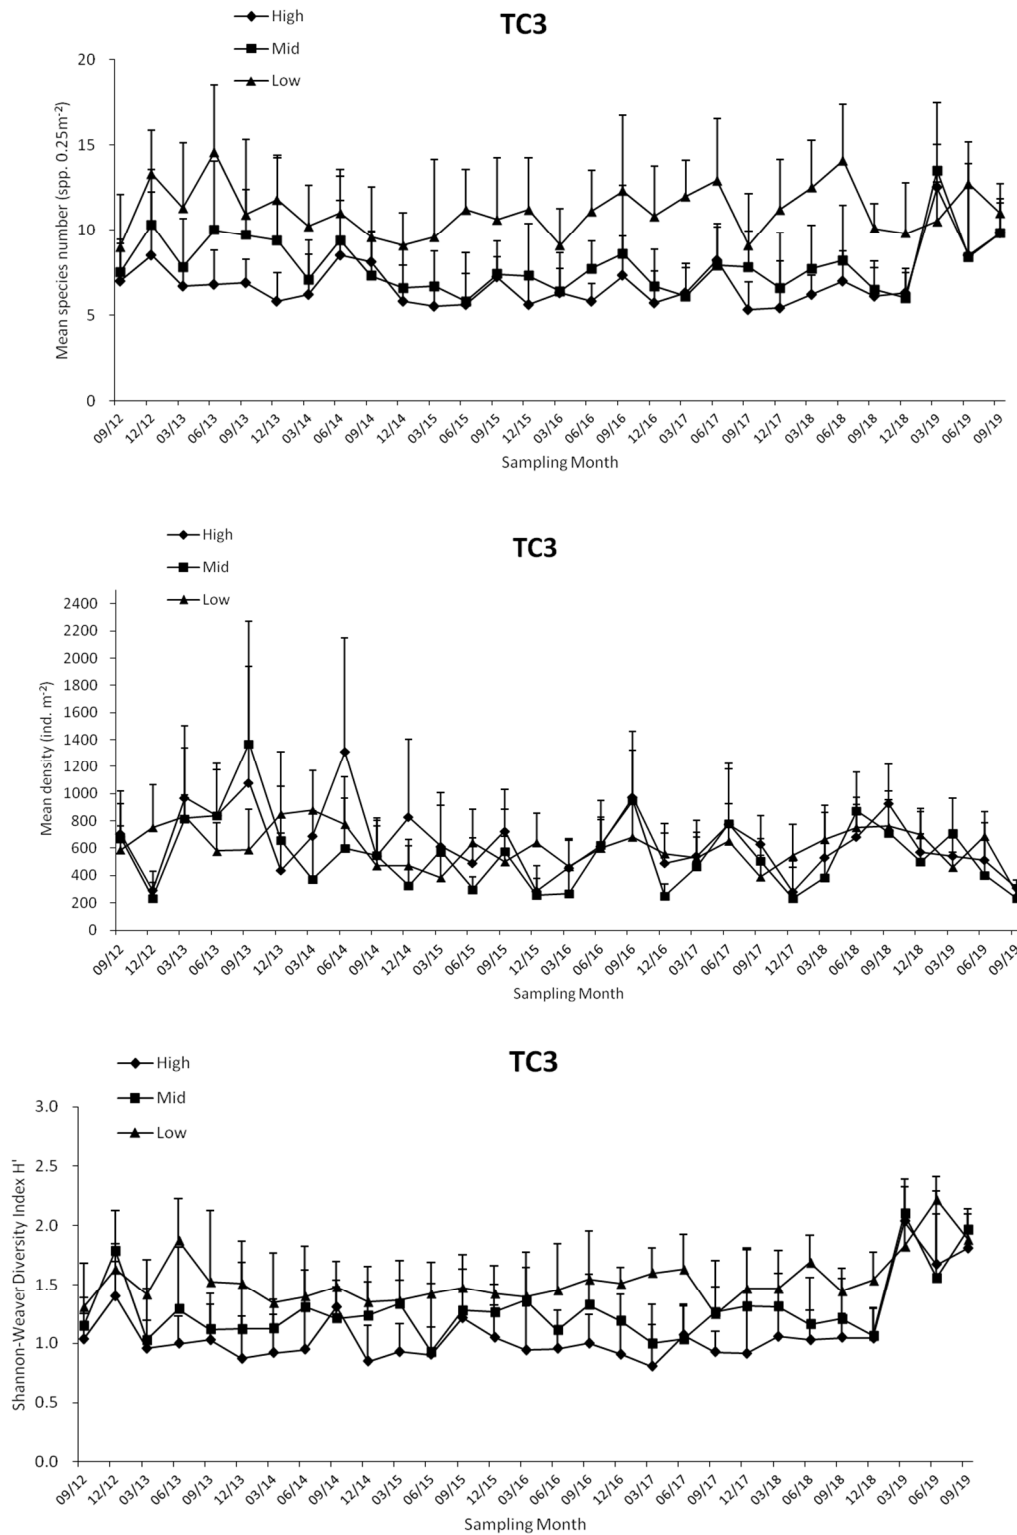
Figure 3.16 Temporal changes of mean number of species, mean density, Shannon-Weaver Diversity Index (H') and Pielou's Species Evenness (J) (mean + SD) at every tidal level in sampling zone TC3

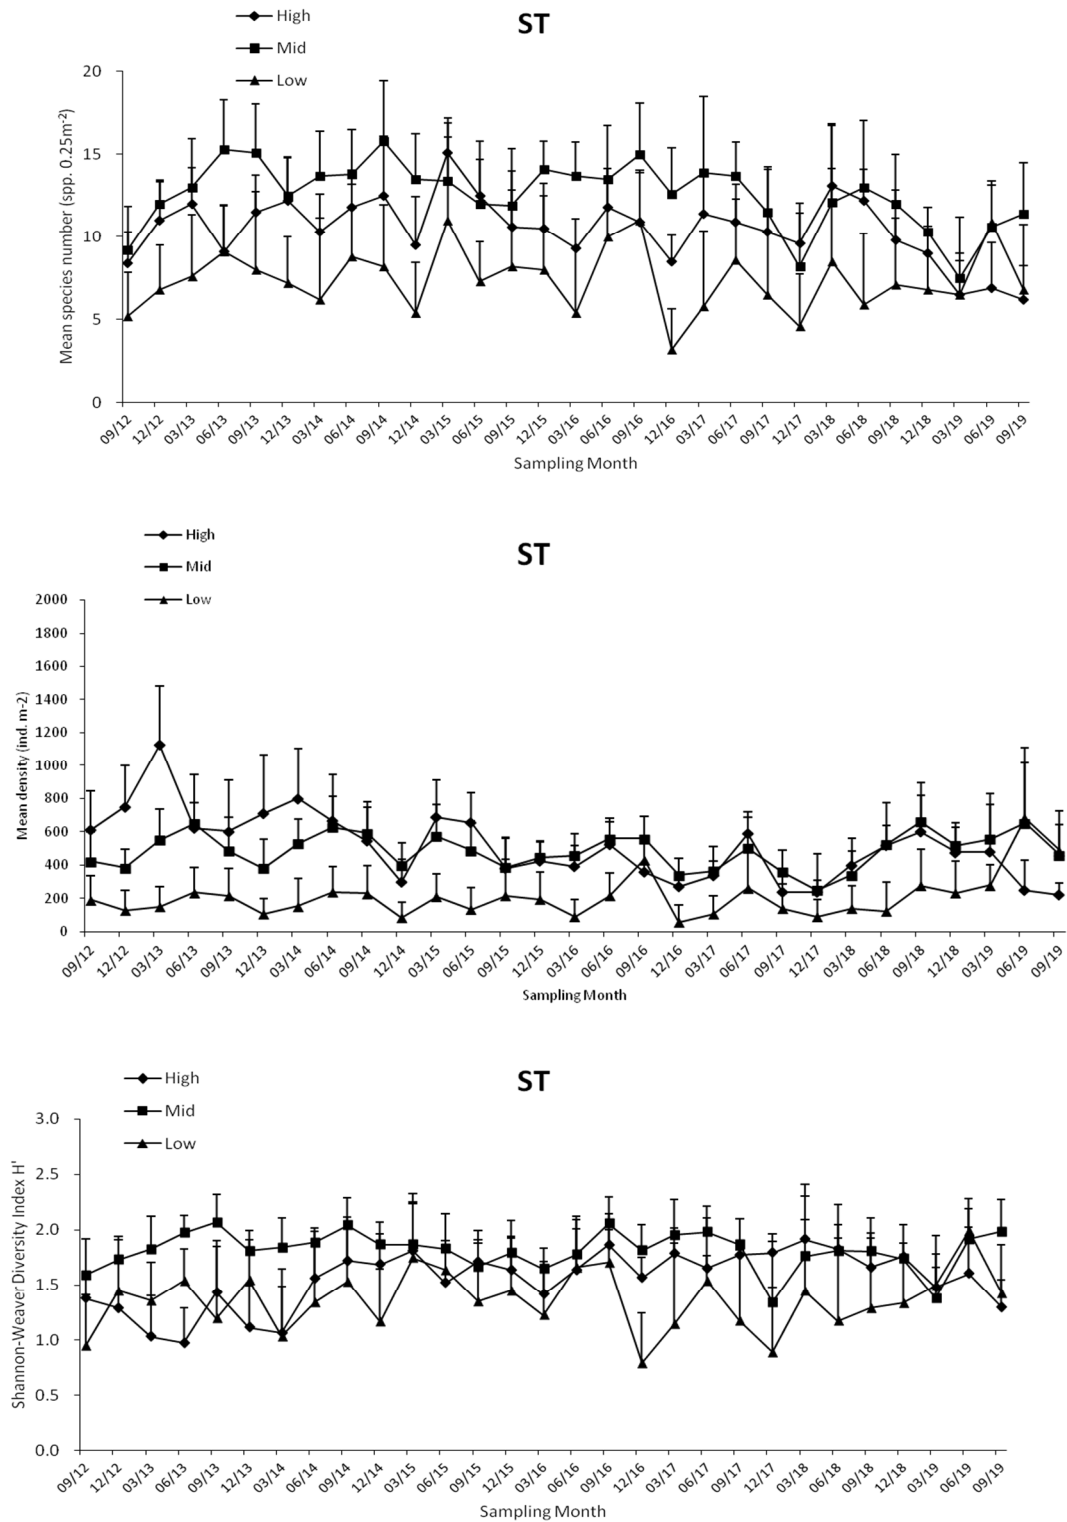
Figure 3.17 Temporal changes of mean number of species, mean density, Shannon-Weaver Diversity Index (H') and Pielou's Species Evenness (J) (mean + SD) at every tidal level in sampling zone S
