Contract No. HY/2011/03

**Hong Kong-Zhuhai-Macao Bridge Hong Kong Link Road
Section between Scenic Hill and Hong Kong Boundary Crossing
Facilities**

Monthly EM&A Report No.87 (December 2019)

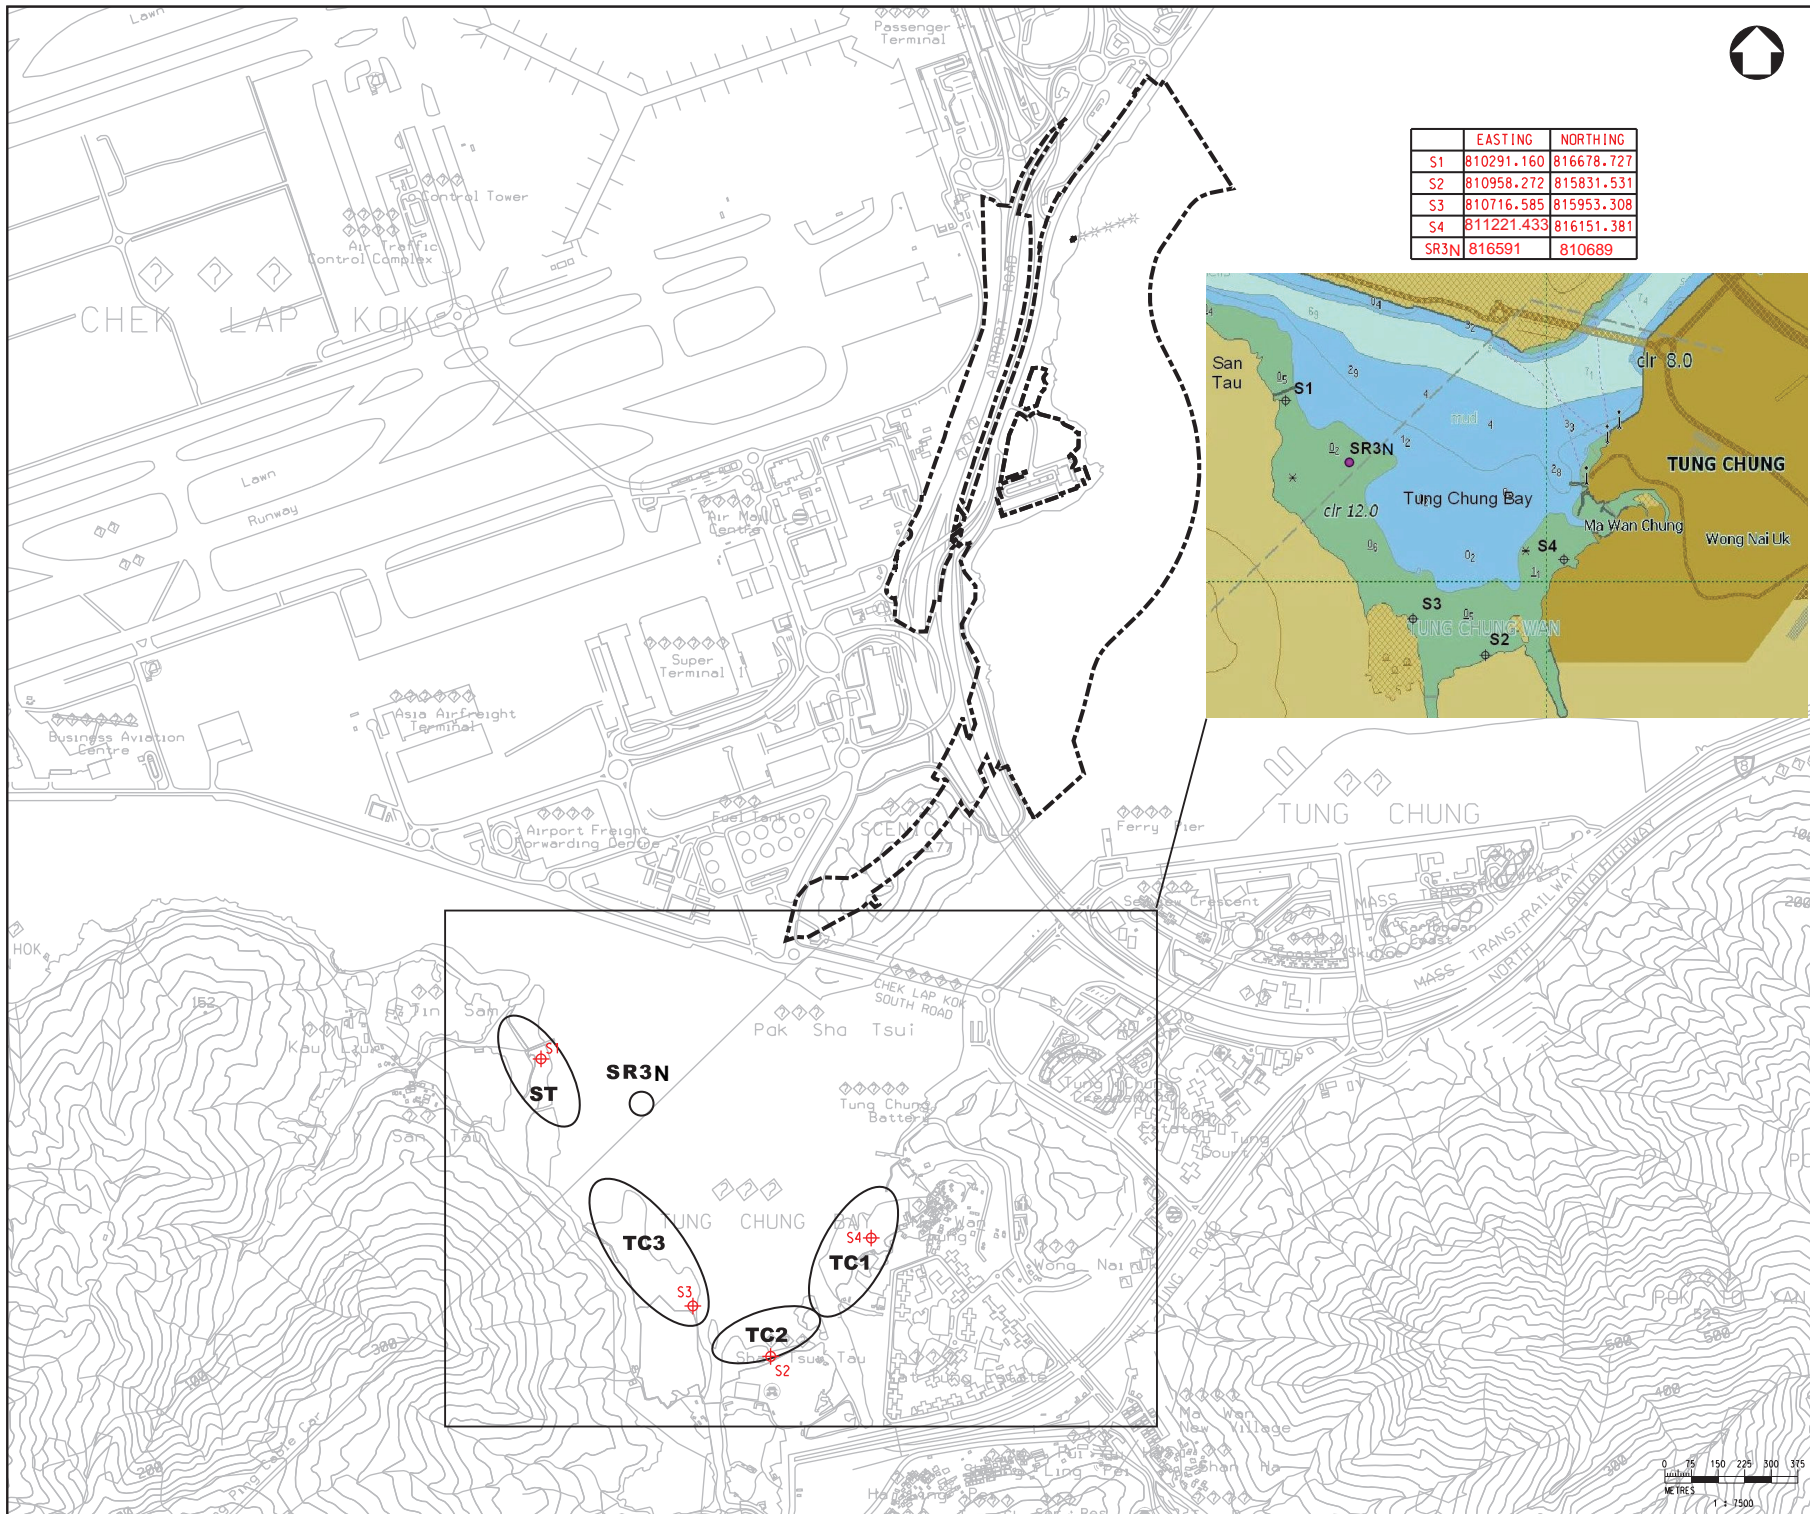
EASTING	NORTHING
S1	810291.160	816678.727
S2	810958.272	815831.531
S3	810716.585	815953.308
S4	811221.433	816151.381
SR3N	816591	810689

- 6.1.4 Four monitoring stations were established based on the site conditions for the sedimentation monitoring and are shown in **Figure 6.1**.

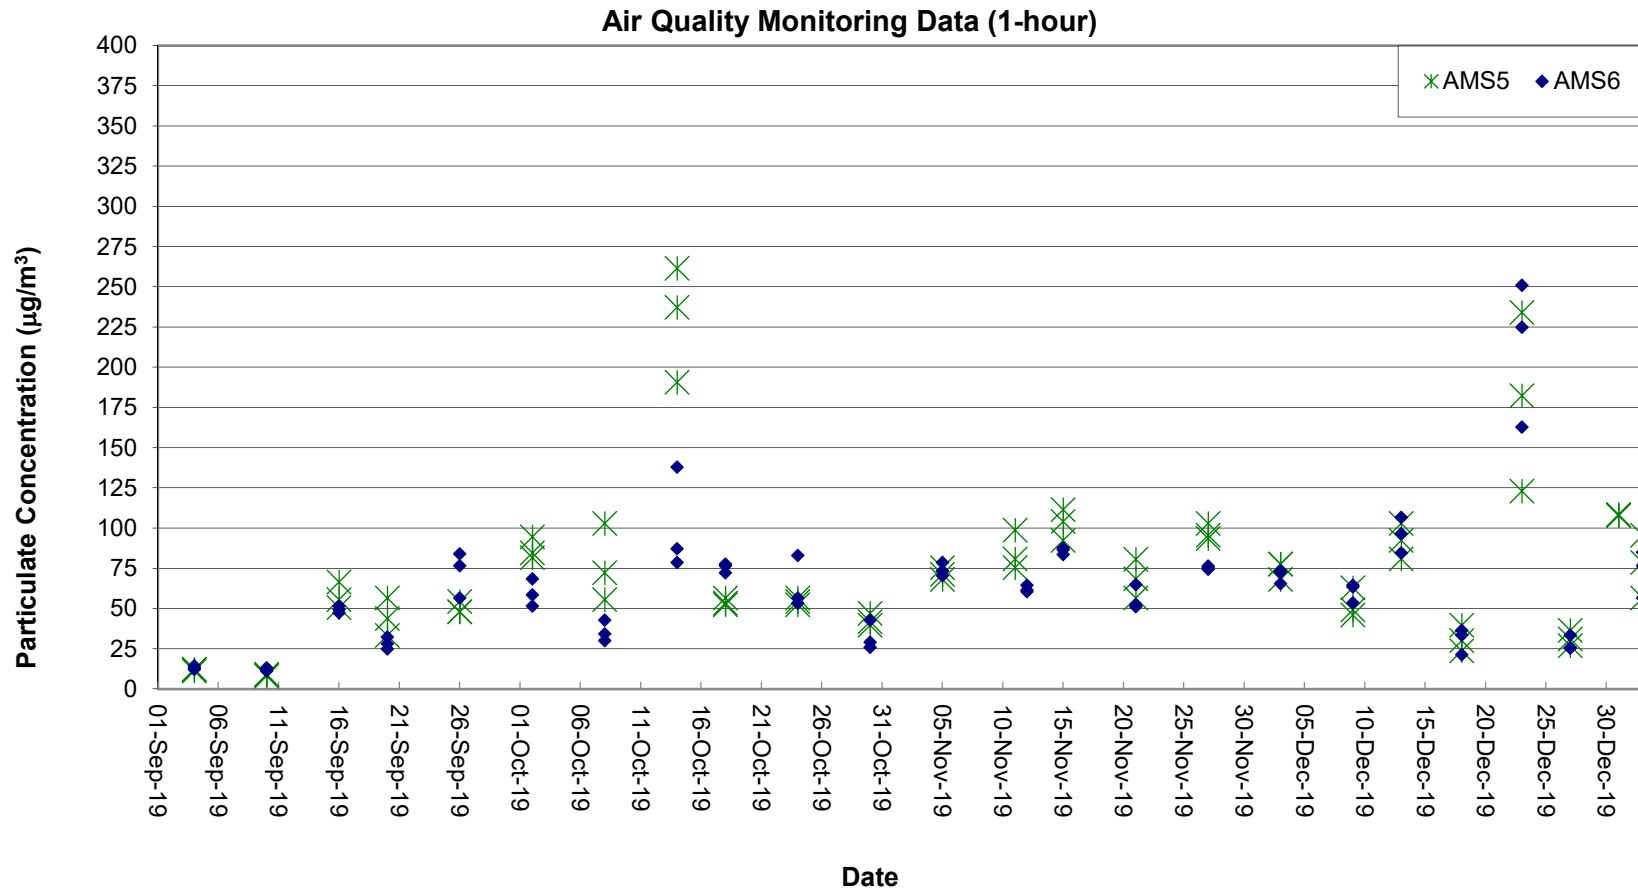
Graphical Plot of 1-hour TSP at AMS5 and AMS6

1) Due to unexpected traffic conditions and safety reason, the 1-hr TSP monitoring at AMS6-Dragonair Building was rescheduled from 11 Nov 2019 to 12 Nov 2019.

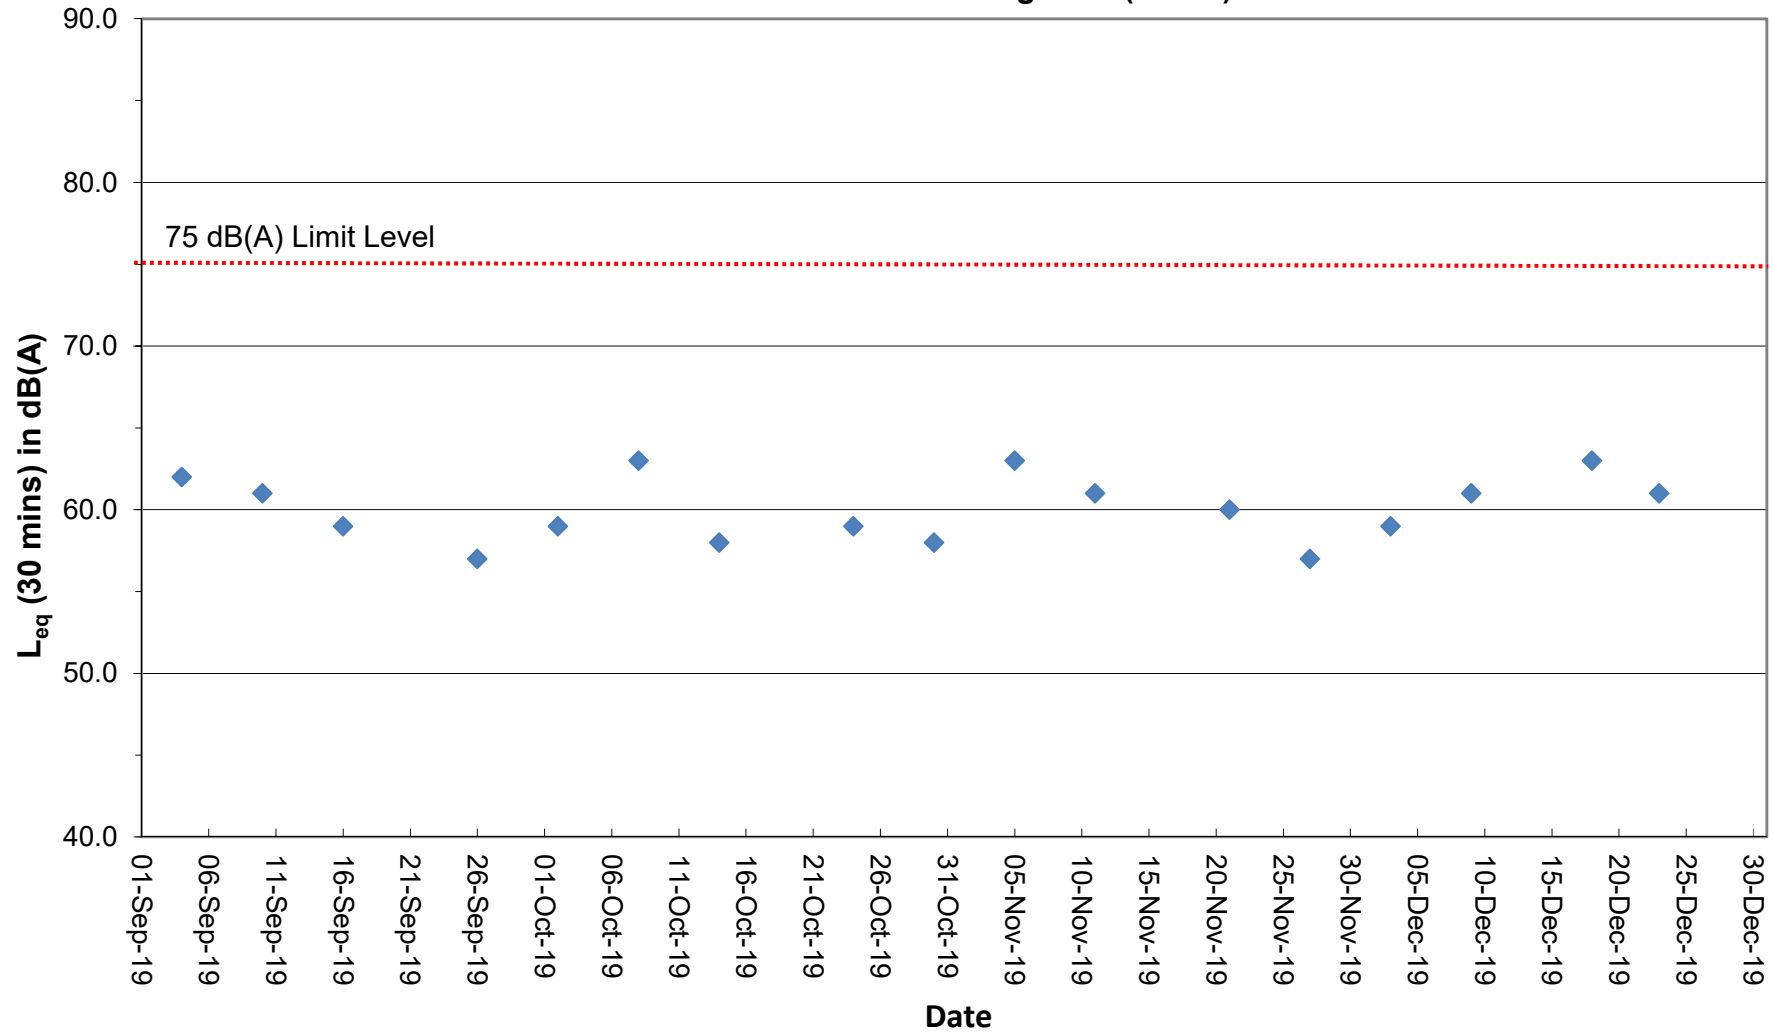
Graphical Plot of Noise Levels at NMS5

(1) A facade correction of +3 dB(A) was applied to the measured noise level.

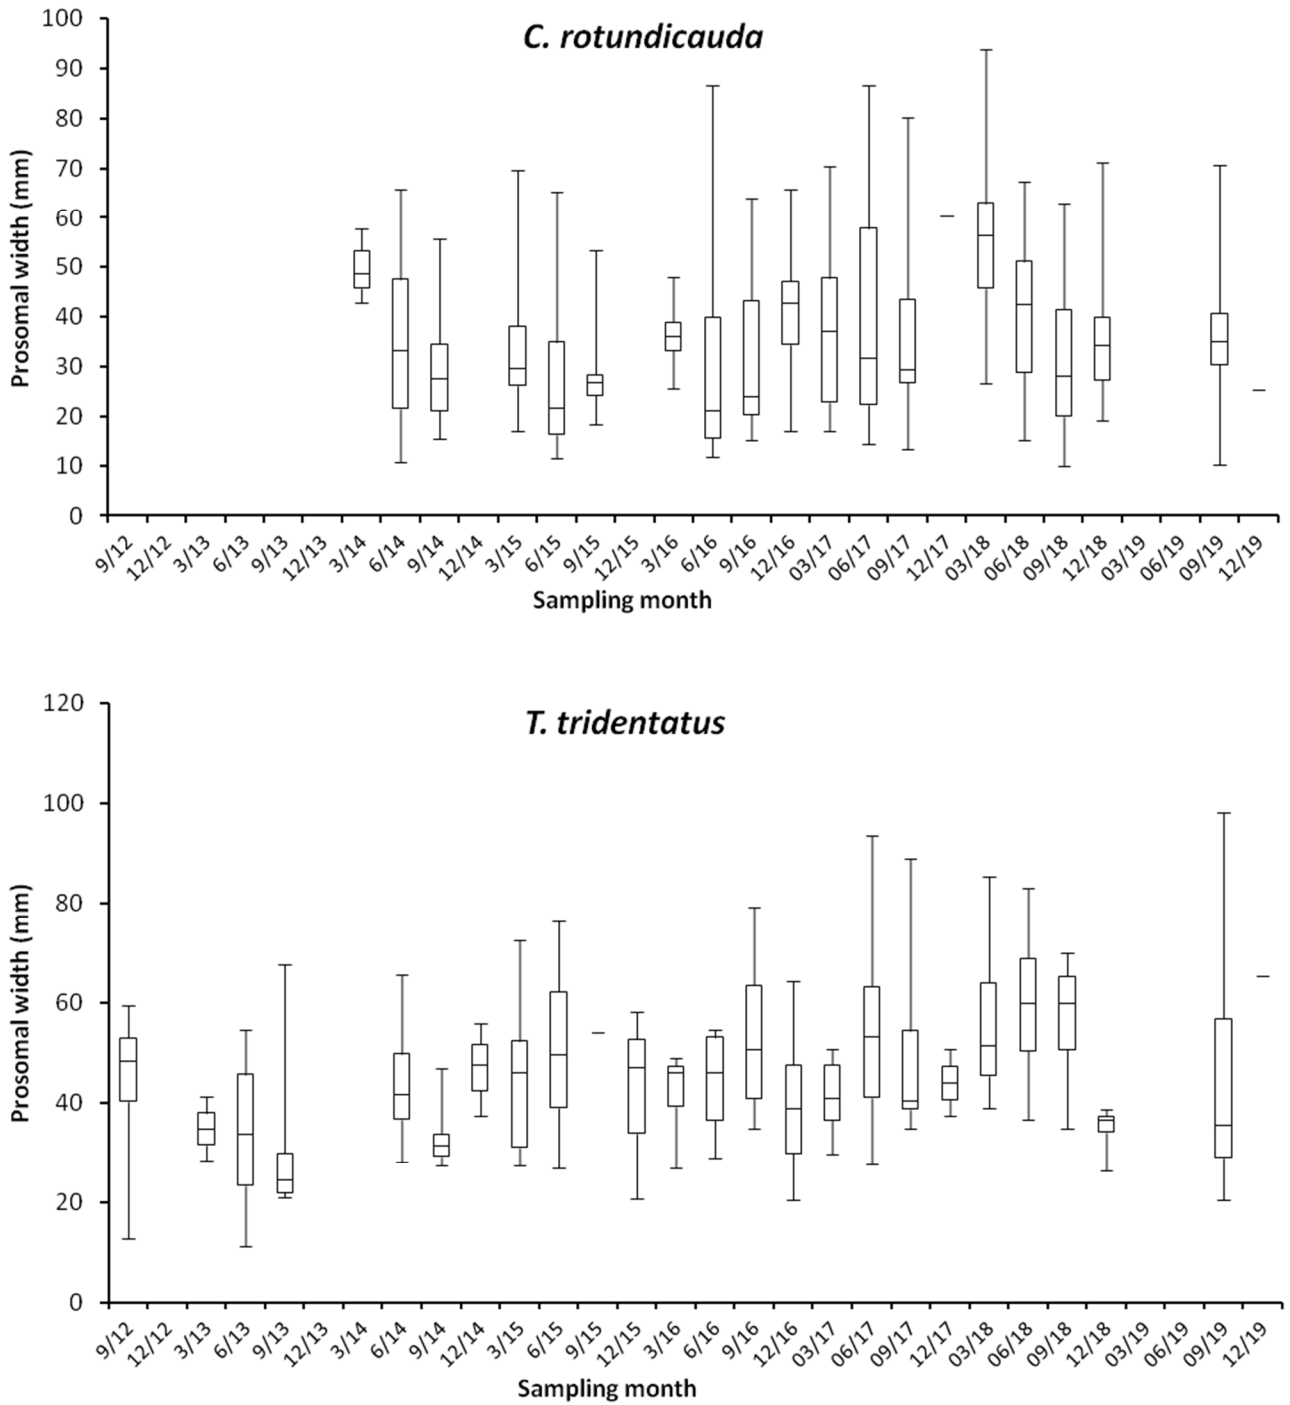
Figure 3.7 Box plot of prosomal width of horseshoe crab in the sampling zone TC3 along the sampling months. (The box represents 50% of the sample (upper to lower quartile) with a middle line showing the median value. The upper whisker and lower whisker showed the 25% of sample above upper quartile and below the lower quartile respectively)

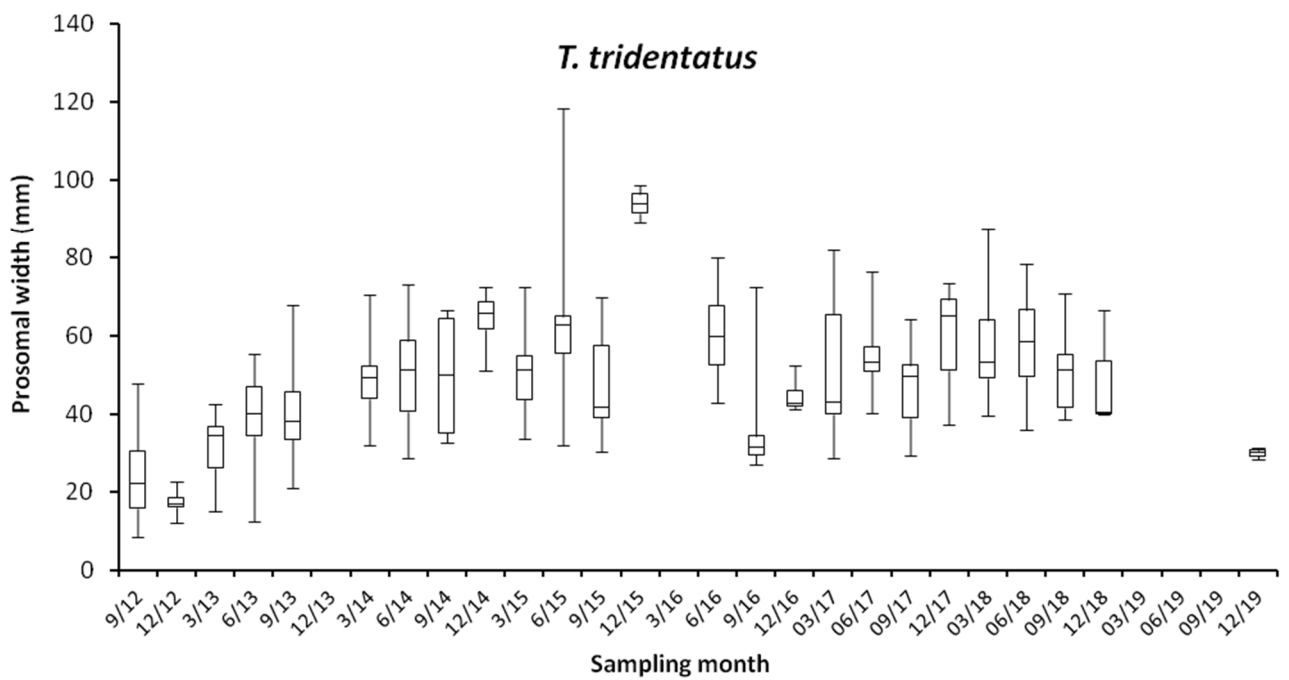
Figure 3.8 Box plot of prosomal width of horseshoe crab in the sampling zone ST along the sampling months. (The box represents 50% of the sample (upper to lower quartile) with a middle line showing the median value. The upper whisker and lower whisker showed the 25% of sample above upper quartile and below the lower quartile respectively.)

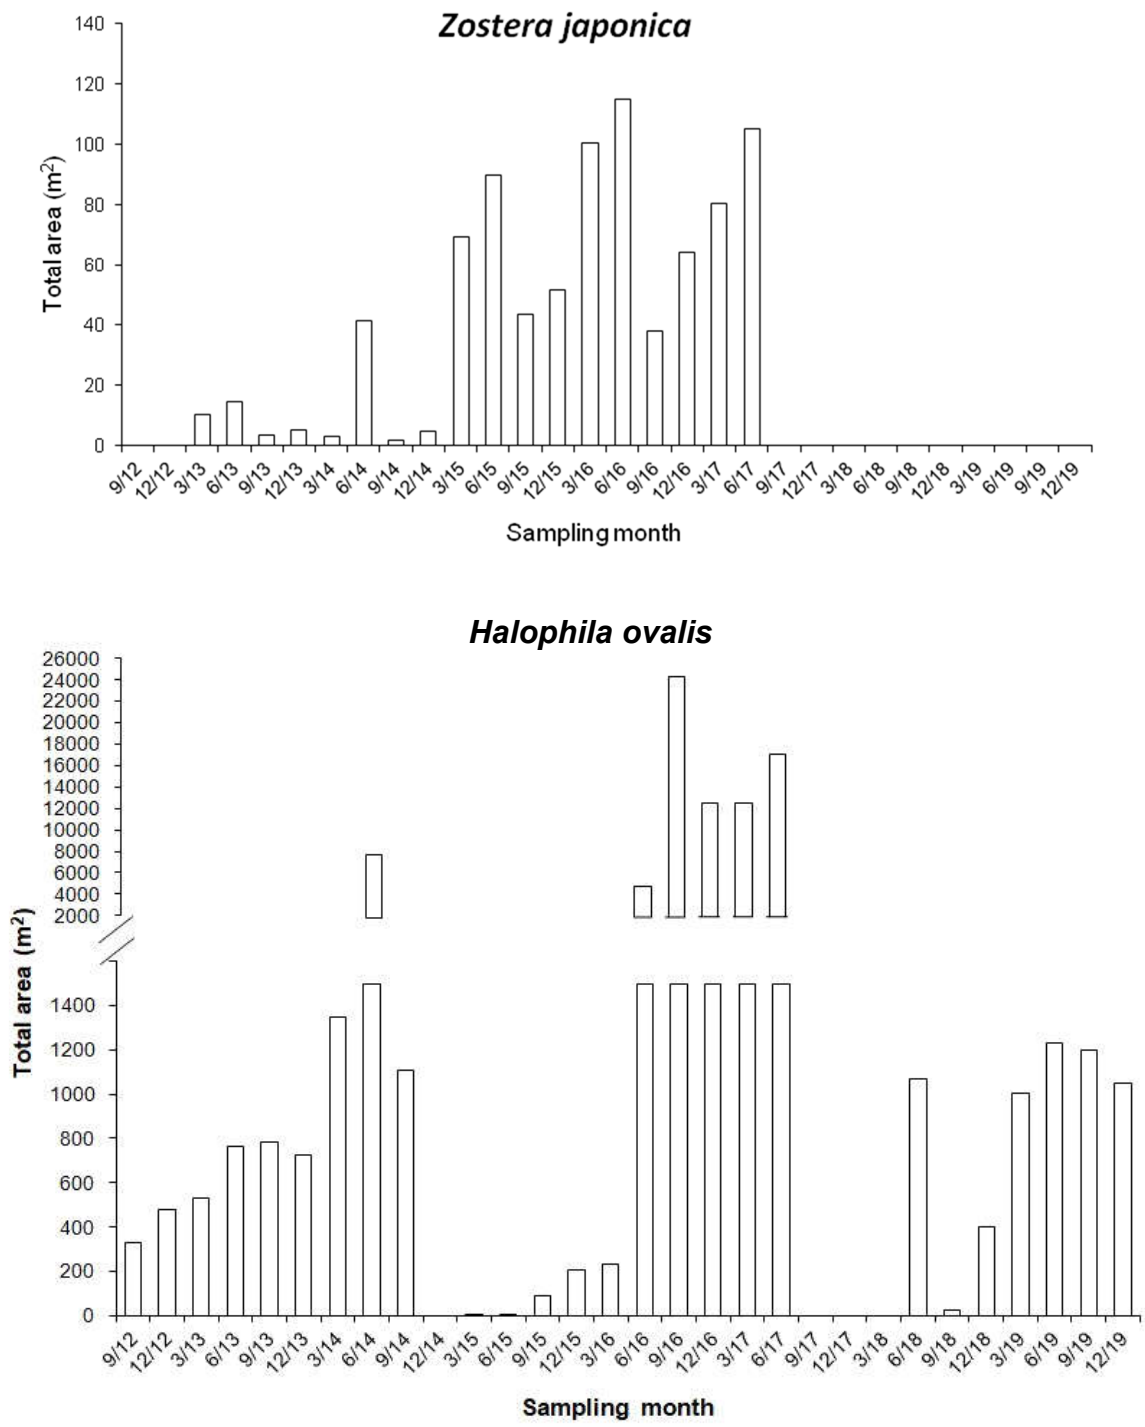
Figure 3.11 Temporal changes of estimated total area of seagrass beds in ST
