Contract No. HY/2011/03

**Hong Kong-Zhuhai-Macao Bridge Hong Kong Link Road
Section between Scenic Hill and Hong Kong Boundary Crossing
Facilities**

Quarterly EM&A Report No. 31 (March 2020 to May 2020)

6 July 2020

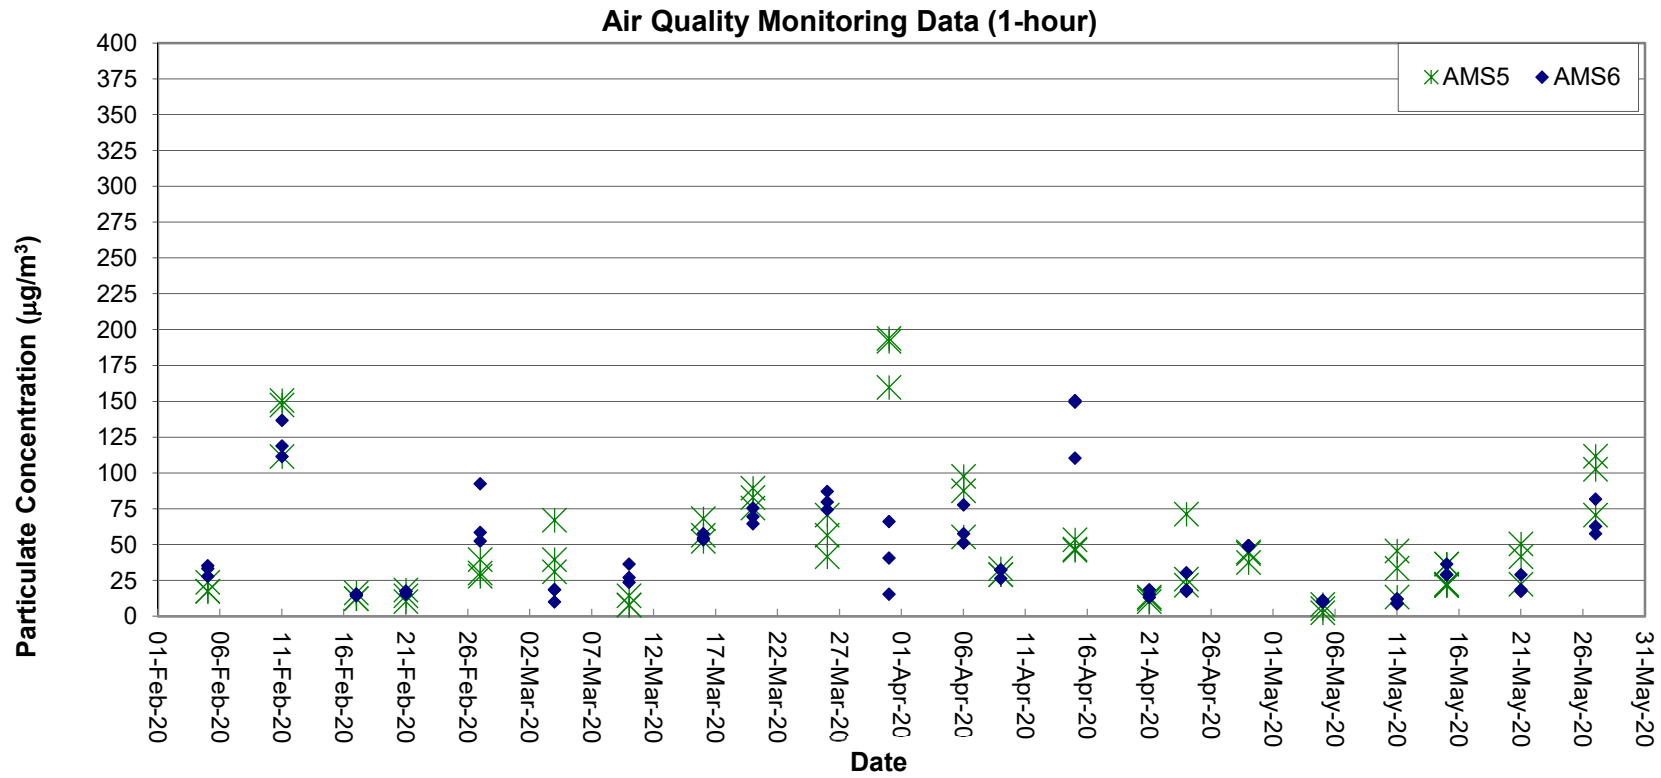
Graphical Plot of 1-hour TSP at AMS5 and AMS6

1) There were no works for Contract No. HY/2011/03 between 25 January 2020 and 2 February 2020. As such, 1-hr TSP monitoring (which was scheduled on 30 January 2020) for stations AMS 5 and AMS 6 were suspended.

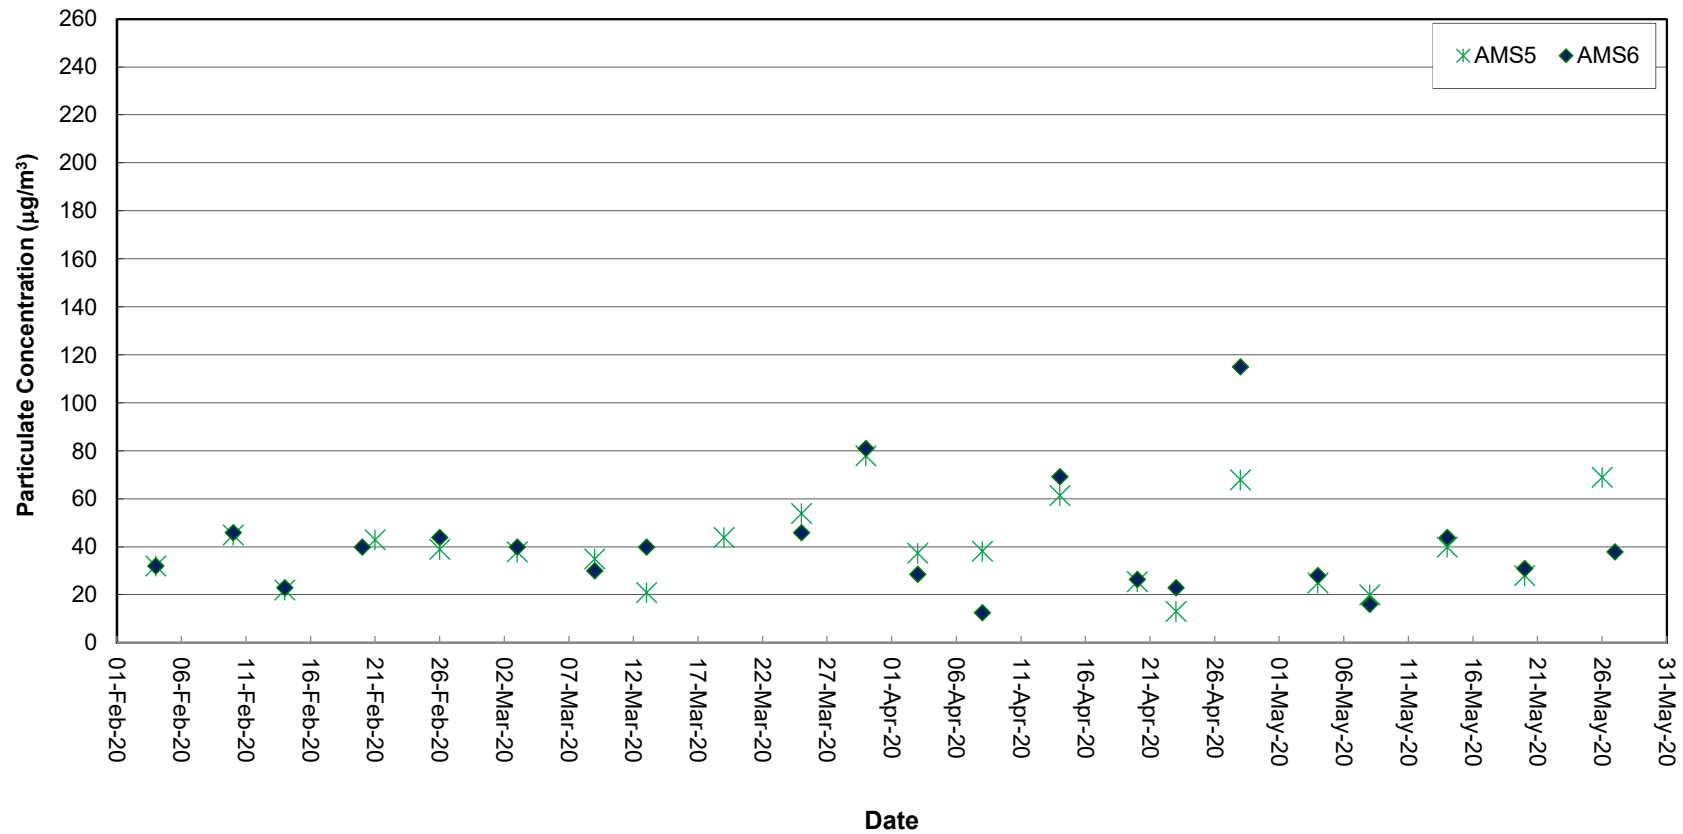
Graphical Plot of 24-hour TSP at AMS5 and AMS6

- 1) There were no works for Contract No. HY/2011/03 between 25 January 2020 and 2 February 2020. As such, 24-hr TSP monitoring (which was scheduled on 29 January 2020) for stations AMS 5 and AMS 6 were suspended.
- 2) Due to power failure, 24-hr TSP monitoring on 20 February 2020 at AMS5 (Ma Wan Chung Village) was rescheduled to 21 Feb 2020.
- 3) Due to power failure and malfunction of High Volume Sampler (HVS) at AMS6 - Dragonair / CNAC (Group) Building (HKIA), 24-hr TSP monitoring on 19 March 2020 at AMS6 was cancelled. The HVS was repaired on 25 March 2020. The 24-hr TSP monitoring at AMS6 was resumed on 25 March 2020.
- 4) Due to power failure, 24-hr TSP monitoring on 26 May 2020 at AMS5 (Ma Wan Chung Village) was rescheduled to 27 May 2020.

Due to power failure and malfunction of High Volume Sampler (HVS) at AMS6 - Dragonair / CNAC (Group) Building (HKIA), 24-hr TSP monitoring on 19 March 2020 at AMS6 was cancelled. The HVS was repaired on 25 March 2020. The 24-hr TSP monitoring at AMS6 was resumed on 25 March 2020.

Due to power failure, 24-hr TSP monitoring on 26 May 2020 at AMS5 (Ma Wan Chung Village) was rescheduled to 27 May 2020.

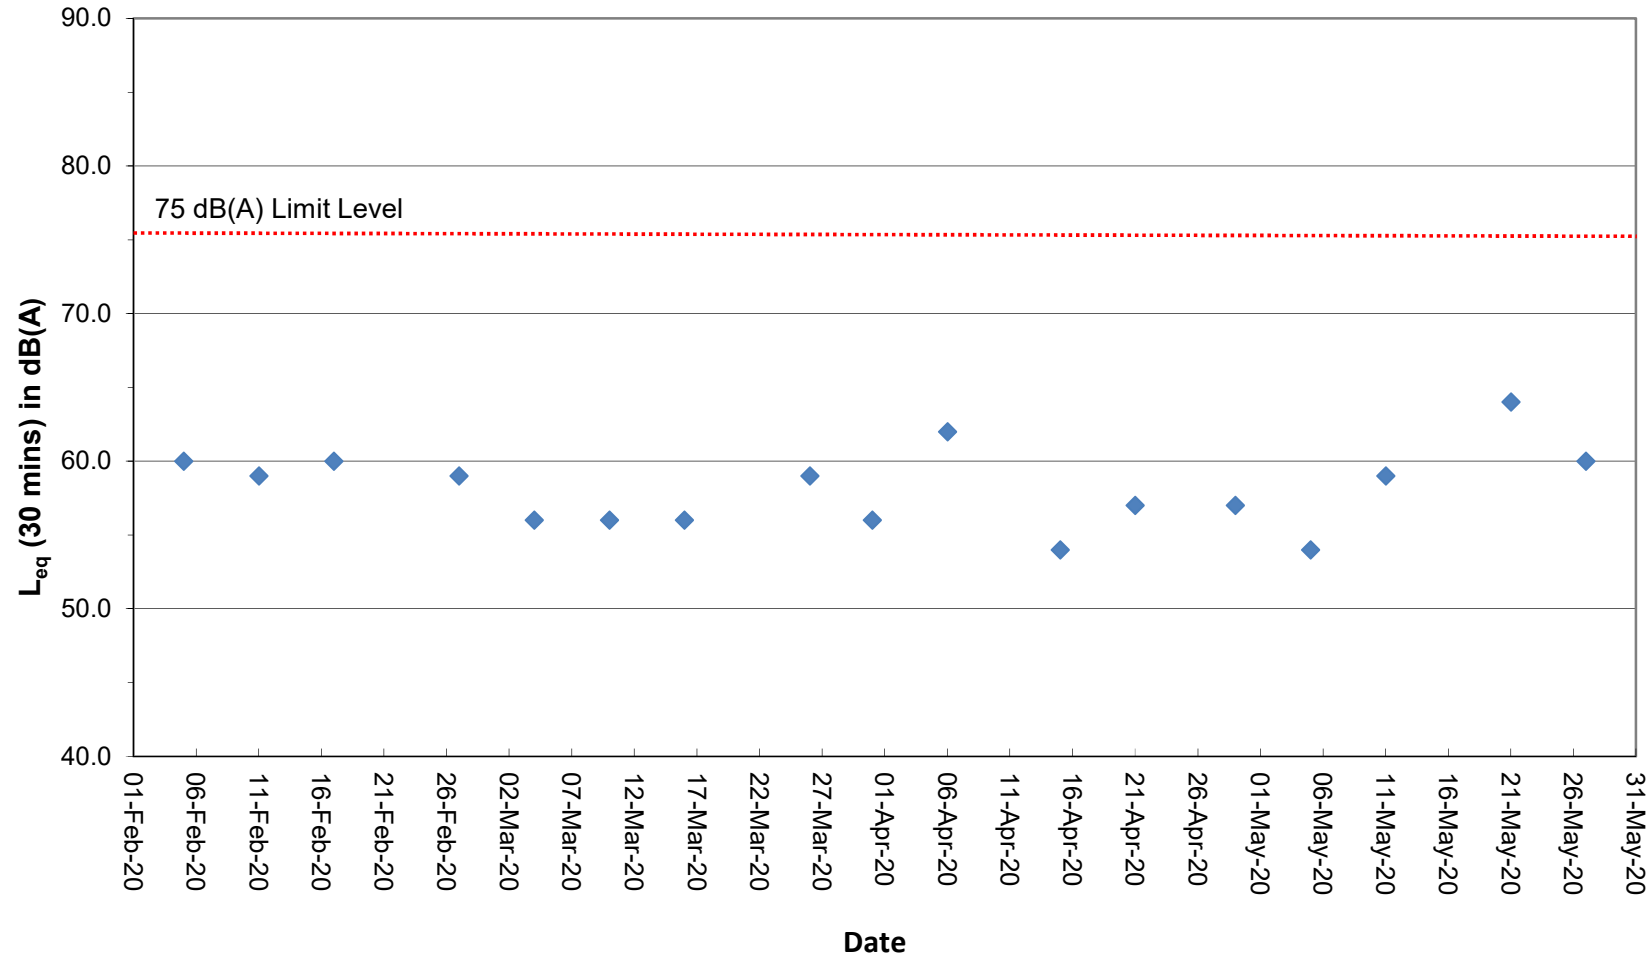
Graphical Plot of Noise Levels at NMS5

(1) A facade correction of +3 dB(A) was applied to the measured noise level.

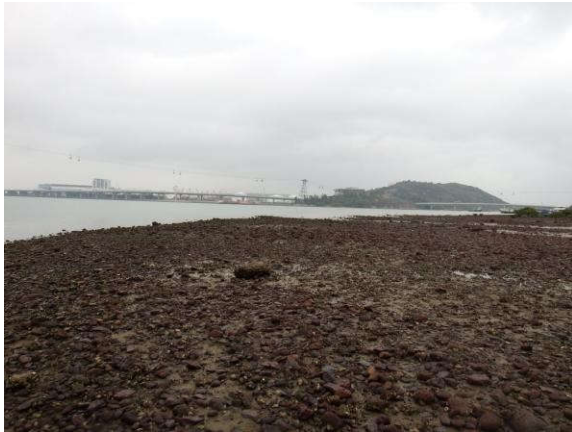
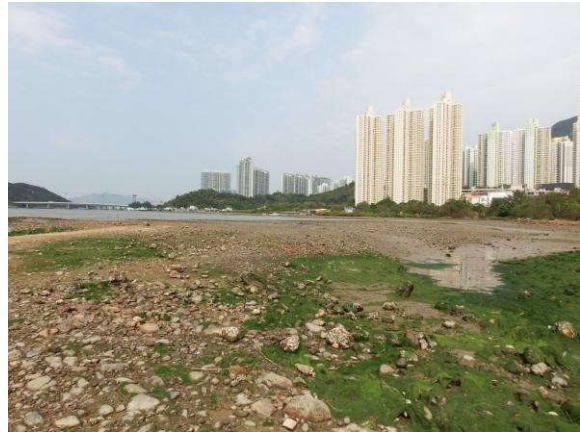
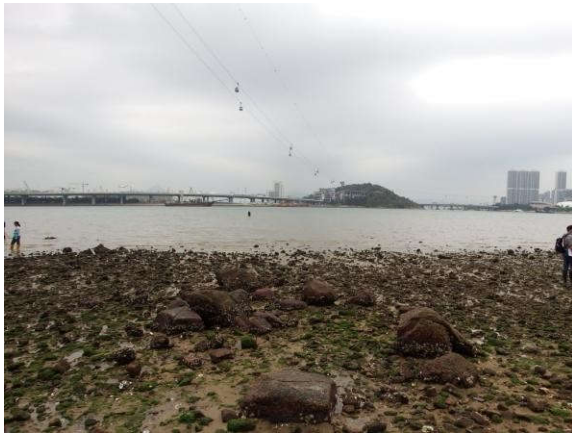
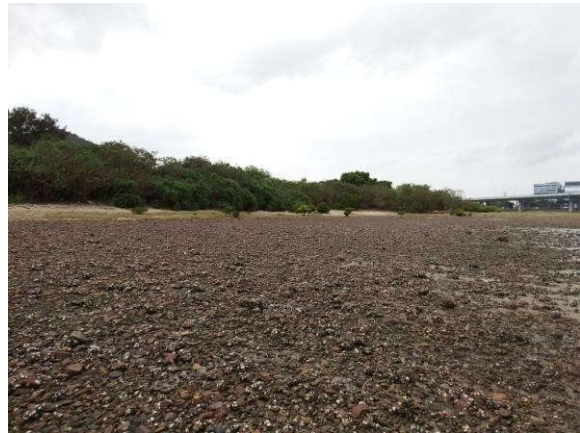
Figure 2.2 *Photographic record of the environment in every sampling zone. (March 2020)*

TC1

TC2

TC3

ST

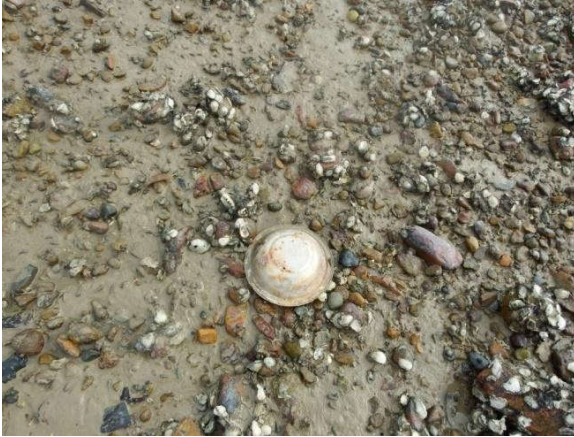
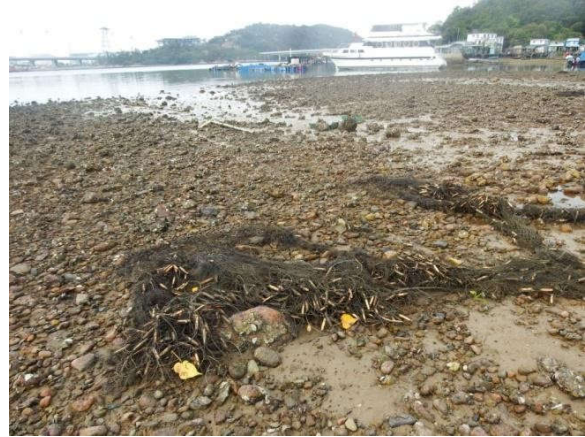
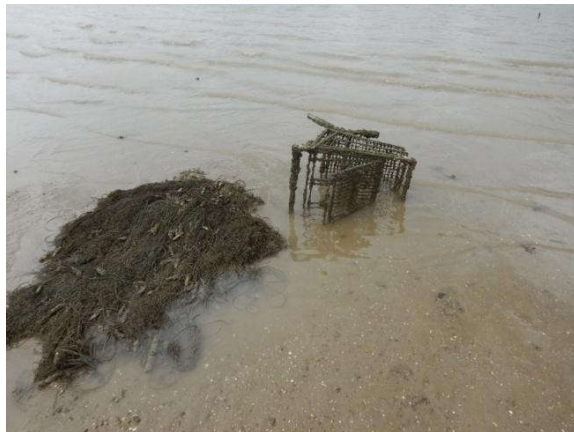
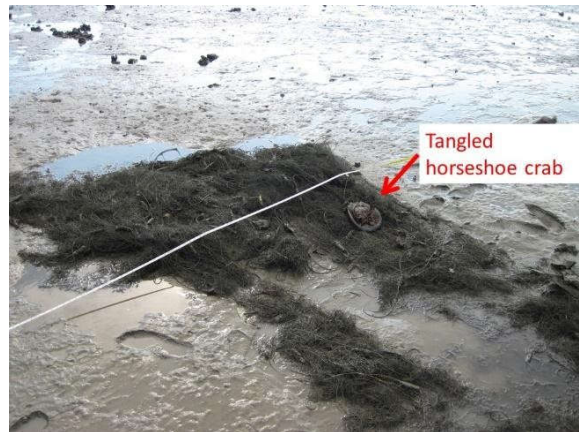
Figure 2.3 *Examples of photographic record of the big trashes found on the mudflat.*

Plastic waste

Trash gill net

Boat wreckage

Trash gill net and hand trolley

A tangled horseshoe crab on a trash net (record in June 2017)

- 3.6.7 Since the field survey of June 2016, increasing number of trashes and even big trashes (**Figure 2.3 of Appendix O**) were found in every sampling zone. It raised a concern about the solid waste dumping and current-driven waste issues in Tung Chung Wan. Respective measures (e.g. manual clean-up) should be implemented by responsible governmental agency units.

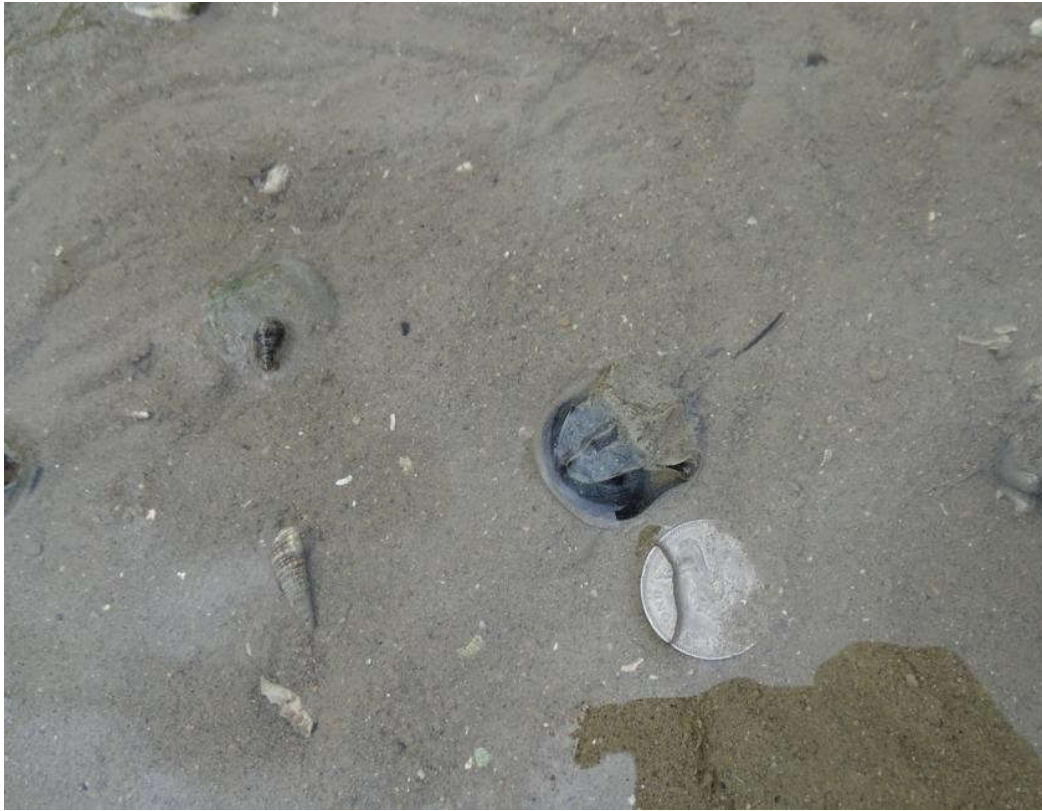
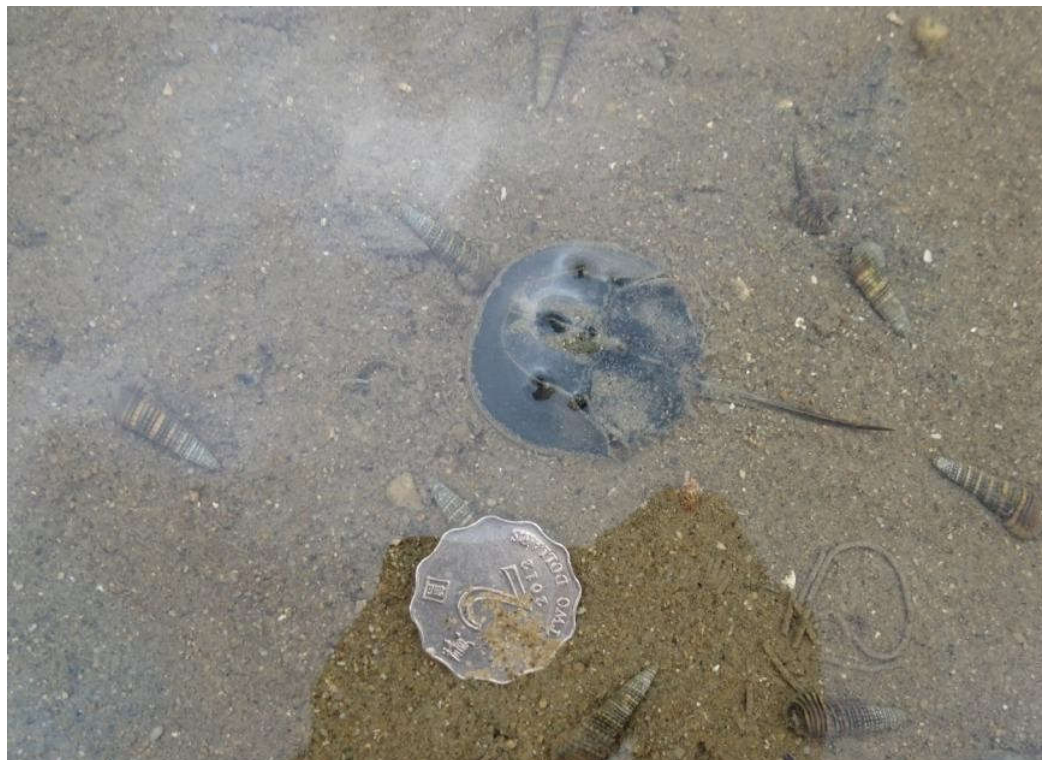
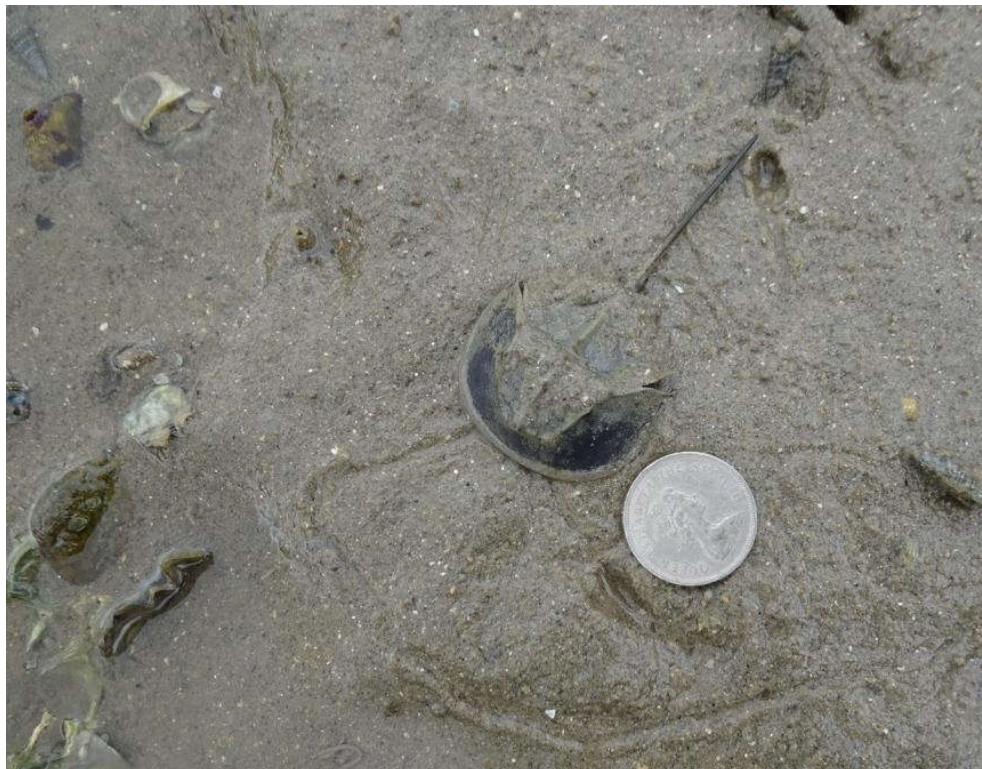
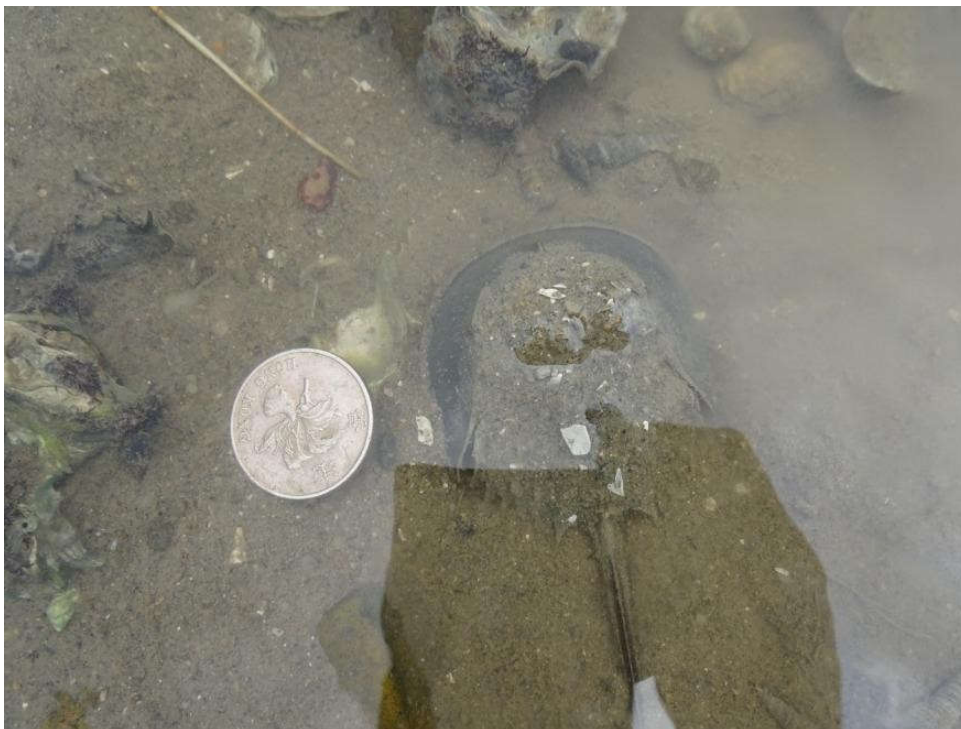
Figure 3.1 Examples of photographic records of horseshoe crab (March 2020)

ST *Carcinoscorpius rotundicauda*

ST *Tachypleus tridentatus*

TC3 *Carcinoscorpius rotundicauda*

TC3 *Tachypleus tridentatus*

- 3.6.16 In total of 5 and 8 individuals of *Carcinoscorpius rotundicauda* and *Tachypleus tridentatus* were found in present survey. The recorded individuals were mainly distributed along the shoreline from TC3 to ST. All of them were observed on similar substratum (fine sand or soft mud, slightly submerged). Among the found horseshoe crabs, a mating pair of *Tachypleus tridentatus* with large prosomal width ($\geq 100\text{mm}$) was recorded in TC1. These two individuals will be excluded from the data analysis to avoid from mixing up the juvenile population living on intertidal habitat. Photo records of the observed horseshoe crab are shown in **Figure 3.1 of Appendix O** and the present survey result regarding horseshoe crab are presented in **Table 3.1 of Appendix O**. The complete survey records are presented in **Annex II of Appendix O**.

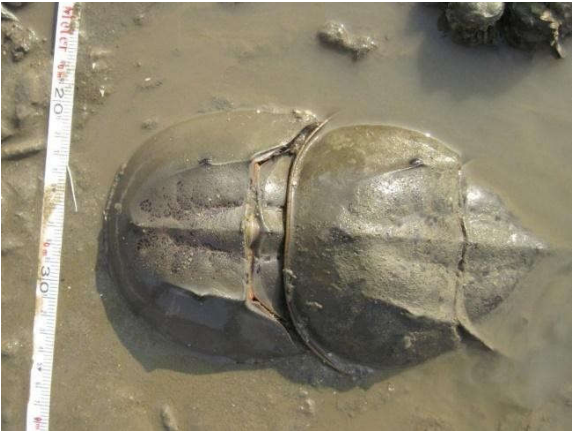
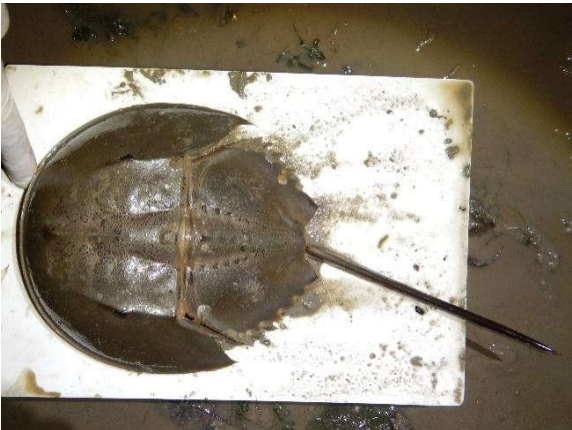
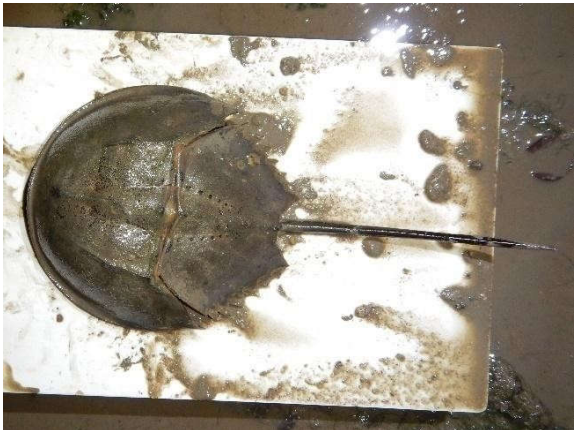
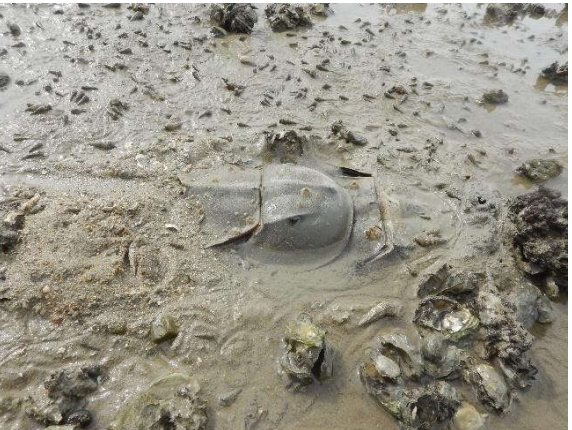
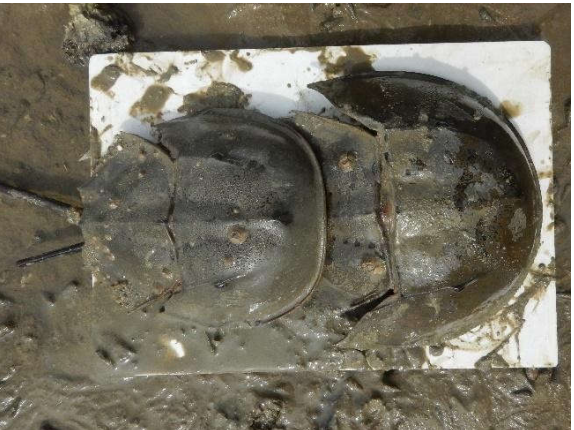
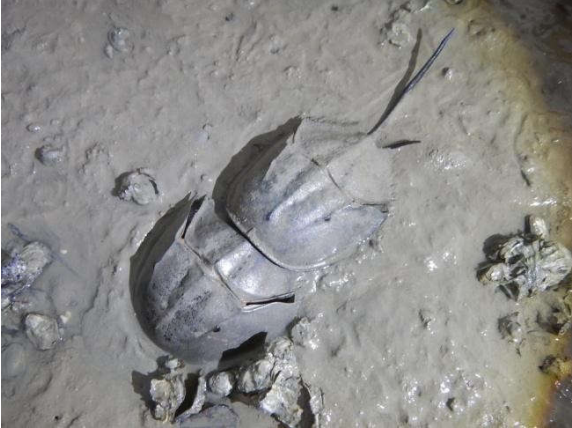
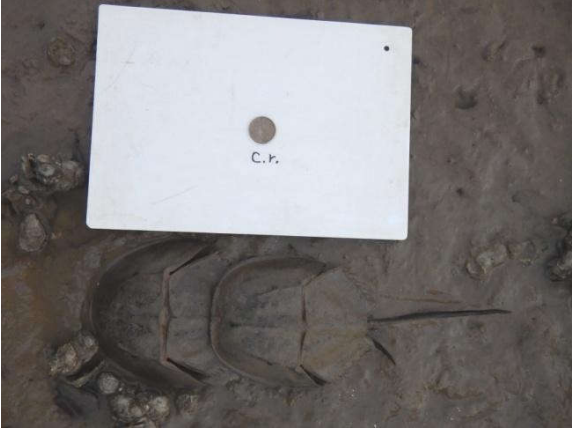
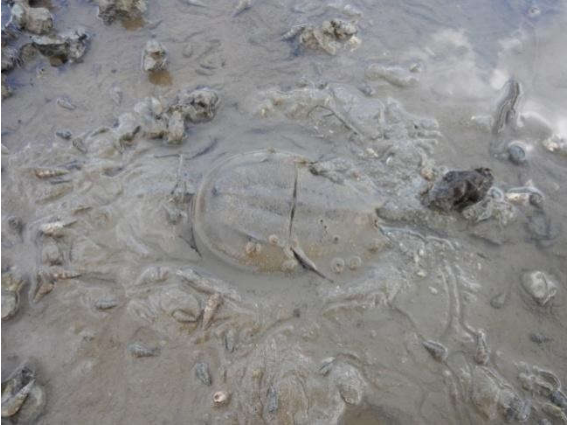
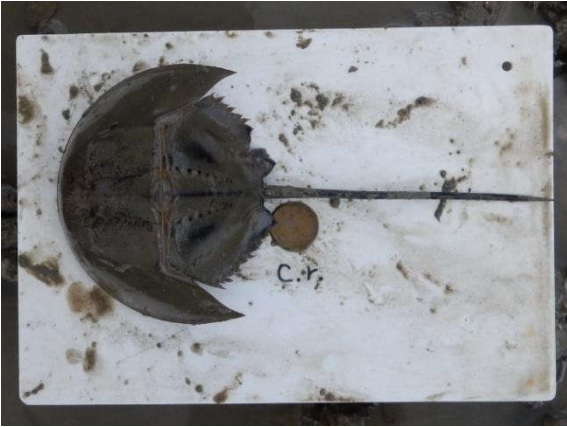
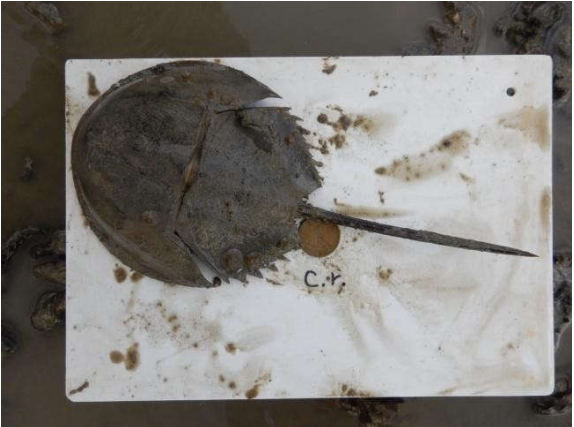
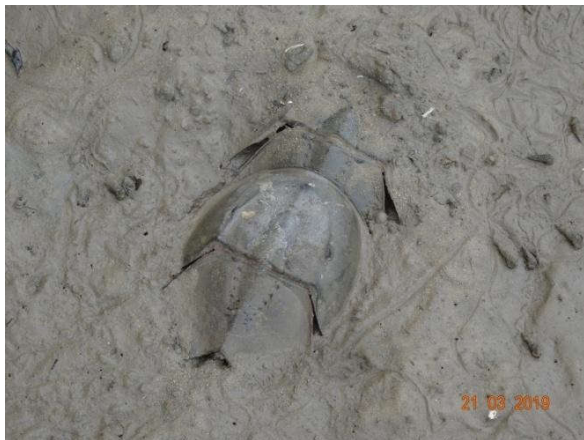
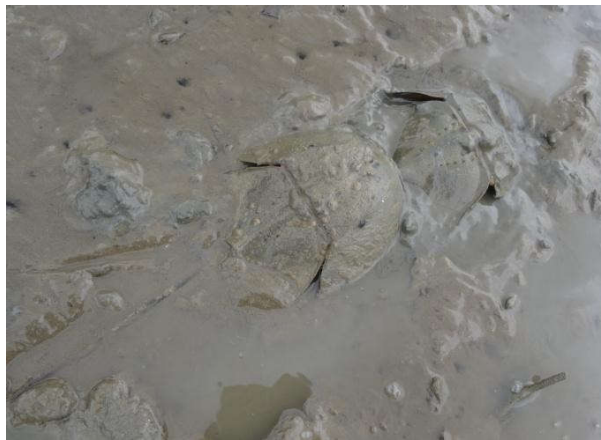
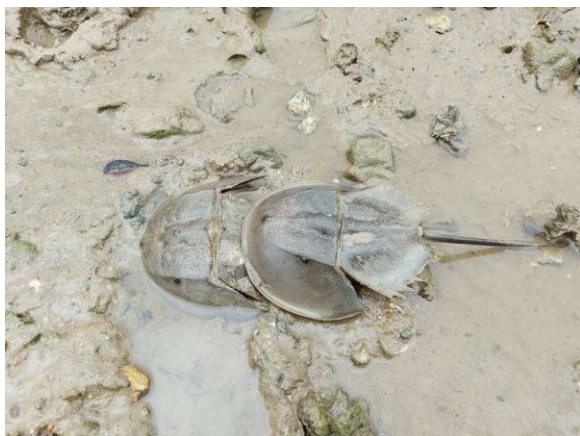
Figure 3.2 Photographic records of mating pairs of horseshoe crab

March 2015 - ST

June 2017 – TC2

June 2017 – TC3

December 2017 – TC3

June 2018 – TC3

March 2019 – TC2

June 2019 – TC3

March 2020 – TC1

- 3.6.19 In the survey of March 2015, there was one important finding that a mating pair of *Carcinoscorpius rotundicauda* was found in ST (prosomal width: male 155.1mm, female 138.2mm). It indicated the importance of ST as a breeding ground of horseshoe crab. In June 2017, mating pairs of *Carcinoscorpius rotundicauda* were found in TC2 (male 175.27 mm, female 143.51 mm) and TC3 (male 182.08 mm, female 145.63 mm) (**Figure 3.2 of Appendix O**). In December 2017 and June 2018, one mating pair was of *Carcinoscorpius rotundicauda* was found in TC3 (December 2017: male 127.80 mm, female 144.61 mm; June 2018: male 139 mm, female 149 mm). In June 2019, 2 mating pairs of *Tachypleus tridentatus* with large body sizes (male 150mm and Female 200mm; Male 180mm and Female 220mm) was found in TC3. Another mating pair of *Tachypleus tridentatus* was found in ST (male 140mm and Female 180mm). In March 2020 (present survey), a pair of *Tachypleus tridentatus* with large body sizes (male 123mm and Female 137mm was recorded in TC1. **Figure 3.2 of Appendix O** shows the photographic records of mating pairs found. The recorded mating pairs were found nearly burrowing in soft mud at low tidal level (0.5-1.0 m above C.D.). The smaller male was holding the opisthosoma (abdomen carapace) of larger female from behind. The mating pair was found in TC1 in March 2020 (present survey), it indicated that breeding of horseshoe crab could be possible along the coast of Tung Chung Wan rather than ST only, as long as suitable substratum was available. Based on the frequency of encounter, the shoreline between TC3 and ST should be more suitable mating ground. Moreover suitable breeding period was believed in wet season (March – September) because tiny individuals (i.e. newly hatched) were usually recorded in June and September every year(**Figure 3.3 of Appendix O**).

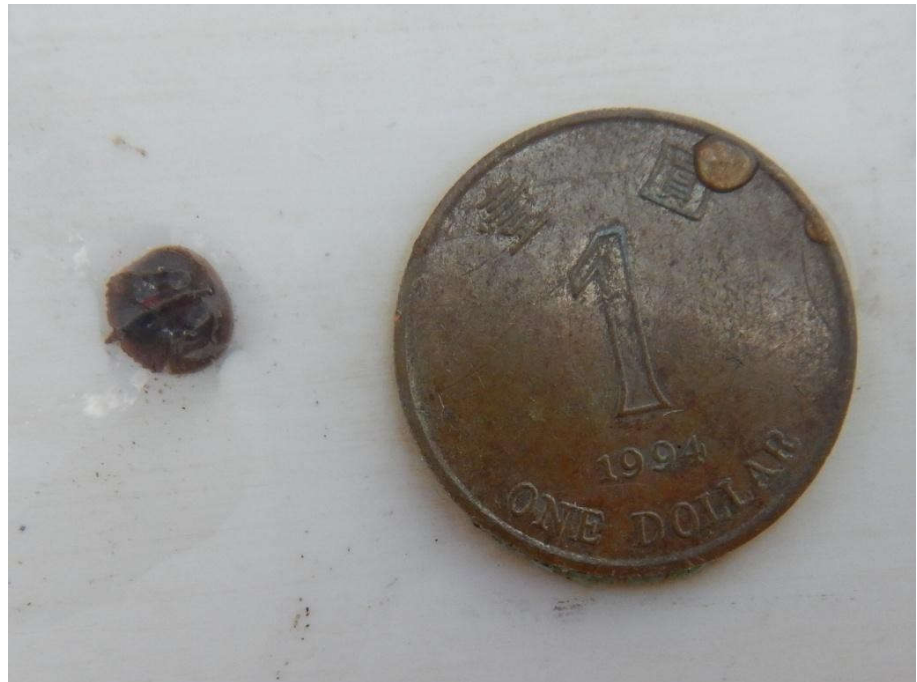
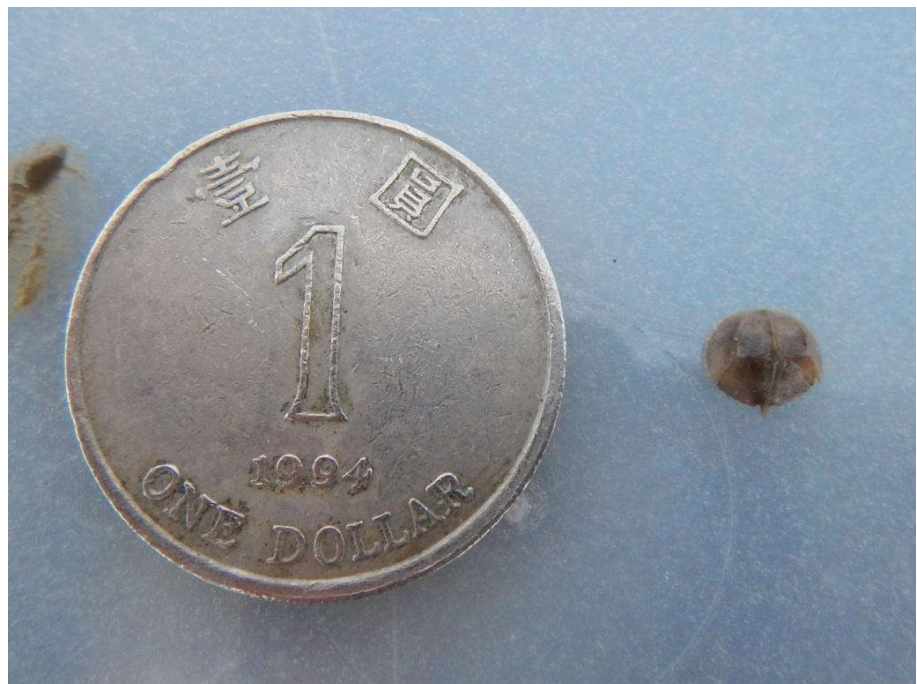
Figure 3.3 *Photographic records of newly hatched individuals of horseshoe crab (September 2018)*

TC1

TC2

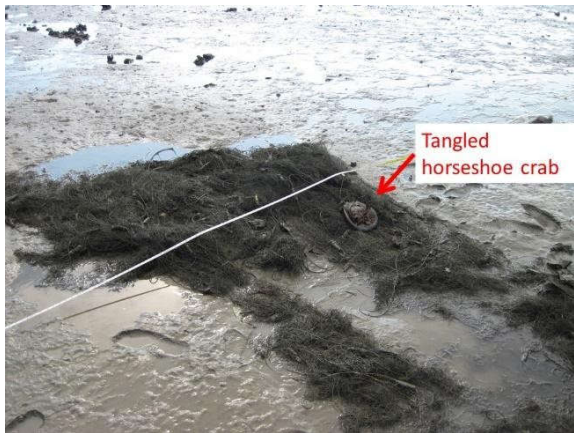
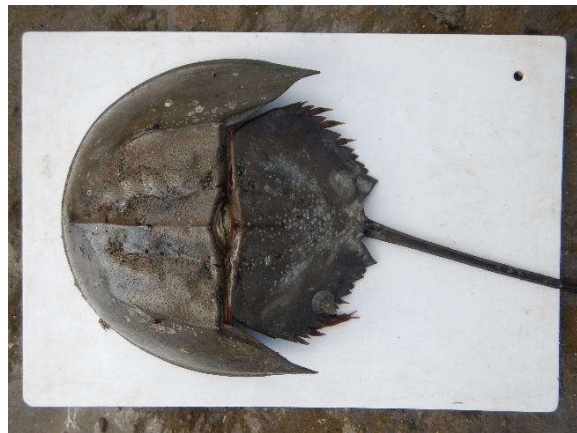
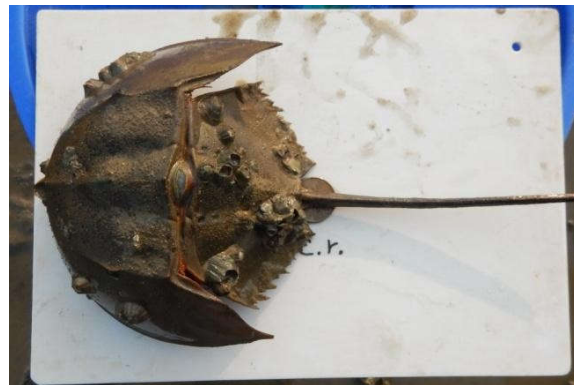
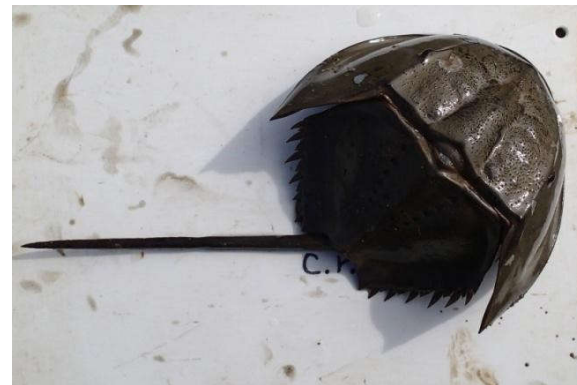
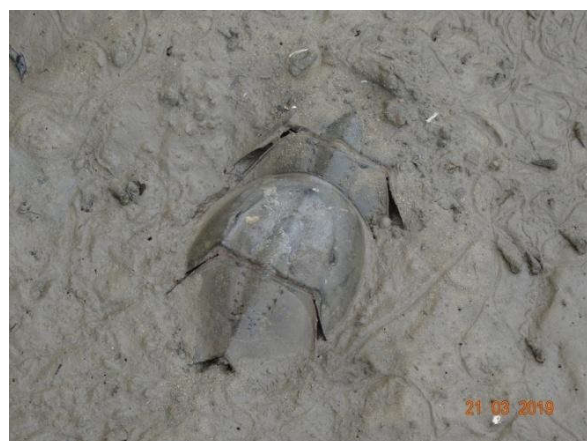
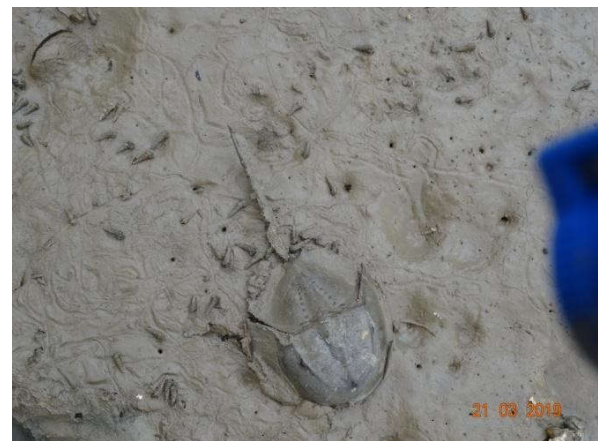
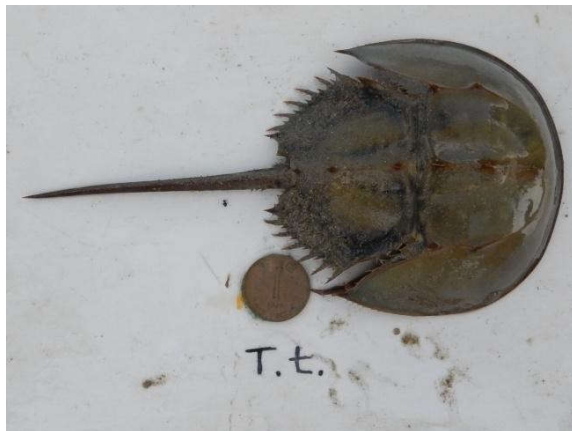
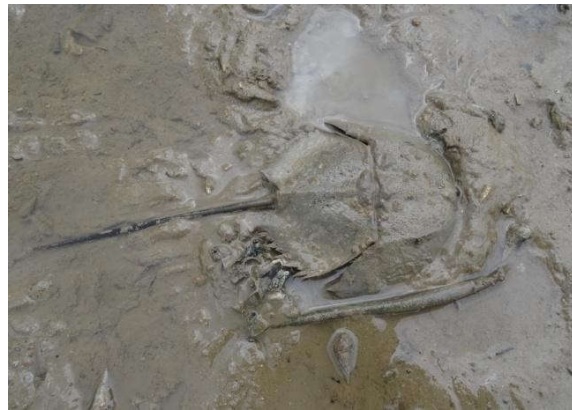
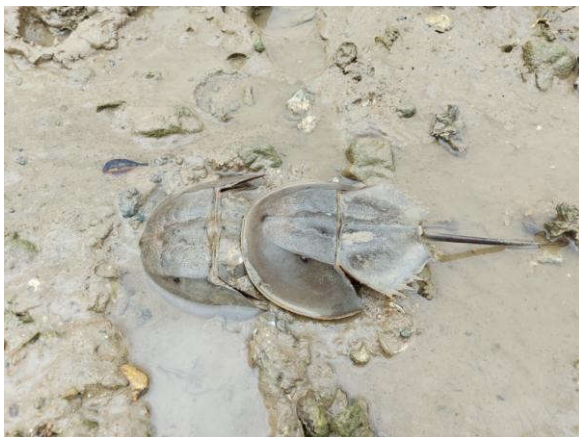
Figure 3.4 *Photographic records of large individuals (>100 mm) of horseshoe crabs records were excluded from data analysis*

June 2017

December 2017

December 2018

March 2019

September 2017

June 2019

March 2020

- 3.6.20 Despite of mating pair, there were occasional records of large individuals of *Carcinoscorpius rotundicauda* (prosomal width ranged 114.45 – 178.67 mm, either single or in pair) and *Tachypleus tridentatus* (prosomal width 103 mm) (**Figure 3.4 of Appendix O**). In December 2018, one large individual of *Carcinoscorpius rotundicauda* was found in TC3 (prosomal width 148.9 mm). In March 2019, 3 large individuals (prosomal width ranged 220 – 310mm) of *Carcinoscorpius rotundicauda* were observed in TC2. In June 2019, there were 3 and 7 large individuals of *Tachypleus tridentatus* were recorded in ST (prosomal width ranged 140 – 180mm) and TC3 (prosomal width ranged 150 – 220mm), respectively. In March 2020, a mating pair of *Tachypleus tridentatus* was recorded in TC1 with prosomal width 123 mm and 137mm. Based on their sizes, it indicated that individuals of prosomal width larger than 100 mm would progress its nursery stage from intertidal habitat to sub-tidal habitat of Tung Chung Wan. These large individuals might move onto intertidal shore occasionally during high tide for foraging and breeding. Because they should be inhabiting sub-tidal habitat most of the time. Their records were excluded from the data analysis to avoid mixing up with juvenile population living on intertidal habitat.

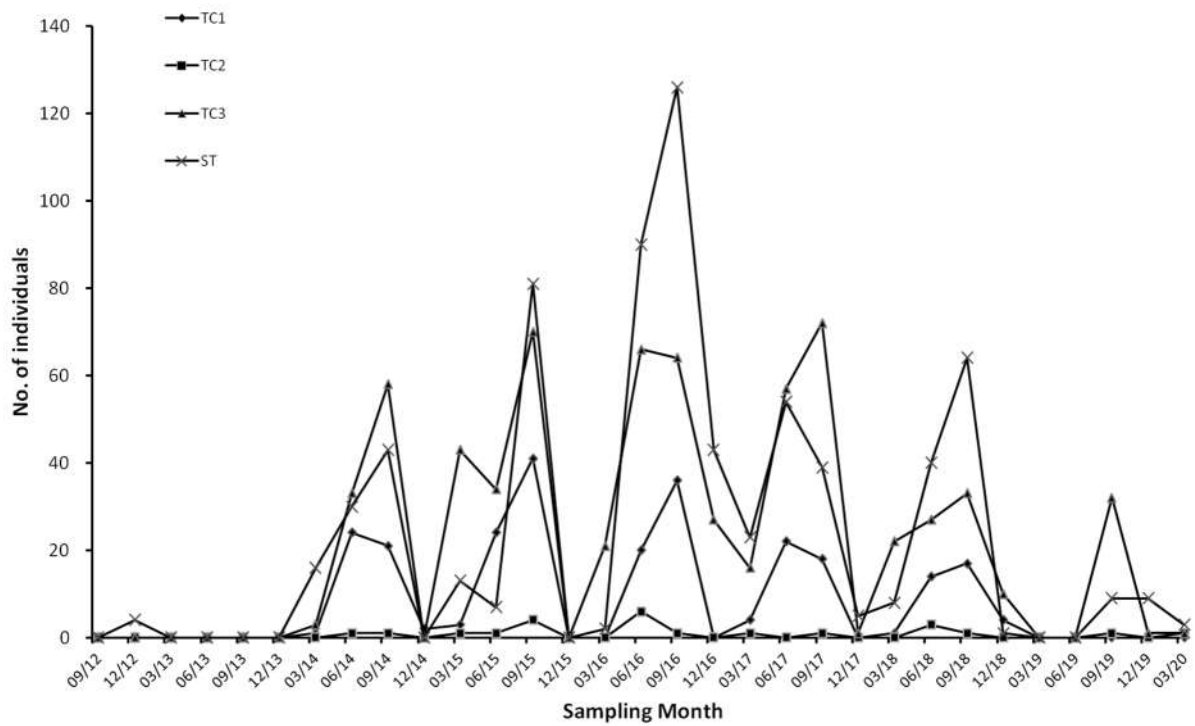
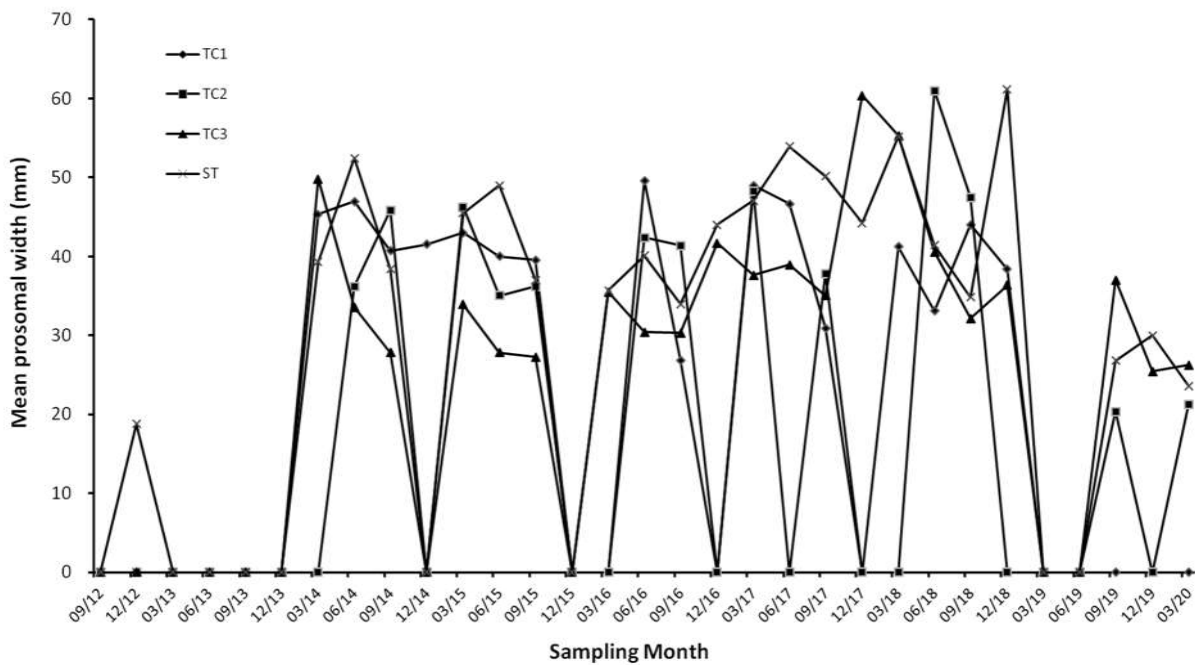
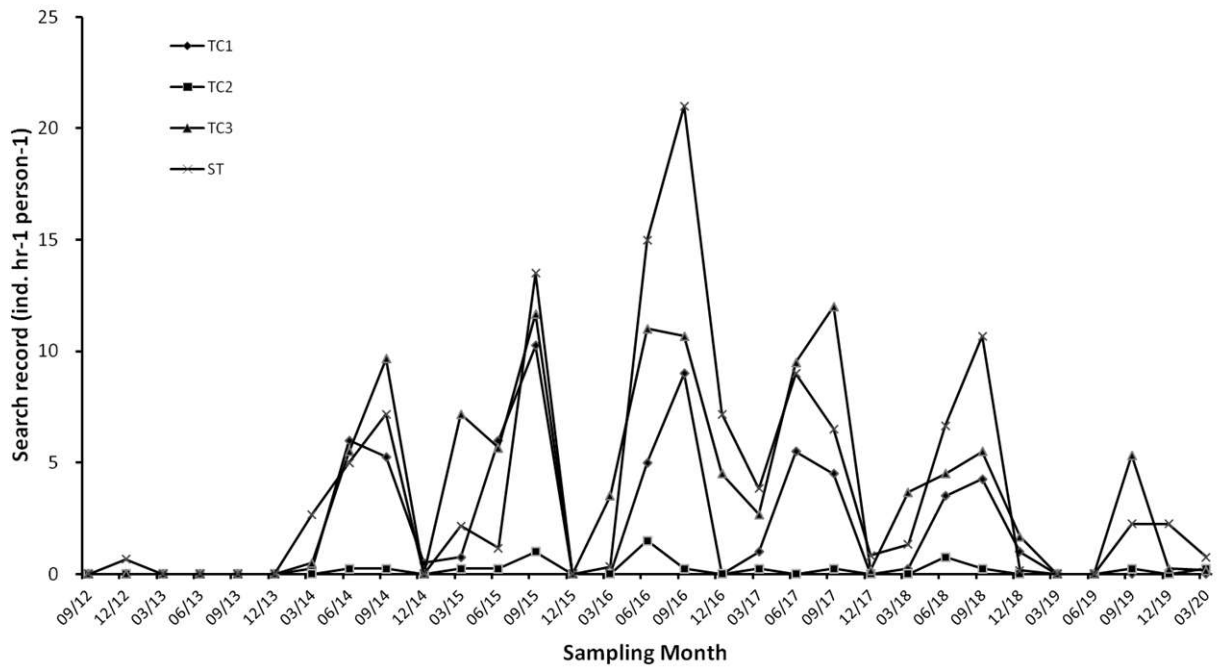
Figure 3.5 Changes of number of individuals mean prosomal width and search record of horseshoe crab *Carcinoscorpius rotundicauda* in every sampling zone along the sampling months

Figure 3.5 (Cont'd) Changes of number of individuals mean prosomal width and search record of horseshoe crab *Carcinoscorpius rotundicauda* in every sampling zone along the sampling months

- 3.6.28 Throughout the monitoring period, the search records of horseshoe crabs were fluctuated and at moderate – very low level in June (**Figures 3.5 and 3.6 of Appendix O**). Low – Very low search record was found in June 2013, totally 82 individuals of *Tachypleus tridentatus* and 0 ind. of *Carcinoscorpius rotundicauda* were found in TC1, TC3 and ST. Compare with the search record of June 2013, the numbers of *Tachypleus tridentatus* were gradually decreased in June 2014 and 2015 (55 ind. in 2014 and 18 ind. in 2015); the number of *Carcinoscorpius rotundicauda* raise to 88 and 66 individuals. in June 2014 and 2015 respectively. In June 2016, the search record increased about 3 times compare with June 2015. In total, 182 individuals of *Carcinoscorpius rotundicauda* and 47 individuals. of *Tachypleus tridentatus* were noted, respectively. Then, the search record was similar to June 2016. The number of recorded *Carcinoscorpius rotundicauda* (133 ind.) slightly dropped in June 2017. However, that of *Tachypleus tridentatus* rapidly increased (125 ind.). In June 2018, the search record was low to moderate while the numbers of *Tachypleus tridentatus* dropped sharply (39 ind.). In March 2019, 3 individuals of *Carcinoscorpius rotundicauda* were observed in TC2. However, all of them were large individuals (prosomal width >100mm), their records are excluded from the data analysis to avoid mixing up with the juvenile population living on intertidal habitat. Throughout the monitoring period, similar distribution of horseshoe crabs population were found in March. Most of the horseshoe crabs were found in TC3 and ST.

- 3.6.29 The search record of horseshoe crab declined obviously in all sampling zones during dry season especially December (**Figures 3.5 and 3.6 of Appendix O**) throughout the monitoring period. Very low – low search record was found in December from 2012 to 2015 (0-4 ind. of *Carcinoscorpius rotundicauda* and 0-12 ind. of *Tachypleus tridentatus*). The horseshoe crabs were inactive and burrowed in the sediments during cold weather (<15 °C). Similar results of low search record in dry season were reported in a previous territory-wide survey of horseshoe crab. For example, the search records in Tung Chung Wan were 0.17 ind. hr⁻¹person⁻¹ and 0.00 ind. hr⁻¹ person⁻¹ in wet season and dry season respectively (details see Li, 2008). Compare with the search record of December from 2012 to 2015, which of December 2016 were much higher relatively. There were totally 70 individuals of *Carcinoscorpius rotundicauda* and 24 individuals of *Tachypleus tridentatus* in TC3 and ST. Since the survey was carried in earlier December with warm and sunny weather (~22 °C during dawn according to Hong Kong Observatory database, Chek Lap Kok station on 5 December 2016), the horseshoe crab was more active (i.e. move onto intertidal shore during high tide for foraging and breeding) and easier to be found. In contrast, there was no search record in TC1 and TC2 because the survey was conducted in mid-December with colder and cloudy weather (~20 °C during dawn on 19 December). The horseshoe crab activity would decrease gradually with the colder climate. In December of 2017 and 2018, very low search records were found again as mentioned above.
