Contract No. HY/2011/03

**Hong Kong-Zhuhai-Macao Bridge Hong Kong Link Road
Section between Scenic Hill and Hong Kong Boundary Crossing
Facilities**

Quarterly EM&A Report No. 31 (March 2020 to May 2020)

6 July 2020

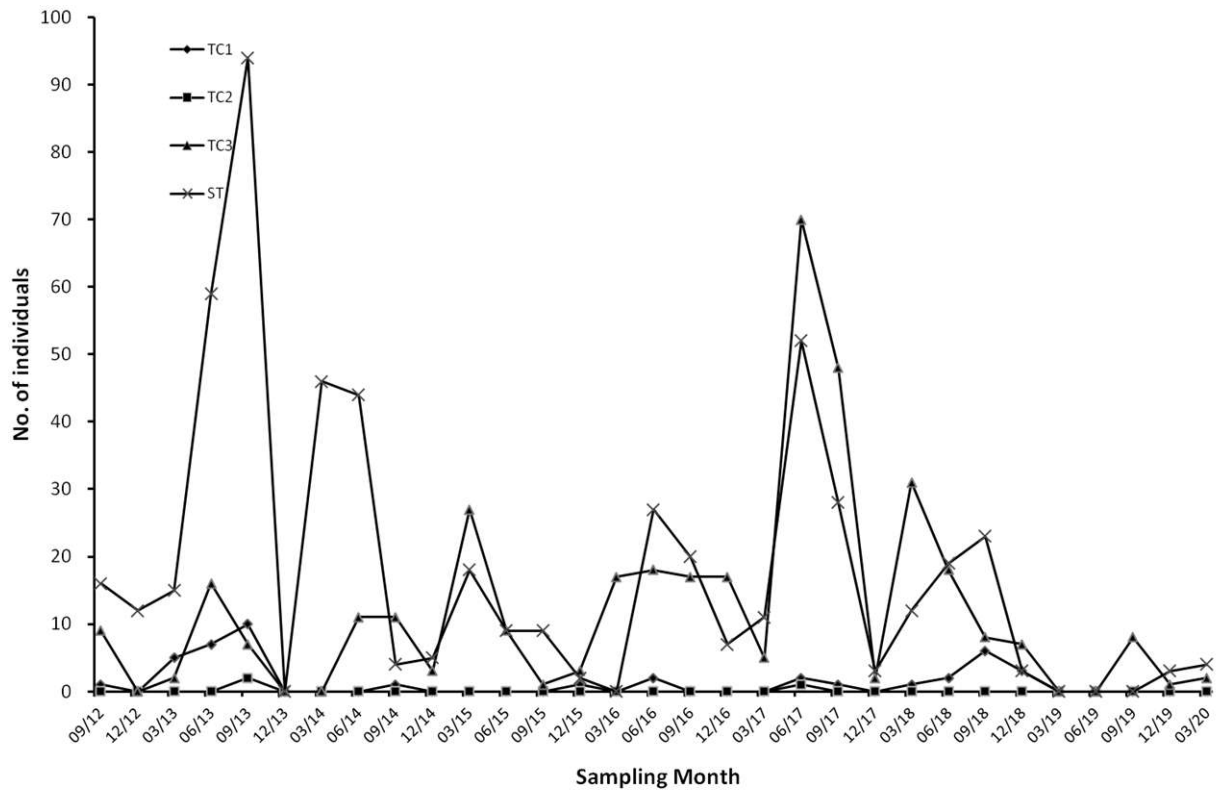
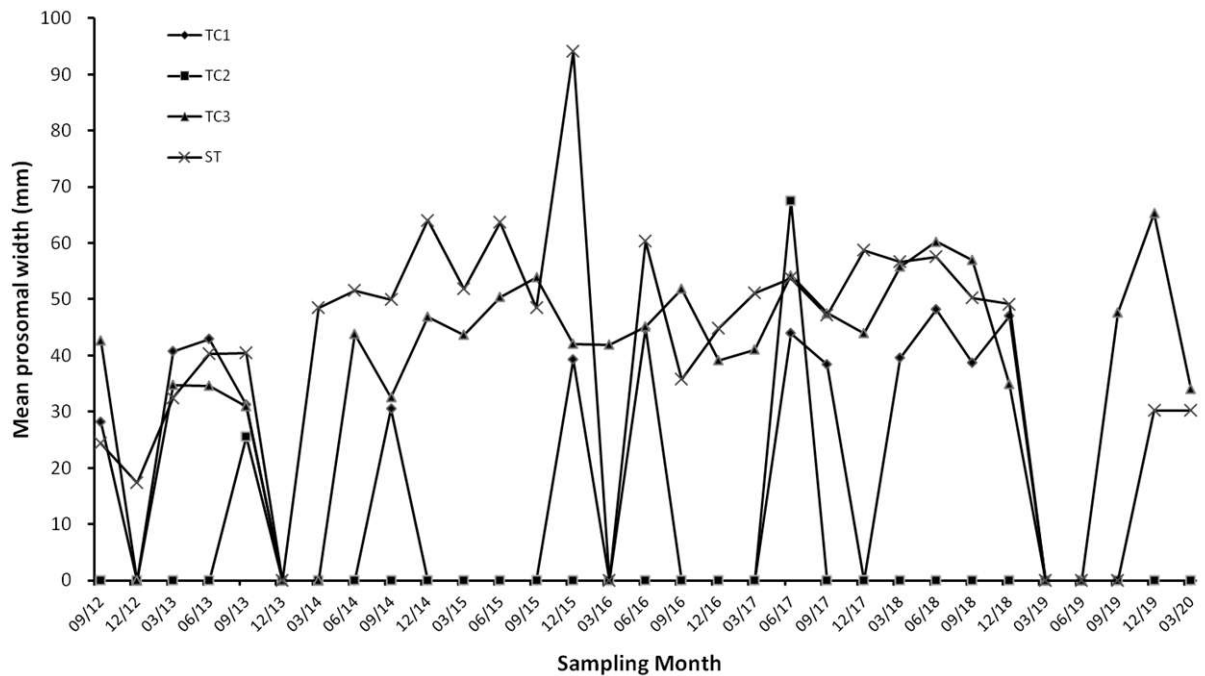
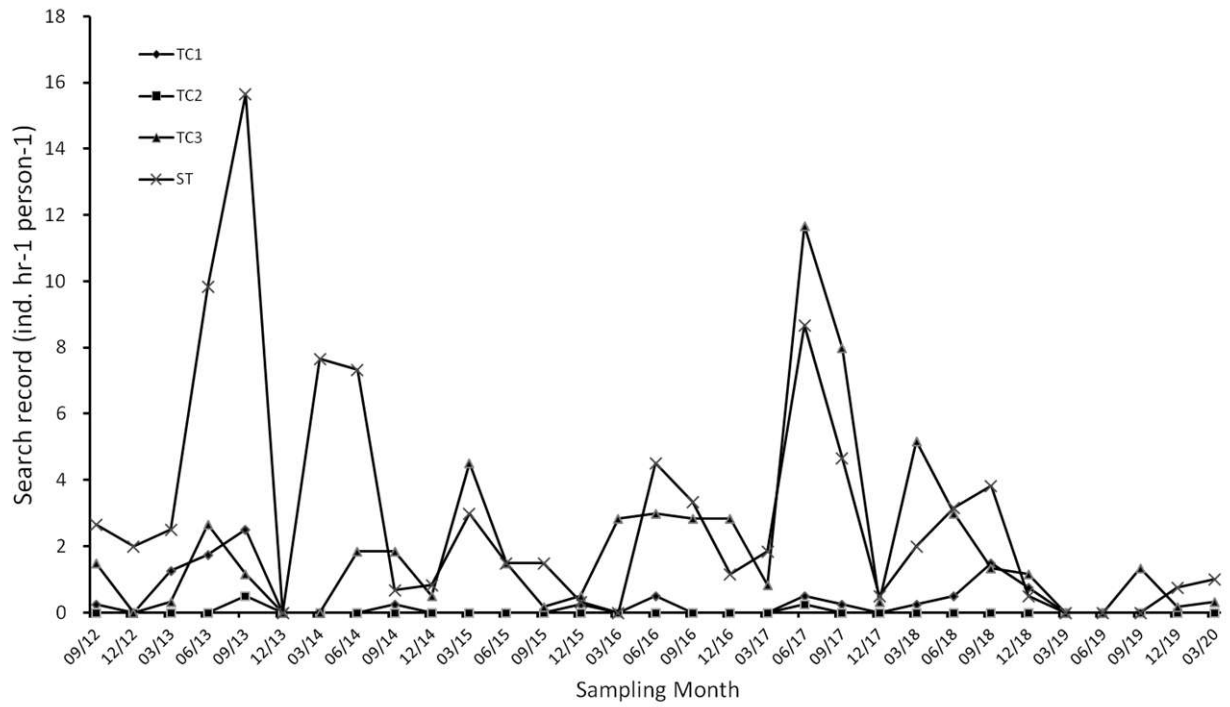
Figure 3.6 Changes of number of individuals mean prosomal width and search record of horseshoe crab *Tachypleus tridentatus* in every sampling zone along the sampling months

Figure 3.6 (Cont'd) Changes of number of individuals mean prosomal width and search record of horseshoe crab *Tachypleus tridentatus* in every sampling zone along the sampling months

- 3.6.28 Throughout the monitoring period, the search records of horseshoe crabs were fluctuated and at moderate – very low level in June (**Figures 3.5 and 3.6 of Appendix O**). Low – Very low search record was found in June 2013, totally 82 individuals of *Tachypleus tridentatus* and 0 ind. of *Carcinoscorpius rotundicauda* were found in TC1, TC3 and ST. Compare with the search record of June 2013, the numbers of *Tachypleus tridentatus* were gradually decreased in June 2014 and 2015 (55 ind. in 2014 and 18 ind. in 2015); the number of *Carcinoscorpius rotundicauda* raise to 88 and 66 individuals. in June 2014 and 2015 respectively. In June 2016, the search record increased about 3 times compare with June 2015. In total, 182 individuals of *Carcinoscorpius rotundicauda* and 47 individuals. of *Tachypleus tridentatus* were noted, respectively. Then, the search record was similar to June 2016. The number of recorded *Carcinoscorpius rotundicauda* (133 ind.) slightly dropped in June 2017. However, that of *Tachypleus tridentatus* rapidly increased (125 ind.). In June 2018, the search record was low to moderate while the numbers of *Tachypleus tridentatus* dropped sharply (39 ind.). In March 2019, 3 individuals of *Carcinoscorpius rotundicauda* were observed in TC2. However, all of them were large individuals (prosomal width >100mm), their records are excluded from the data analysis to avoid mixing up with the juvenile population living on intertidal habitat. Throughout the monitoring period, similar distribution of horseshoe crabs population were found in March. Most of the horseshoe crabs were found in TC3 and ST.

- 3.6.29 The search record of horseshoe crab declined obviously in all sampling zones during dry season especially December (**Figures 3.5 and 3.6 of Appendix O**) throughout the monitoring period. Very low – low search record was found in December from 2012 to 2015 (0-4 ind. of *Carcinoscorpius rotundicauda* and 0-12 ind. of *Tachypleus tridentatus*). The horseshoe crabs were inactive and burrowed in the sediments during cold weather (<15 °C). Similar results of low search record in dry season were reported in a previous territory-wide survey of horseshoe crab. For example, the search records in Tung Chung Wan were 0.17 ind. hr⁻¹person⁻¹ and 0.00 ind. hr⁻¹ person⁻¹ in wet season and dry season respectively (details see Li, 2008). Compare with the search record of December from 2012 to 2015, which of December 2016 were much higher relatively. There were totally 70 individuals of *Carcinoscorpius rotundicauda* and 24 individuals of *Tachypleus tridentatus* in TC3 and ST. Since the survey was carried in earlier December with warm and sunny weather (~22 °C during dawn according to Hong Kong Observatory database, Chek Lap Kok station on 5 December 2016), the horseshoe crab was more active (i.e. move onto intertidal shore during high tide for foraging and breeding) and easier to be found. In contrast, there was no search record in TC1 and TC2 because the survey was conducted in mid-December with colder and cloudy weather (~20 °C during dawn on 19 December). The horseshoe crab activity would decrease gradually with the colder climate. In December of 2017 and 2018, very low search records were found again as mentioned above.

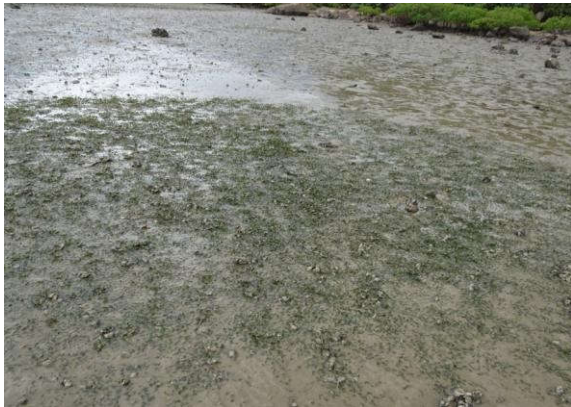
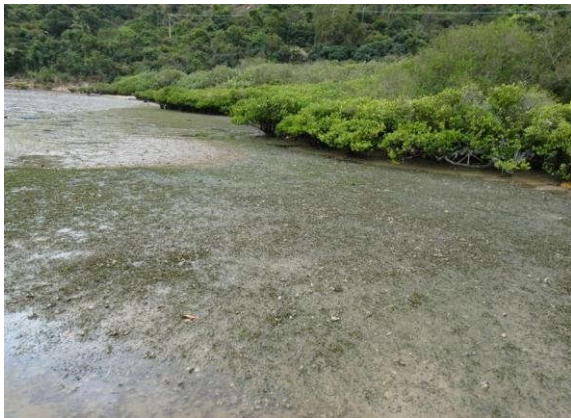
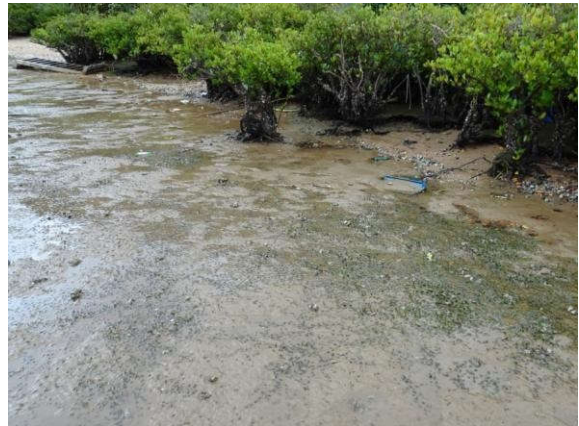
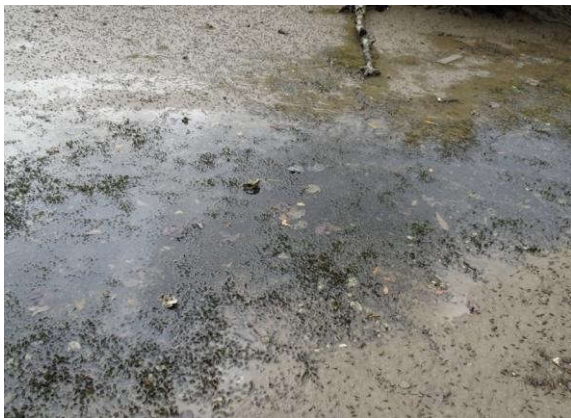
Figure 3.9 *Photographic record of seagrass beds in present survey.*

***Halophila ovalis* in TC3**

***Halophila ovalis* in ST**

- 3.6.40 Only seagrass species *Halophila ovalis* was found in present survey, which was found in TC3 and ST. In ST, there were two small sized and one large sized of seagrass beds found at tidal zone 1.5 – 2.0 m above C.D nearby mangroves plantation. The larger strand had area ~1000 m² in high vegetation coverage (90 – 100%). At close vicinity, a small sized (~4 and 8 m²) of *Halophila ovalis* beds were observed at tidal zone 1.5 – 2.0m above C.D. Both of them were in high vegetation coverage (70 – 100%). In TC3, three small patch of *Halophila ovalis* was found at tidal zone 1.5 – 2.0m above C.D. These seagrass patch had area 1m², 9m² and 25m², respectively. Both of them were in high vegetation coverage (90 – 100%). Another seagrass species *Zostera japonica* was not found in present survey. **Table 3.2 of Appendix O** summarizes the results of present seagrass beds survey and the photograph records of the seagrass are shown on **Figure 3.9 of Appendix O**. The complete record throughout the monitoring period is presented in **Annex III of Appendix O**.

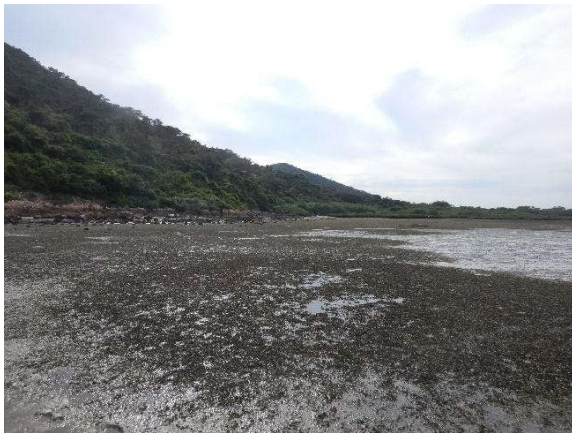
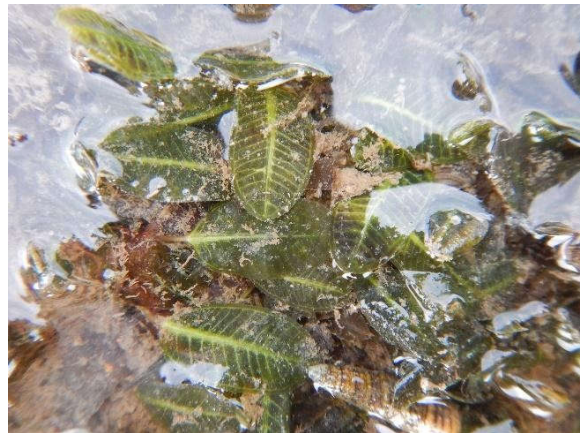
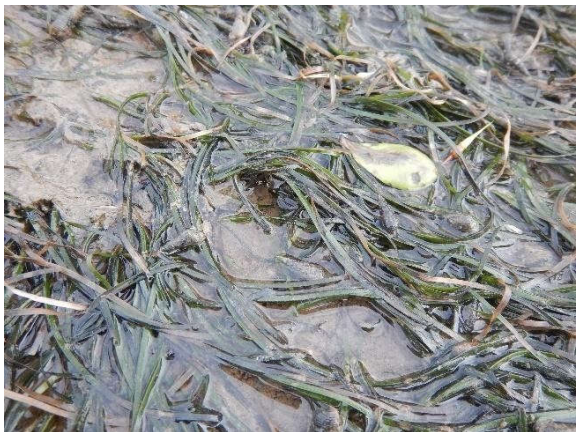
Figure 3.10 Examples of photographic records of seagrass beds (record in June 2017)

Single patch of *Halophila ovalis*

Extensive patch of *Halophila ovalis*

Medium, horizontal patch of *Zostera japonica*

- 3.6.41 Since the commencement of the EM&A monitoring programme, two species of seagrass *Halophila ovalis* and *Zostera japonica* were recorded in TC3 and ST (**Figure 3.10 of Appendix O**). In general, *Halophila ovalis* was occasionally found in TC3 in few, small to medium patches. But it was commonly found in ST in medium to large seagrass bed. Moreover, it had sometimes grown extensively and had covered significant mudflat area at 0.5 – 2.0 m above C.D. between TC3 and ST. Another seagrass species *Zostera japonica* was found in ST only. It was relatively lower in vegetation area and co-existed with *Halophila ovalis* nearby the mangrove strand at 2.0 m above C.D.

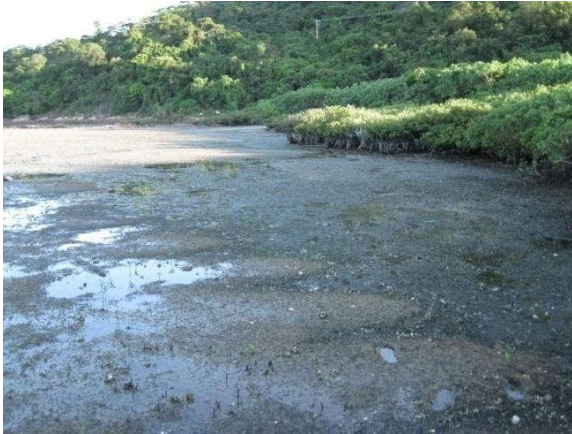
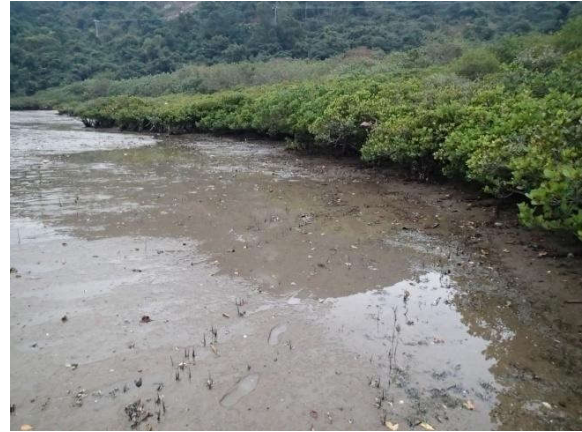
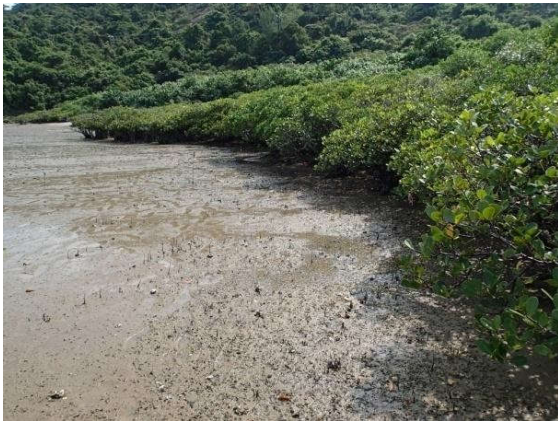
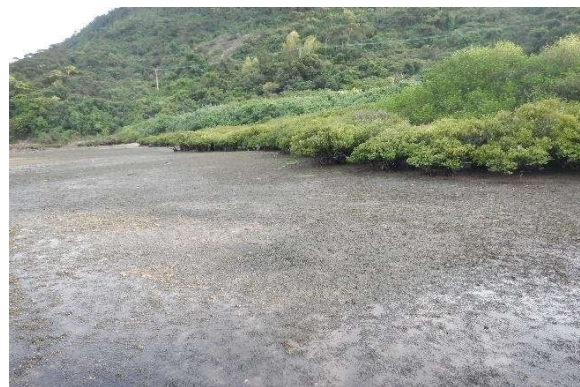
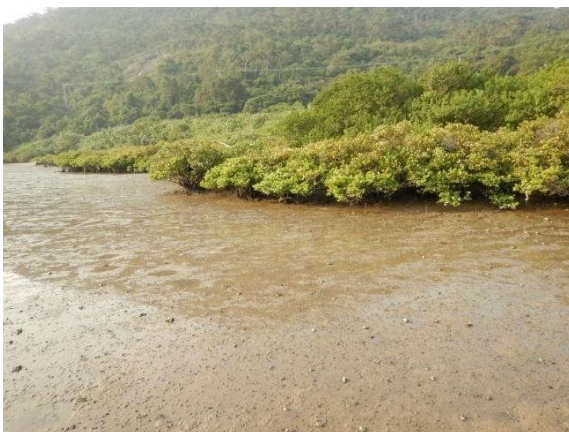
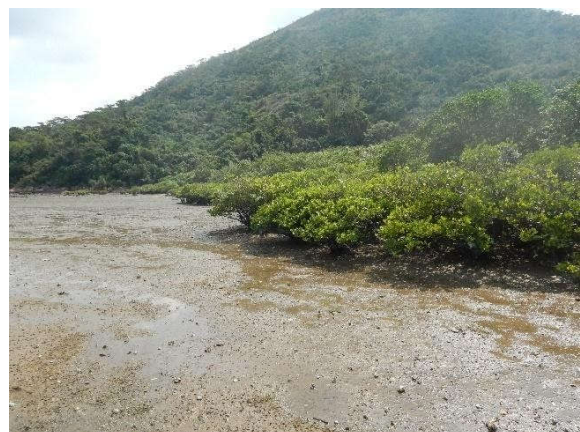
June 2014

December 2014 (no seagrass)

September 2015

June 2017

September 2017-March 2018 (no seagrass)

Figure 3.12 Comparison of pictures taken in different sampling months shows the successive disappearance and recolonization of seagrass beds. The picture of December 2018 was lacking due to night-dawn survey time.

- 3.6.45 In December 2014, all the seagrass patches of *Halophila ovalis* disappeared in ST. **Figure 3.12 of Appendix O** shows the difference of the original seagrass beds area nearby the mangrove vegetation at high tidal level between June 2014 and December 2014. Such rapid loss would not be seasonal phenomenon because the seagrass beds at higher tidal level (2.0 m above C.D.) were present and normal in December 2012 and 2013. According to Fong (1998), similar incident had occurred in ST in the past. The original seagrass area had declined significantly during the commencement of the construction and reclamation works for the international airport at Chek Lap Kok in 1992. The seagrass almost disappeared in 1995 and recovered gradually after the completion of reclamation works. Moreover, incident of rapid loss of seagrass area was also recorded in another intertidal mudflat in Lai Chi Wo in 1998 with unknown reason. Hence, *Halophila ovalis* was regarded as a short-lived and r-strategy seagrass that could colonize areas in short period but disappears quickly under unfavourable conditions (Fong, 1998).

- 3.6.50 **Figure 3.12 of Appendix O** shows the recolonization of seagrass bed in ST from December 2014 to June 2017. From March to June 2015, 2 - 3 small patches of *Halophila ovalis* were newly found co-inhabiting with another seagrass species *Zostera japonica*. But the total patch area of *Halophila ovalis* was still very low compare with previous records. The recolonization rate was low while cold weather and insufficient sunlight were possible factors between December 2014 and March 2015. Moreover, it would need to compete with seagrass *Zostera japonica* for substratum and nutrient, because *Zostera japonica* had extended and covered the original seagrass bed of *Halophila ovalis* at certain degree. From June 2015 to March 2016, the total seagrass area of *Halophila ovalis* had increased rapidly from 6.8 m² to 230.63 m². It had recolonized its original patch locations and covered its competitor *Zostera japonica*. In June 2016, the total seagrass area increased sharply to 4707.3m². Similar to the previous records of March to June 2014, the original patch area of *Halophila ovalis* increased further to a horizontally long strand. Another large seagrass beds colonized the lower tidal zone (1.0 - 1.5 m above C.D.). In September 2016, this patch extended much and covered significant soft mud area of ST, resulting in sharp increase of total area (24245 m²). It indicated the second extensive colonization of this r-selected seagrass. In December 2016, this extensive seagrass patch decreased in size and had separated into few, undistinguishable patches. Moreover, the horizontal strand nearby the mangrove vegetation decreased in size. The total seagrass bed decreased to 12550 m². From March to June 2017, the seagrass bed area remained generally stable (12438 - 17046.5 m²) but the vegetation coverage fluctuated (20 - 50% in March 2017 to 80-100% in June 2017). The whole recolonization process took about 2.5 years.

- 3.6.51 In September 2017, the whole seagrass bed of *Halophila ovalis* disappeared again along the shore of TC3 and ST (**Figure 3.12 of Appendix O**). Similar to the first disappearance of seagrass bed occurred between September and December 2014, strong water current (e.g. cyclone) or deteriorated water qualities (e.g. high turbidity) was the possible cause.

- 3.6.54 Overall, the disappearance of seagrass beds in ST has believed the cause of serial cyclone hit in July and August 2017. Based on previous findings, the seagrass beds of both species were expected to recolonize in the mudflat as long as the vicinal water quality was normal. The whole recolonization process (from few, small patches to extensive strand) would be gradually lasting at least 2 years. From December 2017 to March 2018, there was still no recolonization of few, small patches of seagrass at the usual location (**Figure 3.12 of Appendix O**). It was different from the previous round (March 2015 - June 2017). Until June 2018, the new seagrass patches with small-medium size were found at the usual location (seaward side of mangrove plantation at 2.0 m C.D.) again, indicating the recolonization. However, the seagrass bed area decreased sharply to 22.5 m² in September 2018. Again, it was believed that the decrease was due to the hit of the super cyclone in September 2018 (Mangkhuton 16th September, highest signal 10). From December 2018 to June 2019, the seagrass bed area increased from 404 m² to 1229 m² while the vegetation coverage is also increased. (December 2018: 5 – 85%; March 2019: 50 – 100% and June 2019: 60 – 100%). Relatively, the whole recolonization process would occur slower than the previous round (more than 2 years). From September 2019 to March 2020 (present survey), the seagrass bed area slightly decreased from 1200 m² to 1032 m² which were in normal fluctuation.

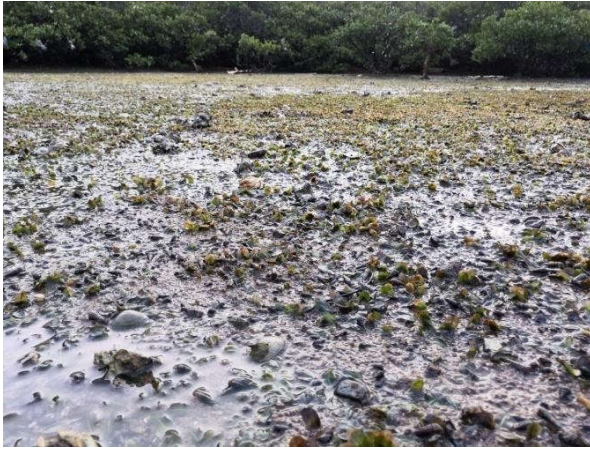
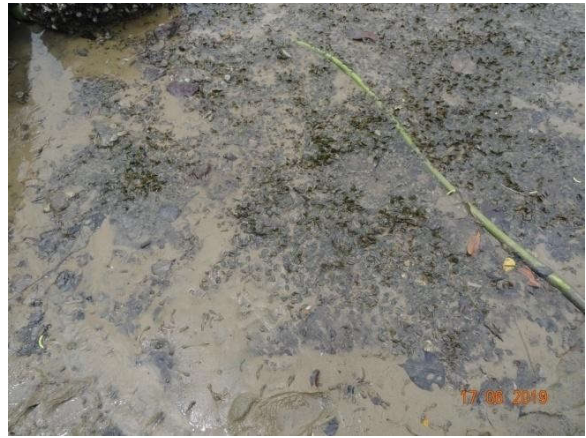
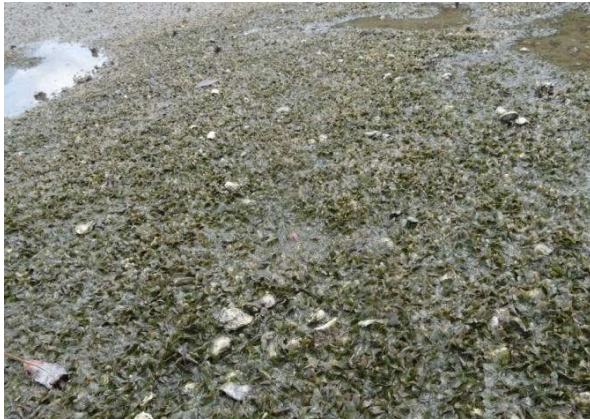
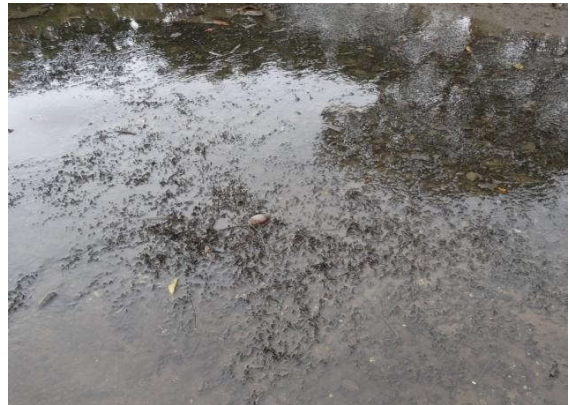
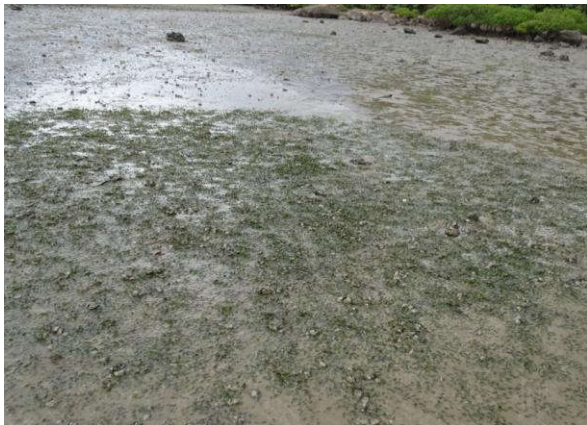
March 2019

June 2019

September 2019

December 2019

March 2020

Figure 3.12 (Cont'd) Comparison of pictures taken in different sampling months shows the successive disappearance and recolonization of seagrass beds. The picture of December 2018 was lacking due to night-dawn survey time.

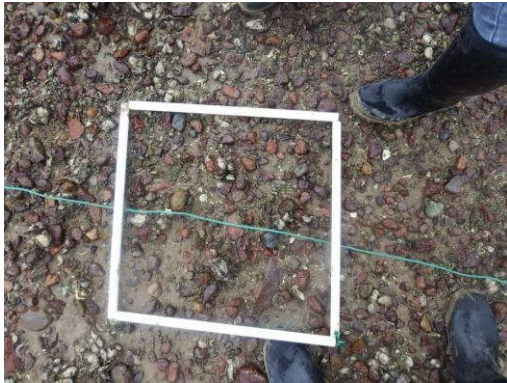
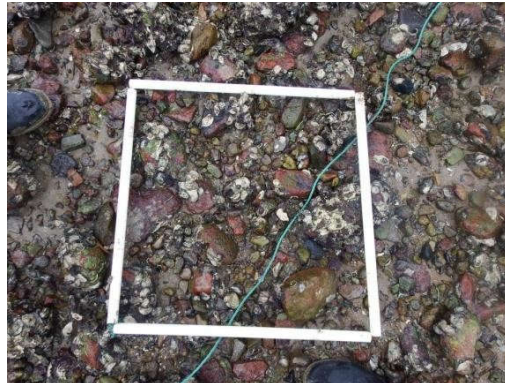
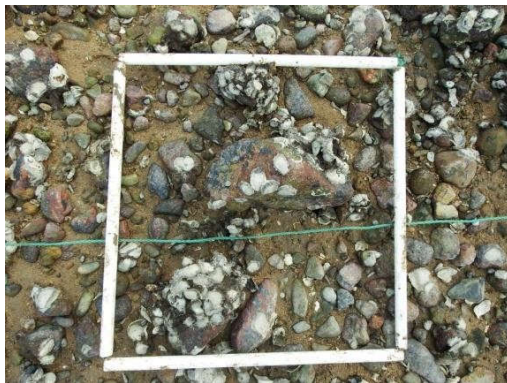
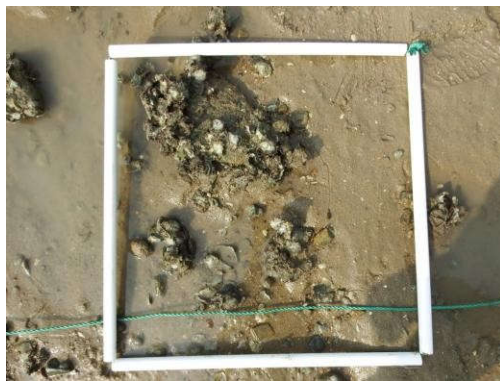
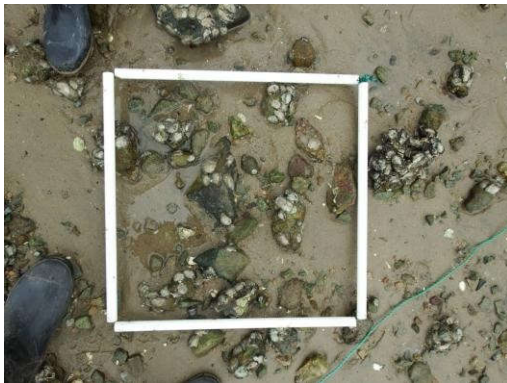
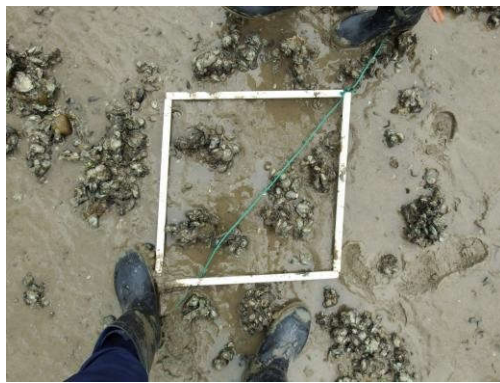
Figure 3.13 *Examples of photographic records of quadrat for intertidal soft shore community survey (H: 2.0 m above C.D.; M: 1.5 m above C.D.; L: 1.0 m above C.D.)*

- 3.6.56 **Table 3.3 and Figure 3.13 of Appendix O** show the substratum types along the horizontal transect at every tidal level in all sampling zones. The relative distribution of substratum types was estimated by categorizing the substratum types (Gravels & Boulders / Sands / Soft mud) of the ten random quadrats along the horizontal transect. The distribution of substratum types varied among tidal levels and sampling zones:

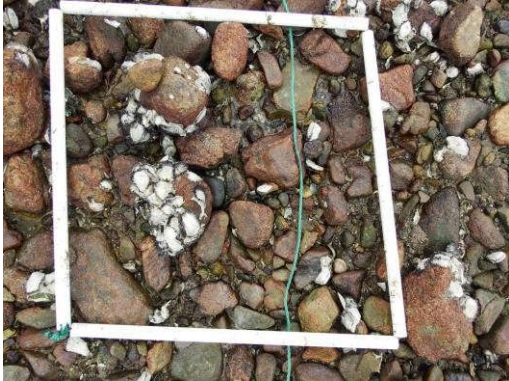
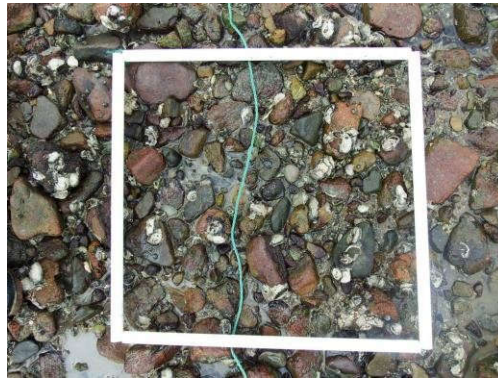
Figure 3.13.(Cont'd) *Examples of photographic records of quadrat for intertidal soft shore community survey (H: 2.0 m above C.D.; M: 1.5 m above C.D.; L: 1.0 m above C.D.)*

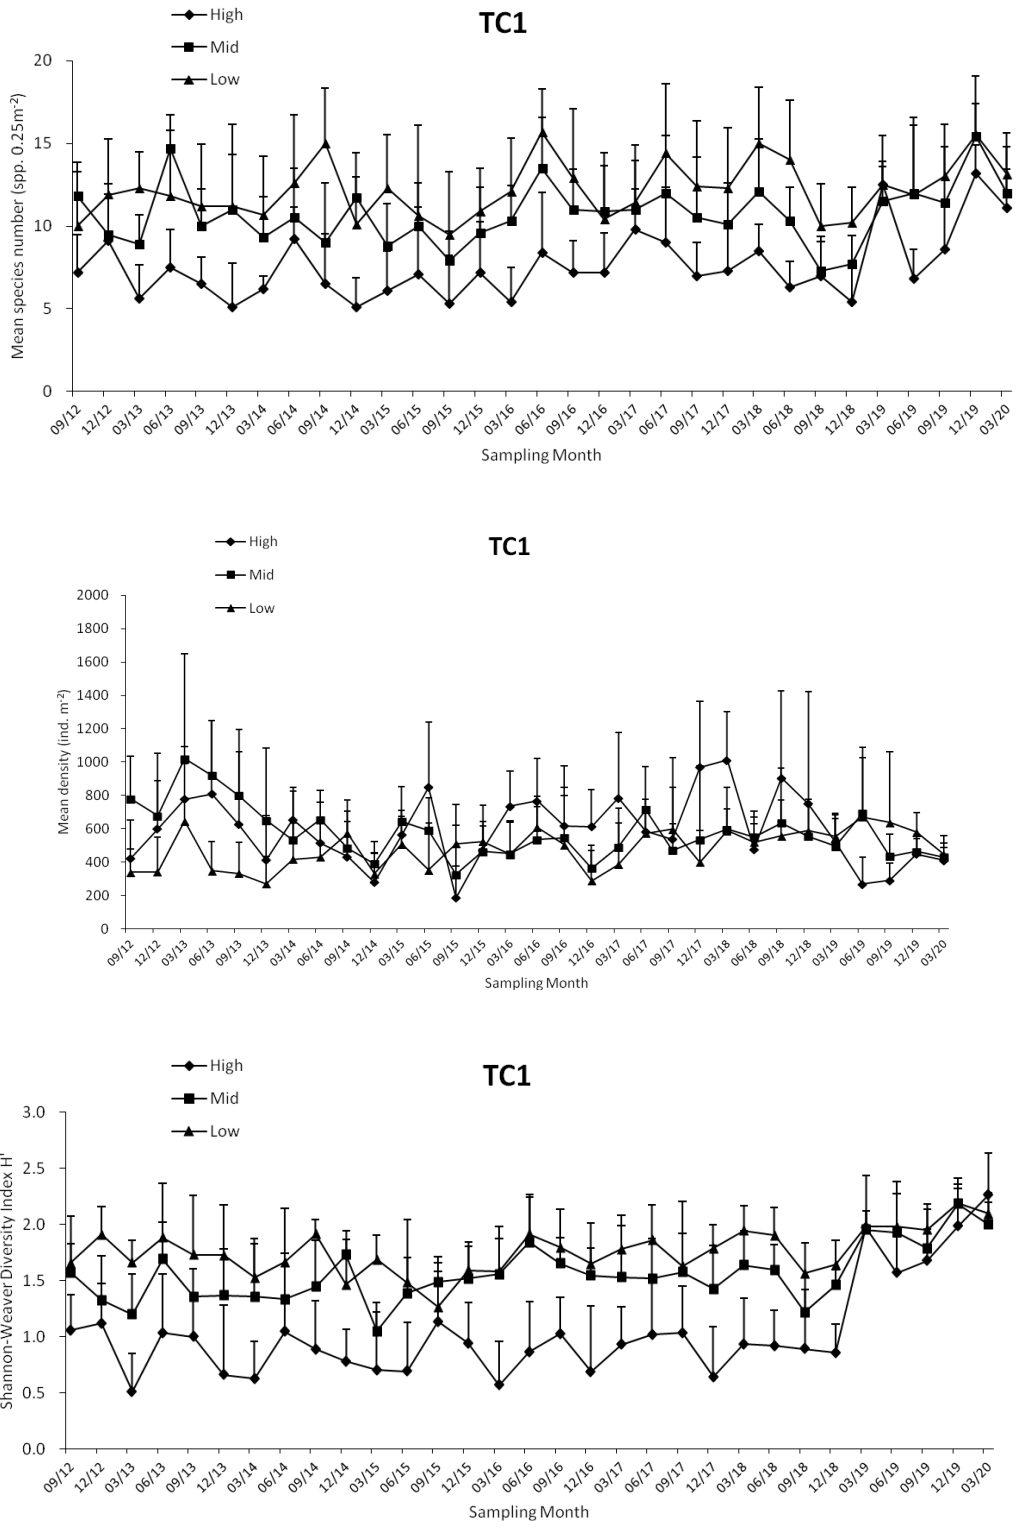
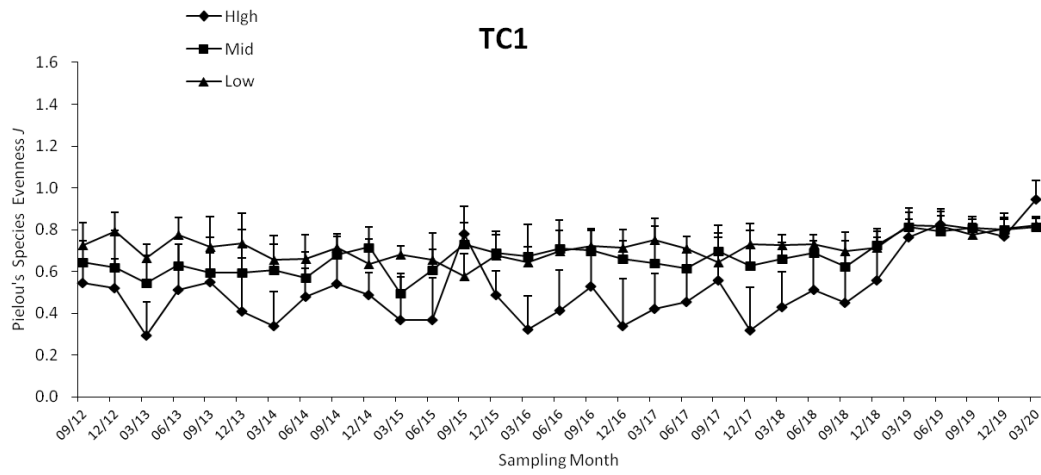
Figure 3.14 Temporal changes of mean number of species, mean density, Shannon-Weaver Diversity Index (H') and Pielou's Species Evenness (J) (mean + SD) at every tidal level in sampling zone TC1

Figure 3.14(Cont'd) Temporal changes of mean number of species, mean density, Shannon-Weaver Diversity Index (H') and Pielou's Species Evenness (J) (mean + SD) at every tidal level in sampling zone TC1

- 3.6.69 In the present survey, no clear trend of mean species number, mean density, H' and J observed among the tidal level.
- 3.6.70 **Figures 3.14 to 3.17 of Appendix O** show the temporal changes of mean species number, mean density, H' and J at every tidal level and in every sampling zone along the sampling months. In general, all the biological parameters fluctuated seasonally throughout the monitoring period. Lower mean species number and density were recorded in dry season (December) but the mean H' and J fluctuated within a limited range.

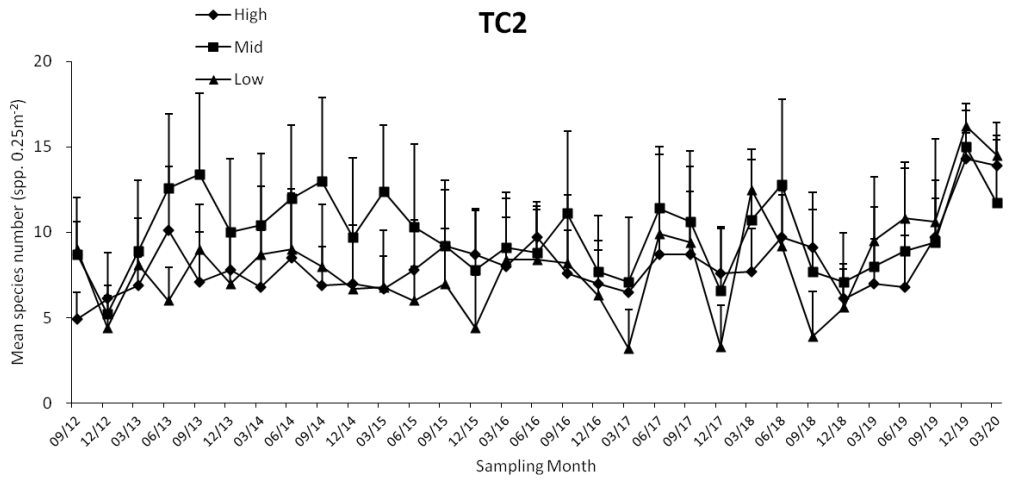
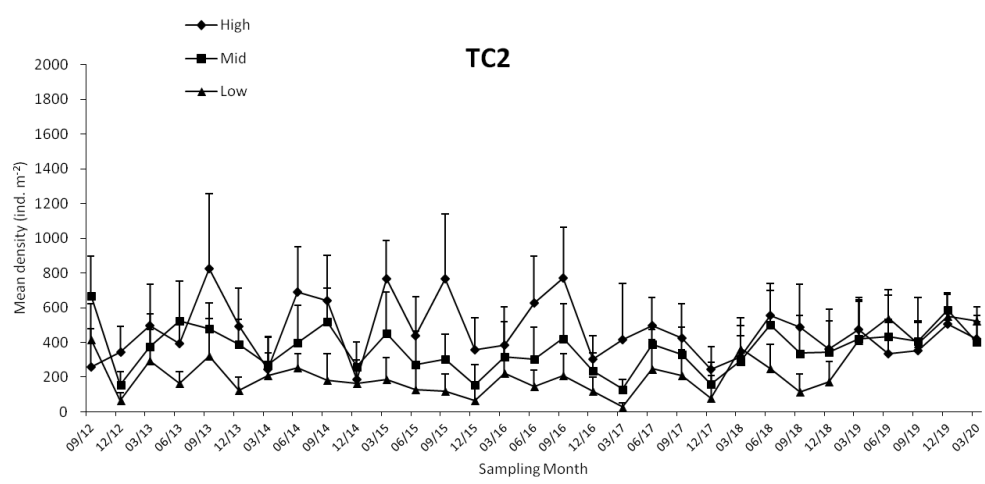
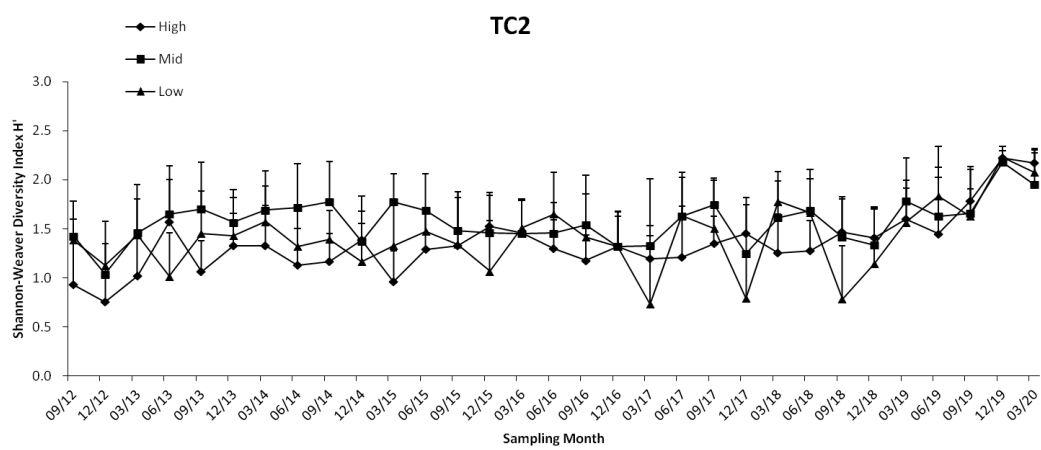
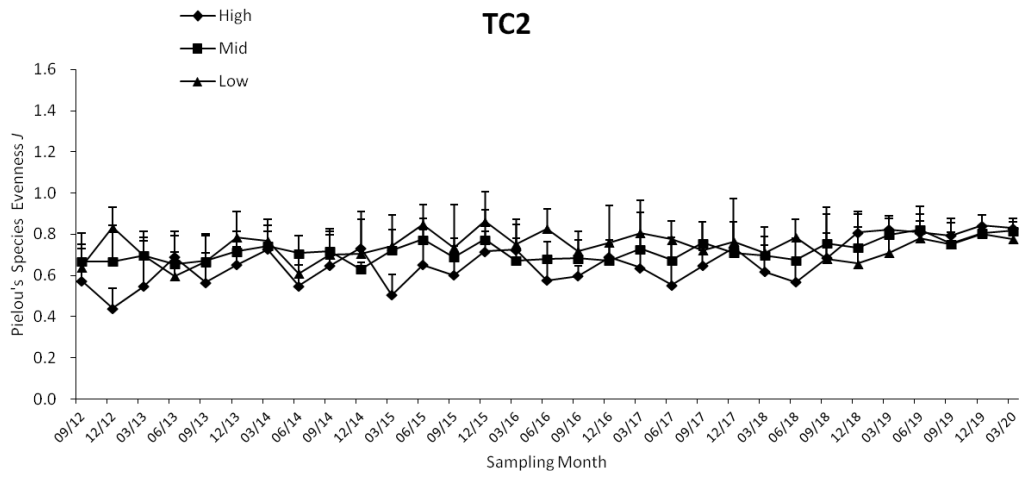
Figure 3.15 Temporal changes of mean number of species, mean density, Shannon-Weaver Diversity Index (H') and Pielou's Species Evenness (J) (mean + SD) at every tidal level in sampling zone TC2

Figure3.15(Cont'd) Temporal changes of mean number of species, mean density, Shannon-Weaver Diversity Index (H') and Pielou's Species Evenness (J) (mean + SD) at every tidal level in sampling zone TC2

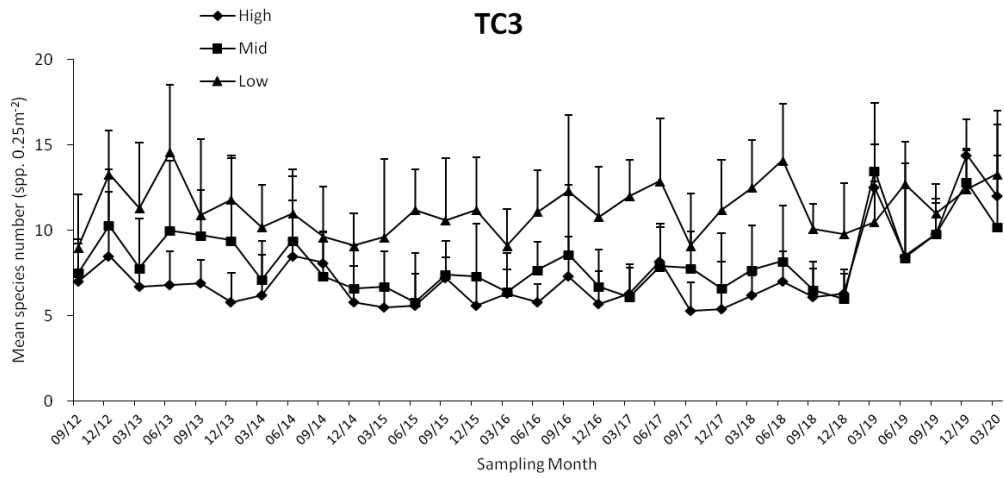
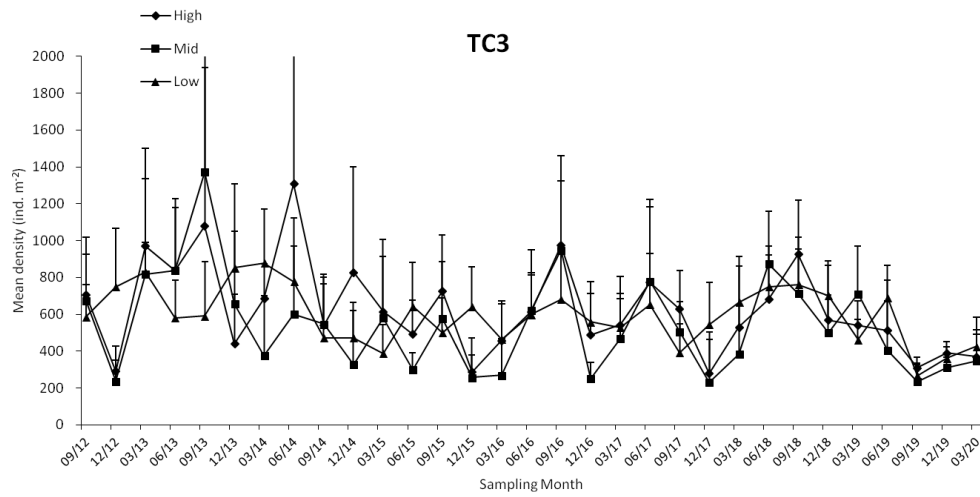
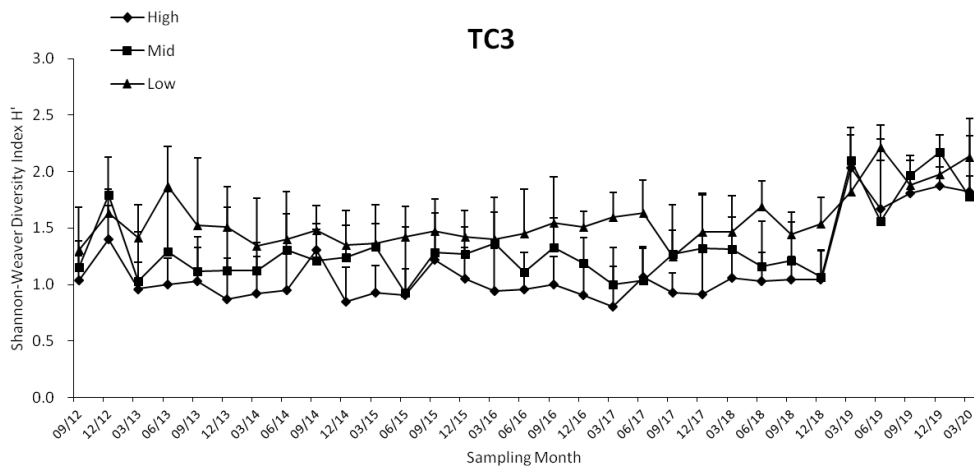
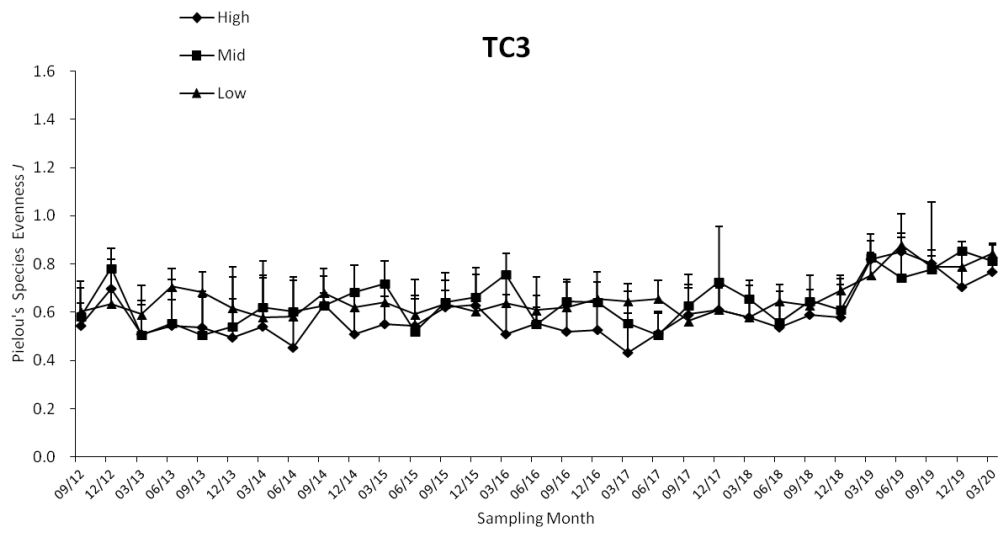
Figure 3.16 Temporal changes of mean number of species, mean density, Shannon-Weaver Diversity Index (H') and Pielou's Species Evenness (J) (mean + SD) at every tidal level in sampling zone TC3

Figure 3.16(Cont'd) Temporal changes of mean number of species, mean density, Shannon-Weaver Diversity Index (H') and Pielou's Species Evenness (J) (mean + SD) at every tidal level in sampling zone TC3

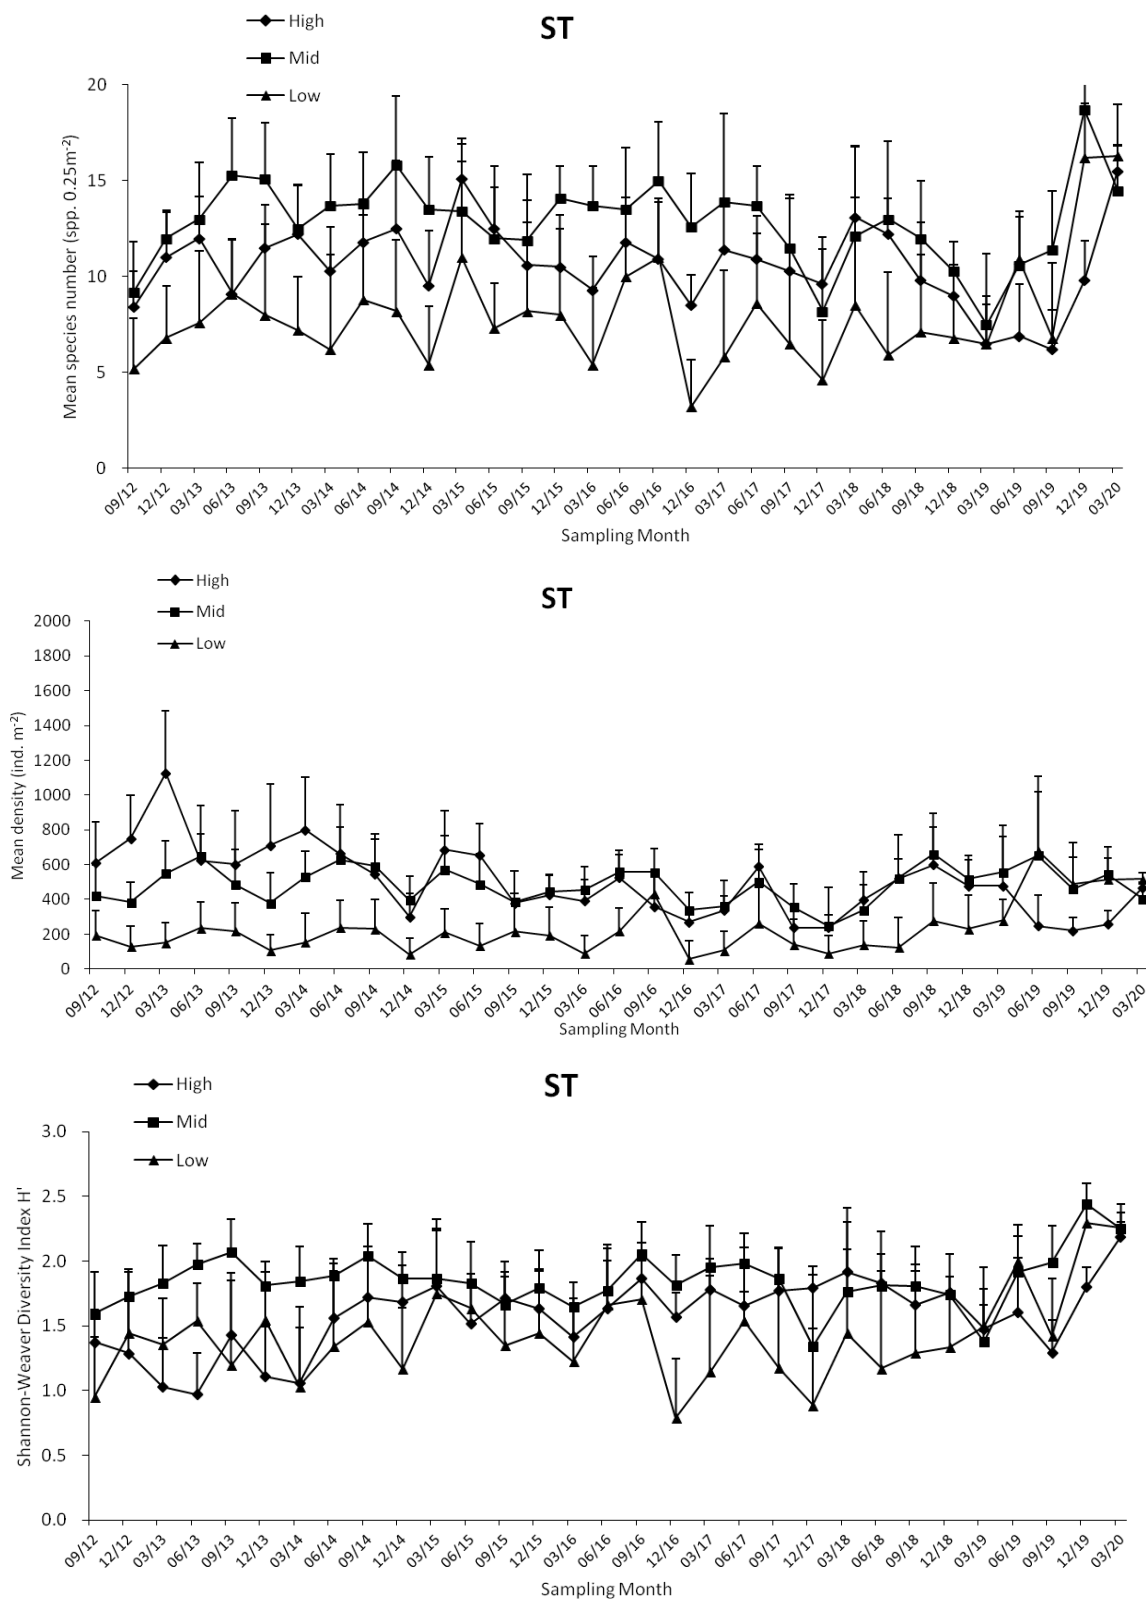
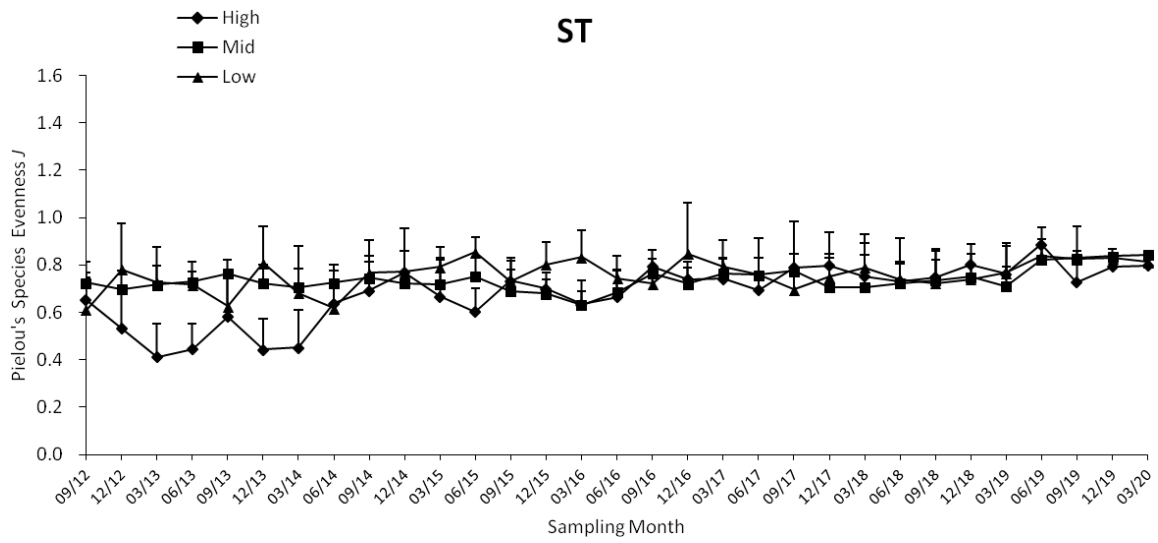
Figure 3.17 Temporal changes of mean number of species, mean density, Shannon-Weaver Diversity Index (H') and Pielou's Species Evenness (J) (mean + SD) at every tidal level in sampling zone S

Figure 3.17(Cont'd) Temporal changes of mean number of species, mean density, Shannon-Weaver Diversity Index (H') and Pielou's Species Evenness (J) (mean + SD) at every tidal level in sampling zone ST
