Contract No. HY/2011/03

**Hong Kong-Zhuhai-Macao Bridge Hong Kong Link Road
Section between Scenic Hill and Hong Kong Boundary Crossing
Facilities**

Quarterly EM&A Report No. 32 (June 2020 to August 2020)

28 September 2020

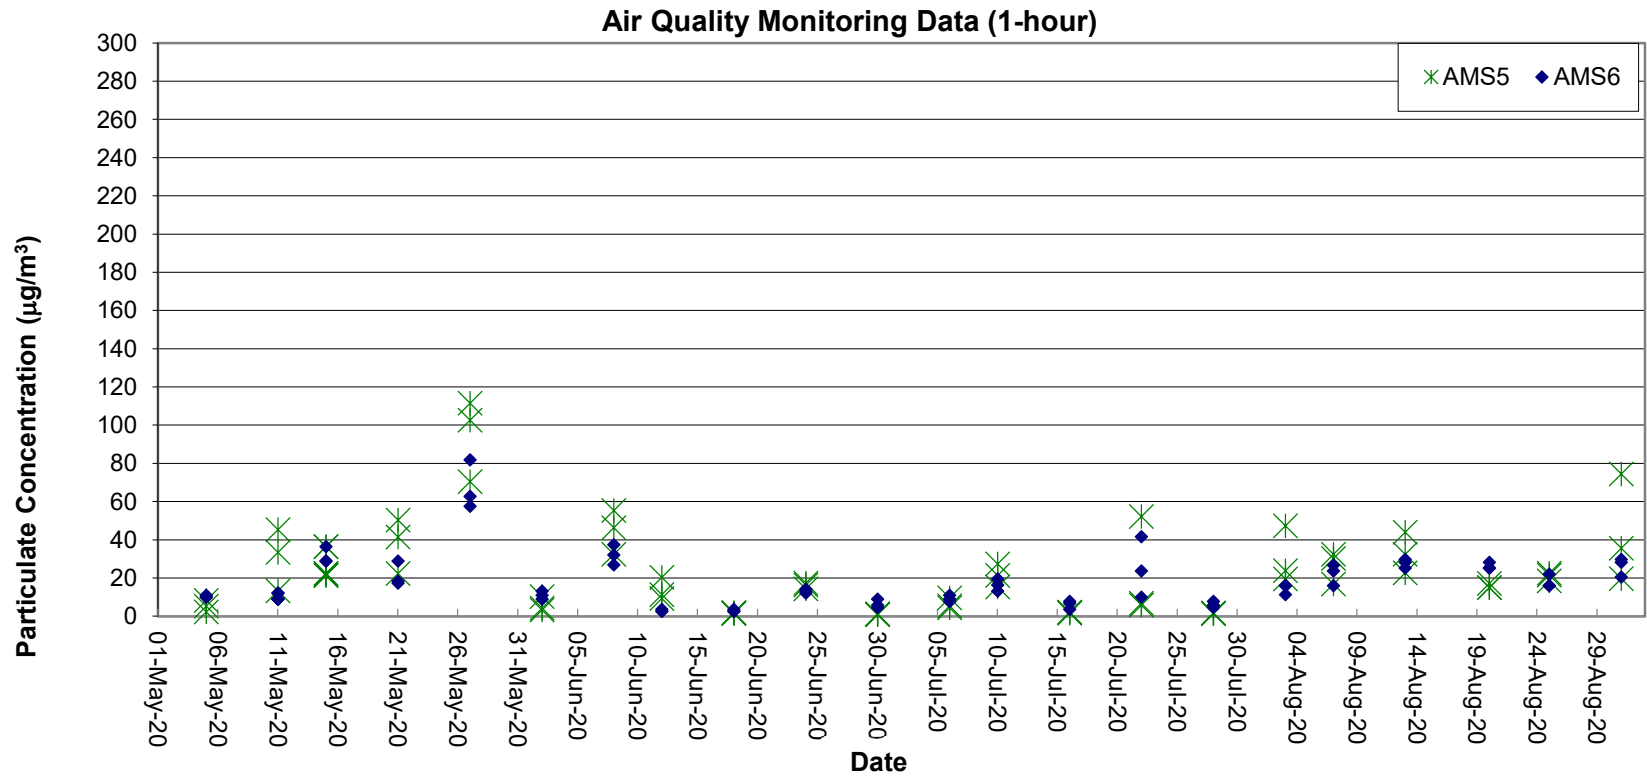
Graphical Plot of 1-hour TSP at AMS5 and AMS6

1) Due to adverse weather condition on 19 August 2020 (Tropical Cyclone Warning Signal No.3 or above was hoisted by HKO), 1-hr TSP monitoring at AMS5 - Ma Wan Chung Village and AMS6 - Dragonair / CNAC (Group) Building (HKIA) on 19 August 2020 were rescheduled to 20 August 2020.

Due to adverse weather condition on 19 August 2020 (Tropical Cyclone Warning Signal No.3 or above was hoisted by HKO), 1-hr TSP monitoring at AMS5 - Ma Wan Chung Village and AMS6 - Dragonair / CNAC (Group) Building (HKIA) and noise monitoring at NMS5 - Ma Wan Chung Village were rescheduled to 20 August 2020.

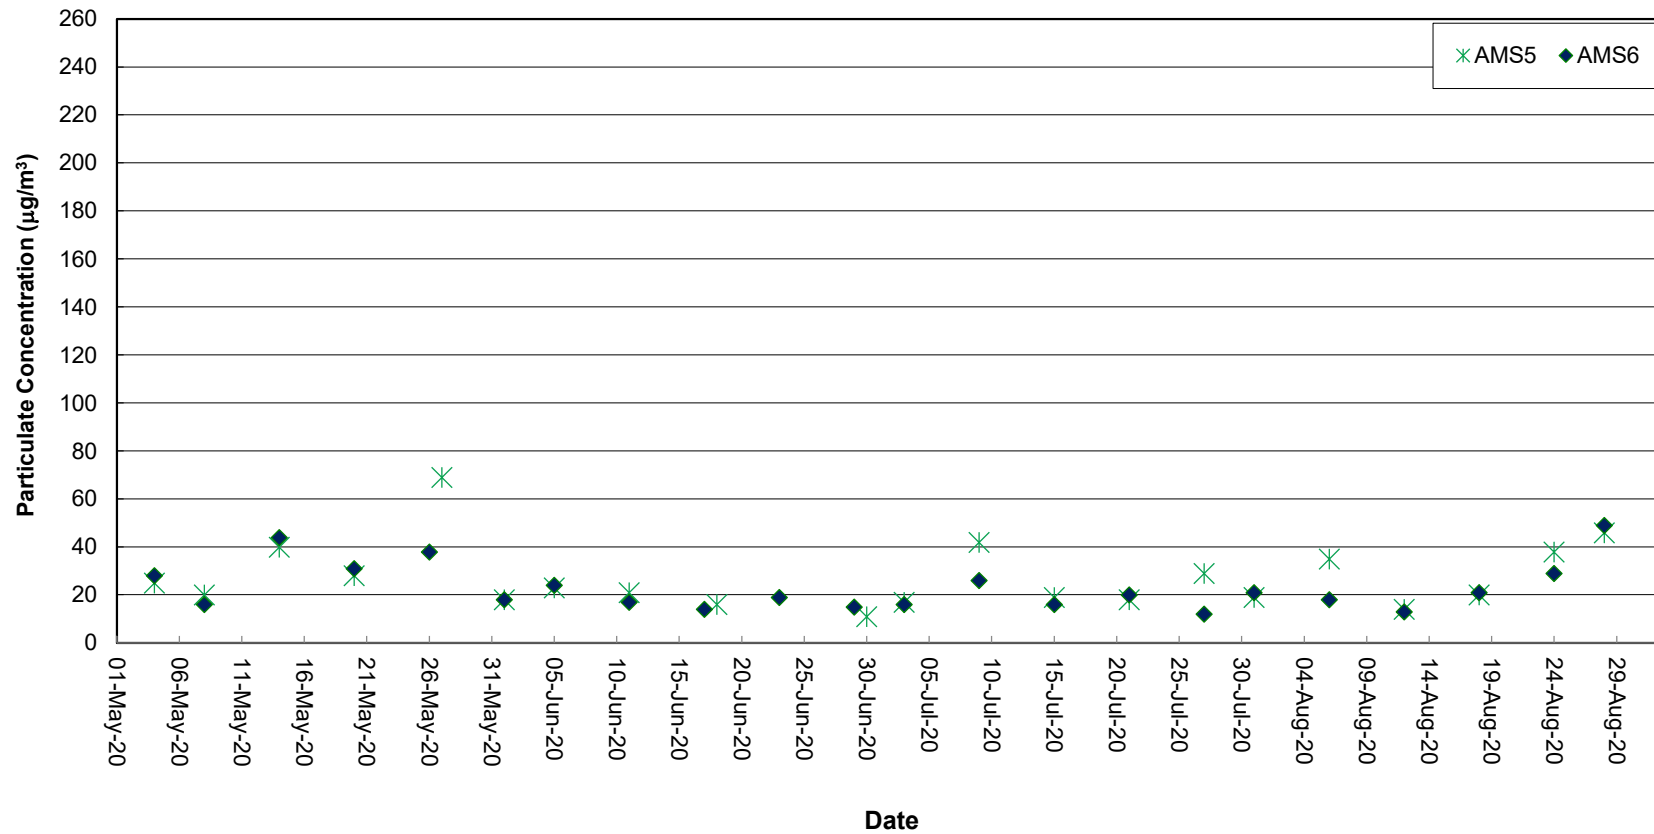
Graphical Plot of 24-hour TSP at AMS5 and AMS6

- 1) Due to power failure, 24-hr TSP monitoring on 26 May 2020 at AMS5 (Ma Wan Chung Village) was rescheduled to 27 May 2020.
- 2) Due to power failure, 24-hr TSP monitoring on 17 June 2020 at AMS5 was rescheduled to 18 June 2020.
- 3) Due to malfunction of HVS at AMS5, the 24-hr TSP monitoring on 23 June 2020 was cancelled. Competent person repaired the HVS on 30 June 2020. The 24-hr TSP monitoring on 29 June 2020 at AMS5 was rescheduled to 30 June 2020.

Due to power failure, 24-hr TSP monitoring on 17 June 2020 at AMS5 was rescheduled to 18 June 2020.

Due to malfunction of high volume sampler (HVS) at AMS5, the 24-hr TSP monitoring on 23 June 2020 was cancelled. Competent person repaired the HVS on 30 June 2020. The 24-hr TSP monitoring on 29 June 2020 at AMS5 was rescheduled to 30 June 2020.

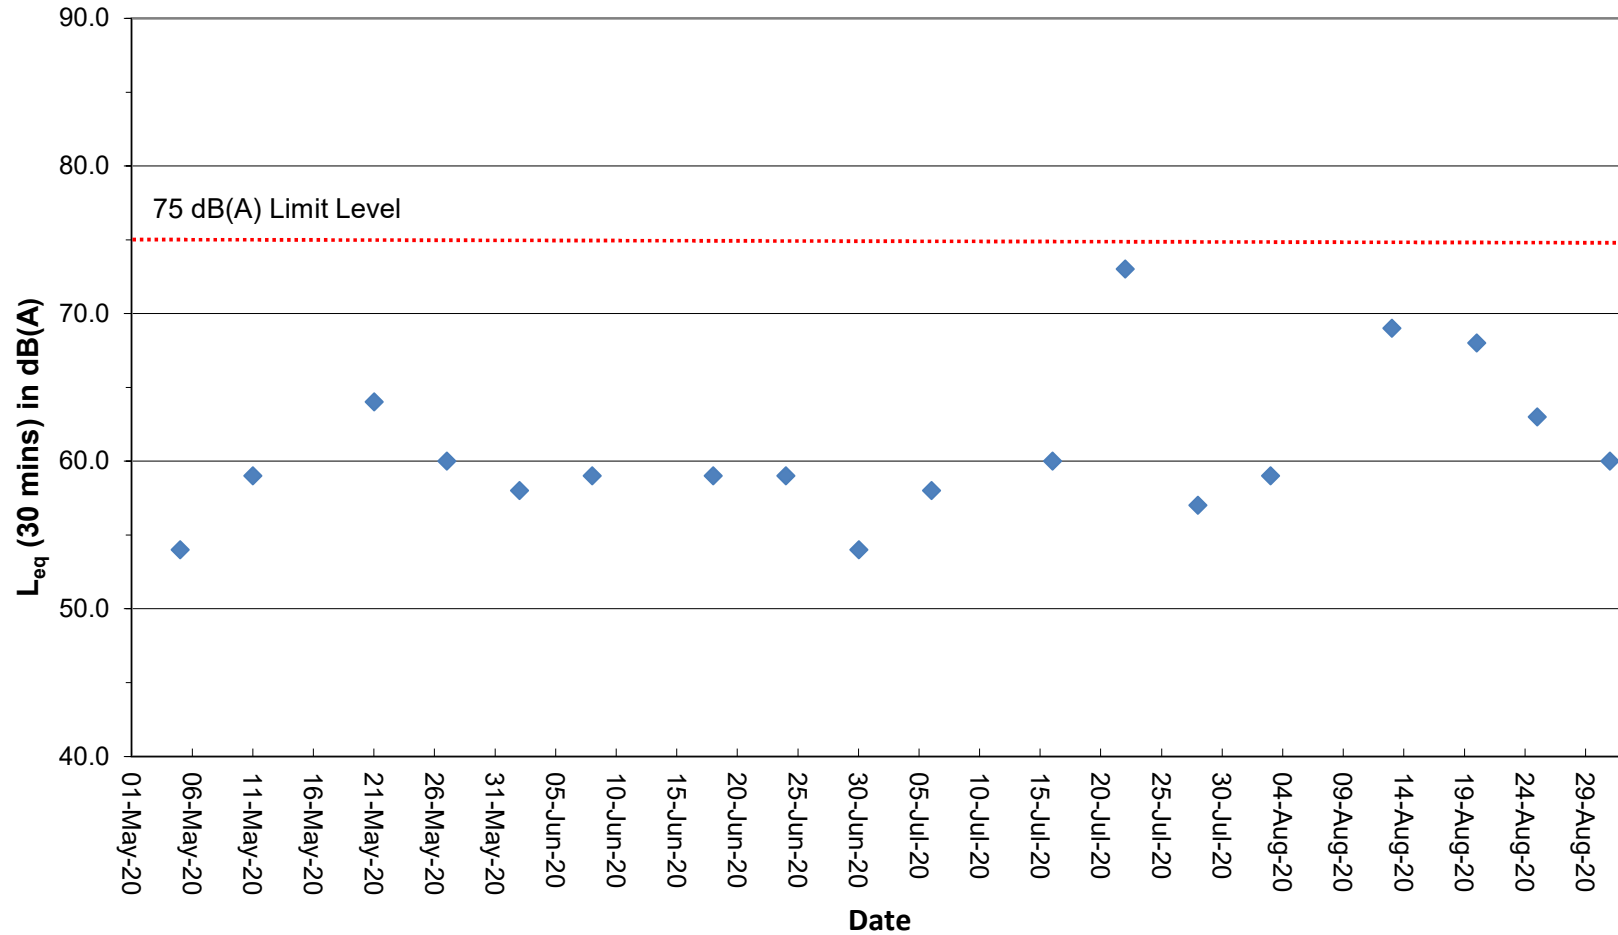
Graphical Plot of Noise Levels at NMS5

- (1) A facade correction of +3 dB(A) was applied to the measured noise level.
- (2) Due to adverse weather condition on 19 August 2020 (Tropical Cyclone Warning Signal No.3 or above was hoisted by HKO), noise monitoring at NMS5 - Ma Wan Chung Village was rescheduled to 20 August 2020.

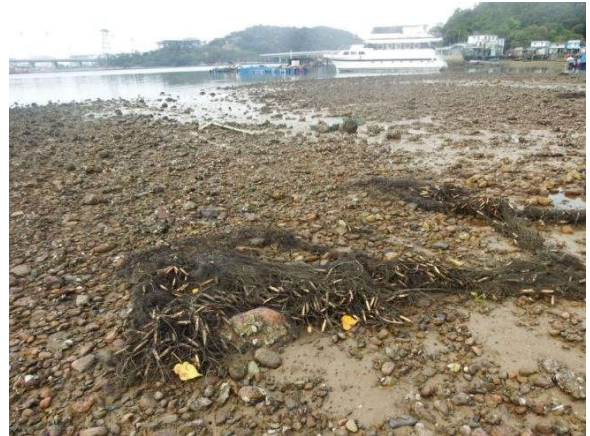
Figure 2.3 *Examples of photographic record of the big trashes found on the mudflat.*

Plastic waste

Trash gill net

Trash gill net and hand trolley

A tangled horseshoe crab on a trash net
(record in June 2017)

- 3.6.7 Since the field survey of June 2016, increasing number of trashes and even big trashes (**Figure 2.3 of Appendix O**) were found in every sampling zone. It raised a concern about the solid waste dumping and current-driven waste issues in Tung Chung Wan. Respective measures (e.g. manual clean-up) should be implemented by responsible governmental agency units.

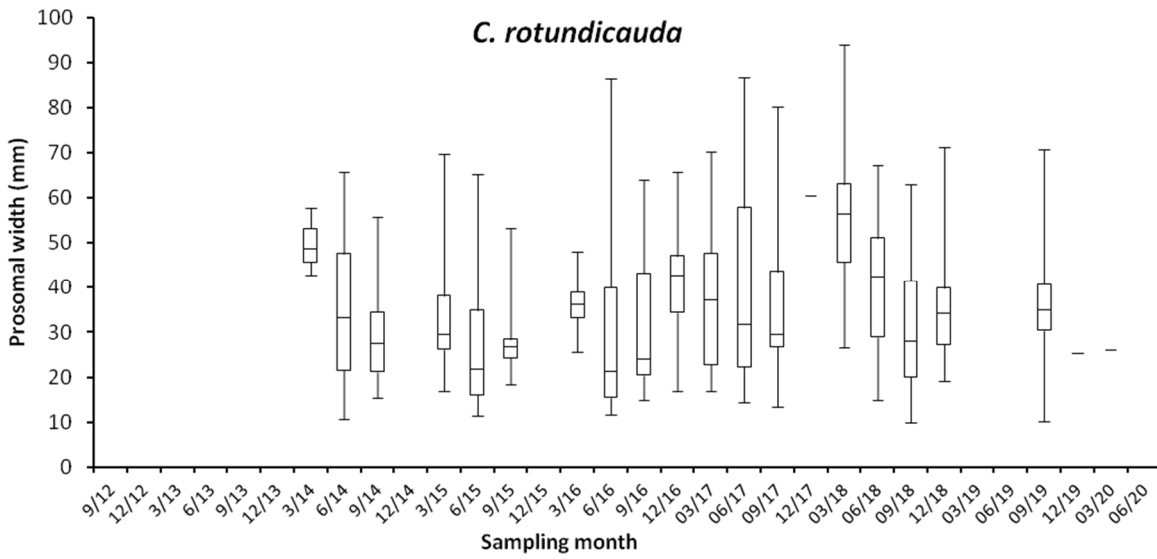
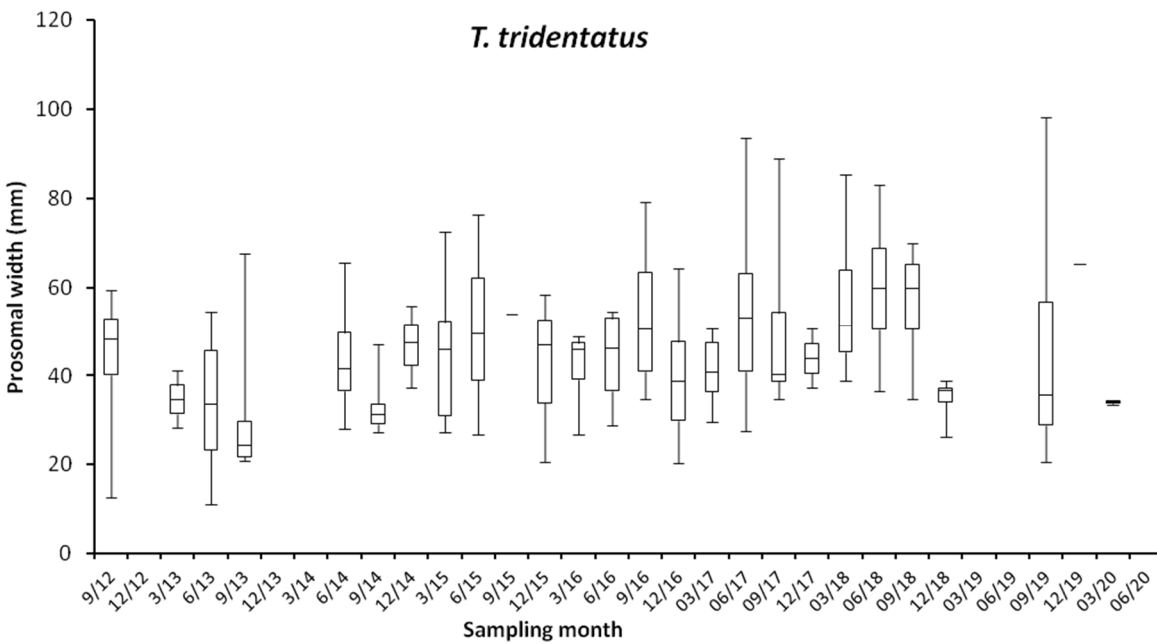
Figure 3.7 Box plot of prosomal width of horseshoe crab in the sampling zone TC3 along the sampling months. (The box represents 50% of the sample (upper to lower quartile) with a middle line showing the median value. The upper whisker and lower whisker showed the 25% of sample above upper quartile and below the lower quartile respectively)

3.6.33 **Figure 3.7 of Appendix O** shows the changes of prosomal width of *Carcinoscorpius rotundicauda* and *Tachypleus tridentatus* in TC3. As mentioned above, *Carcinoscorpius rotundicauda* was rarely found between September 2012 and December 2013 hence the data were lacking. In March 2014, the major size (50% of individual records between upper (top box) and lower quartile (bottom box)) ranged 40 – 60 mm while only few individuals were found. From March 2014 to September 2018, the median prosomal width (middle line of whole box) and major size (whole box) decreased after March of every year. It was due to more small individuals found in June indicating new rounds of spawning. Also, there were slight increasing trends of body size from June to March of next year since 2015. It indicated a stable growth of individuals. Focused on larger juveniles (upper whisker), the size range was quite variable (prosomal width 60 – 90 mm) along the sampling months. Juveniles reaching this size might gradually migrate to sub-tidal habitats.

3.6.34 For *Tachypleus tridentatus*, the major size ranged 20-50 mm while the number of individuals fluctuated from September 2012 to June 2014. Then a slight but consistent growing trend was observed from September 2014 to June 2015. The prosomal width increased from 25 – 35 mm to 35 – 65 mm. As mentioned, the large individuals might have reached a suitable size for migrating from the nursery soft shore to subtidal habitat. It accounted for the declined population in TC3. From March to September 2016, slight increasing trend of major size was noticed again. From December 2016 to June 2017, similar increasing trend of major size was noted with much higher number of individuals. It reflected new round of spawning. In September 2017, the major size decreased while the trend was different from previous two years. Such decline might be the cause of serial cyclone hit between June and September 2017 (to be discussed in the 'Seagrass survey' section). From December 2017 to September 2018, increasing trend was

noted again. It indicated a stable growth of individuals. From September 2018 to that of next year, the average prosomal widths were decreased from 60mm to 36mm. It indicated new rounds of spawning occurred during September to November 2018. In December 2019, an individual with larger body size (prosomal width 65mm) was found in TC3 which reflected the stable growth of individuals. In March 2020, the average prosomal width (middle line of the whole box) of *Tachypleus tridentatus* in TC3 was 33.97 mm which is smaller than that in December 2019. It was in normal fluctuation. In June 2020 (present survey), no horseshoe crab was recorded in TC3. Across the whole monitoring period, the larger juveniles (upper whisker) usually reached 60 – 80 mm in prosomal width, even 90 mm occasionally. The juveniles reaching this size might gradually migrate to sub-tidal habitats.

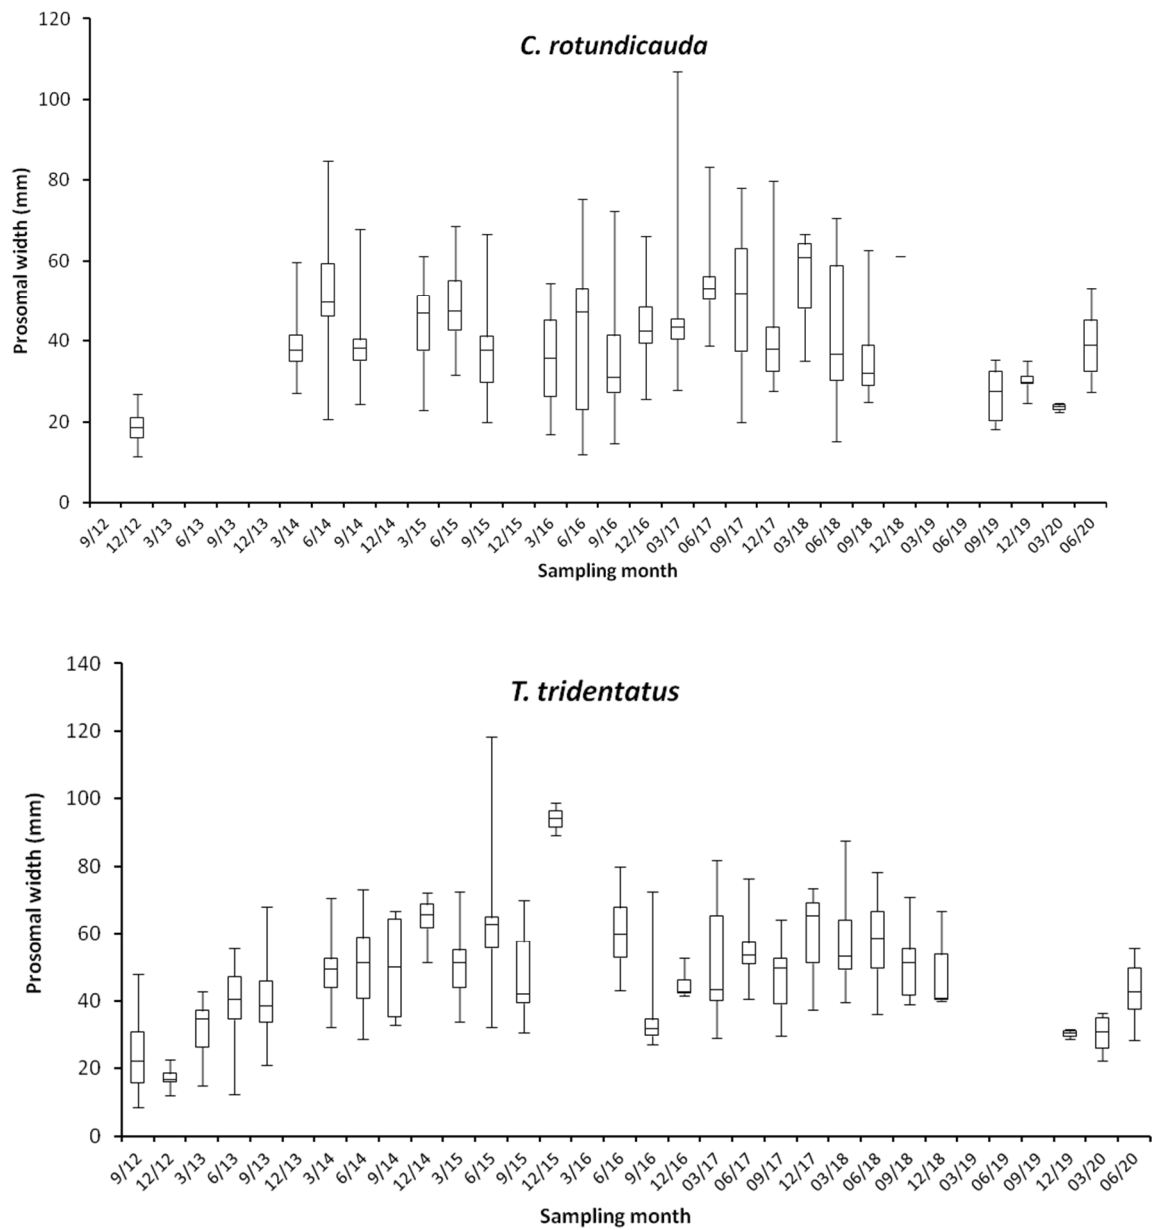
Figure 3.8 Box plot of prosomal width of horseshoe crab in the sampling zone ST along the sampling months. (The box represents 50% of the sample (upper to lower quartile) with a middle line showing the median value. The upper whisker and lower whisker showed the 25% of sample above upper quartile and below the lower quartile respectively.)

- 3.6.35 **Figure 3.8 of Appendix O** shows the changes of prosomal width of *Carcinoscorpius rotundicauda* and *Tachypleus tridentatus* in ST. As mentioned above, *Carcinoscorpius rotundicauda* was rarely found between September 2012 and December 2013 hence the data were lacking. From March 2014 to September 2018, the size of major population decreased and more small individuals (i.e. lower whisker) were recorded after June of every year. It indicated new round of spawning. Also, there were similar increasing trends of body size from September to June of next year between 2014 and 2017. It indicated a stable growth of individuals. The larger juveniles (i.e. upper whisker usually ranged 60 – 80 mm in prosomal width except one individual (prosomal width 107.04 mm) found in March 2017. It reflected juveniles reaching this size would gradually migrate to sub-tidal habitats.
