**Contract No. HY/2011/03**

**Hong Kong-Zhuhai-Macao Bridge Hong Kong Link Road  
Section between Scenic Hill and Hong Kong Boundary Crossing  
Facilities**

**Monthly EM&A Report No.99 (December 2020)**

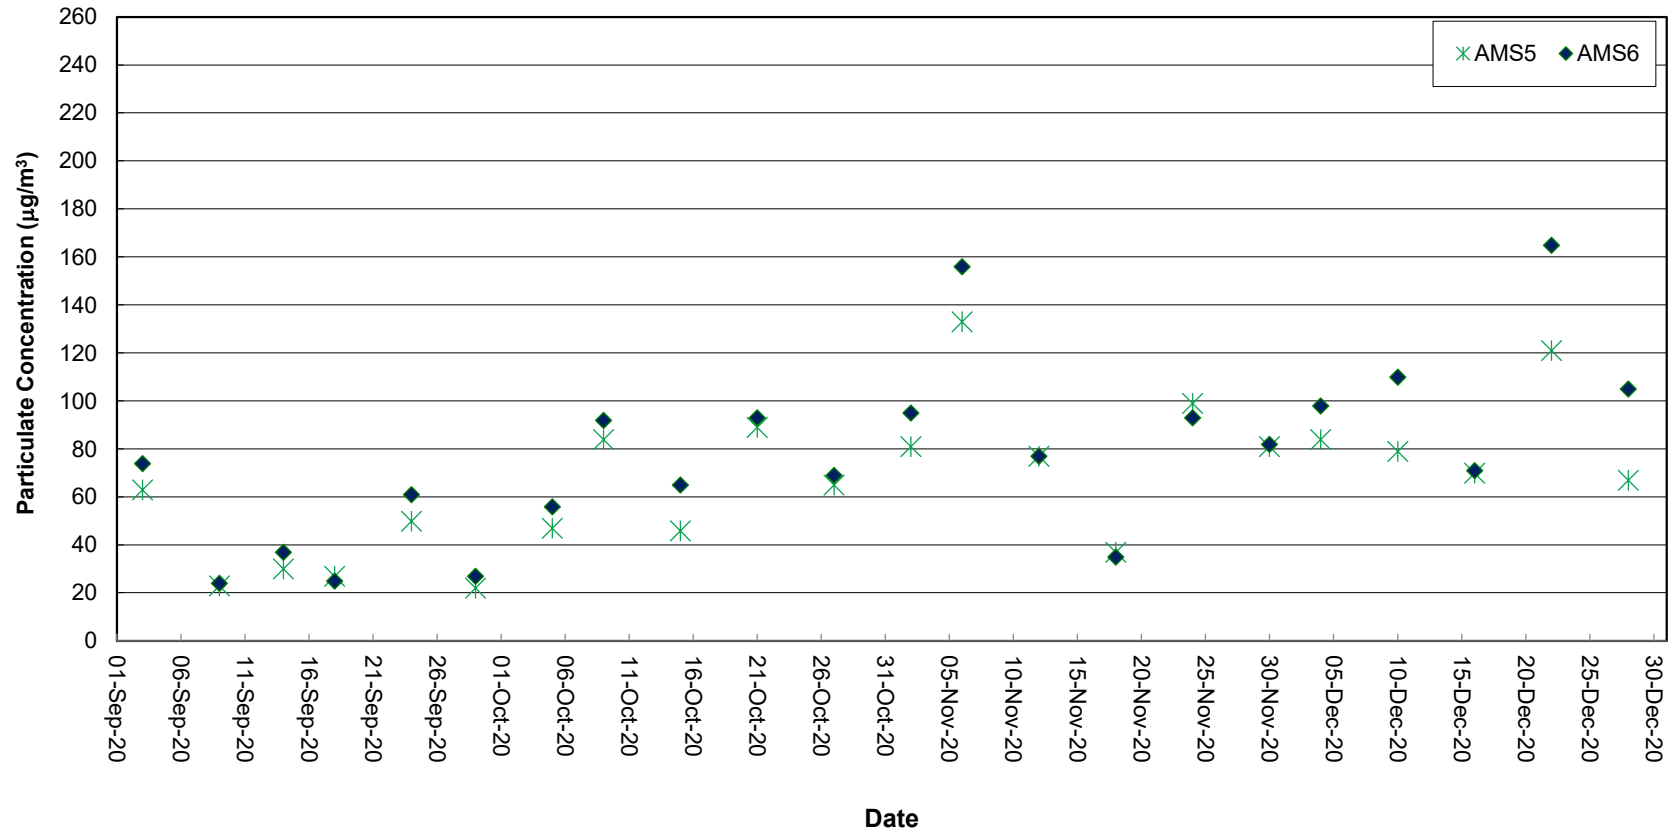
Graphical Plot of 24-hour TSP at AMS5 and AMS6

HKLR	HY/2011/03	2020-12-04	AMS6	08:00	24-hr TSP	98	µg/m <sup>3</sup>
HKLR	HY/2011/03	2020-12-10	AMS6	08:00	24-hr TSP	110	µg/m <sup>3</sup>
HKLR	HY/2011/03	2020-12-16	AMS6	08:00	24-hr TSP	71	µg/m <sup>3</sup>
HKLR	HY/2011/03	2020-12-22	AMS6	08:00	24-hr TSP	165	µg/m <sup>3</sup>
HKLR	HY/2011/03	2020-12-28	AMS6	08:00	24-hr TSP	105	µg/m <sup>3</sup>

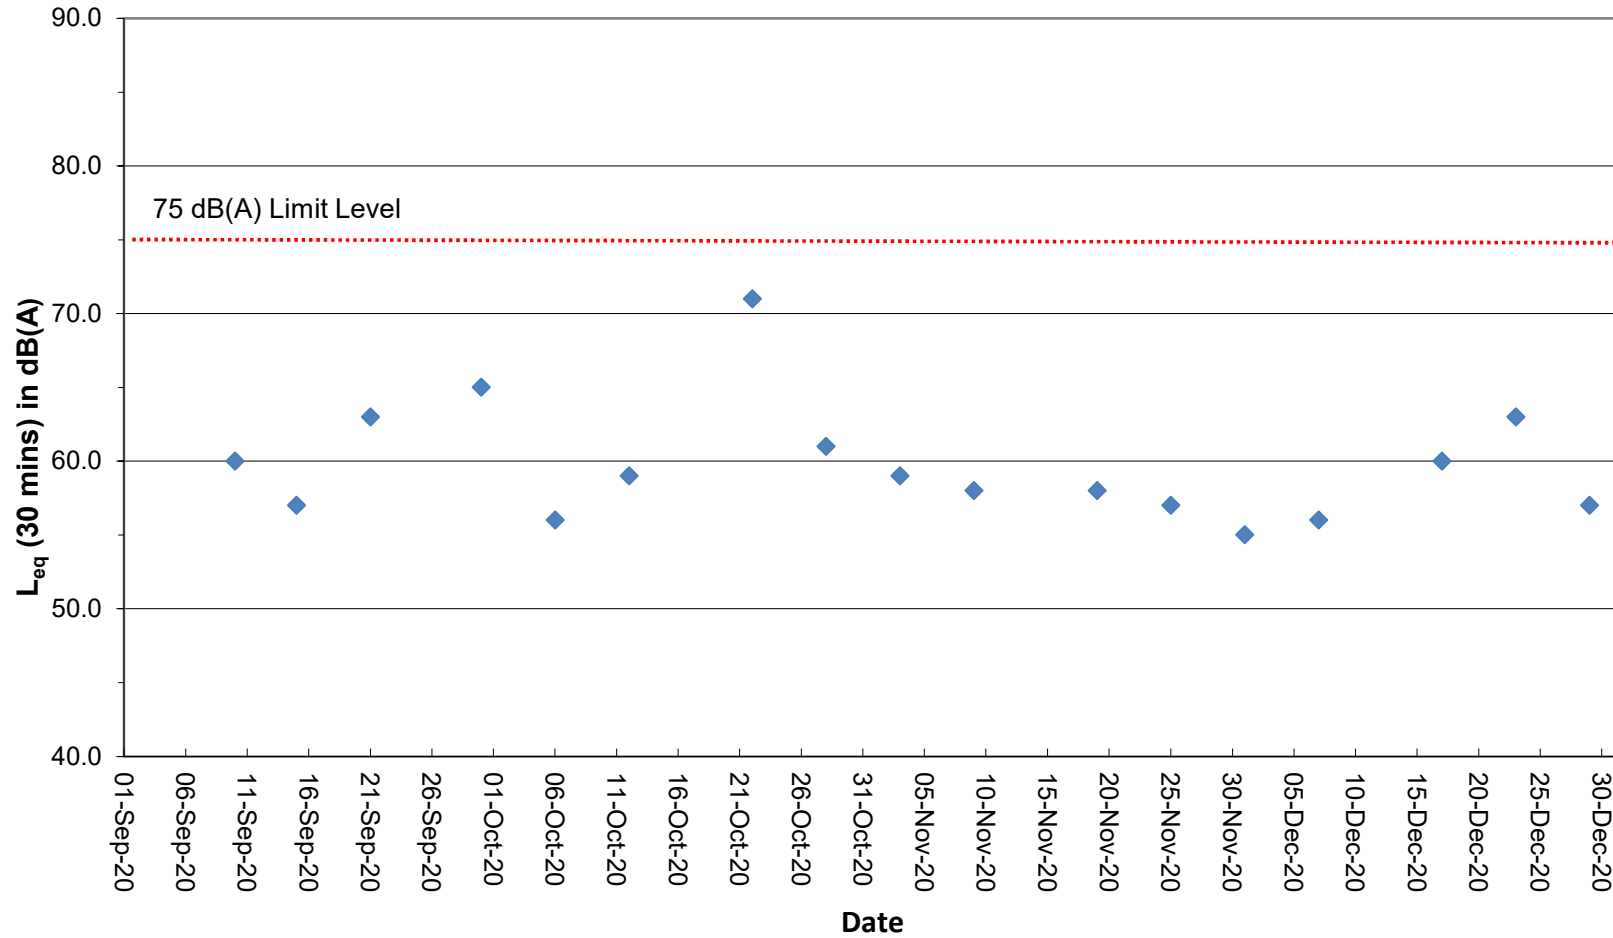
## Graphical Plot of Noise Levels at NMS5

### Continuous Noise Monitoring Data (NMS5)

(1) A facade correction of +3 dB(A) was applied to the measured noise level.

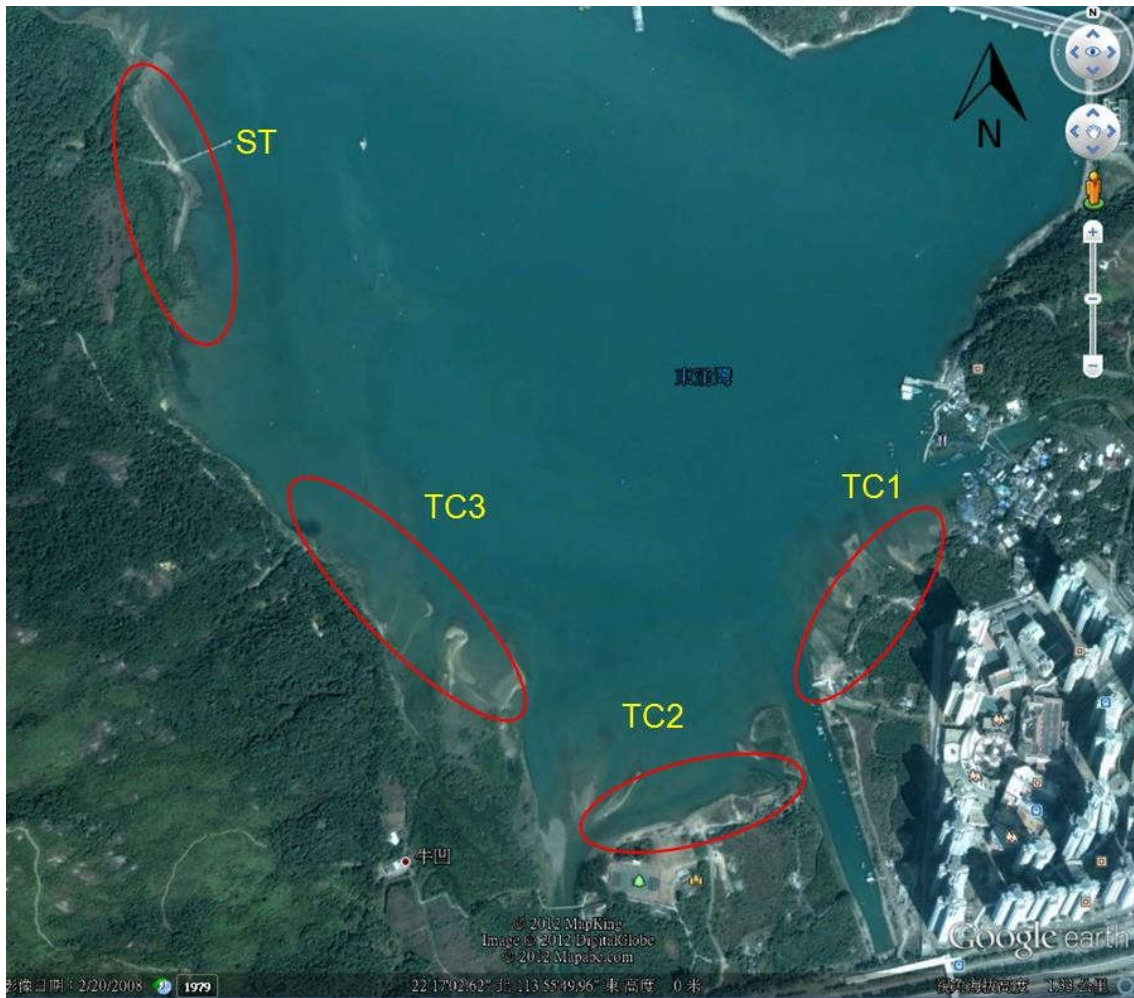
**Figure 2.1.** Locations of sampling zones. The study site was divided into three sampling zones (TC1, TC2, TC3) in Tung Chung Bay and one zone in San Tau (ST) (map generated from Google Map).

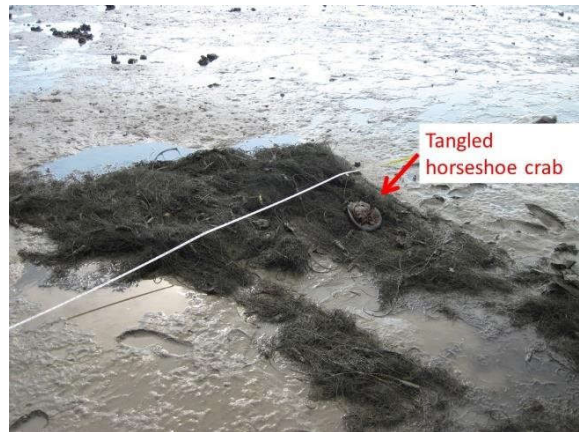
**Figure 2.3** *Examples of photographic record of the big trashes found on the mudflat.*

Trash gill net and hand trolley

A tangled horseshoe crab on a trash net  
(record in June 2017)

- 6.3.2 Since the field survey of June 2016, increasing number of trashes and even big trashes (**Figure 2.3 of Appendix I**) were found in every sampling zone. It raised a concern about the solid waste dumping and current-driven waste issues in Tung Chung Wan. Respective measures (e.g. manual clean-up) should be implemented by responsible governmental agency units.

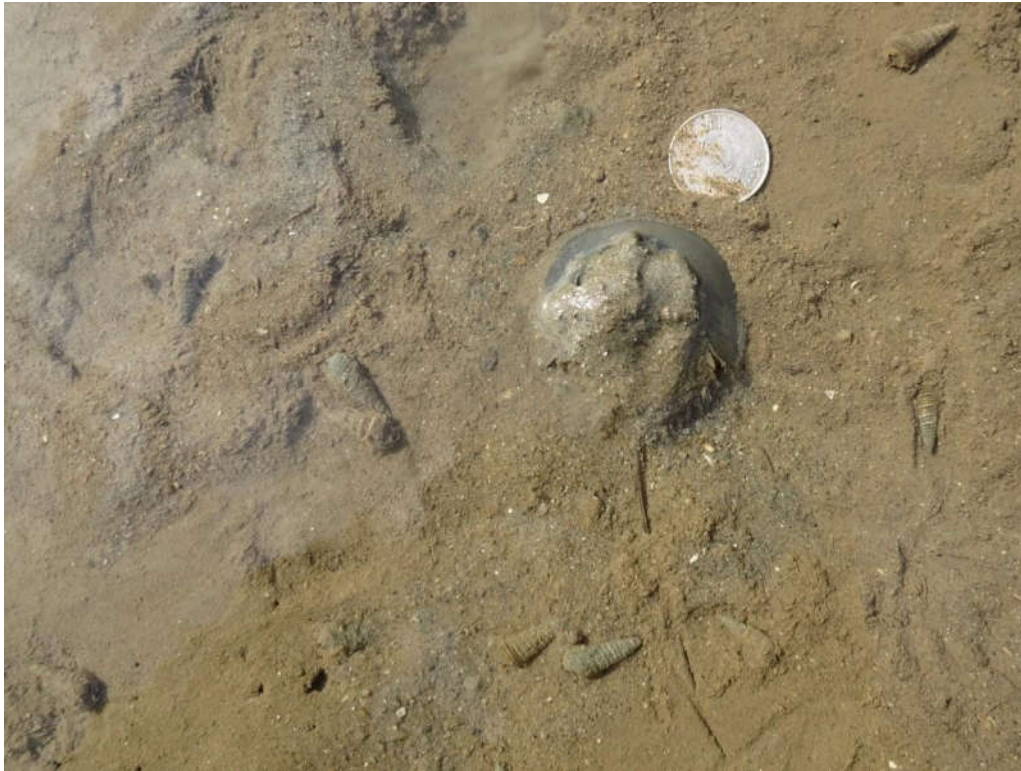
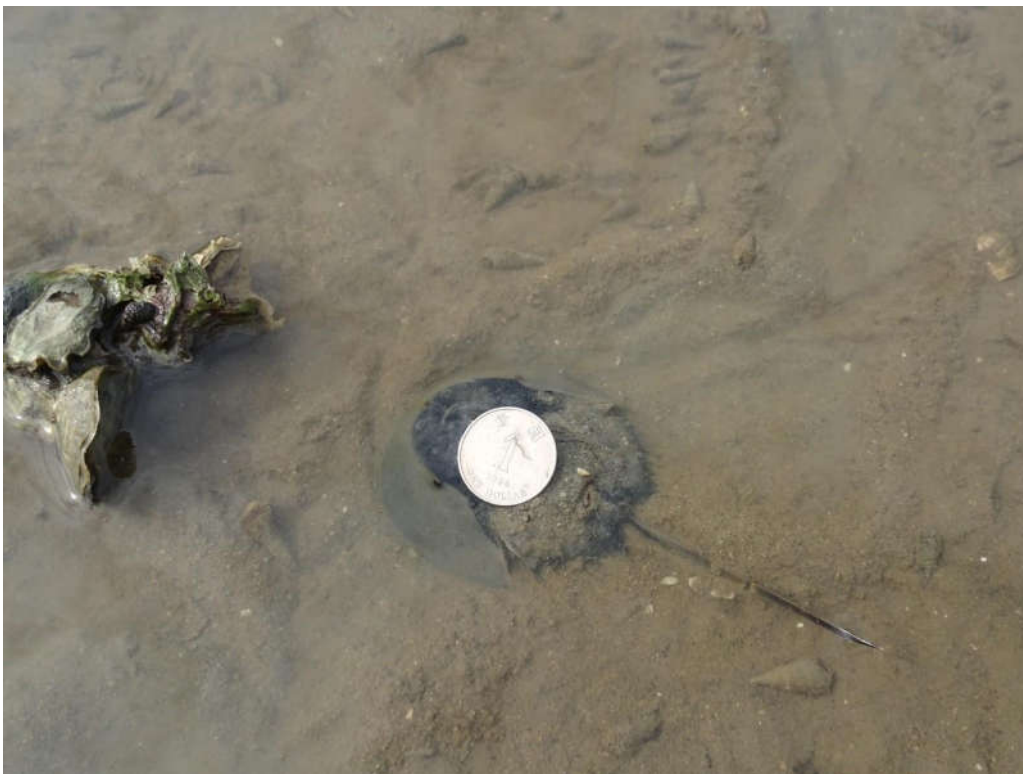
**Figure 3.1** Examples of photographic records of horseshoe crab (December 2020)

**ST *Carcinoscorpius rotundicauda***

**ST *Tachypleus tridentatus***

- 6.5.1 In total of 3 and 7 individuals of *Carcinoscorpius rotundicauda* and *Tachypleus tridentatus* were found in present survey. The recorded individuals were mainly distributed along the shoreline in ST. All of them were observed on similar substratum (fine sand or soft mud, slightly submerged). Photo records of the observed horseshoe crab are shown in **Figure 3.1 of Appendix I** and the present survey result regarding horseshoe crab are presented in **Table 3.1 of Appendix I**. The complete survey records are presented in **Annex II of Appendix I**.

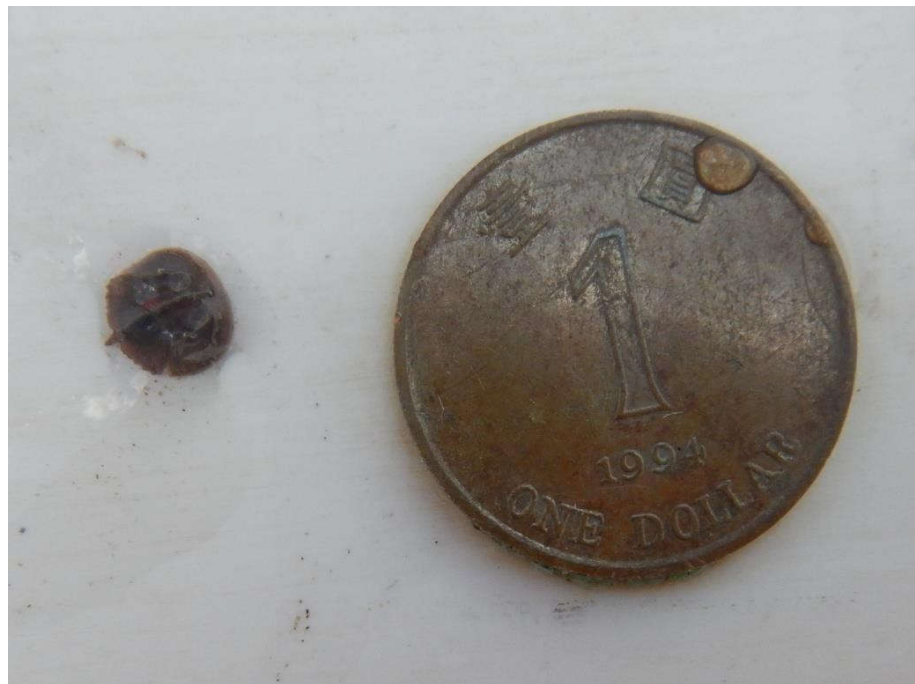
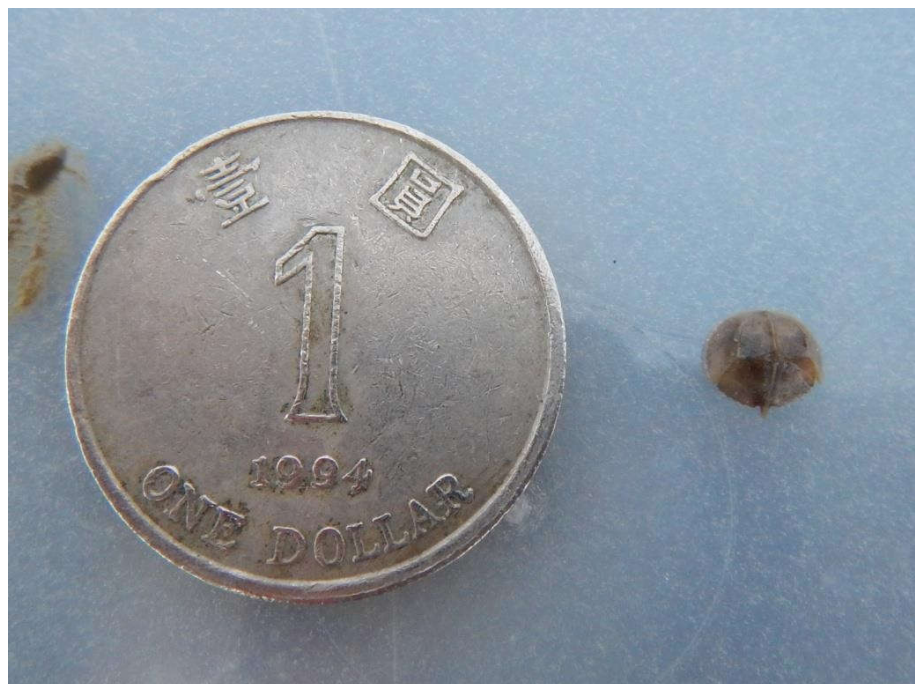
**Figure 3.3** *Photographic records of newly hatched individuals of horseshoe crab (September 2018)*

TC1

TC2

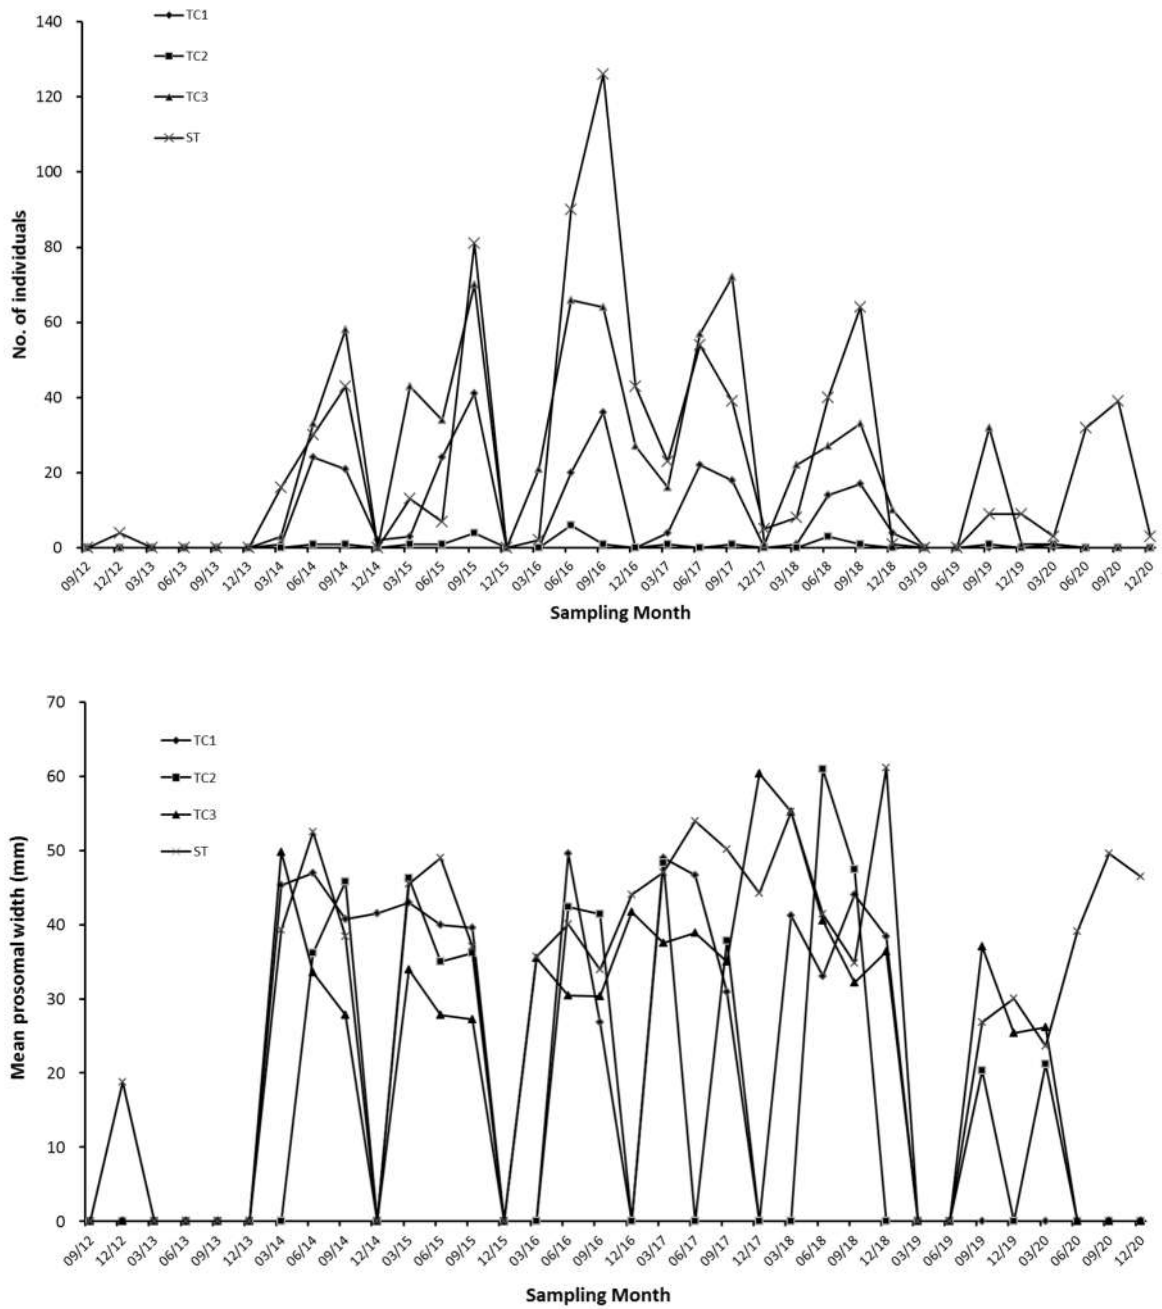
**Figure 3.5** Changes of number of individuals mean prosomal width and search record of horseshoe crab *Carcinoscorpius rotundicauda* in every sampling zone along the sampling months

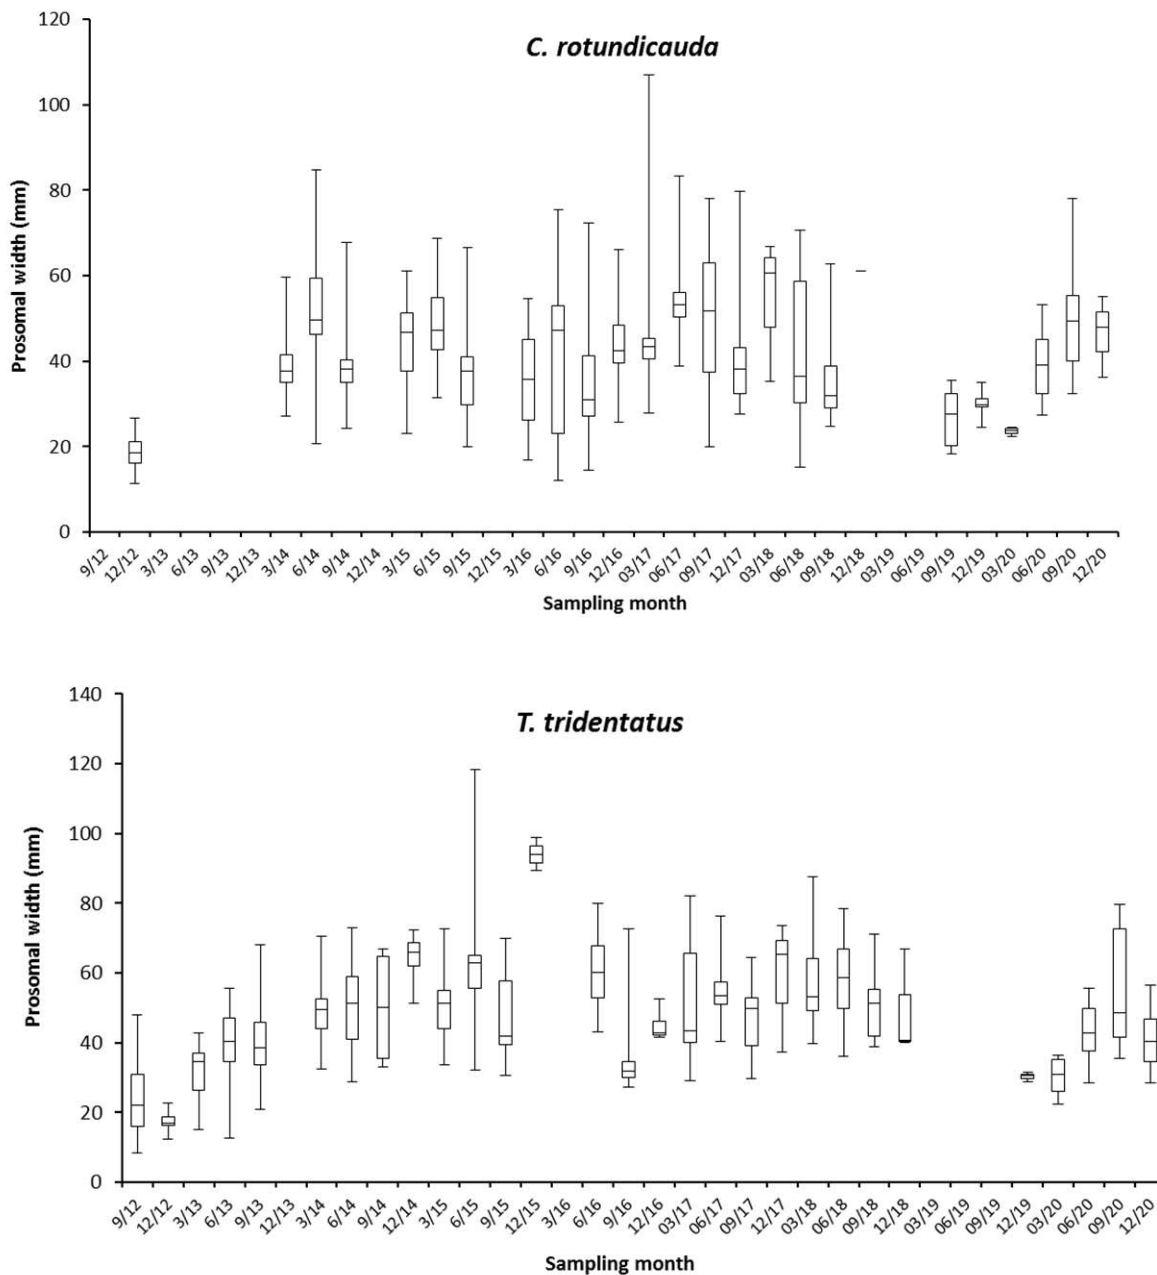
**Figure 3.8** Box plot of prosomal width of horseshoe crab in the sampling zone ST along the sampling months. (The box represents 50% of the sample (upper to lower quartile) with a middle line showing the median value. The upper whisker and lower whisker showed the 25% of sample above upper quartile and below the lower quartile respectively.)

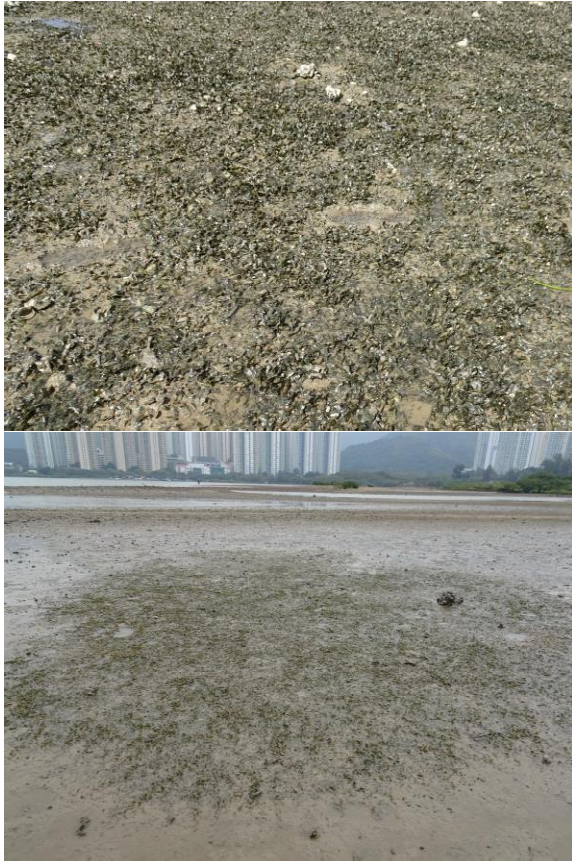
**Figure 3.9** *Photographic record of seagrass beds in present survey.*

***Halophila ovalis* in TC3**

<b>Sampling zone</b>	TC3 <i>Halophila ovalis</i>	ST <i>Halophila ovalis</i>
<b>Number of patches</b>	3	3
<b>Total area (m<sup>2</sup>)</b>	126	954
<b>Average area (m<sup>2</sup>)</b>	42	318
