**Contract No. HY/2011/03**

**Hong Kong-Zhuhai-Macao Bridge Hong Kong Link Road  
Section between Scenic Hill and Hong Kong Boundary Crossing  
Facilities**

**Monthly EM&A Report No.114 (March 2022)**

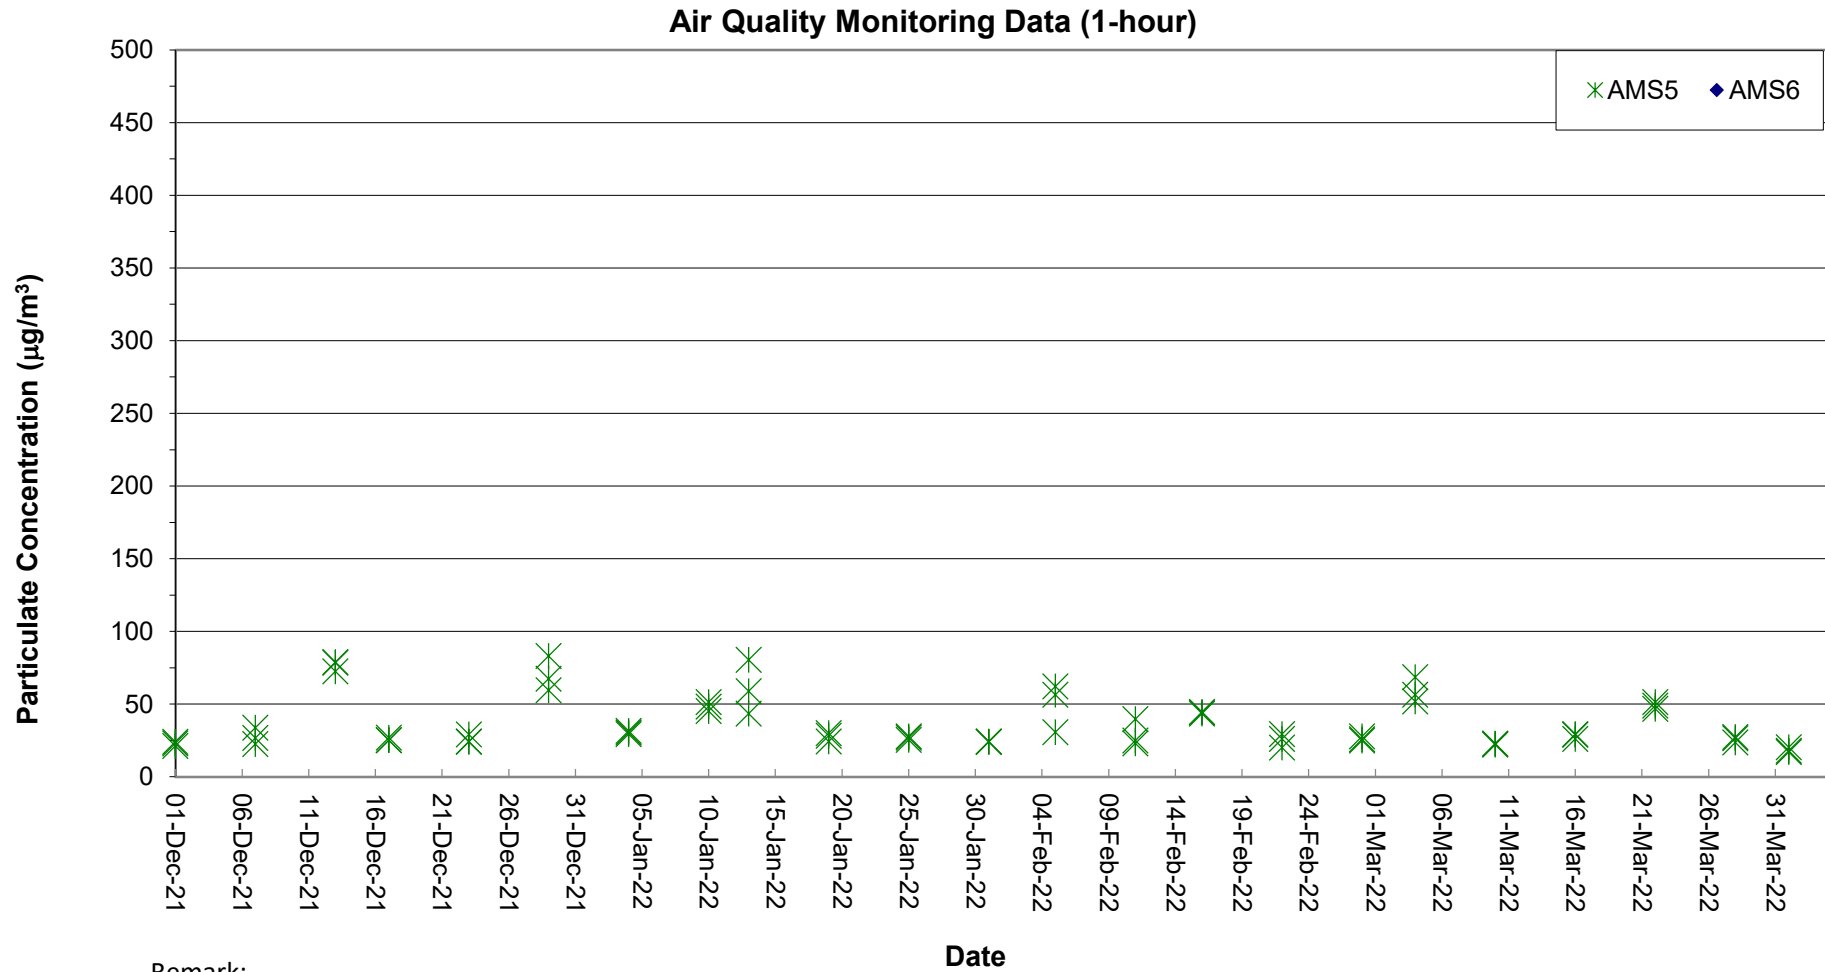
Graphical Plot of 1-hour TSP at AMS5 and AMS6

1) The existing air quality monitoring location AMS6 - Dragonair / CNAC (Group) Building (HKIA) was handed over to Airport Authority Hong Kong on 31 March 2021. 1-hr TSP monitoring at AMS6 was temporarily suspended starting from 1 April 2021.

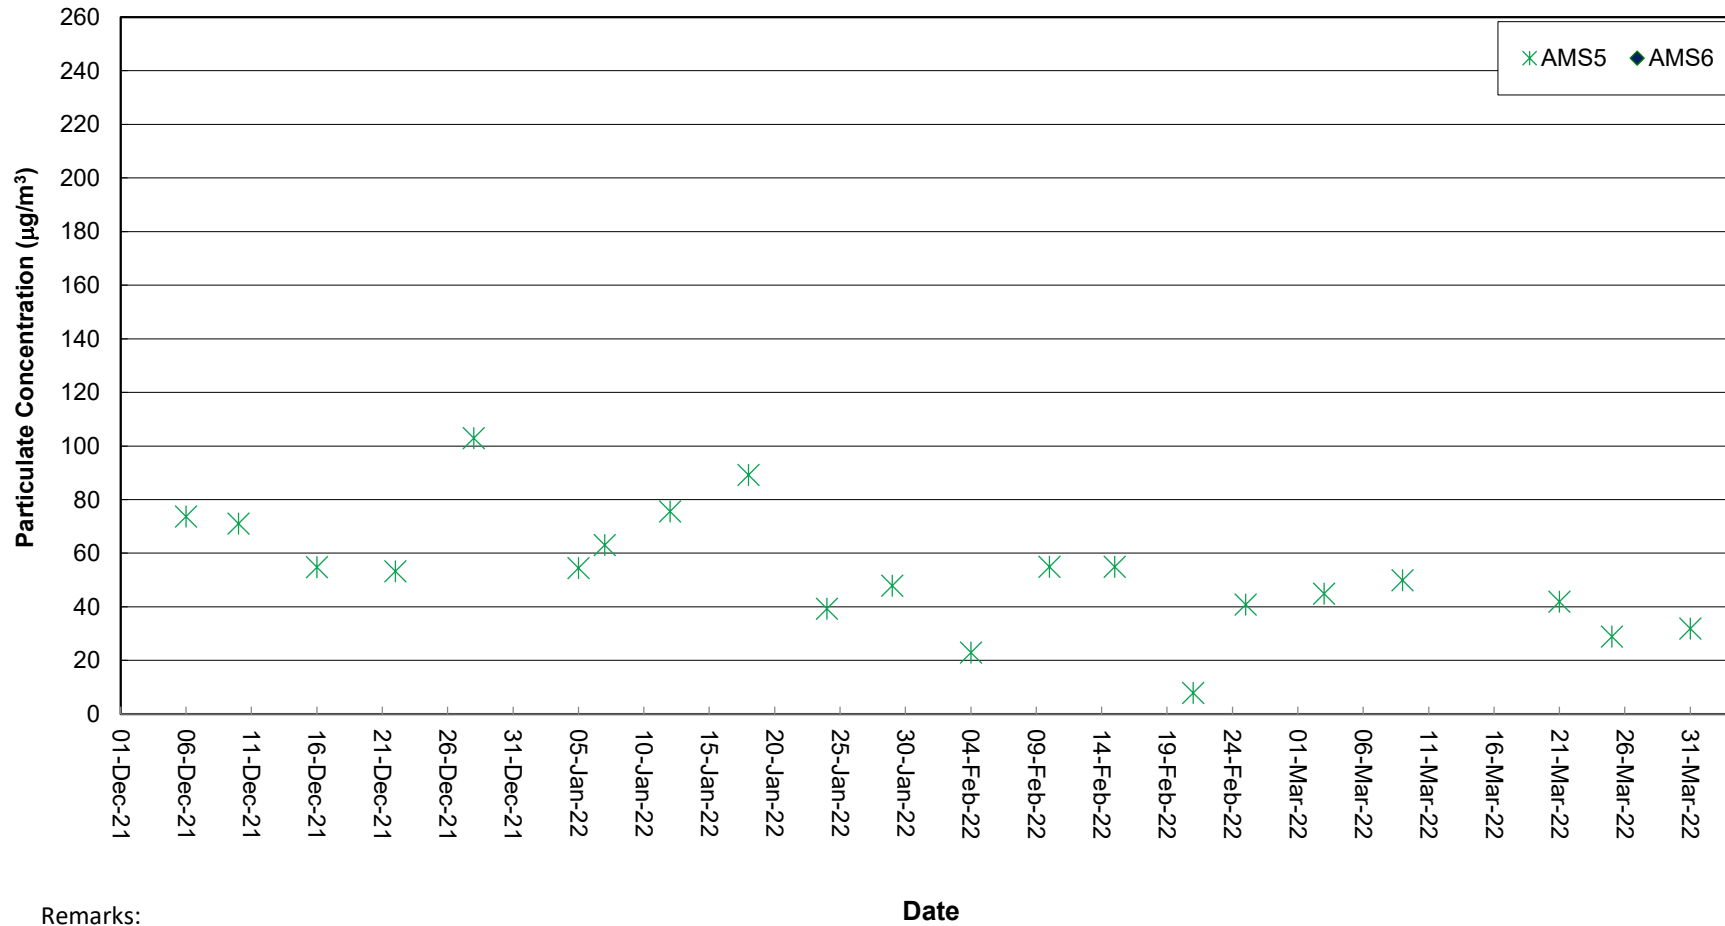
Graphical Plot of 24-hour TSP at AMS5 and AMS6

1) The existing air quality monitoring location AMS6 - Dragonair / CNAC (Group) Building (HKIA) was handed over to Airport Authority Hong Kong on 31 March 2021. 24-hr TSP monitoring at AMS6 was temporarily suspended starting from 1 April 2021.

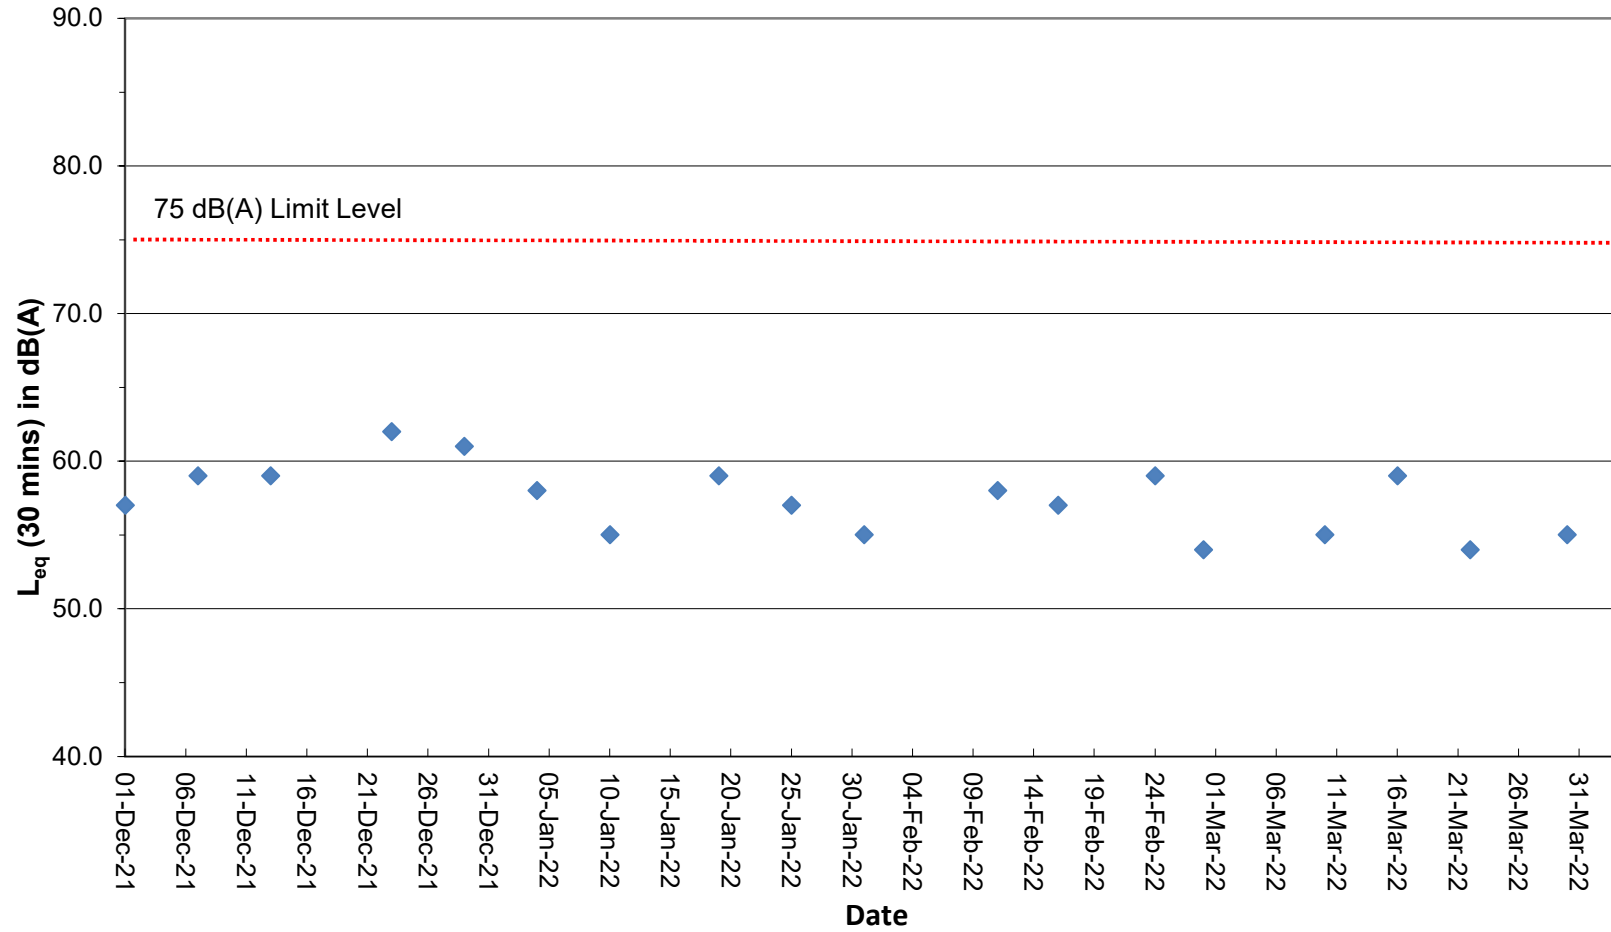
## Graphical Plot of Noise Levels at NMS5

- (1) A facade correction of +3 dB(A) was applied to the measured noise level.
- (2) Due to bad weather condition on 28 March 2022, noise monitoring at NMS5 was rescheduled from 28 March 2022 to 30 March 2022.

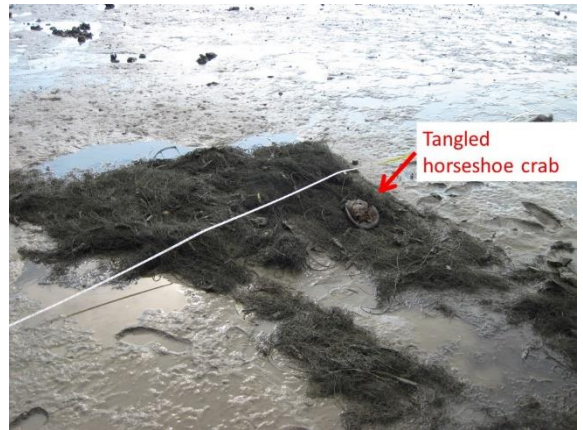
**Figure 2.3** Examples of photographic record of the big trashes found on the mudflat.

Trash gill net and hand trolley

A tangled horseshoe crab on a trash net (record in June 2017)

- 6.3.2 Since the field survey of June 2016, increasing number of trashes and even big trashes (**Figure 2.3 of Appendix I**) were found in every sampling zone. It raised a concern about the solid waste dumping and current-driven waste issues in Tung Chung Wan. Respective measures (e.g. manual clean-up) should be implemented by responsible governmental agency units.

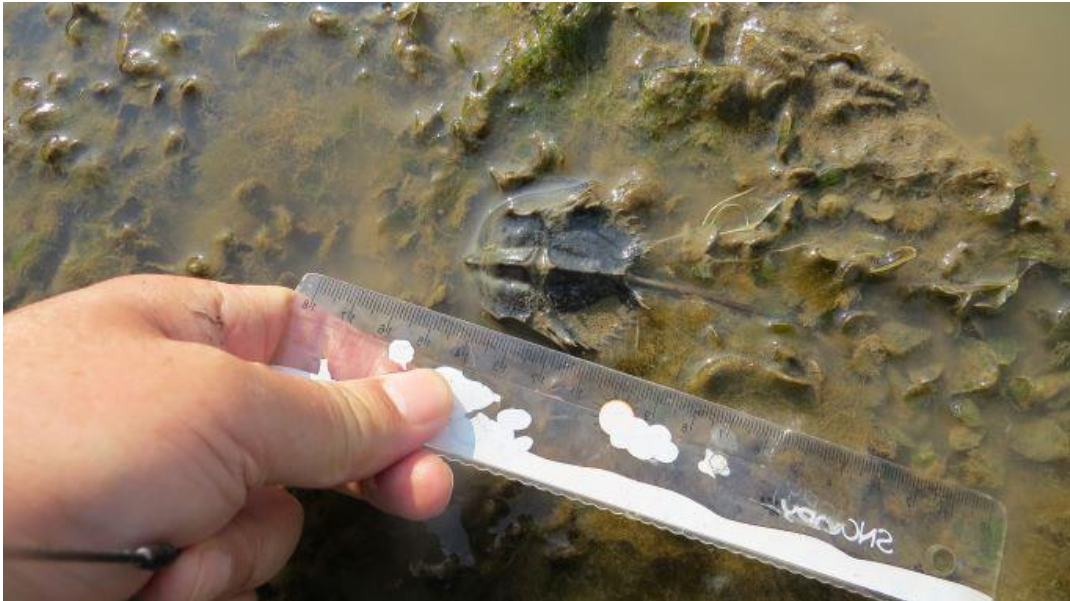
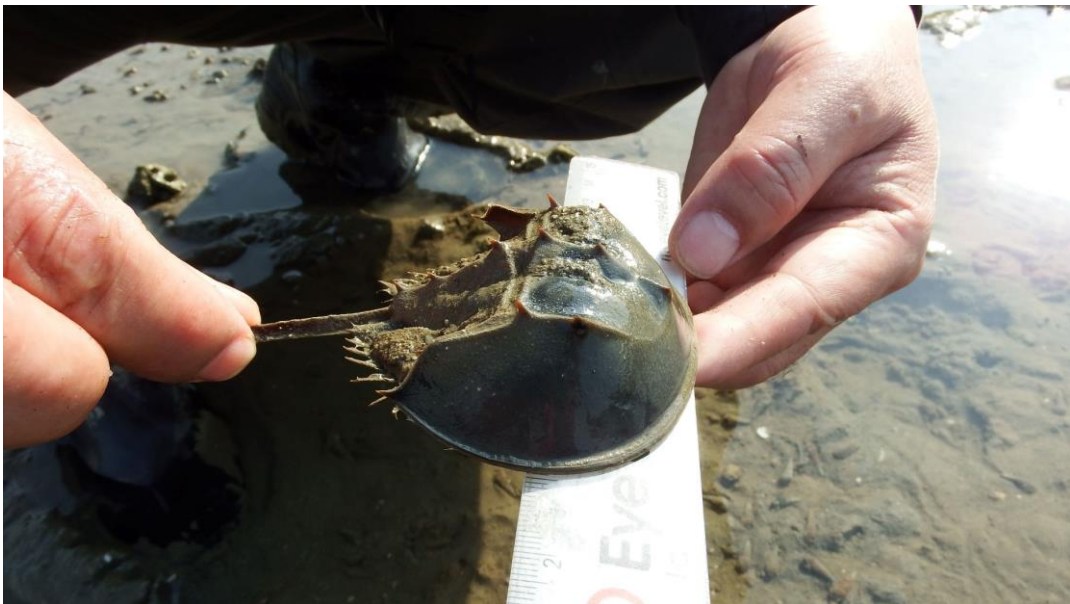
**Figure 3.1** Examples of photographic records of horseshoe crab (Mar 2022)

**ST *Carcinoscorpius rotundicauda***

**ST *Tachypleus tridentatus***

- 6.5.1 In total of 10 individuals of juveniles *Carcinoscorpius rotundicauda* and *Tachypleus tridentatus* were found in present survey. The recorded individuals were mainly distributed along the shoreline in ST and TC3. No adult specimen was recorded. All of them were observed on similar substratum (fine sand or soft mud, slightly submerged). Photo records of the observed horseshoe crab are shown in **Figure 3.1 of Appendix I** and the present survey result regarding horseshoe crab are presented in **Table 3.1 of Appendix I**. The complete survey records are presented in **Annex II of Appendix I**.
