Contract No. HY/2011/03

**Hong Kong-Zhuhai-Macao Bridge Hong Kong Link Road
Section between Scenic Hill and Hong Kong Boundary Crossing
Facilities**

Monthly EM&A Report No.117 (June 2022)

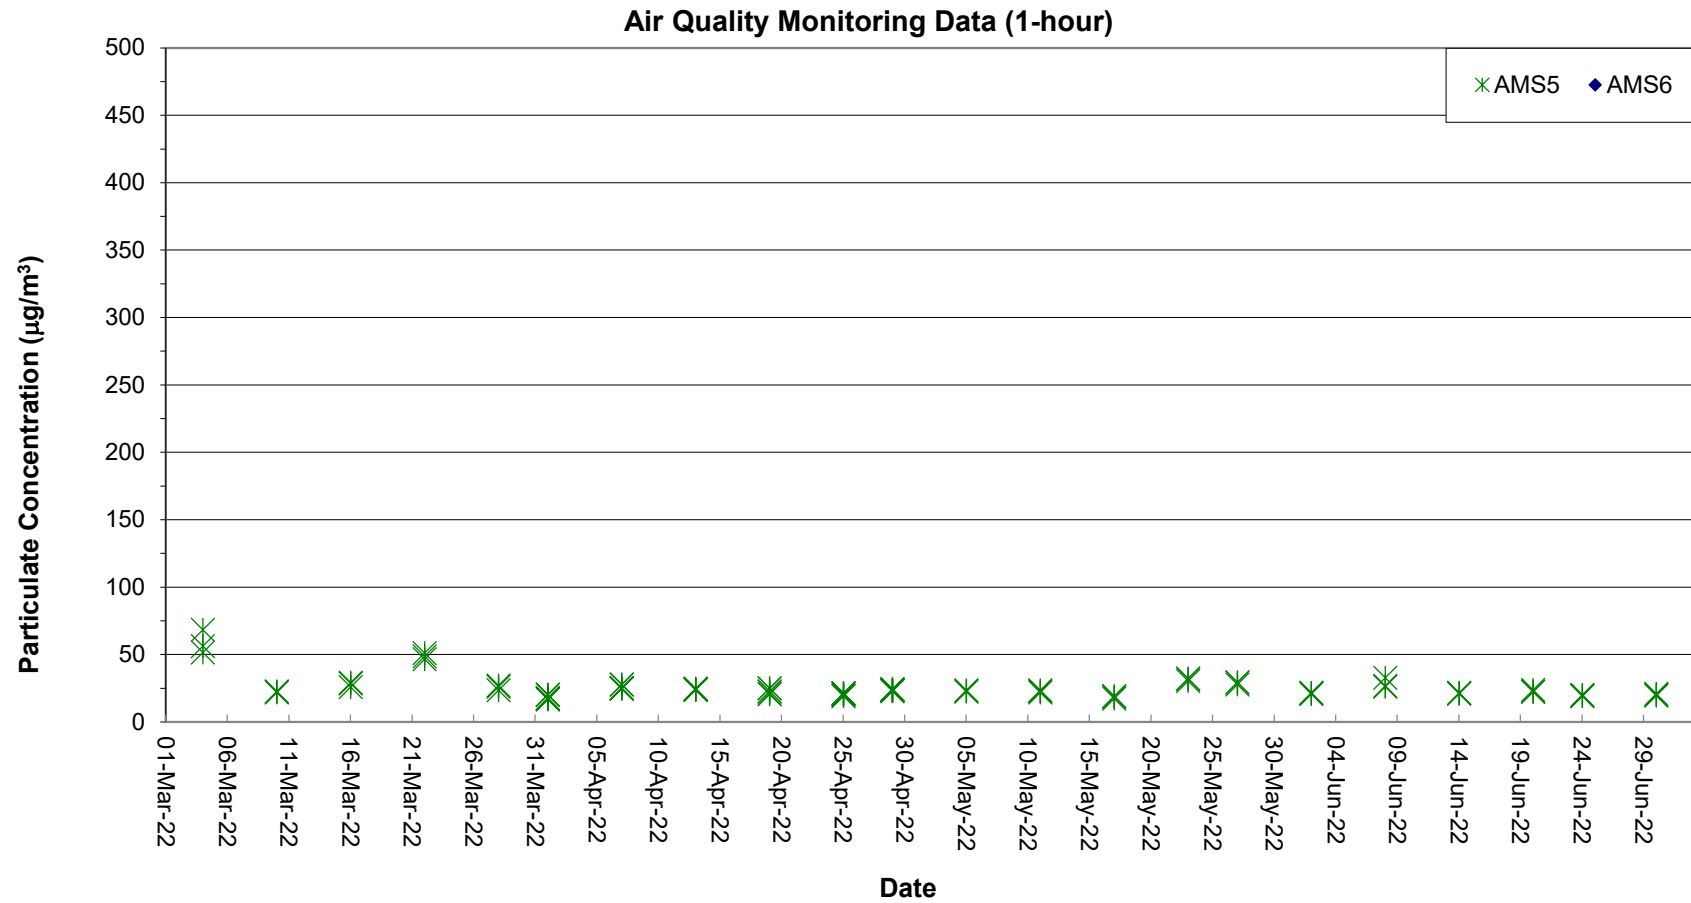
Graphical Plot of 1-hour TSP at AMS5 and AMS6

1) The existing air quality monitoring location AMS6 - Dragonair / CNAC (Group) Building (HKIA) was handed over to Airport Authority Hong Kong on 31 March 2021. 1hr and 24 hr air quality monitoring at AMS6 was temporarily suspended starting from 1 April 2021.

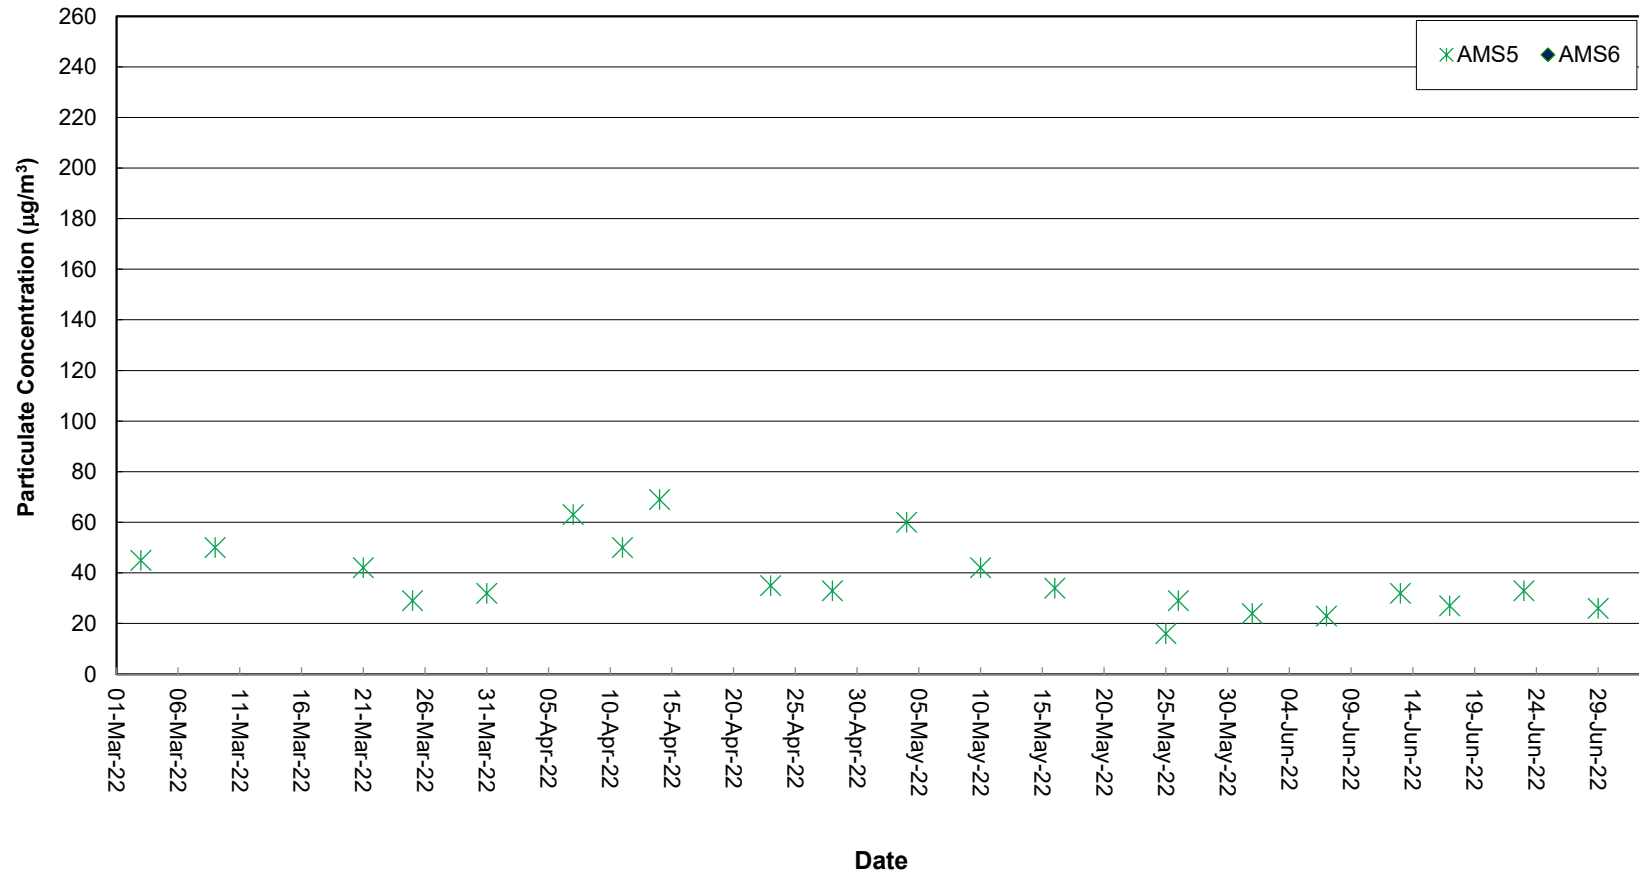
Graphical Plot of 24-hour TSP at AMS5 and AMS6

- 1) The existing air quality monitoring location AMS6 - Dragonair / CNAC (Group) Building (HKIA) was handed over to Airport Authority Hong Kong on 31 March 2021. 24-hr TSP monitoring at AMS6 was temporarily suspended starting from 1 April 2021.

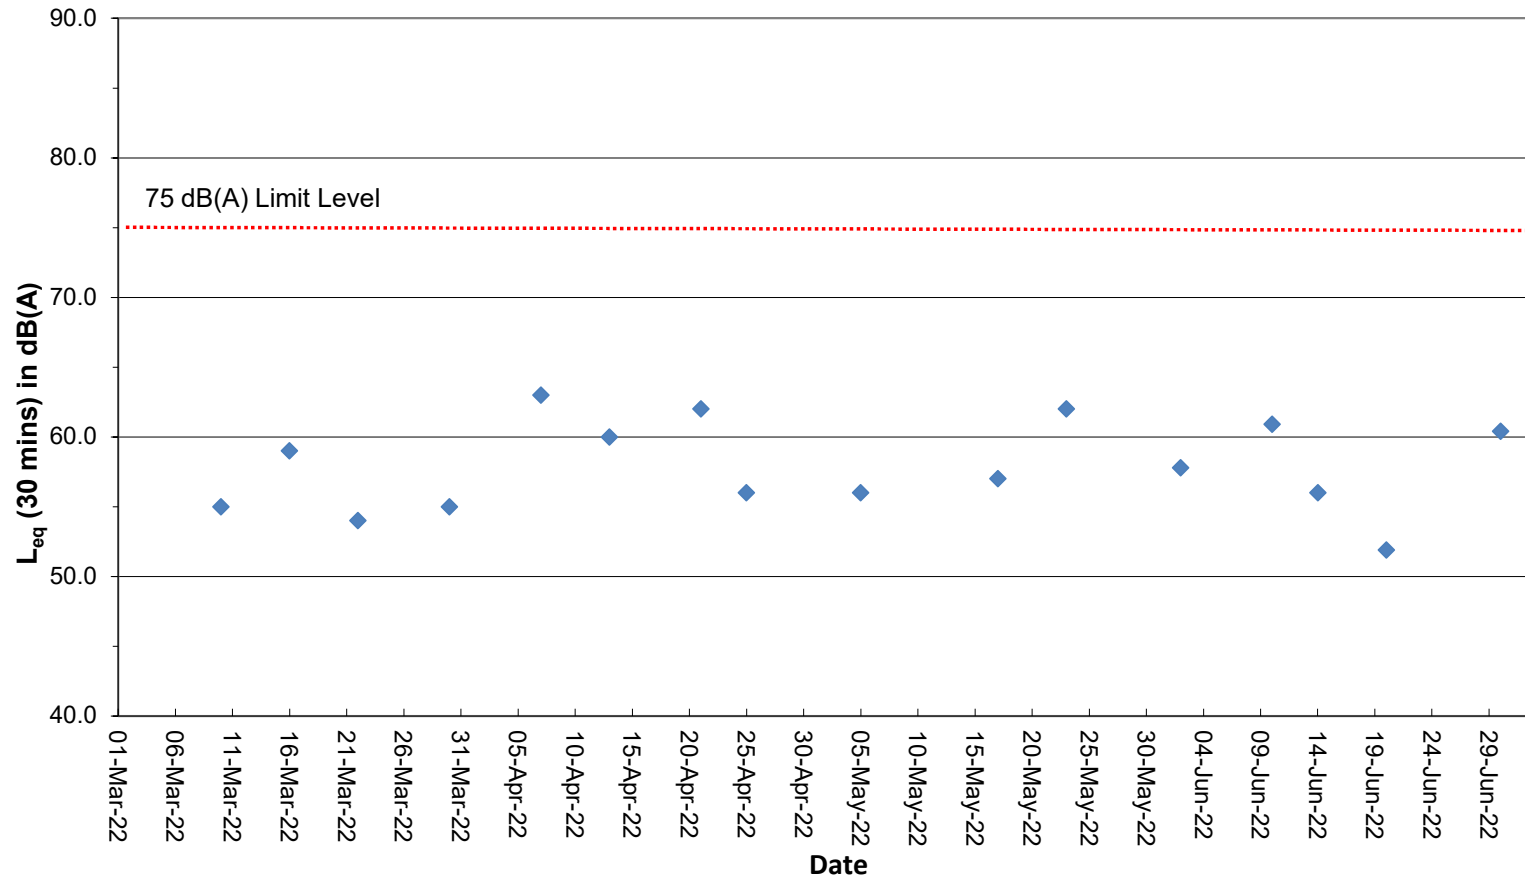
Graphical Plot of Noise Levels at NMS5

Remarks:

- (1) A facade correction of +3 dB(A) was applied to the measured noise level.
- (2) Due to poor weather condition on 8 June 2022, noise monitoring at NMS5 – Ma Wan Chung Village was rescheduled to 10 June 2022

Due to poor weather condition on 8 June 2022, noise monitoring at NMS5 – Ma Wan Chung Village was rescheduled to 10 June 2022.

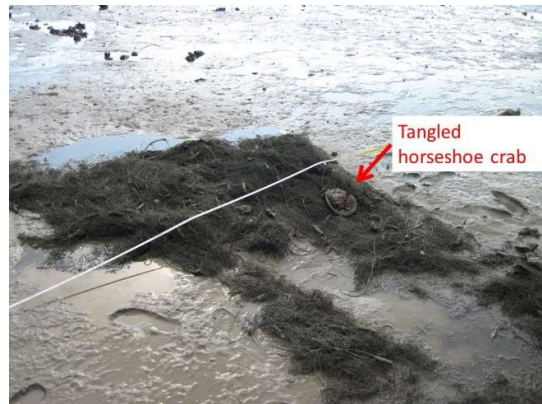
Trash gill net and hand trolley

A tangled horseshoe crab on a trash net (record in June 2017)

Figure 2.3 Examples of photographic record of the big trashes found on the mudflat.

- 6.3.2 Since the field survey of June 2016, increasing number of trashes and even big trashes (**Figure 2.3 of Appendix I**) were found in every sampling zone. It raised a concern about the solid waste dumping and current-driven waste issues in Tung Chung Wan. Respective measures (e.g., manual clean-up) should be implemented by responsible governmental agency units.

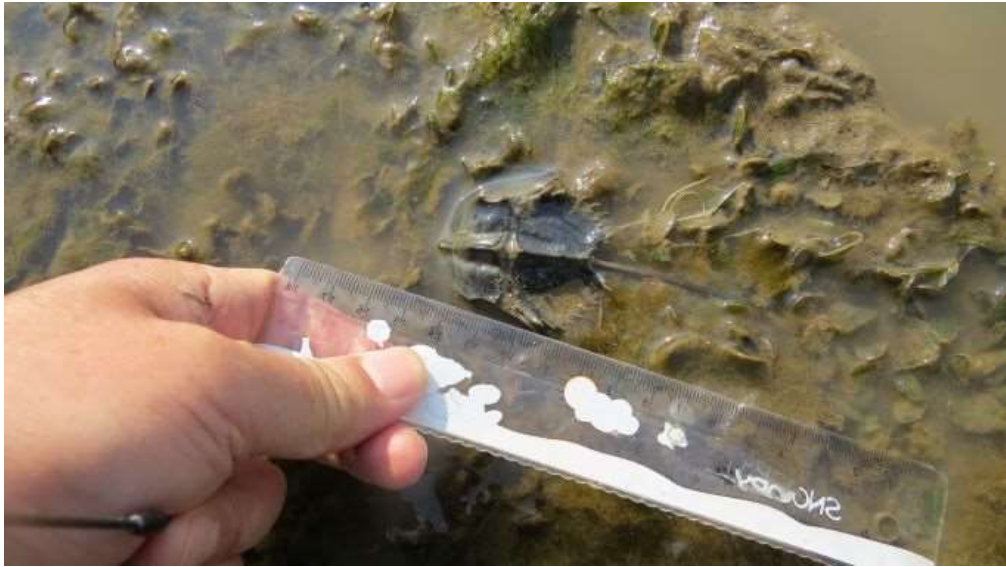
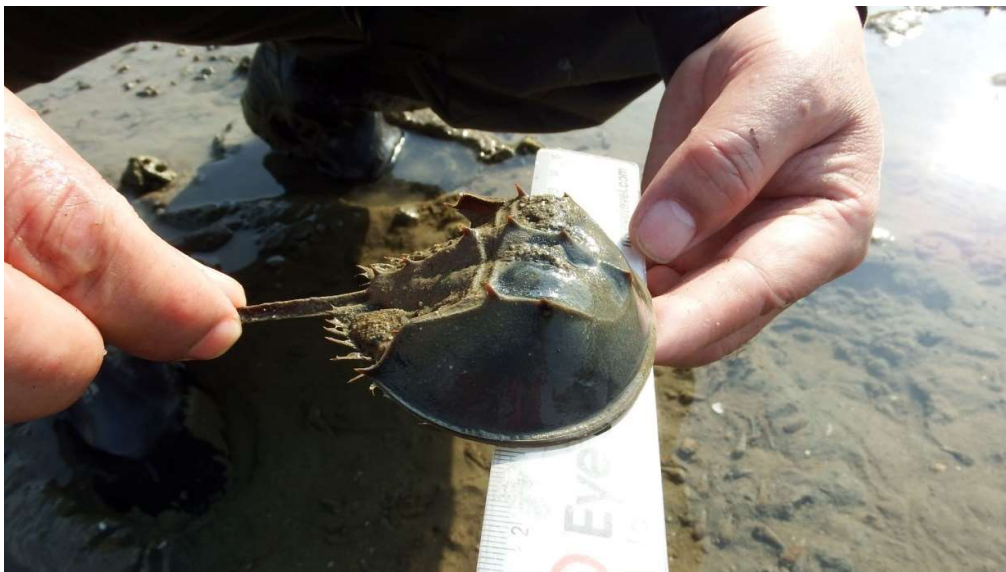
Figure 3.1 *Examples of photographic records of horseshoe crab (Mar 2022)*

ST *Carcinoscorpius rotundicauda*

ST *Tachypleus tridentatus*

- 6.5.1 In total of 13 individuals of *Carcinoscorpius rotundicauda* and *Tachypleus tridentatus* were found in present survey. The recorded individuals were mainly distributed along the shoreline in TC1 and TC3. 7 adults specimens were recorded with one mating pair, 4 being trapped in an abandoned fish trap and one died body. All of them were observed on similar substratum (fine sand or soft mud, slightly submerged). 6 juveniles specimens were found in present survey. Large adult individuals (prospmal width >100mm) are excluded from the data analysis to avoid mixing up with juvenile population living on intertidal habitat. Photo records of the observed horseshoe crab are shown in **Figure 3.1 of Appendix I** and the present survey result regarding horseshoe crab are presented in **Table 3.1 of Appendix I**. The complete survey records are presented in **Annex II of Appendix I**.

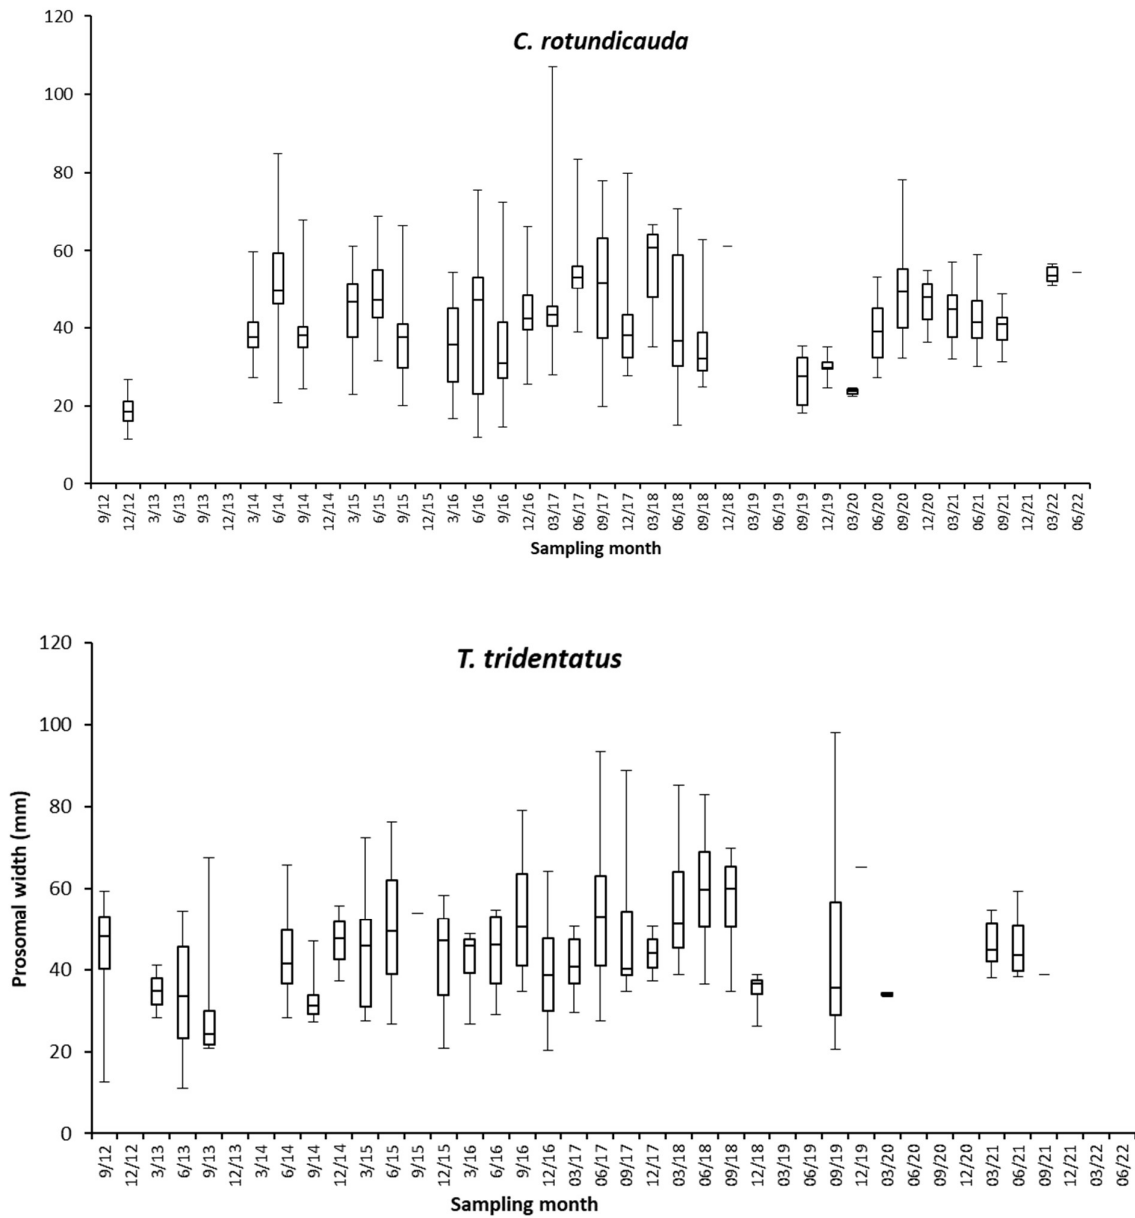
Figure 3.8 Box plot of prosomal width of horseshoe crab in the sampling zone ST along the sampling months. (The box represents 50% of the sample (upper to lower quartile) with a middle line showing the median value. The upper whisker and lower whisker showed the 25% of sample above upper quartile and below the lower quartile respectively.)

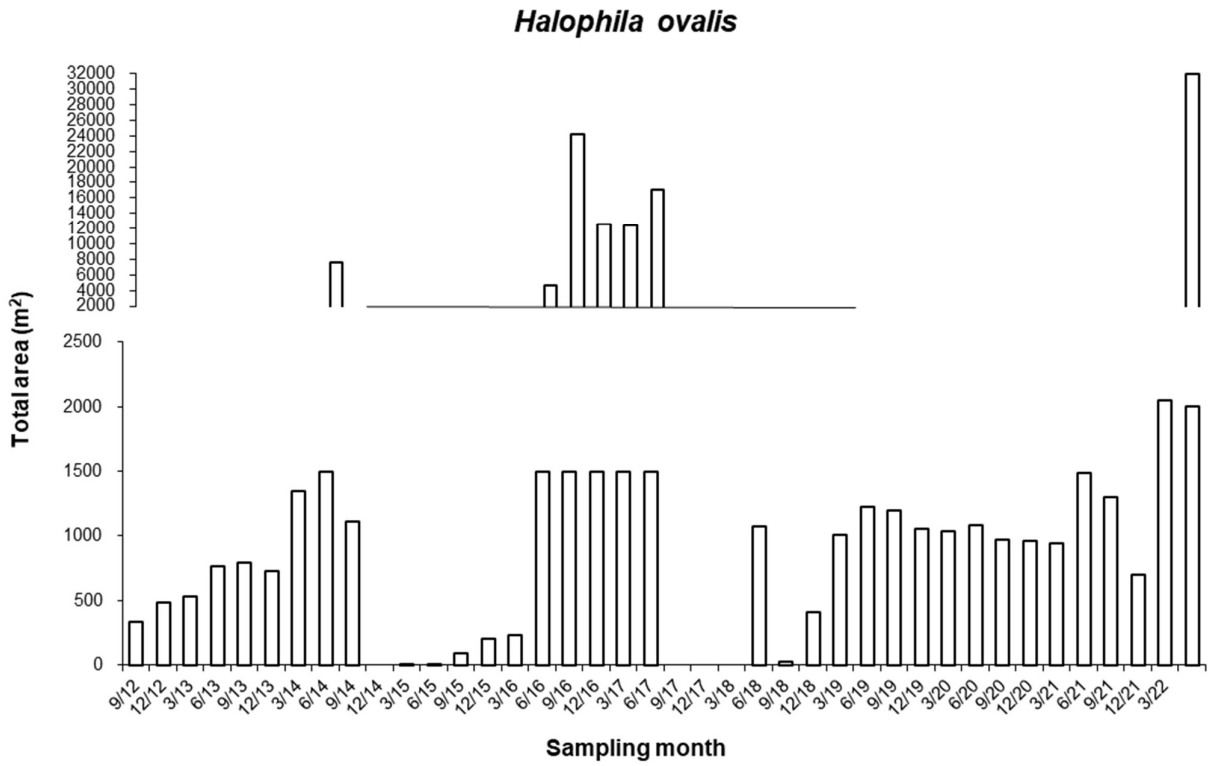
Figure 3.11 Temporal changes of estimated total area of seagrass beds in ST

Sampling zone	TC3 <i>Halophila ovalis</i>	ST <i>Halophila ovalis</i>	ST <i>Zostera japonica</i>
Number of patches	3	6	1
Total area (m²)	2800	32000	20
Average area (m²)	933.33	5333.33	20
