Contract No. HY/2011/03

**Hong Kong-Zhuhai-Macao Bridge Hong Kong Link Road
Section between Scenic Hill and Hong Kong Boundary Crossing
Facilities**

Monthly EM&A Report No.123 (Dec 2022)

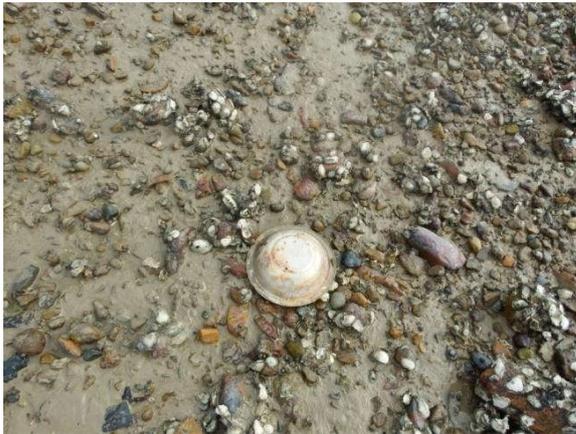
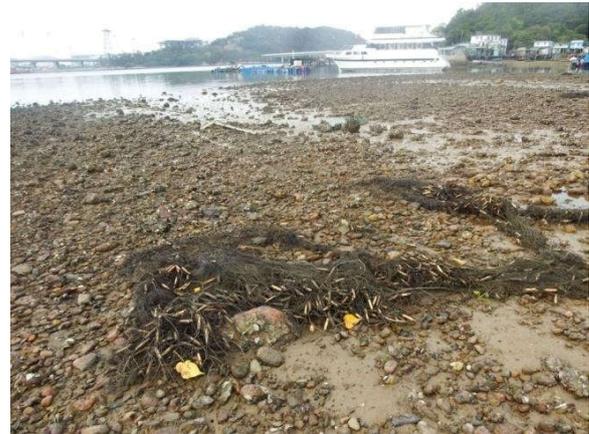
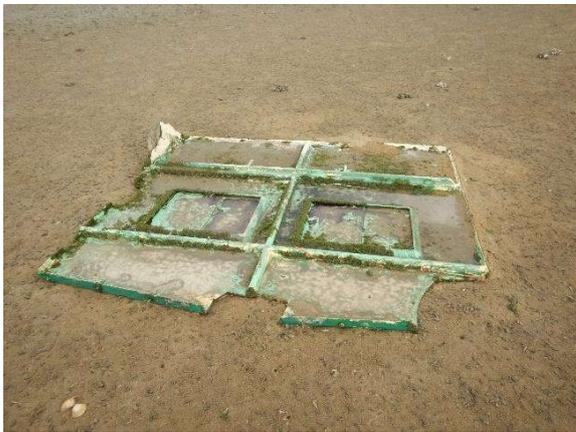
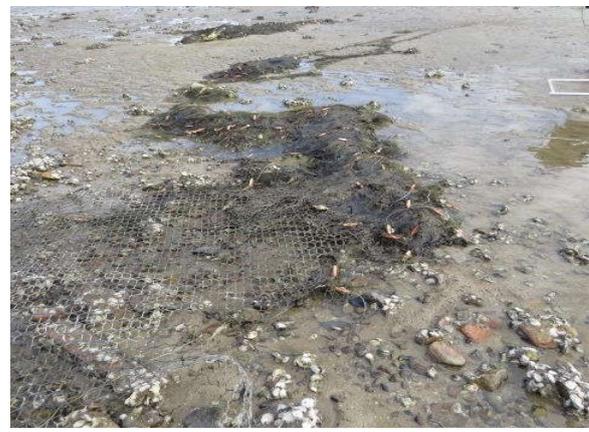
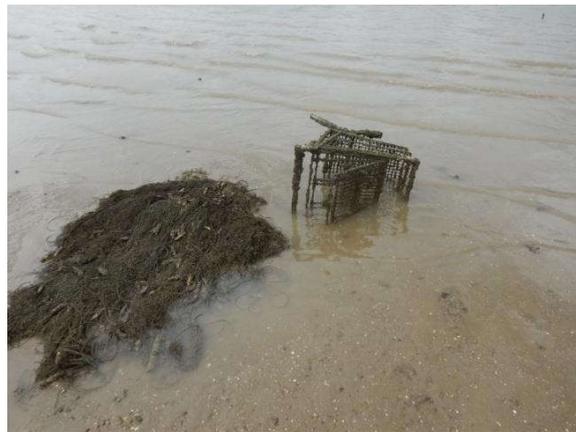
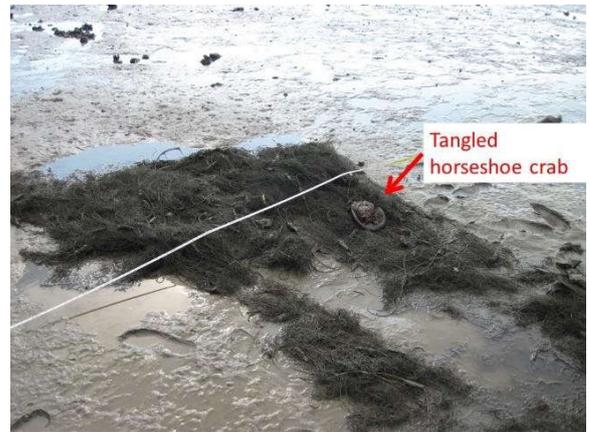
Figure 2.3 Examples of photographic record of the big trashes found on the mudflat.

- 6.3.2 Since the field survey of June 2016, increasing number of trashes and even big trashes (**Figure 2.3 of Appendix I**) were found in every sampling zone. It raised a concern about the solid waste dumping and current-driven waste issues in Tung Chung Wan. Respective measures (e.g., manual clean-up) should be implemented by responsible governmental agency units.

Plastic waste

Trash gill net

Boat wreckage

Trash gill net and hand trolley

A tangled horseshoe crab on a trash net (record in June 2017)

- 6.3.4 In June 2017, a big horseshoe crab was tangled by a trash gill net in ST mudflat (**Figure 2.3 of Appendix I**). It was released to sea once after photo recording. The horseshoe crab of such size should be inhabiting sub-tidal environment while it forages on intertidal shore occasionally during high tide period. If it is tangled by the trash net for few days, it may die due to starvation or overheat during low tide period. These trash gill nets are definitely 'fatal trap' for the horseshoe crabs and other marine life. Manual clean-up should be implemented as soon as possible by responsible governmental agency units.

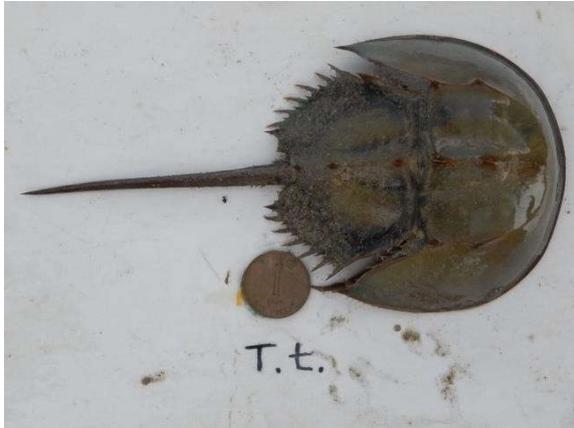
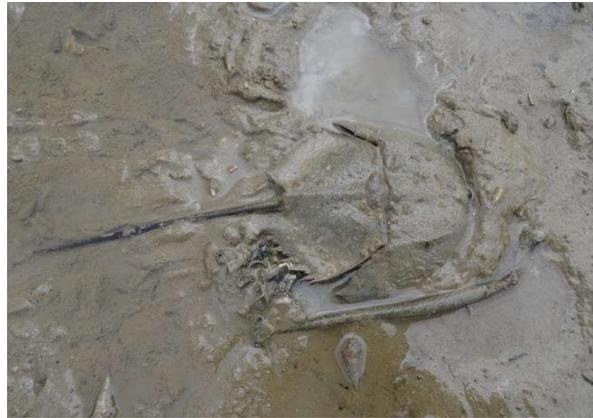
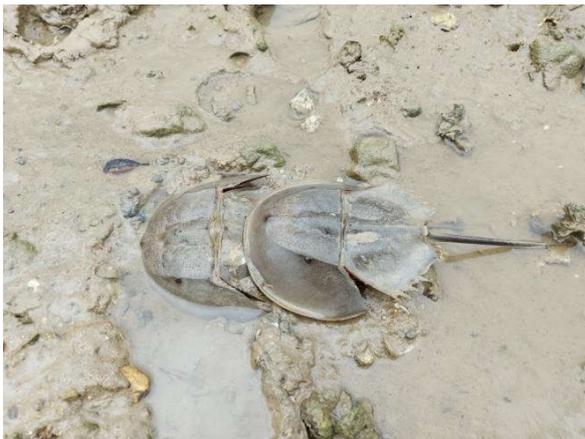
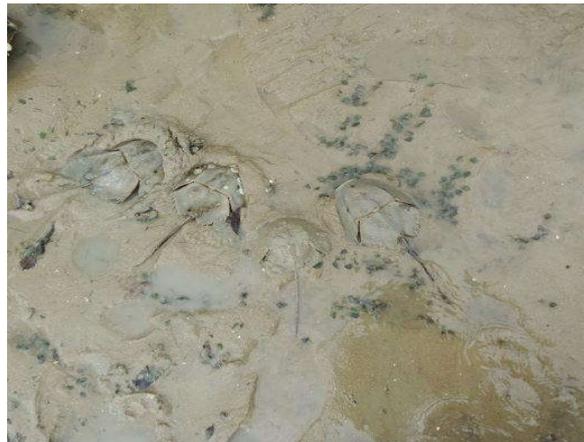
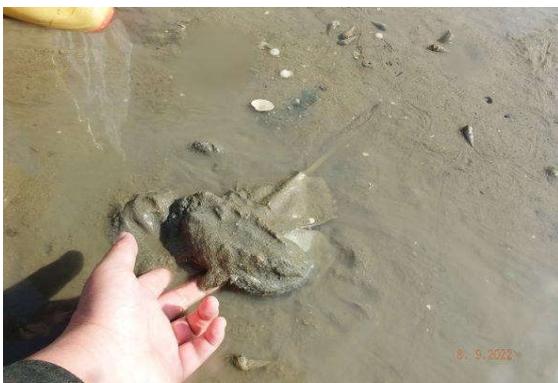
Figure 3.4 *Photographic records of large individuals (>100 mm) of horseshoe crabs records were excluded from data analysis*

- 6.5.3 No horseshoe crab was recorded during surveys conducted in present survey (December 2022). 3 adult individuals (prosomal width >100mm) of *Carcinoscorpius rotundicauda* were recorded in September 2022 survey, with one alive, one dead in TC3 and one dead in TC2. In June 2022, 7 large individuals (prosomal width >100mm) of *Carcinoscorpius rotundicauda* was recorded (prosomal width ranged 131.4mm-140.3mm) in TC3. In December 2018, one large individual of *Carcinoscorpius rotundicauda* was found in TC3 (prosomal width 148.9 mm). In March 2019, 3 large individuals (prosomal width ranged 220 – 310mm) of *Carcinoscorpius rotundicauda* were observed in TC2. In June 2019, there were 3 and 7 large individuals of *Tachypleus tridentatus* recorded in ST (prosomal width ranged 140 – 180mm) and TC3 (prosomal width ranged 150 – 220mm), respectively. In March 2020, a mating pair of *Tachypleus tridentatus* was recorded in TC1 with prosomal width 123 mm and 137mm. Based on their sizes, it indicated that individuals of prosomal width larger than 100 mm would progress its nursery stage from intertidal habitat to sub-tidal habitat of Tung Chung Wan. The photo records of the large horseshoe crab are shown in **Figure 3.4 of Appendix I**. These large individuals might move onto intertidal shore occasionally during high tide for foraging and breeding. Because they should be inhabiting sub-tidal habitat most of the time. Their records were excluded from the data analysis to avoid mixing up with juvenile population living on intertidal habitat.

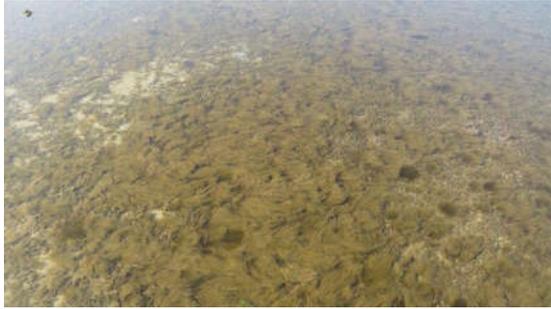
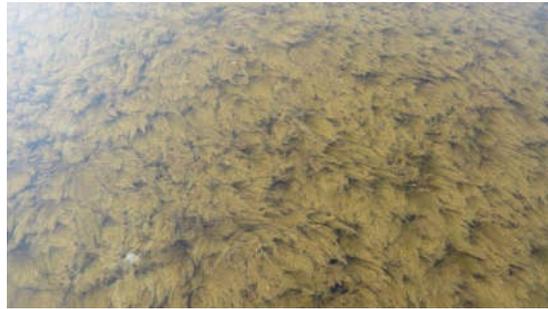
ST increased significantly to approximately 2040 m² which believed to be related to more rain in current dry season. It was observed that the brown filamental algae bloom occurred at ST site in March 2022. Distribution of the algae was overlap with seagrass beds, mainly the species *Halophila ovalis* and the algae was grown over the top of the seagrass. In some areas, the brown filamental algae full covered the seagrass bed, refer to **Figure 3.9 of Appendix I**. The seagrass was still alive when checked during the field survey. Whether the algae bloom will kill seagrass in longer period time is unknown. The seagrass distribution and health condition should be checked in coming June monitoring. The algae bloom of the brown filamental algae at the seagrass bed is disappeared as observed in June 2022, refer to **Figure 3.9 of Appendix I**. Seagrass in present survey (September 2022) has decreased compared to June 2022 due to normal seasonal change.

Photos below: Brown filamental algae bloom at ST, March 2022

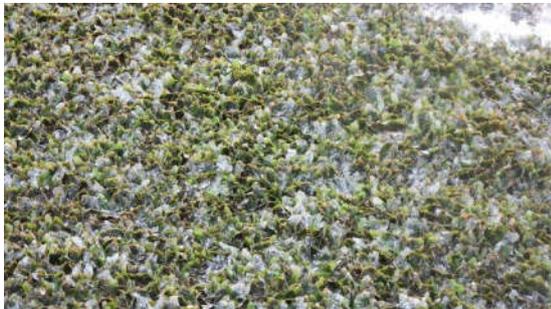
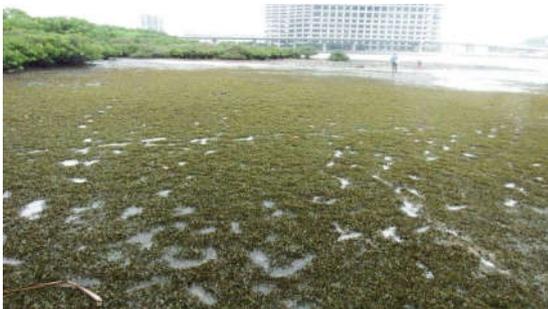
Photos below: Brown filamental algae at seagrass bed at ST disappeared, June 2022, *Halophila ovalis* covered large area of mudflat

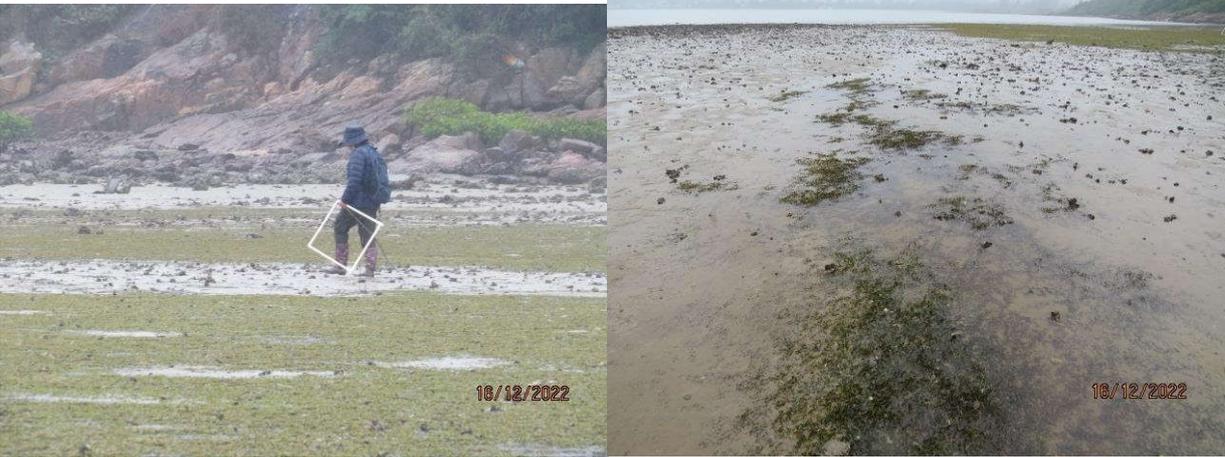
- 6.5.24 Two seagrass species *Halophila ovalis* and *Zostera japonica* were found in present survey. *Halophila ovalis* was found in TC3 and ST and *Zostera japonica* was found only in ST. In ST, there were six large sized of *Halophila ovalis* found at tidal zone 1.5m above C.D nearby mangroves plantation. The larger strand had area ~6600m² in moderate vegetation coverage (30 - 40%), ~3800m² in moderate vegetation coverage (30 - 35%), ~1000m² in moderate vegetation coverage (25 - 30%) and three ~600 - 180m² in low to moderate vegetation coverage (10 - 25%). In TC3, 3 large patches of *Halophila ovalis* were found at tidal zone 1.5m above C.D. The larger strand had area ~1600m² in moderate vegetation coverage (40 - 50%), ~1200m² in moderate vegetation coverage (30 - 45%) and ~480m² in moderate vegetation coverage (20- 30%). At close vicinity to mangrove, one small sized (5m²) of *Zostera japonica* beds were observed at tidal zone 2.0m above C.D. **Table 3.2 of Appendix I** summarizes the results of present seagrass beds survey and the photograph records of the seagrass are shown on **Figure 3.9 of Appendix I**. The complete record throughout the monitoring period is presented in **Annex III of Appendix I**.

***Halophila ovalis* in TC3**

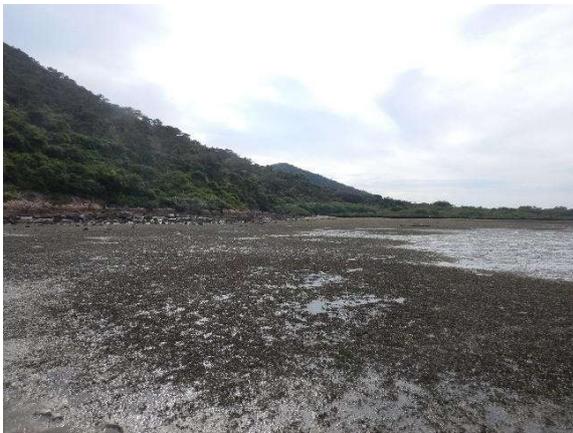
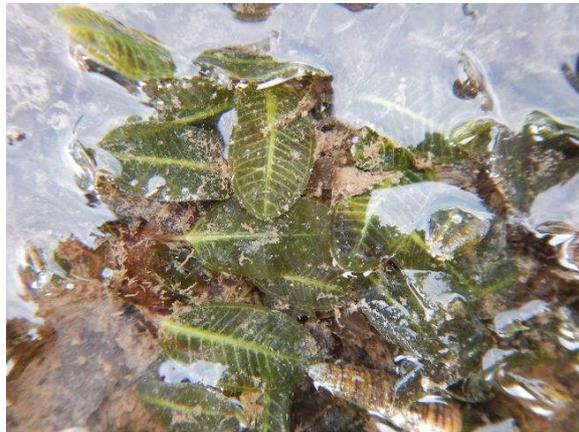
TC3 - ST

Extensive patch of *Halophila ovalis*

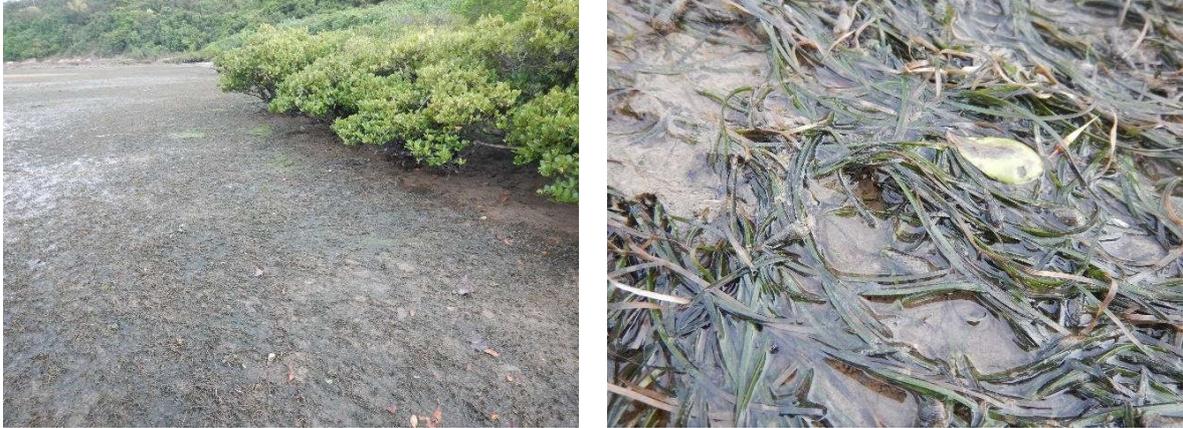
ST

Medium, horizontal patch of *Zostera japonica*

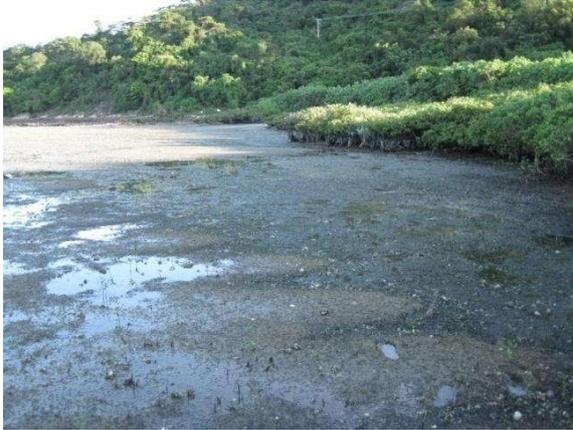
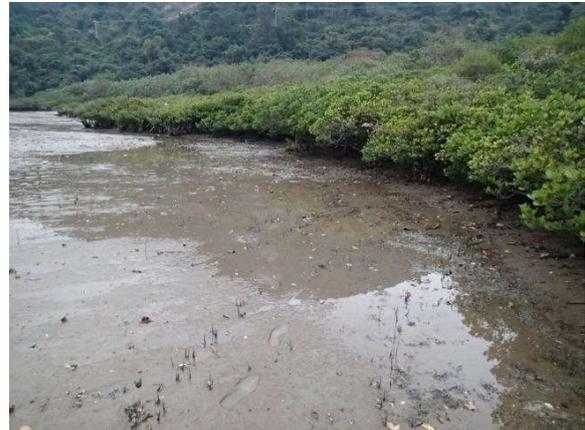
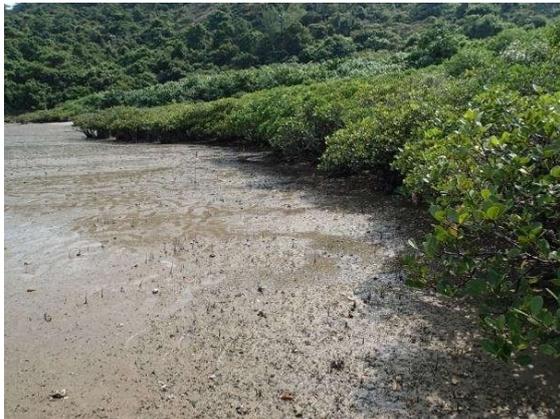
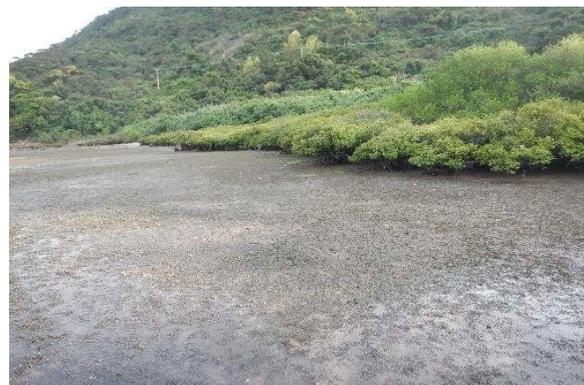
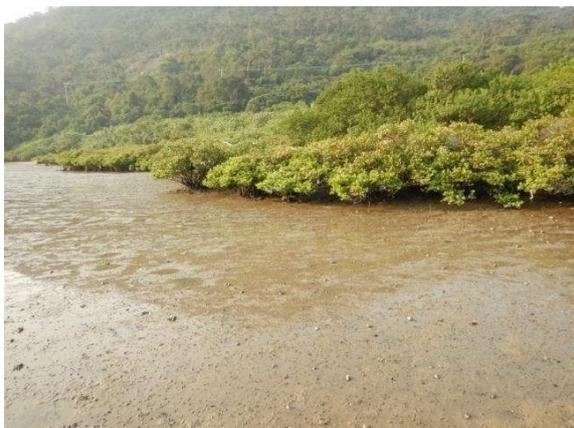
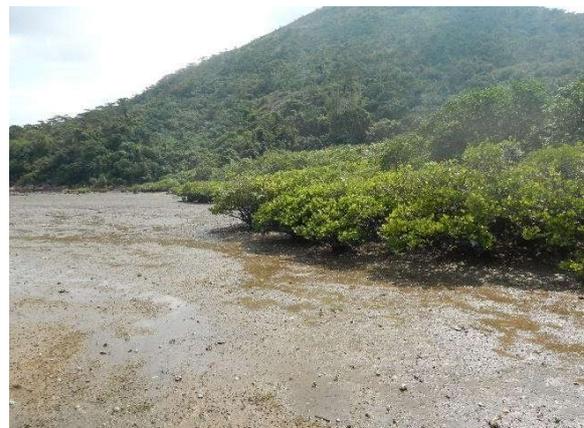
- 6.5.29 In December 2014, all the seagrass patches of *Halophila ovalis* disappeared in ST. **Figure 3.12 of Appendix I** shows the difference of the original seagrass beds area nearby the mangrove vegetation at high tidal level between June 2014 and December 2014. Such rapid loss would not be seasonal phenomenon because the seagrass beds at higher tidal level (2.0 m above C.D.) were present and normal in December 2012 and 2013. According to Fong (1998), similar incident had occurred in ST in the past. The original seagrass area had declined significantly

6.5.34 **Figure 3.12 of Appendix I** shows the recolonization of seagrass bed in ST from December 2014 to June 2017. From March to June 2015, 2 – 3 small patches of *Halophila ovalis* were newly found co-inhabiting with another seagrass species *Zostera japonica*. But the total patch area of *Halophila ovalis* was still very low compare with previous records. The recolonization rate was low while cold weather and insufficient sunlight were possible factors between December 2014 and March 2015. Moreover, it would need to compete with seagrass *Zostera japonica* for substratum and nutrient, because *Zostera japonica* had extended and covered the original seagrass bed of *Halophila ovalis* at certain degree. From June 2015 to March 2016, the total seagrass area of *Halophila ovalis* had increased rapidly from 6.8 m² to 230.63 m². It had recolonized its original patch locations and covered its competitor *Zostera japonica*. In June 2016, the total seagrass area increased sharply to 4707.3m². Similar to the previous records of March to June 2014, the original patch area of *Halophila ovalis* increased further to a horizontally long strand. Another large seagrass beds colonized the lower tidal zone (1.0 – 1.5 m above C.D.). In September 2016, this patch extended much and covered significant soft mud area of ST, resulting in sharp increase of total area (24245 m²). It indicated the second extensive colonization of this *r*-selected seagrass. In December 2016, this extensive seagrass patch decreased in size and had separated into few, undistinguishable patches. Moreover, the horizontal strand nearby the mangrove vegetation decreased in size. The total seagrass bed decreased to 12550 m². From March to June 2017, the seagrass bed area remained generally stable (12438- 17046.5 m²) but the vegetation coverage fluctuated (20 – 50% in March 2017 to 80 – 100% in June 2017). The whole recolonization process took about 2.5 years.

- 6.5.35 In September 2017, the whole seagrass bed of *Halophila ovalis* disappeared again along the shore of TC3 and ST (**Figure 3.12 of Appendix I**). Similar to the first disappearance of seagrass bed occurred between September and December 2014, strong water current (e.g. cyclone) or deteriorated water qualities (e.g. high turbidity) was the possible cause.

Figure 3.12 Comparison of pictures taken in different sampling months shows the successive disappearance and recolonization of seagrass beds. The picture of December 2018 was lacking due to night-dawn survey time.

- 6.5.38 Overall, the disappearance of seagrass beds in ST has believed the cause of serial cyclone hit in July and August 2017. Based on previous findings, the seagrass beds of both species were expected to recolonize in the mudflat as long as the vicinal water quality was normal. The whole recolonization process (from few, small patches to extensive strand) would be gradually lasting at least 2 years. From December 2017 to March 2018, there was still no recolonization of few, small patches of seagrass at the usual location (**Figure 3.12 of Appendix I**). It was different from the previous round (March 2015 – June 2017). Until June 2018, the new seagrass patches with small-medium size were found at the usual location (seaward side of mangrove plantation at 2.0 m C.D.) again, indicating the recolonization. However, the seagrass bed area decreased sharply to 22.5 m² in September 2018. Again it was believed that the decrease was due to the hit of the super cyclone in September 2018 (Mangkhutun 16th September, highest signal 10). From December 2018 to June 2019, the seagrass bed area increased from 404 m² to 1229 m² while the vegetation coverage is also increased (December 2018: 5– 85%; March 2019: 50 – 100% and June 2019: 60 – 100%). Relatively, the whole recolonization process would occur slower than the previous round (more than 2 years). From September 2019 to March 2021, the seagrass bed area in ST slightly decreased from 1200 m² to 942.05 m², which were in normal fluctuation. From March 2021 to December 2021, the seagrass bed area in ST decreased from 942.05 m² to 680m², which were in normal fluctuation. In March 2022, the seagrass bed area in
