**Contract No. HY/2011/03**

**Hong Kong-Zhuhai-Macao Bridge Hong Kong Link Road  
Section between Scenic Hill and Hong Kong Boundary Crossing  
Facilities**

**Monthly EM&A Report No.135 (Dec 2023)**

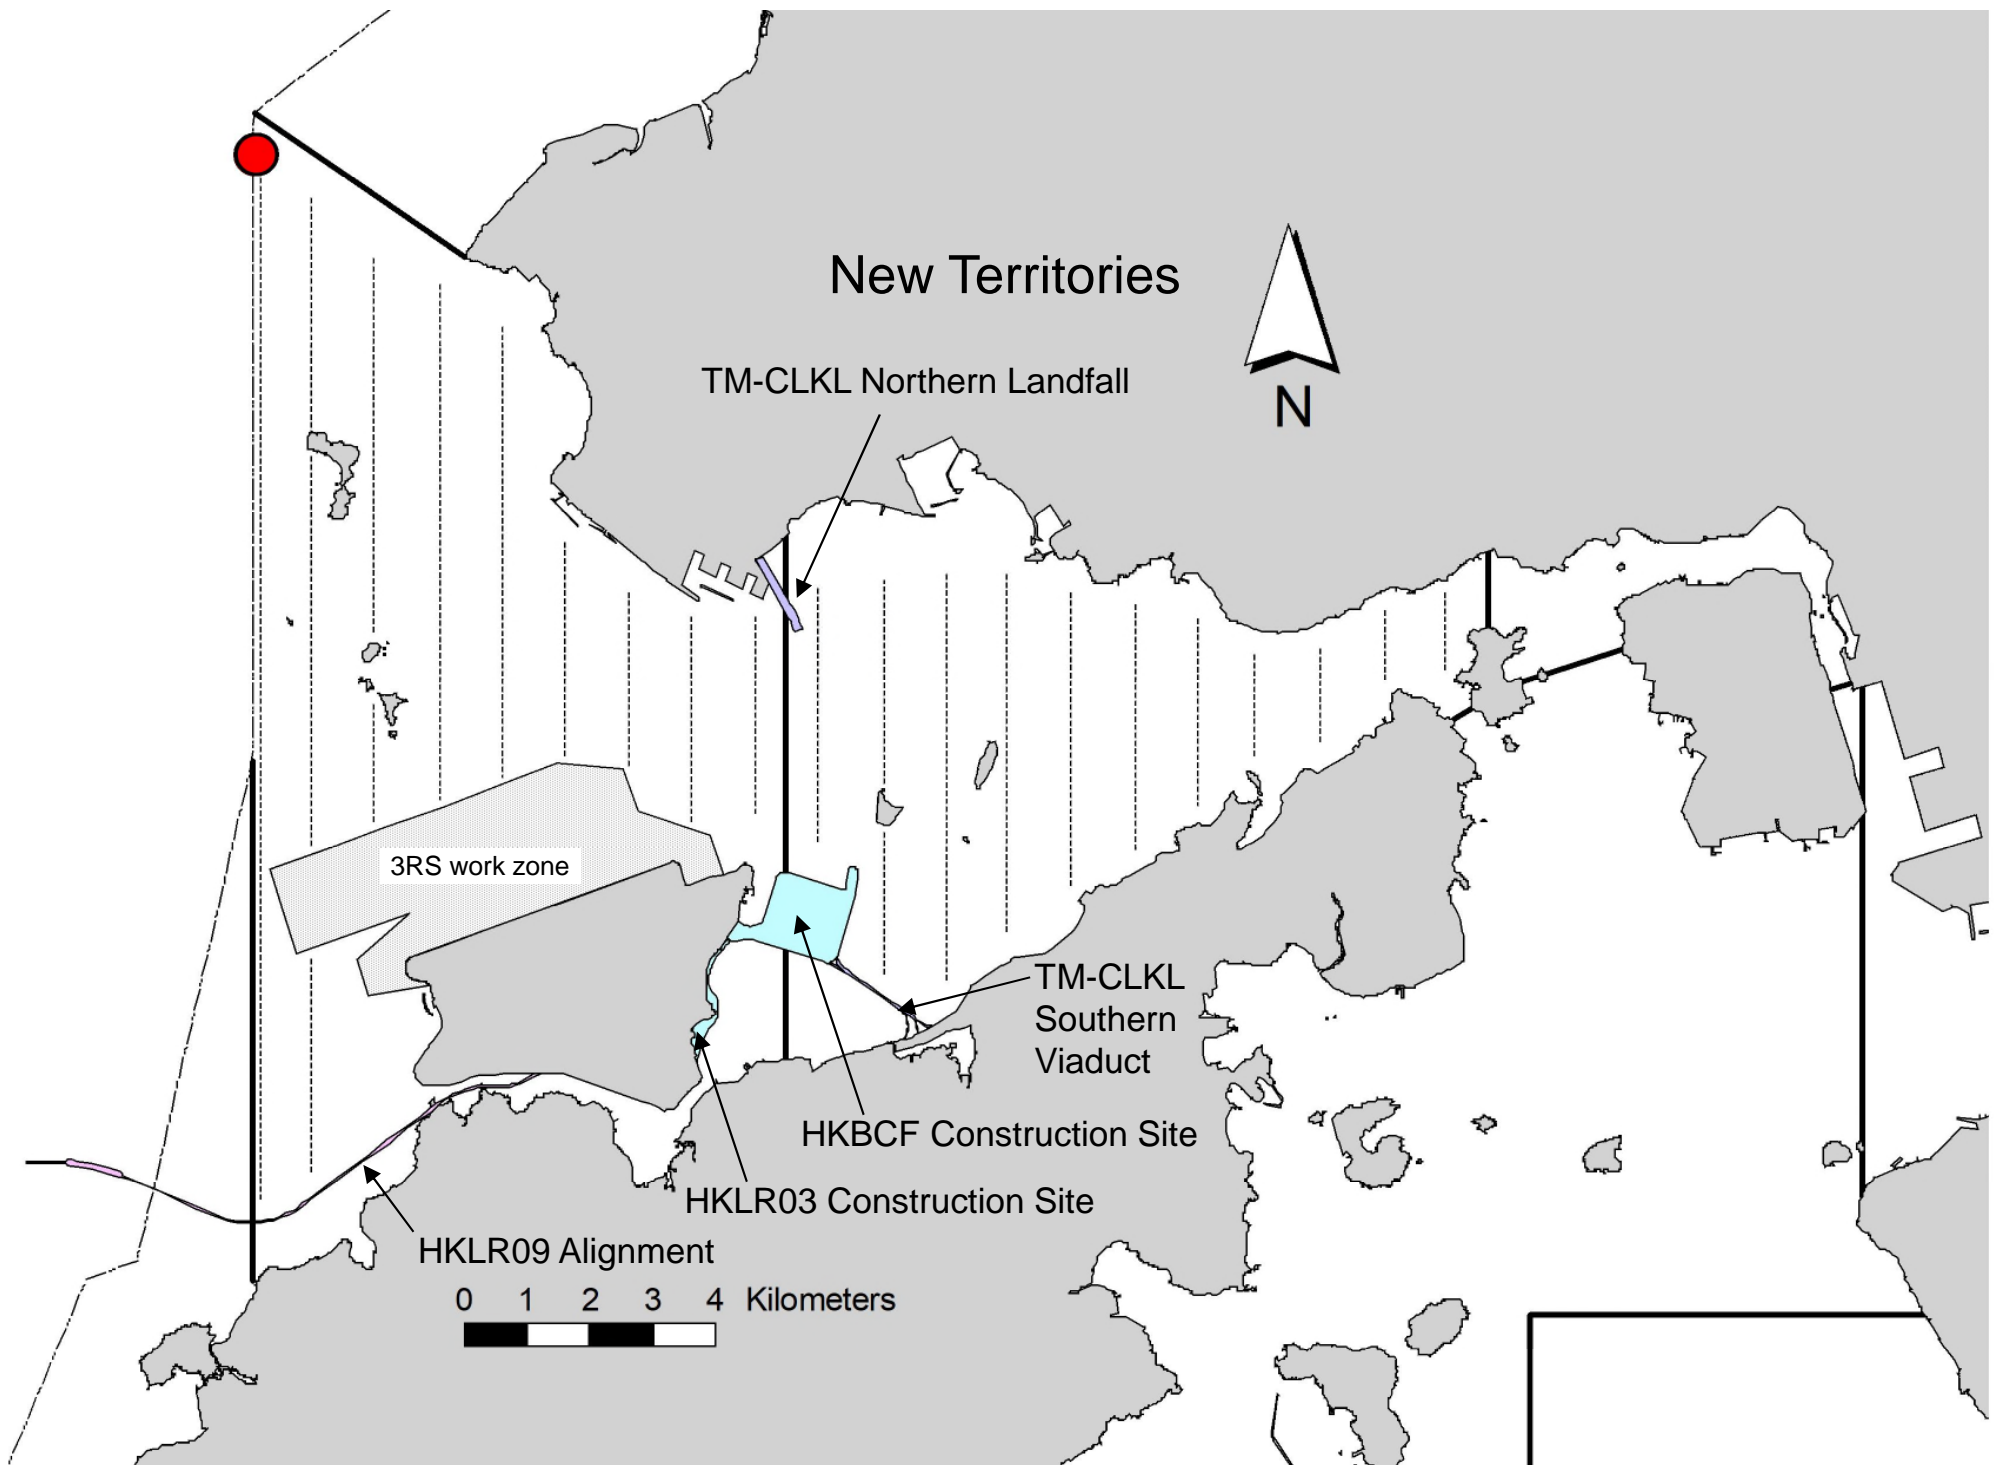
Figure 6. Distribution of Chinese White Dolphin Sightings during December 2023 HKLR03 Monitoring Surveys

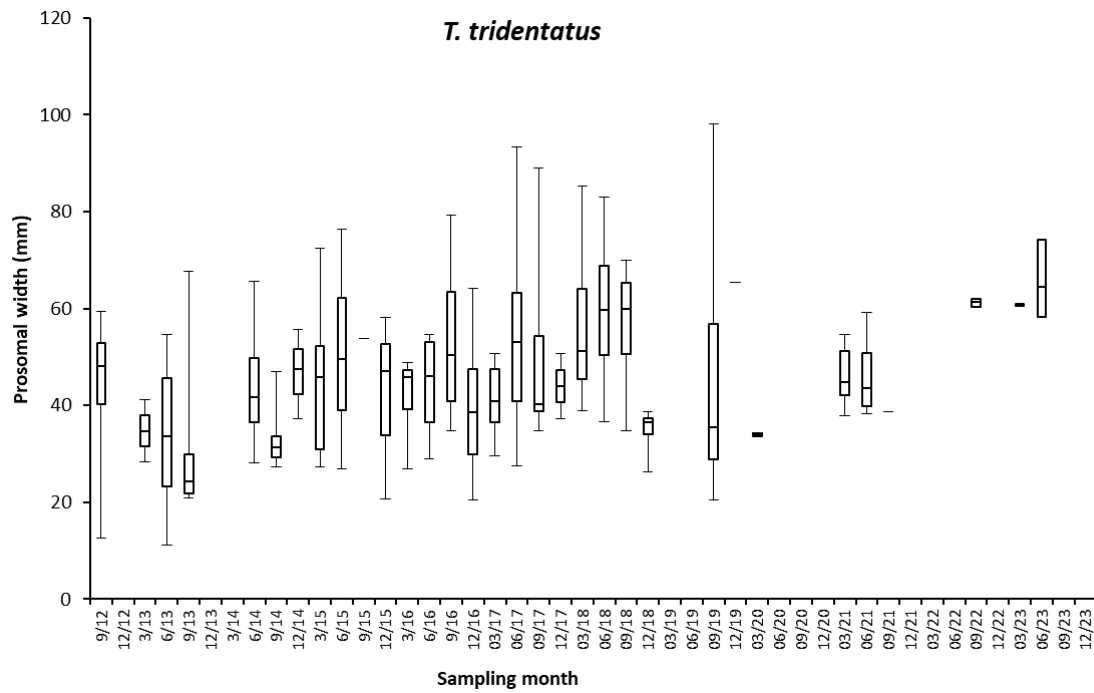
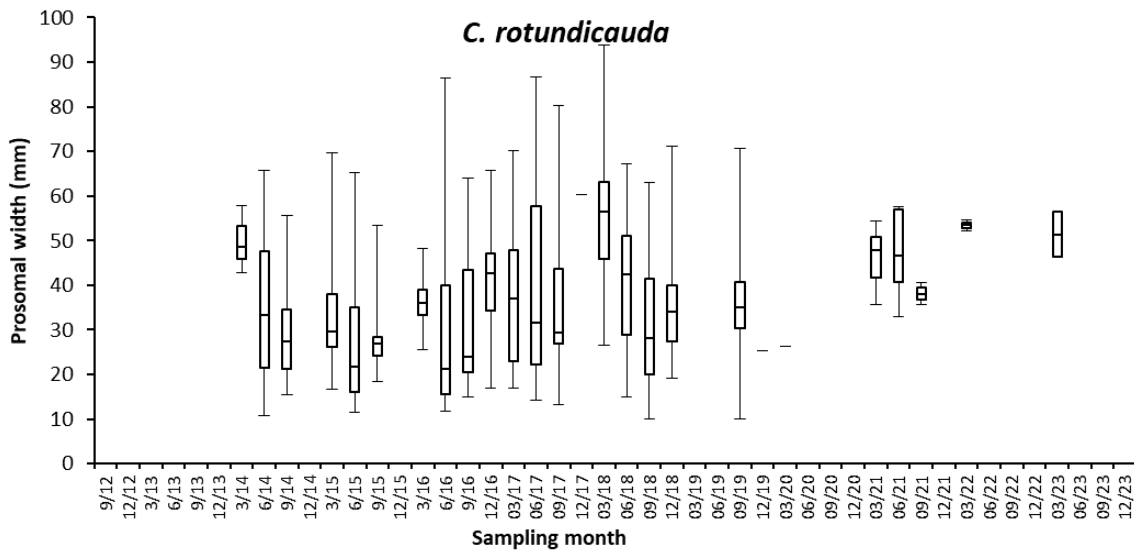
**Figure 3.7** Box plot of prosomal width of horseshoe crab in the sampling zone TC3 along the sampling months. (The box represents 50% of the sample (upper to lower quartile) with a middle line showing the median value. The upper whisker and lower whisker showed the 25% of sample above upper quartile and below the lower quartile respectively)

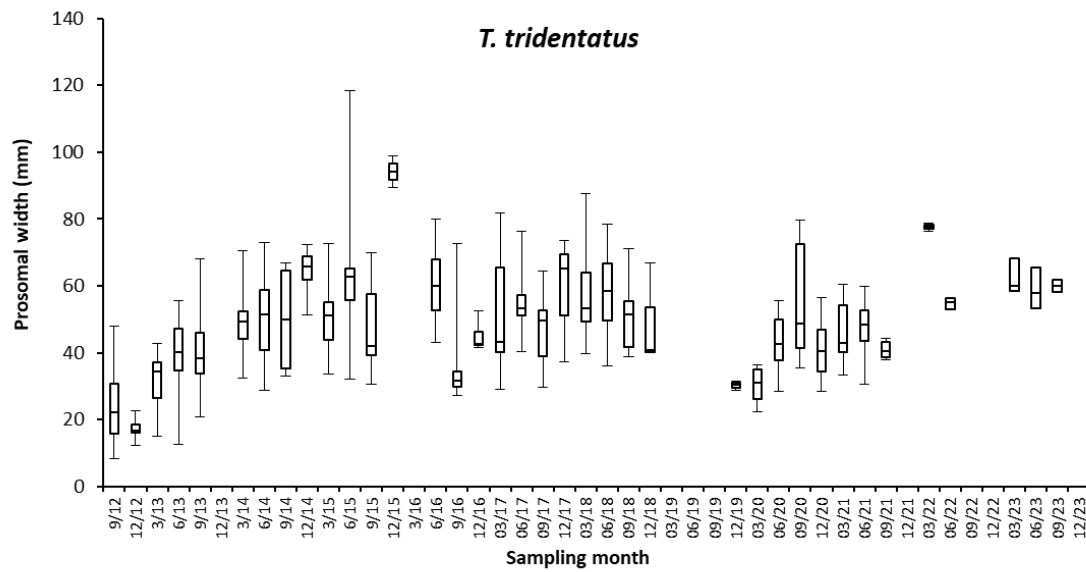
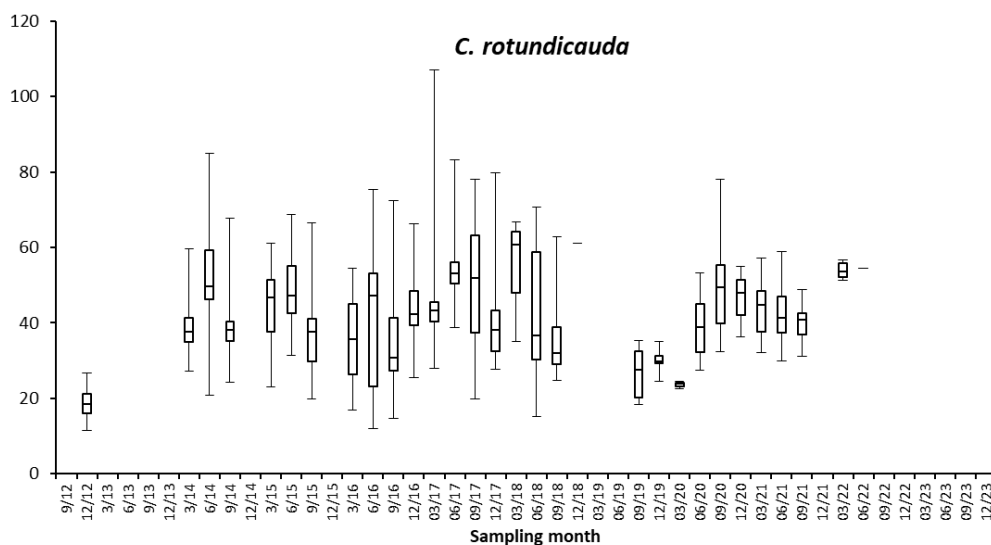
**Figure 3.8** Box plot of prosomal width of horseshoe crab in the sampling zone ST along the sampling months. (The box represents 50% of the sample (upper to lower quartile) with a middle line showing the median value. The upper whisker and lower whisker showed the 25% of sample above upper quartile and below the lower quartile respectively.)

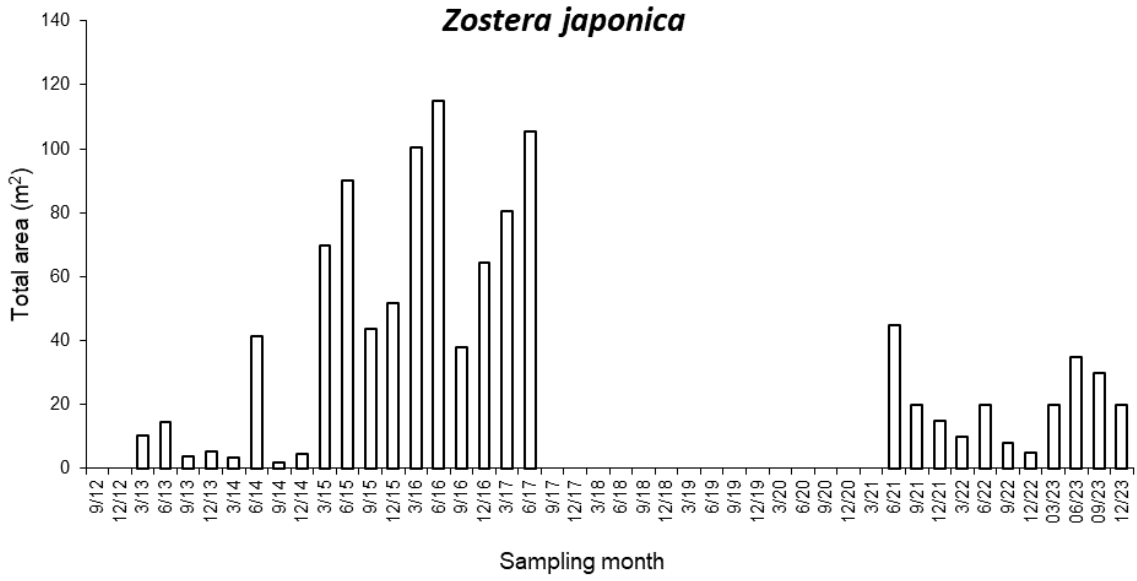
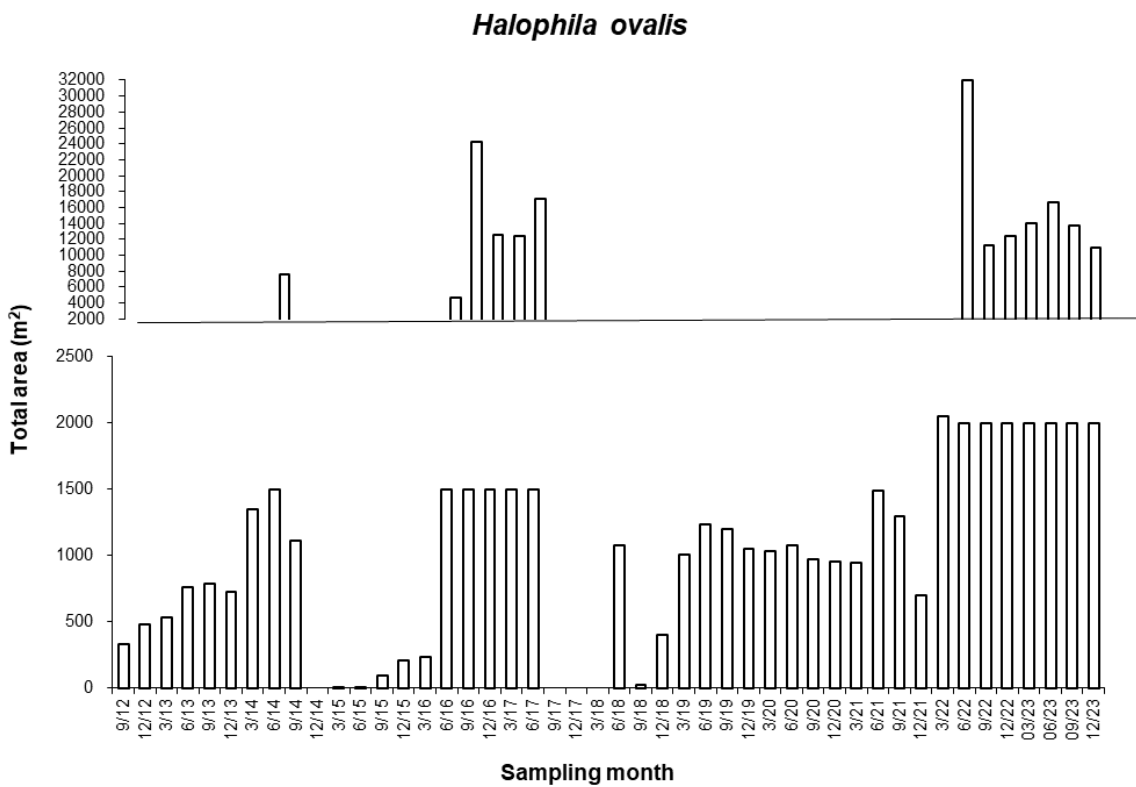
**Figure 3.11** Temporal changes of estimated total area of seagrass beds in ST

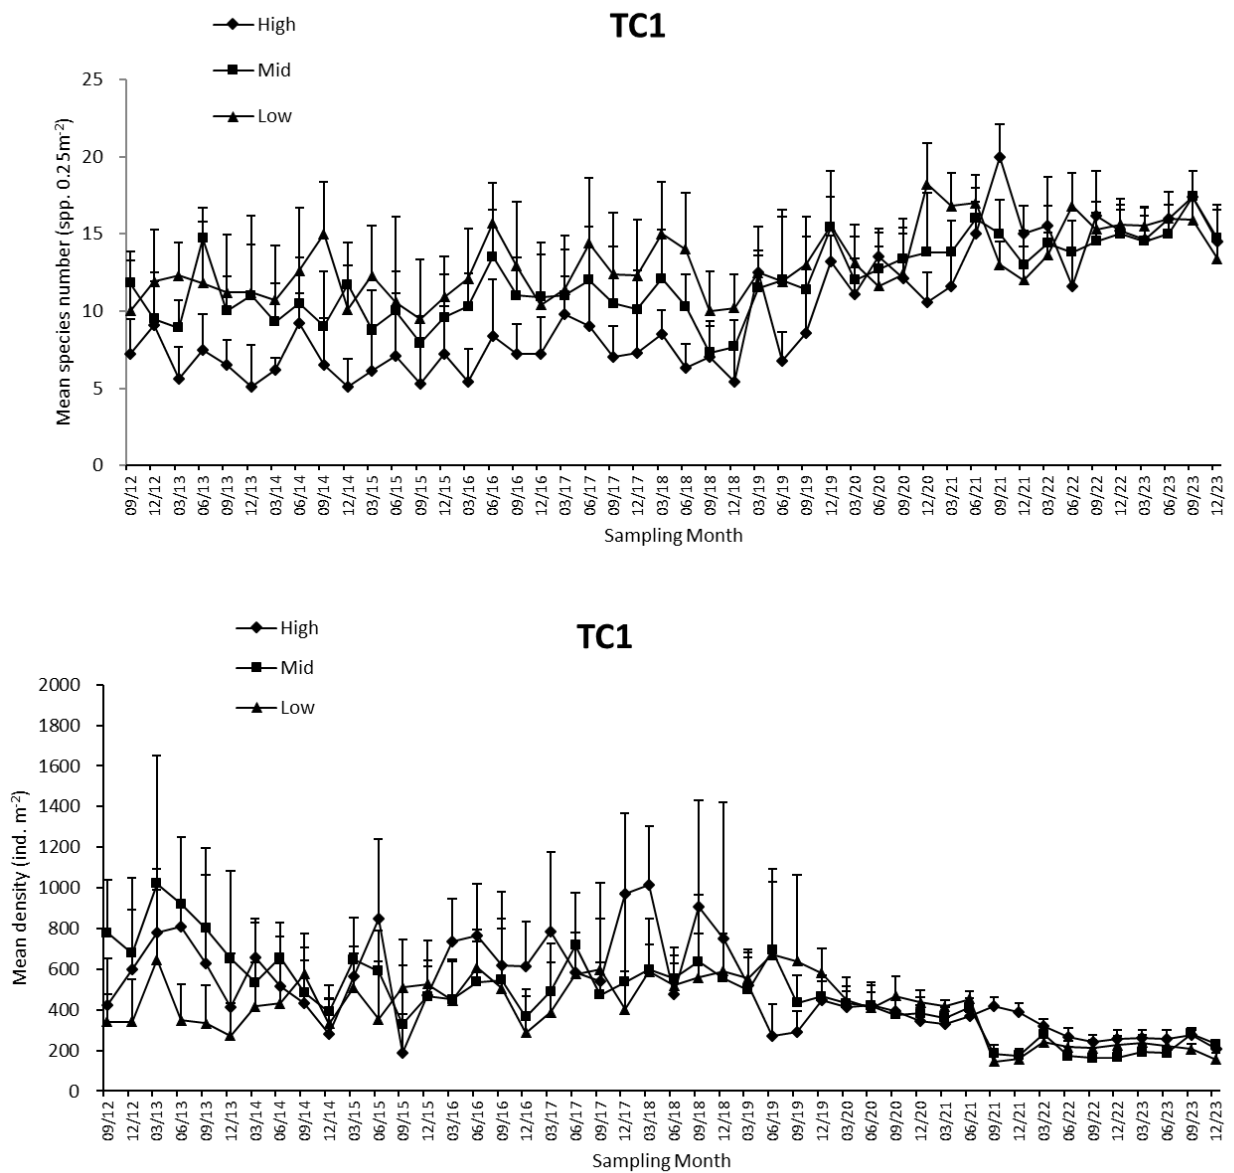
**Figure 3.14** Temporal changes of mean number of species, mean density, Shannon-Weaver Diversity Index ( $H'$ ) and Pielou's Species Evenness ( $J$ ) (mean + SD) at every tidal level in sampling zone TC1

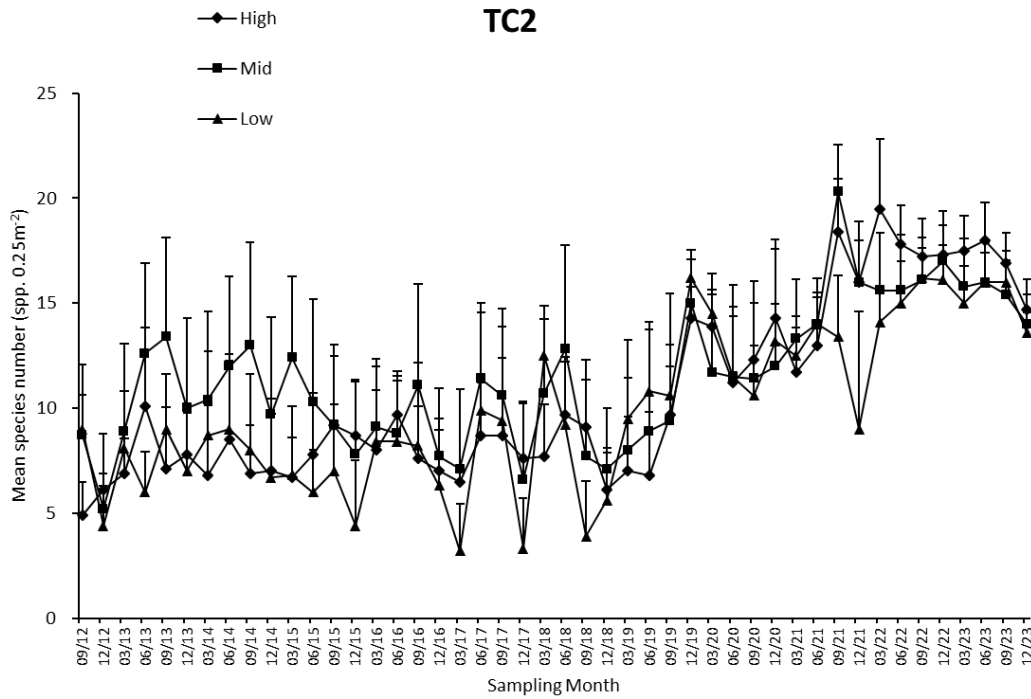
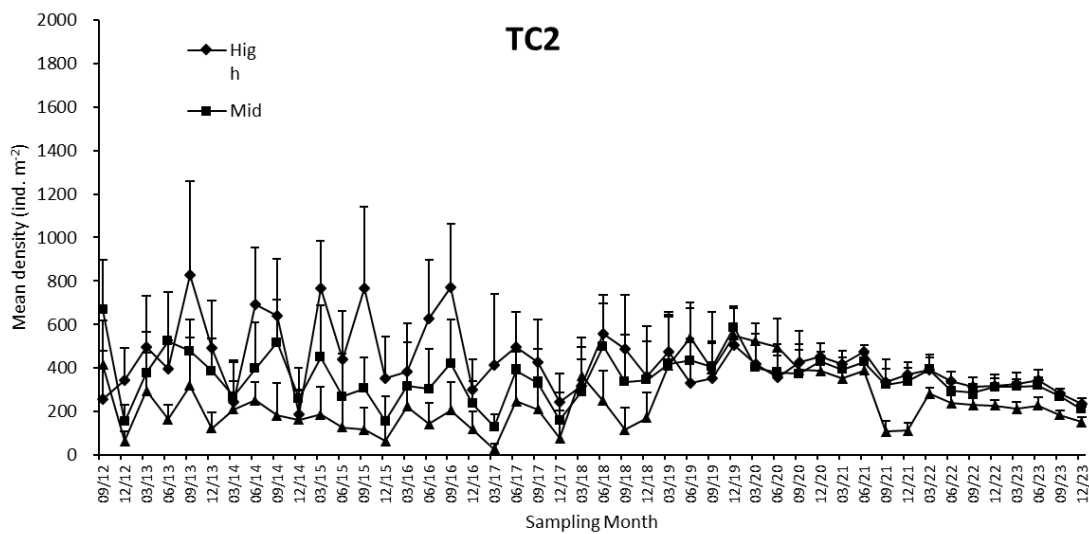
**Figure 3.15** Temporal changes of mean number of species, mean density, Shannon-Weaver Diversity Index ( $H'$ ) and Pielou's Species Evenness ( $J$ ) (mean + SD) at every tidal level in sampling zone TC2

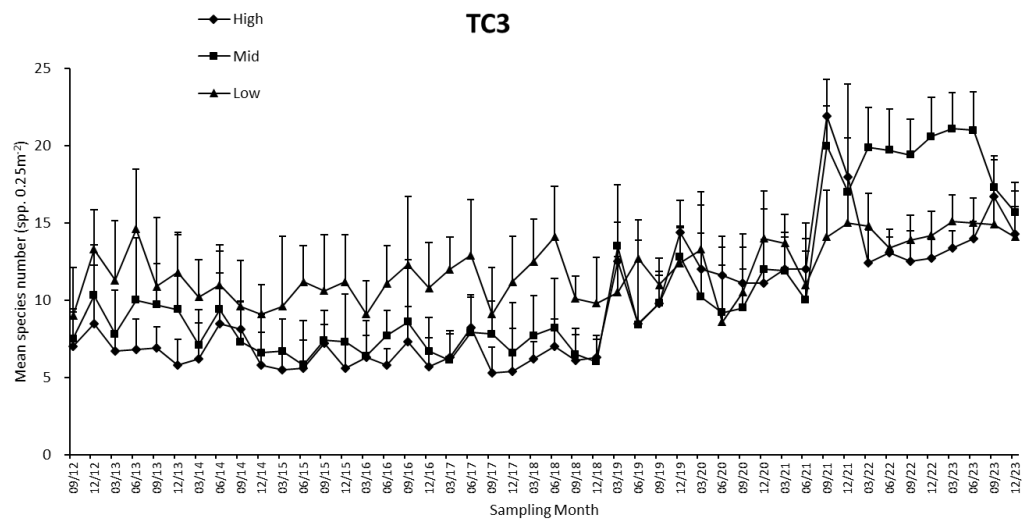
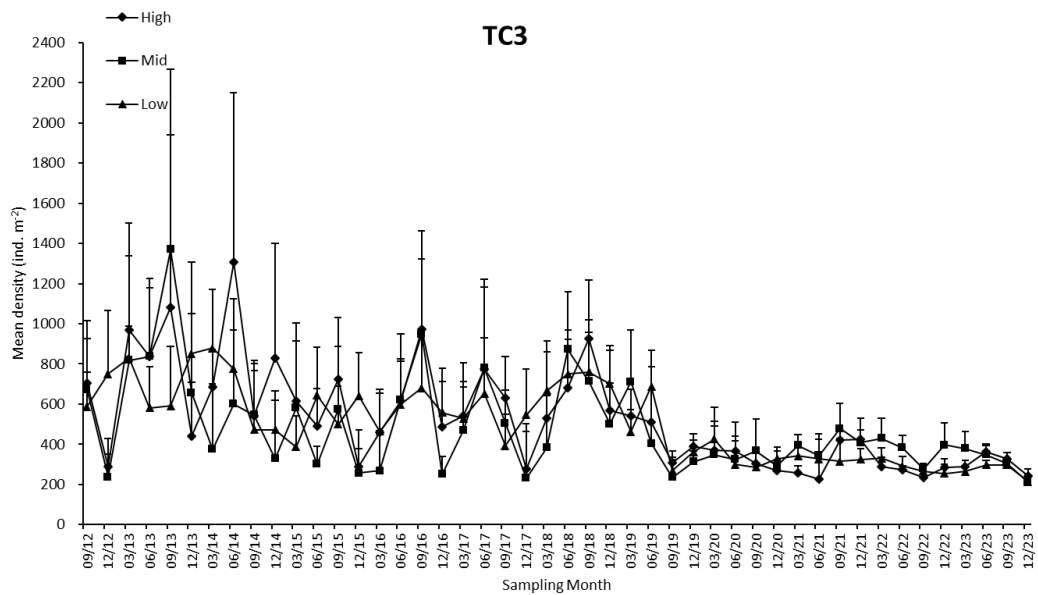
**Figure 3.16** Temporal changes of mean number of species, mean density, Shannon-Weaver Diversity Index ( $H'$ ) and Pielou's Species Evenness ( $J$ ) (mean + SD) at every tidal level in sampling zone TC3

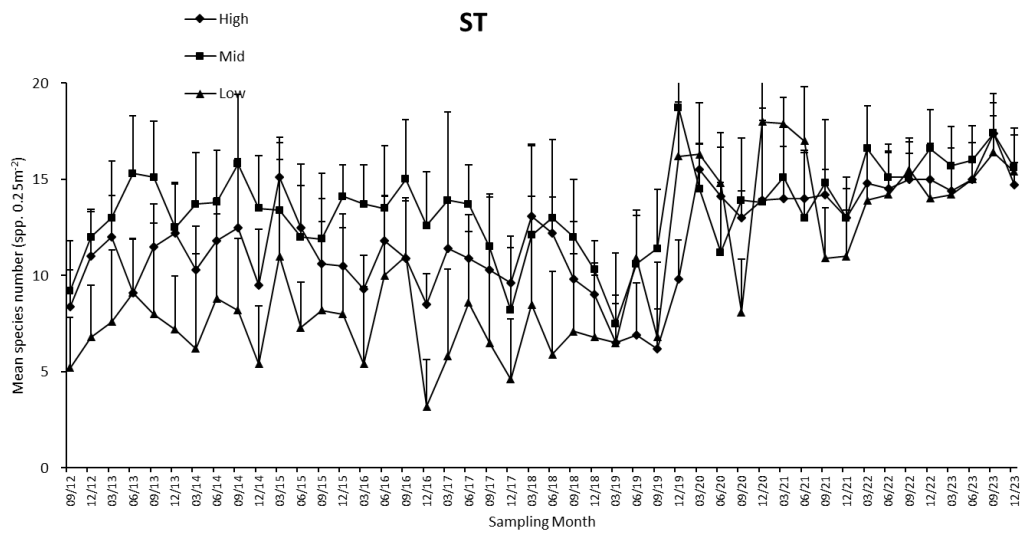
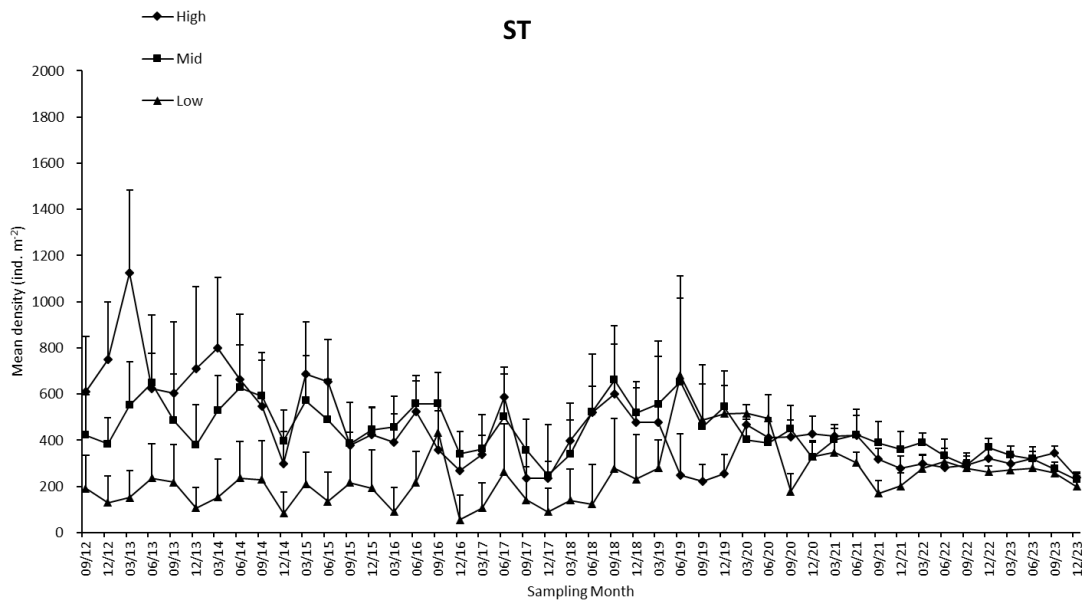
**Figure 3.17** Temporal changes of mean number of species, mean density, Shannon-Weaver Diversity Index ( $H'$ ) and Pielou's Species Evenness ( $J$ ) (mean + SD) at every tidal level in sampling zone ST
