Contract No. HY/2011/03

**Hong Kong-Zhuhai-Macao Bridge Hong Kong Link Road
Section between Scenic Hill and Hong Kong Boundary Crossing
Facilities**

Quarterly EM&A Report No. 39 (March 2022 to May 2022)

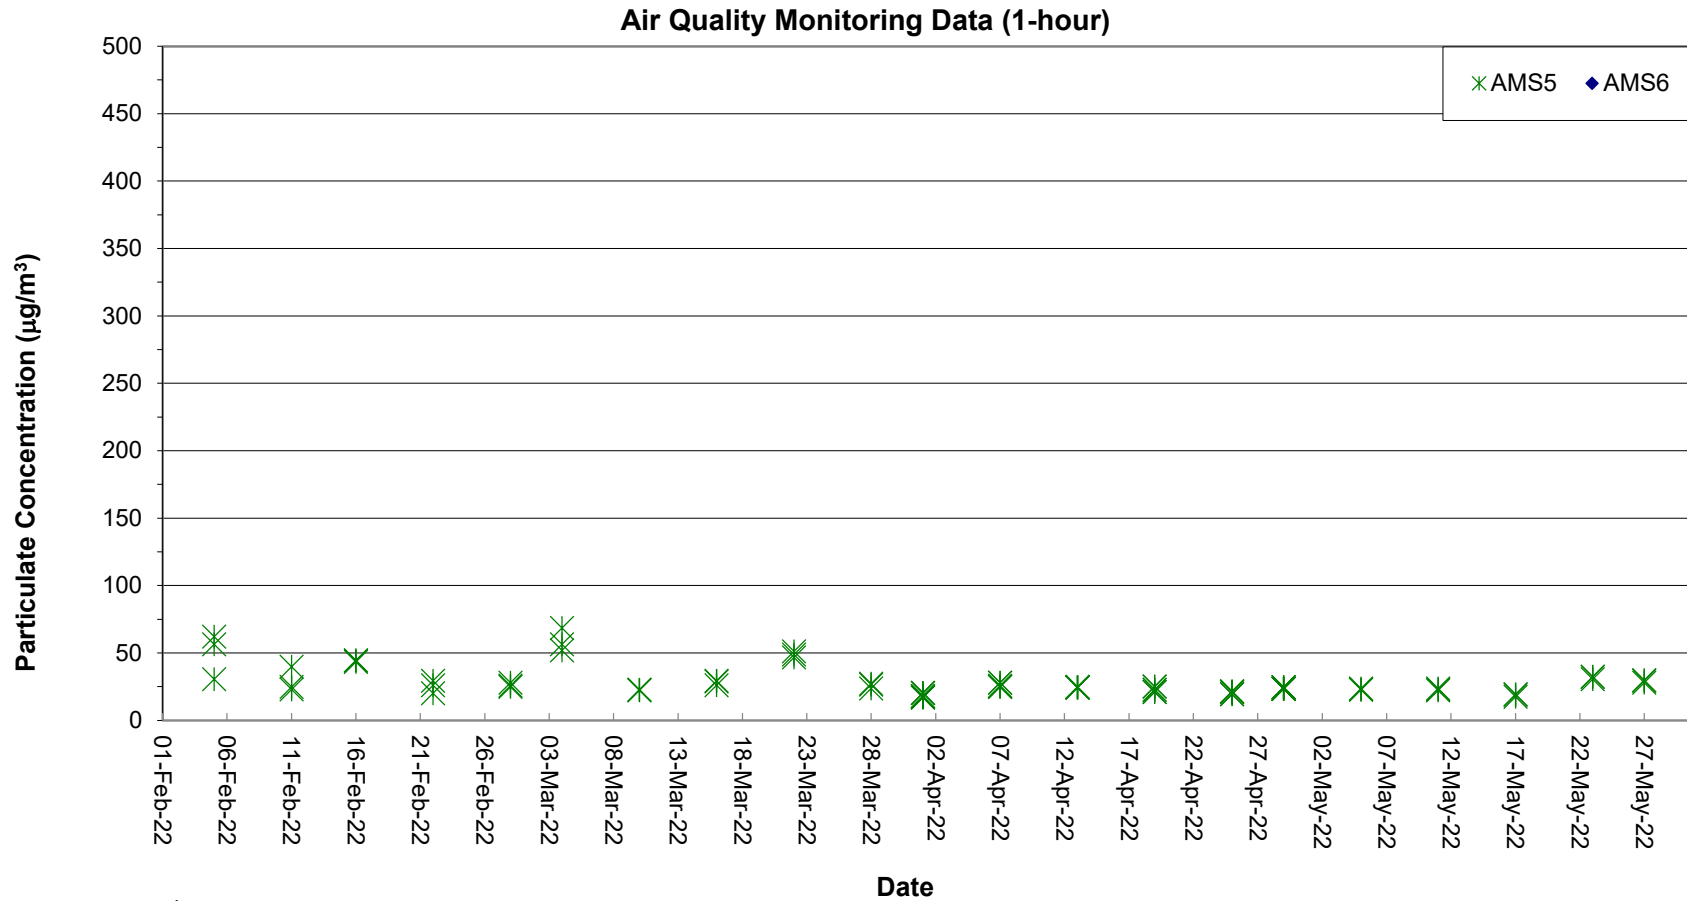
Graphical Plot of 1-hour TSP at AMS5 and AMS6

1) The existing air quality monitoring location AMS6 - Dragonair / CNAC (Group) Building (HKIA) was handed over to Airport Authority Hong Kong on 31 March 2021. 1-hr TSP monitoring at AMS6 was temporarily suspended starting from 1 April 2021.

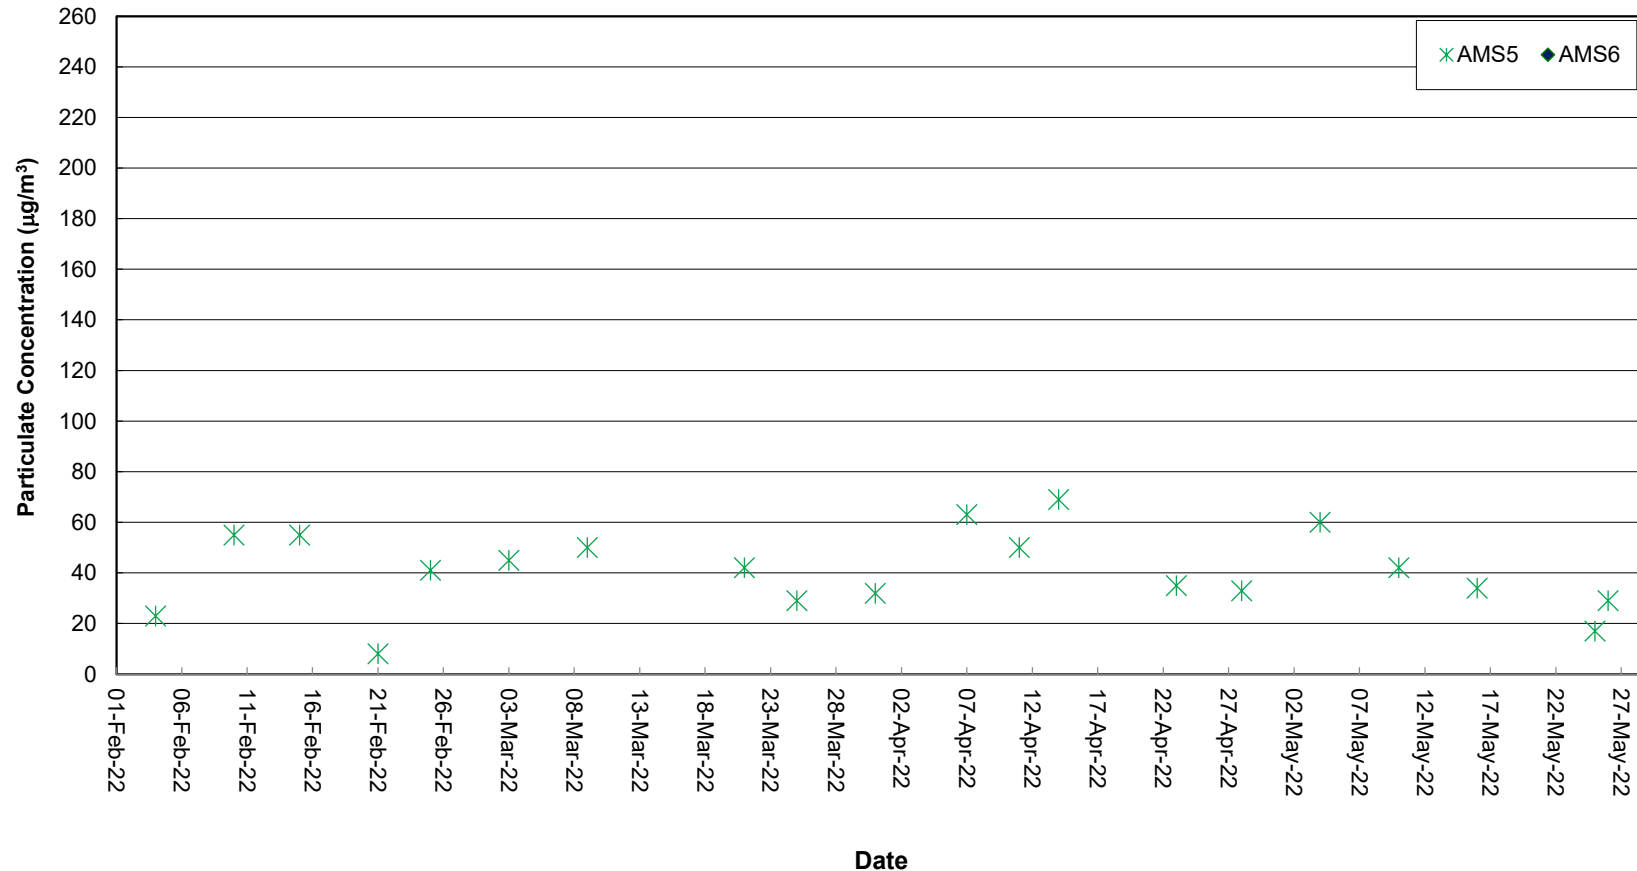
Graphical Plot of 24-hour TSP at AMS5 and AMS6

- 1) The existing air quality monitoring location AMS6 - Dragonair / CNAC (Group) Building (HKIA) was handed over to Airport Authority Hong Kong on 31 March 2021. 24-hr TSP monitoring at AMS6 was temporarily suspended starting from 1 April 2021.

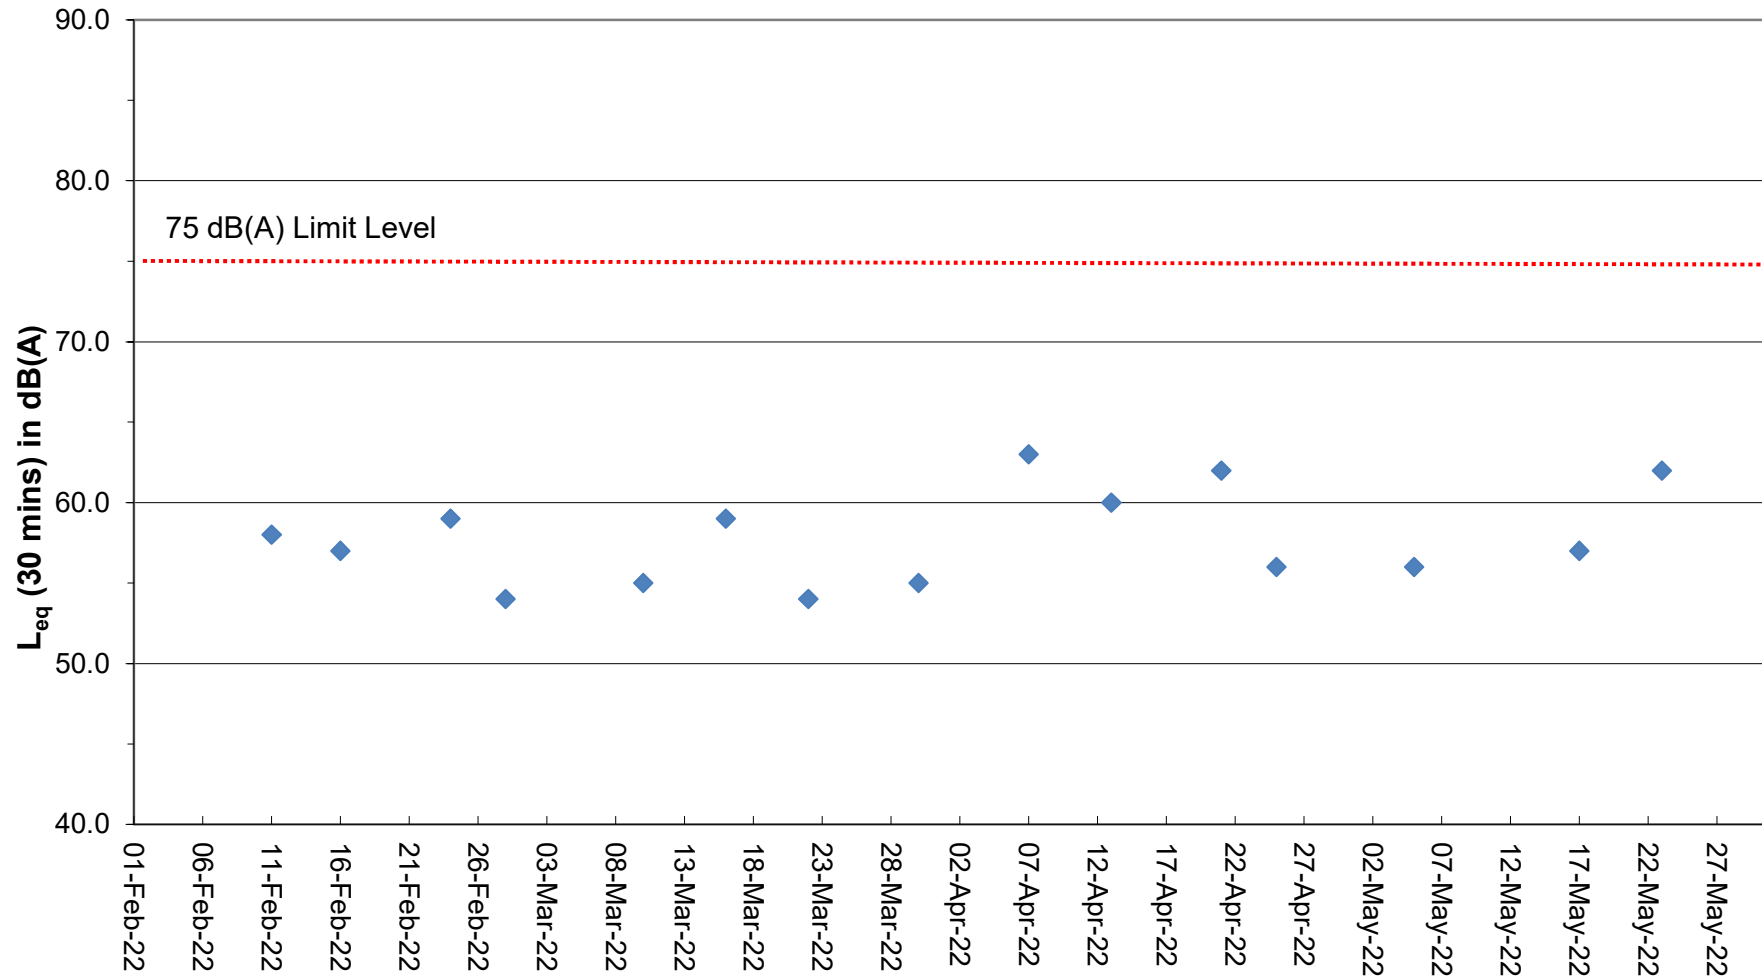
Continuous Noise Monitoring Data (NMS5)

- (1) A facade correction of +3 dB(A) was applied to the measured noise level.
- (2) Due to bad weather condition on 28 March 2022, noise monitoring at NMS5 was rescheduled from 28 March 2022 to 30 March 2022.
- (3) Due to bad weather condition on 19 April 2022, noise monitoring at NMS5 was rescheduled from 19 April 2022 to 21 April 2022.

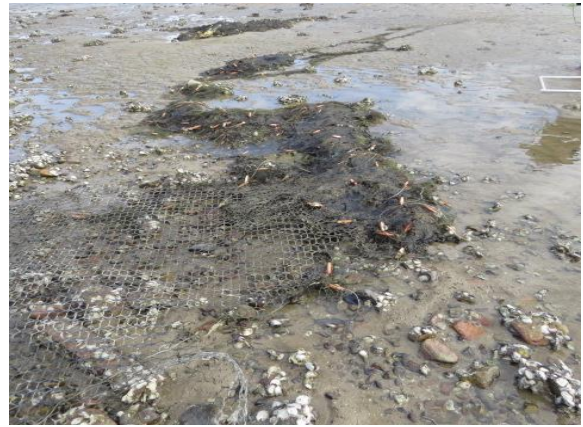
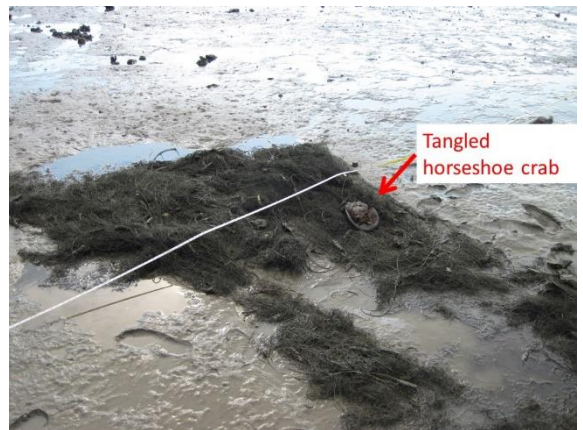
Figure 2.3 *Examples of photographic record of the big trashes found on the mudflat.*

Plastic waste

Trash gill net

Boat wreckage

Trash gill net and hand trolley

A tangled horseshoe crab on a trash net
(record in June 2017)

- 3.6.7 Since the field survey of June 2016, increasing number of trashes and even big trashes (**Figure 2.3 of Appendix O**) were found in every sampling zone. It raised a concern about the solid waste dumping and current-driven waste issues in Tung Chung Wan. Respective measures (e.g. manual clean-up) should be implemented by responsible governmental agency units.

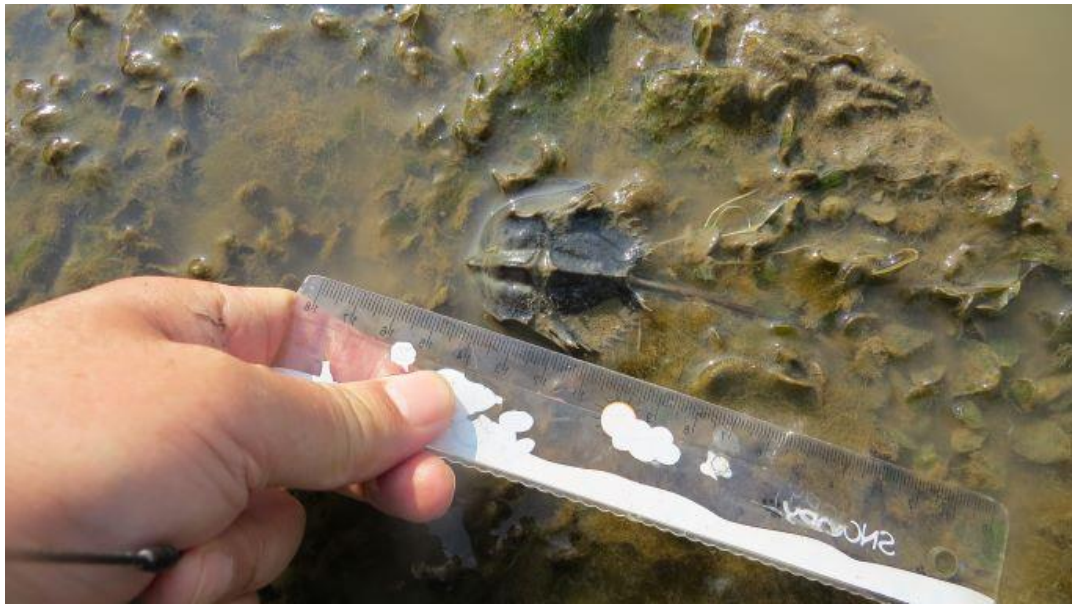
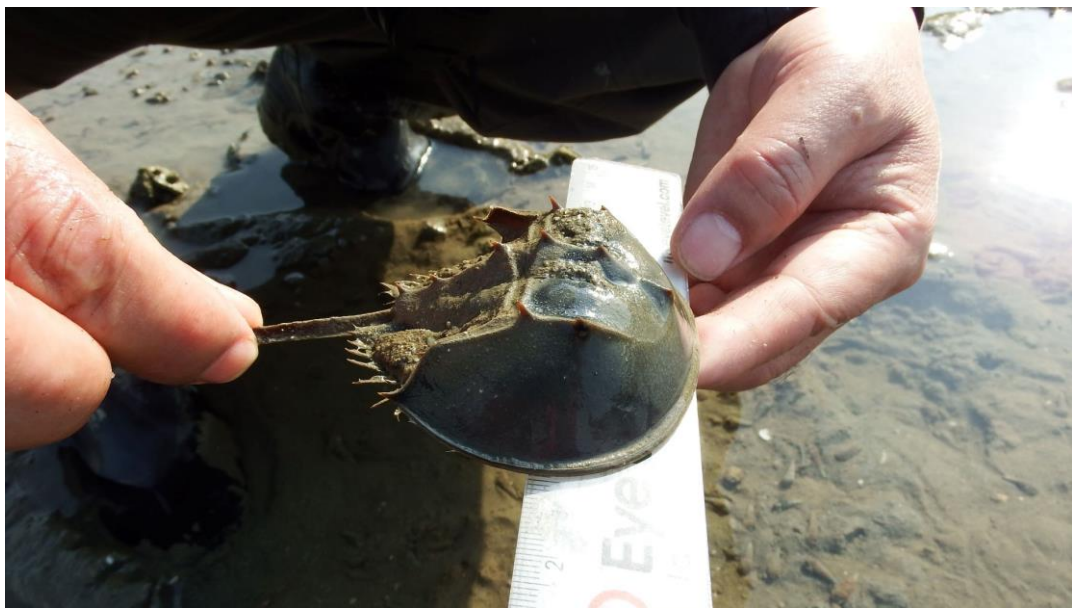
Figure 3.1 *Examples of photographic records of horseshoe crab (Mar 2022)*

ST *Carcinoscorpius rotundicauda*

ST *Tachypleus tridentatus*

- 3.6.16 In total of 10 individuals of juveniles *Carcinoscorpius rotundicauda* and *Tachypleus tridentatus* were found in present survey. The recorded individuals were mainly distributed along the shoreline in ST and TC3. No adult specimen was recorded. All of them were observed on similar substratum (fine sand or soft mud, slightly submerged). Photo records of the observed horseshoe crab are shown in **Figure 3.1 of Appendix O** and the present survey result regarding

- 3.6.17 For *Carcinoscorpius rotundicauda*, more individuals (5 ind.) were found in ST with average body size 53.89mm (prosomal width ranged 51.22-56.66mm). In TC3, 2 individuals with average body size 53.42mm (prosomal width ranged 52.21-54.63mm) were found in present survey. The search record in ST (0.83 ind. hr⁻¹. Person-1) and TC3 (0.33 ind. hr⁻¹. Person-1) were very low. No *Carcinoscorpius rotundicauda* was recorded in TC1 and TC2 in present survey.

- 3.6.18 For *Tachypleus tridentatus*, 2 individuals with average body size 77.59 mm (prosomal width ranged 76.32-78.86 mm) were found in ST in present survey. The search records in ST (0.33 ind. hr⁻¹. Person-1) was very low. No *Tachypleus tridentatus* was found in TC1, TC2 and TC3 in present survey.

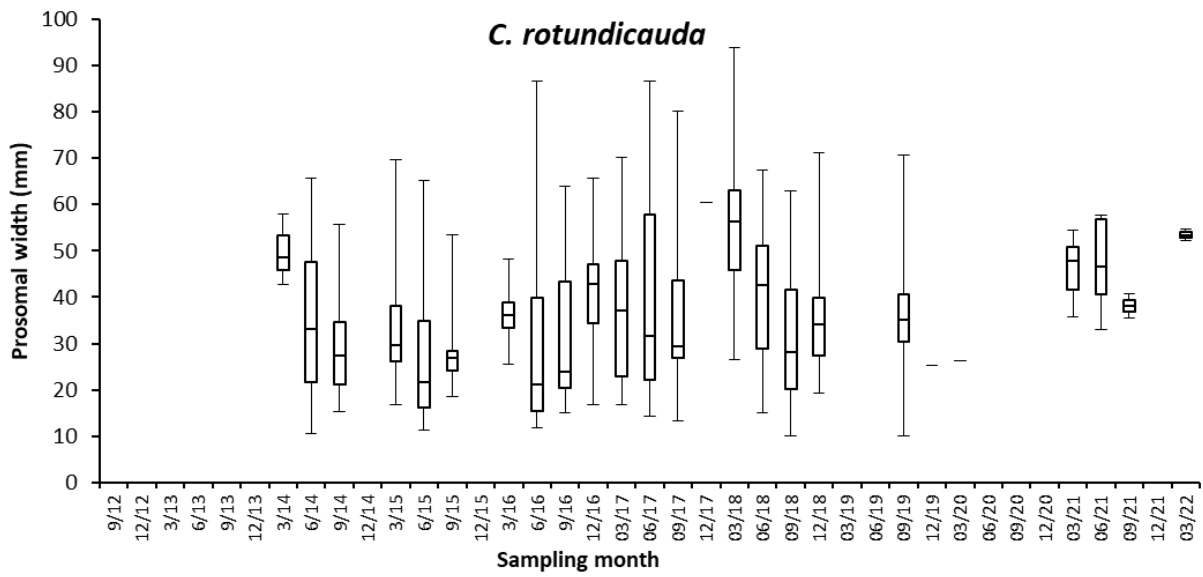
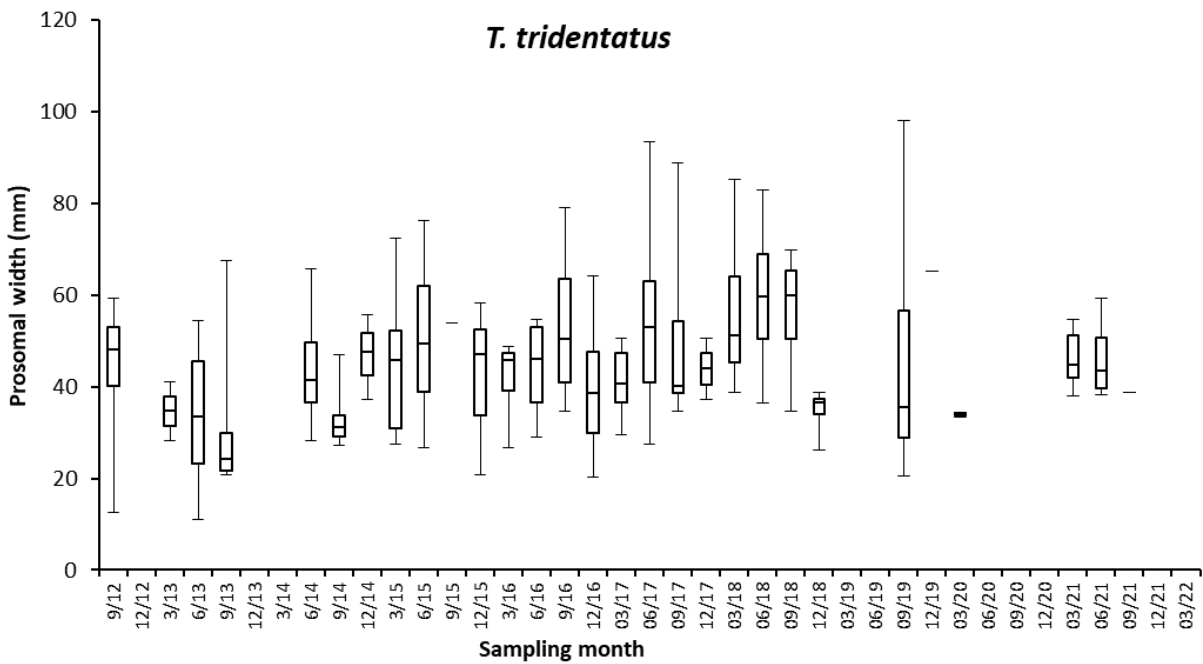
Figure 3.7 Box plot of prosomal width of horseshoe crab in the sampling zone TC3 along the sampling months. (The box represents 50% of the sample (upper to lower quartile) with a middle line showing the median value. The upper whisker and lower whisker showed the 25% of sample above upper quartile and below the lower quartile respectively)

- 3.6.34 **Figure 3.7 of Appendix O** shows the changes of prosomal width of *Carcinoscorpius rotundicauda* and *Tachypleus tridentatus* in TC3. As mentioned above, *Carcinoscorpius rotundicauda* was rarely found between September 2012 and December 2013 hence the data were lacking. In March 2014, the major size (50% of individual records between upper (top box) and lower quartile (bottom box)) ranged 40 – 60 mm while only few individuals were found. From March 2014 to September 2018, the median prosomal width (middle line of whole box) and major size (whole box) decreased after March of every year. It was due to more small individuals found in June indicating new rounds of spawning. Also, there were slight increasing trends of body size from June to March of next year since 2015. It indicated a stable growth of individuals. Focused on larger juveniles (upper whisker), the size range was quite variable (prosomal width 60 – 90 mm) along the sampling months. Juveniles reaching this size might gradually migrate to sub-tidal habitats. In March 2022, 2 *Carcinoscorpius rotundicauda* with body size (prosomal width 52.21-54.63mm) were found in TC3. The findings were relatively lower than the previous record in March. This can be due to the natural variation caused by multi-environmental factors.

- 3.6.35 For *Tachypleus tridentatus*, the major size ranged 20-50 mm while the number of individuals fluctuated from September 2012 to June 2014. Then a slight but consistent growing trend was observed from September 2014 to June 2015. The prosomal width increased from 25 – 35 mm to 35 – 65 mm. As mentioned, the large individuals might have reached a suitable size for migrating from the nursery soft shore to subtidal habitat. It accounted for the declined population in TC3. From March to September 2016, slight increasing trend of major size was noticed again. From December 2016 to June 2017, similar increasing trend of major size was noted with much higher number of individuals. It reflected new round of spawning. In September 2017, the major size decreased while the trend was different from previous two years. Such decline might be the cause of serial cyclone hit between June and September 2017 (to be discussed in the 'Seagrass survey' section). From December 2017 to September 2018, increasing trend was noted again. It indicated a stable growth of individuals. From September 2018 to that of next year, the average prosomal widths were decreased from 60mm to 36mm. It indicated new rounds of spawning occurred during September to November 2018. In December 2019, an individual with larger body size (prosomal width 65mm) was found in TC3 which reflected the stable growth of individuals. In March 2020, the average prosomal width (middle line of the

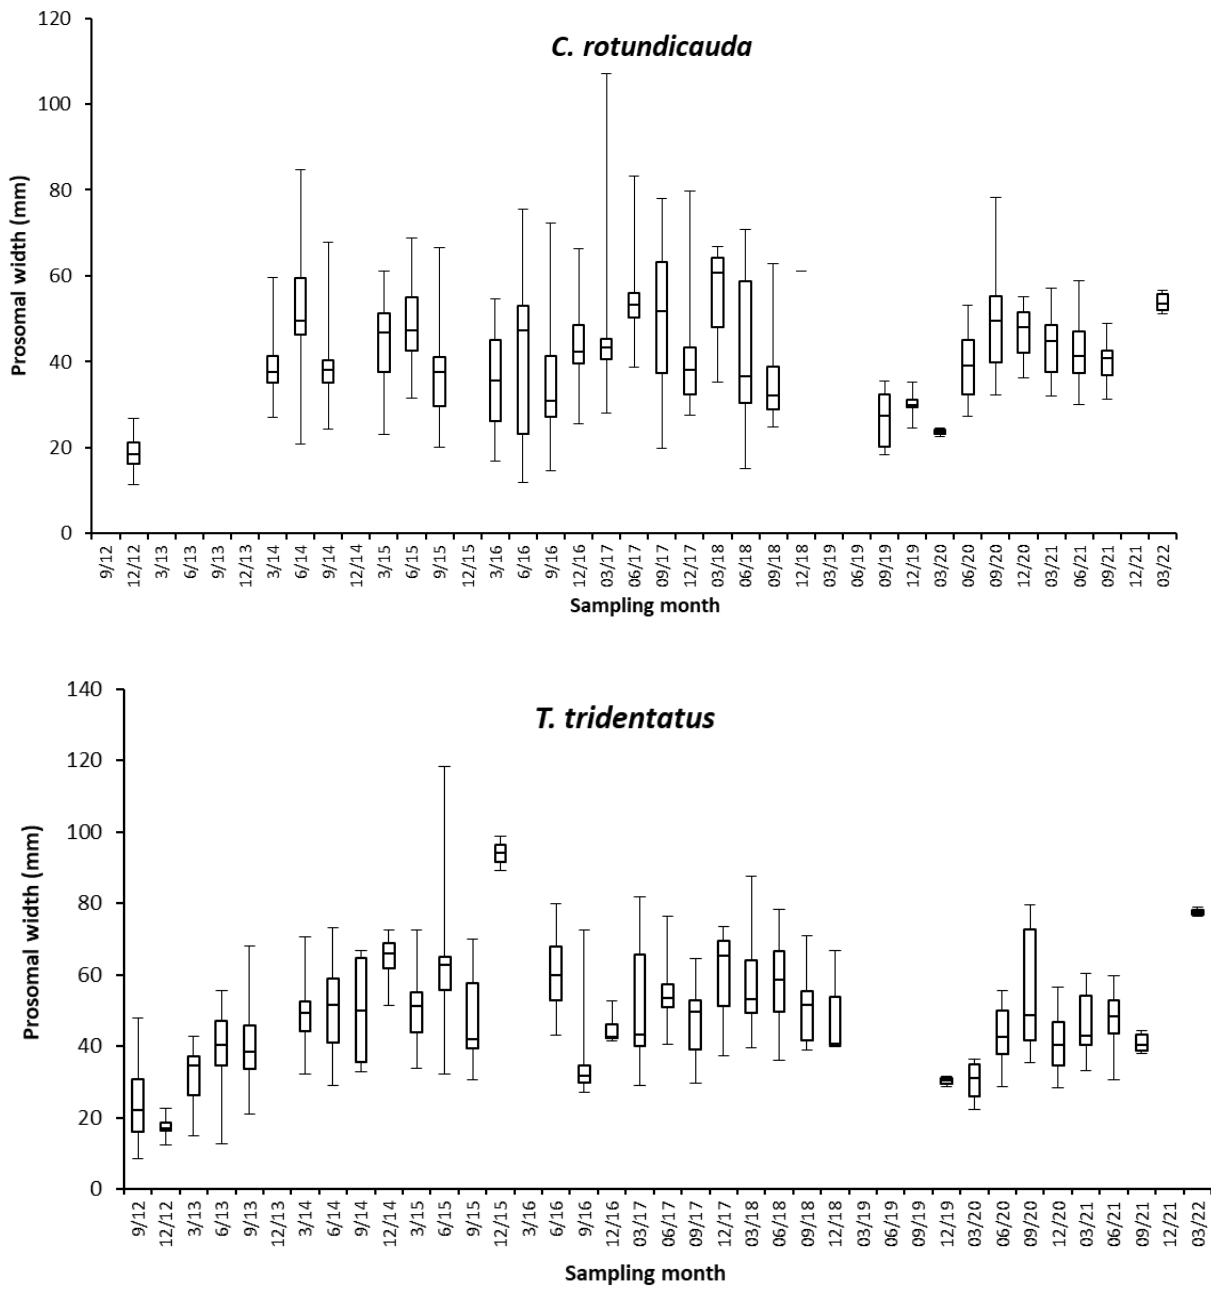
Figure 3.8 Box plot of prosomal width of horseshoe crab in the sampling zone ST along the sampling months. (The box represents 50% of the sample (upper to lower quartile) with a middle line showing the median value. The upper whisker and lower whisker showed the 25% of sample above upper quartile and below the lower quartile respectively.)

- 3.6.36 **Figure 3.8 of Appendix O** shows the changes of prosomal width of *Carcinoscorpius rotundicauda* and *Tachypleus tridentatus* in ST. As mentioned above, *Carcinoscorpius rotundicauda* was rarely found between September 2012 and December 2013 hence the data were lacking. From March 2014 to September 2018, the size of major population decreased and more small individuals (i.e. lower whisker) were recorded after June of every year. It indicated new round of spawning. Also, there were similar increasing trends of body size from September to June of next year between 2014 and 2017. It indicated a stable growth of individuals. The larger juveniles (i.e. upper whisker usually ranged 60 – 80 mm in prosomal width except one individual (prosomal width 107.04 mm) found in March 2017. It reflected juveniles reaching this size would gradually migrate to sub-tidal habitats.

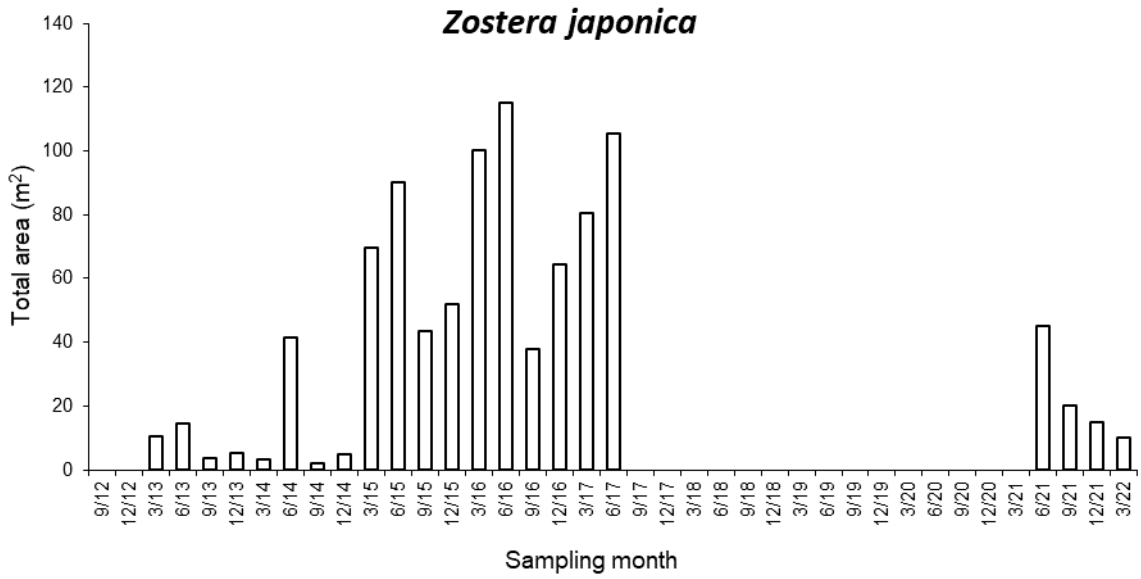
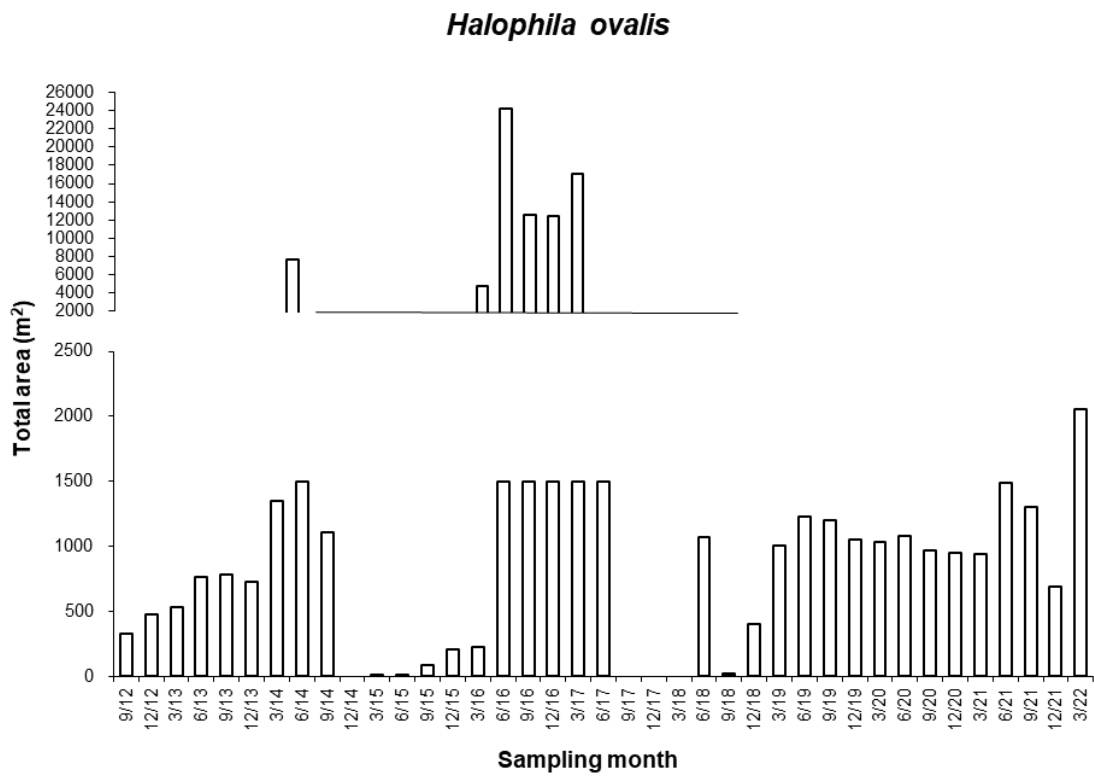
Figure 3.11 Temporal changes of estimated total area of seagrass beds in ST

Sampling zone	TC3 <i>Halophila ovalis</i>	ST <i>Halophila ovalis</i>	ST <i>Zostera japonica</i>
Number of patches	3	6	1
Total area (m²)	560	2050	10
Average area (m²)	186.67	341.67	10
