**Contract No. HY/2011/03**

**Hong Kong-Zhuhai-Macao Bridge Hong Kong Link Road  
Section between Scenic Hill and Hong Kong Boundary Crossing  
Facilities**

**Quarterly EM&A Report No. 40 (June 2022 to August 2022)**

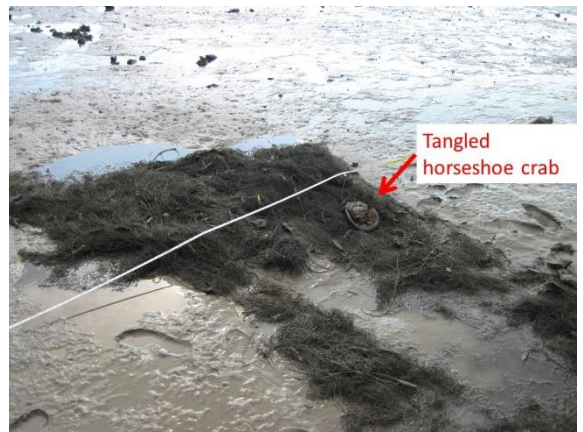
A tangled horseshoe crab on a trash net (record in June 2017)

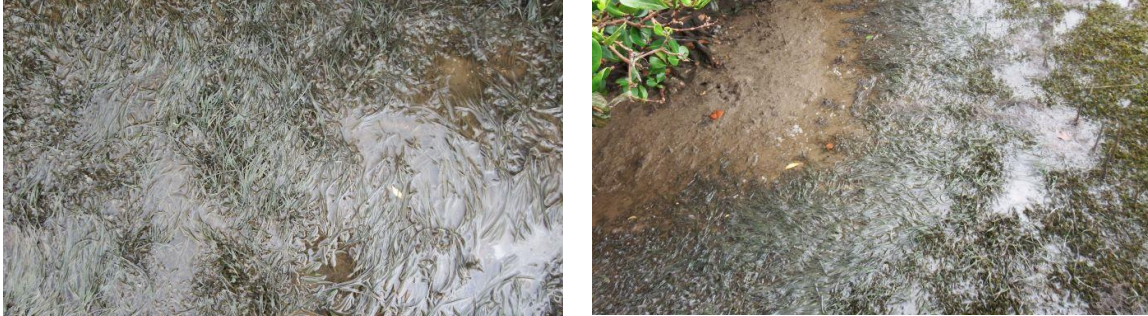
**Figure 3.9 (Cont'd)** *Photographic record of seagrass beds in present survey.*

- 3.6.55 Overall, the disappearance of seagrass beds in ST has believed the cause of serial cyclone hit in July and August 2017. Based on previous findings, the seagrass beds of both species were expected to recolonize in the mudflat as long as the vicinal water quality was normal. The whole recolonization process (from few, small patches to extensive strand) would be gradually lasting at least 2 years. From December 2017 to March 2018, there was still no recolonization of few, small patches of seagrass at the usual location (**Figure 3.12 of Appendix O**). It was different from the previous round (March 2015 - June 2017). Until June 2018, the new seagrass patches with small-medium size were found at the usual location (seaward side of mangrove plantation at 2.0 m C.D.) again, indicating the recolonization. However, the seagrass bed area decreased sharply to 22.5 m<sup>2</sup> in September 2018. Again, it was believed that the decrease was due to the hit of the super cyclone in September 2018 (Mangkhuton 16<sup>th</sup> September, highest signal 10). From December 2018 to June 2019, the seagrass bed area increased from 404 m<sup>2</sup> to 1229 m<sup>2</sup> while the vegetation coverage is also increased. (December 2018: 5 - 85%; March 2019: 50 - 100% and June 2019: 60 - 100%). Relatively, the whole recolonization process would occur slower than the previous round (more than 2 years). From September 2019 to March 2021, the seagrass bed area in ST slightly decreased from 1200 m<sup>2</sup> to 942.05 m<sup>2</sup>, which were in normal fluctuation. From March 2021 to December 2021, the seagrass bed area in ST decreased from 942.05 m<sup>2</sup> to 680 m<sup>2</sup>, which were in normal fluctuation. In March 2022, the seagrass bed area in ST increased significantly to approximately 2040 m<sup>2</sup>, which believed to be related to more rain in current dry season. It was observed that the brown filamental algae bloom occurred at ST site in March 2022. Distribution of the algae was overlap with seagrass beds, mainly the species *Halophila ovalis* and the algae was grown over the top of the seagrass. In some areas, the brown filamental algae full covered the seagrass bed, refer to **Figure 3.9 of Appendix O**. The seagrass was still alive when checked during the field survey. Whether the algae bloom will kill seagrass in longer period time is unknown. The algae bloom of the brown filamental algae at the seagrass bed is disappeared as observed in June 2022, refer to **Figure 3.9 of Appendix O**.

***Halophila ovalis* and *Zostera japonica* in ST**

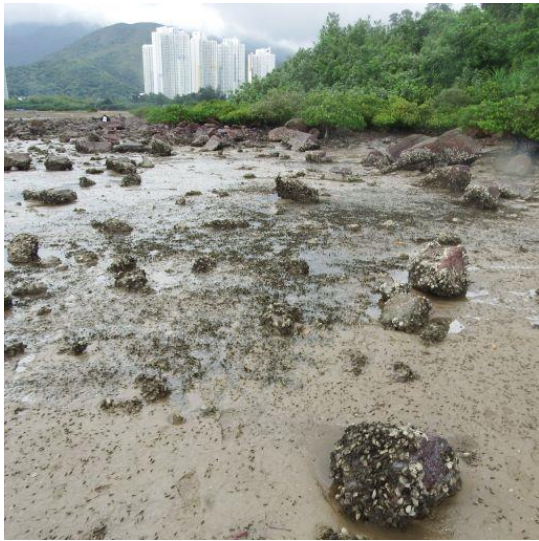
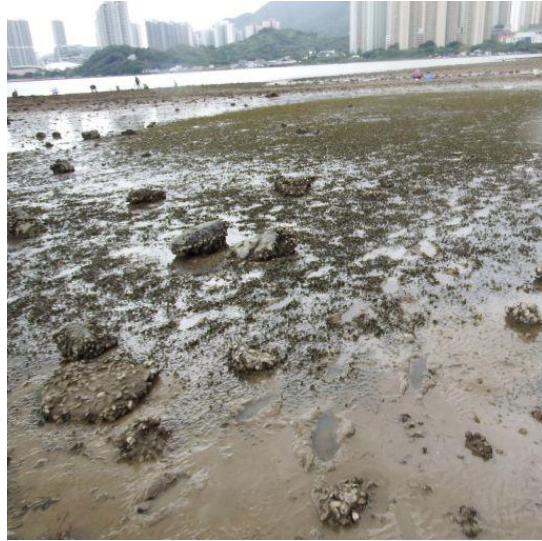
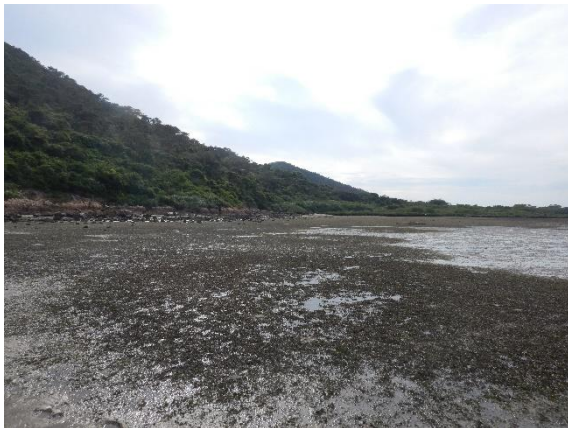
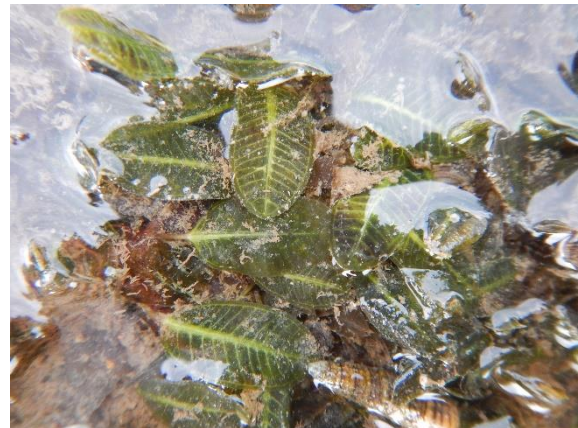
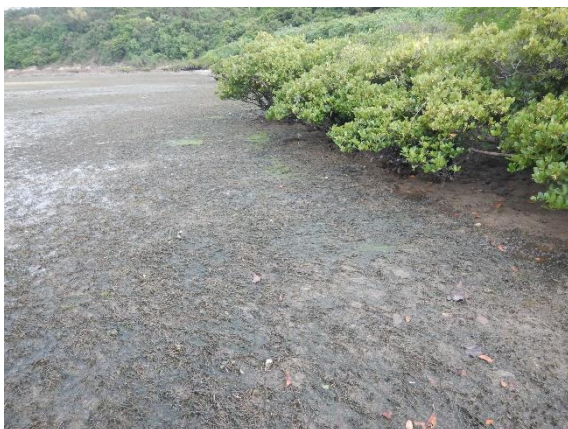
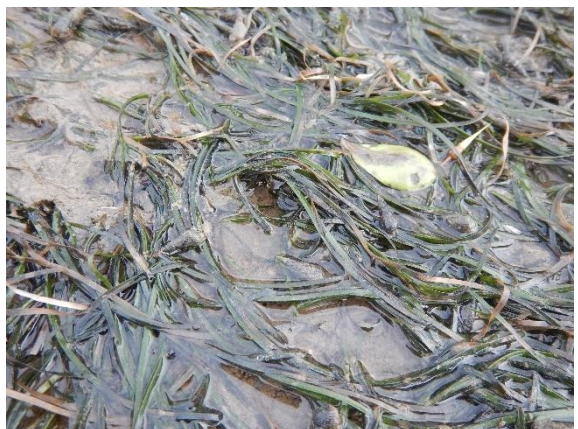
**Figure 3.10** Examples of photographic records of seagrass beds (record in June 2017)

- 3.6.42 Since the commencement of the EM&A monitoring programme, two species of seagrass *Halophila ovalis* and *Zostera japonica* were recorded in TC3 and ST (**Figure 3.10 of Appendix O**). In general, *Halophila ovalis* was occasionally found in TC3 in few, small to medium patches. But it was commonly found in ST in medium to large seagrass bed. Moreover it had sometimes grown extensively and had covered significant mudflat area at 0.5 – 2.0 m above C.D. between TC3 and ST. Another seagrass species *Zostera japonica* was found in ST only. It was relatively lower in vegetation area and co-existed with *Halophila ovalis* nearby the mangrove strand at 2.0 m above C.D.

Single (left) and extended (right) patch of *Halophila ovalis*

Extensive patch of *Halophila ovalis*

Medium, horizontal patch of *Zostera japonica*

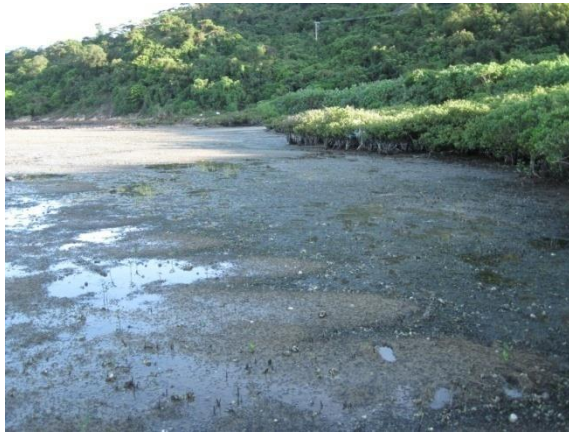
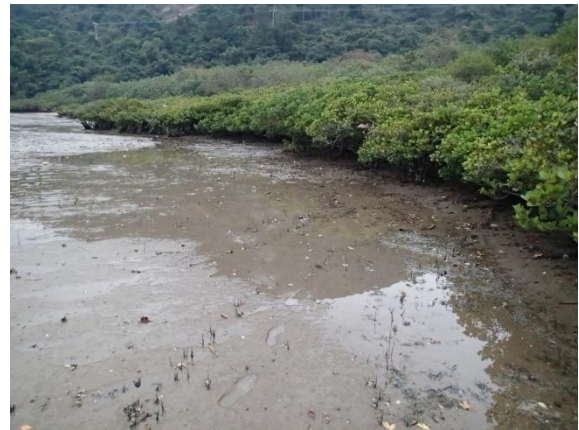
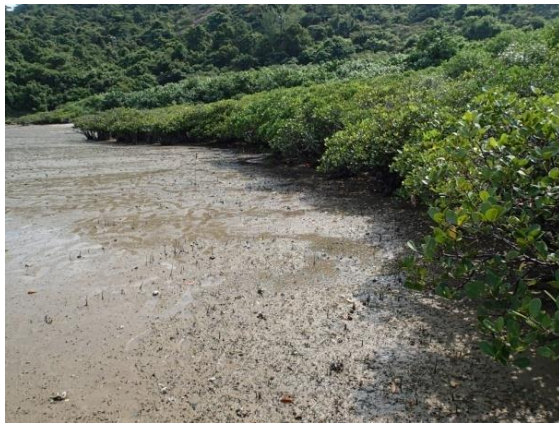
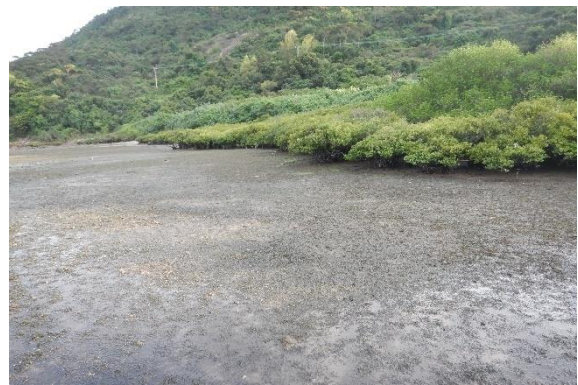
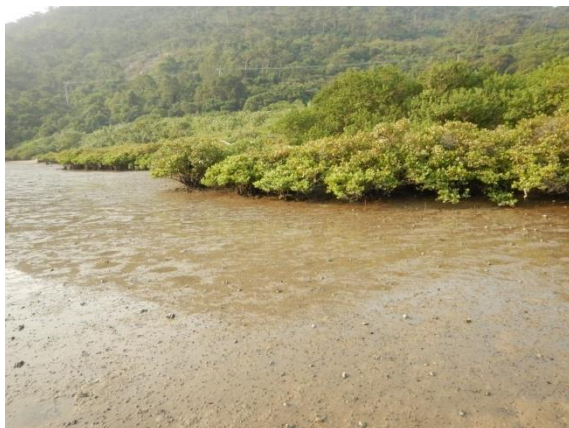
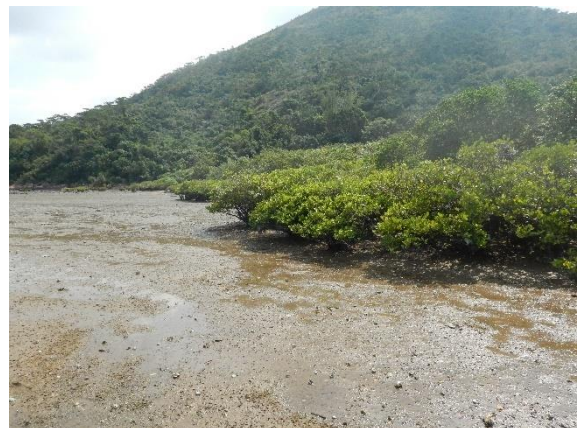
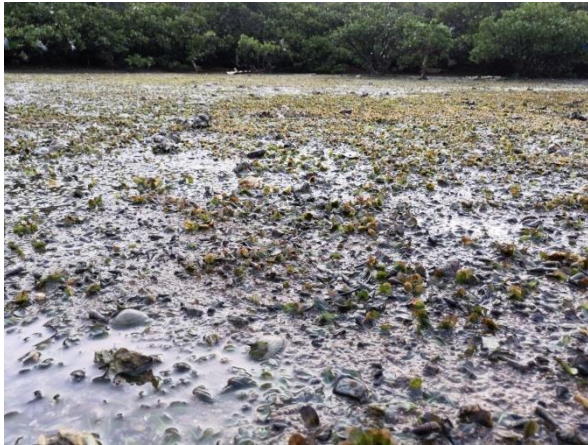
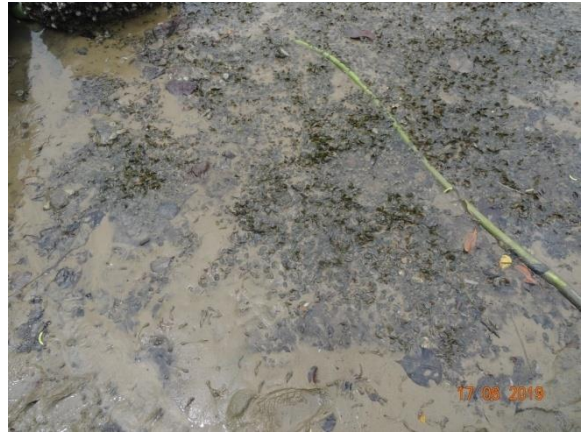
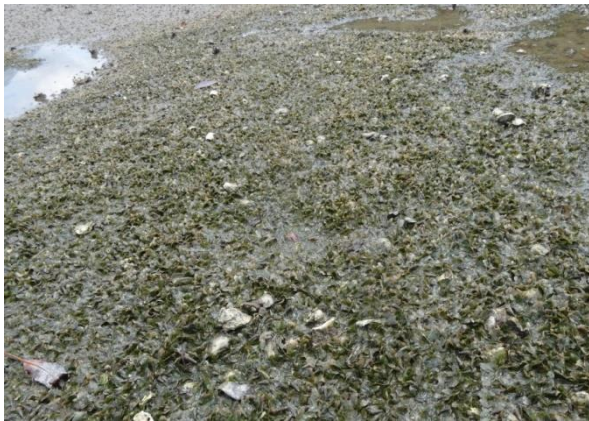
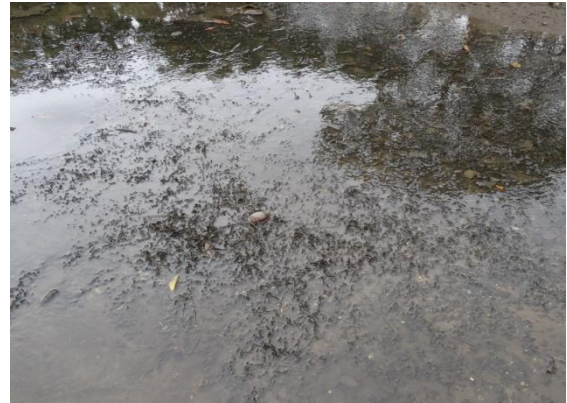
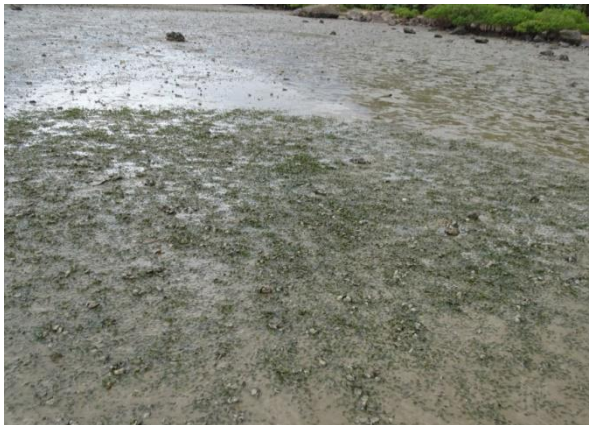
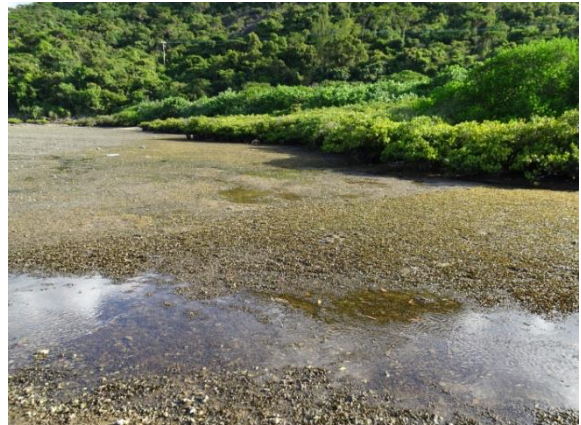
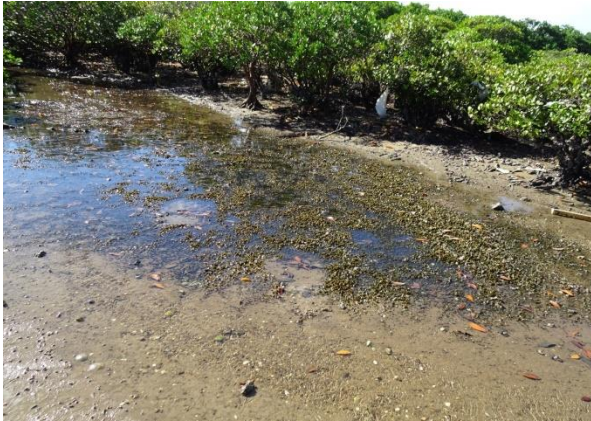
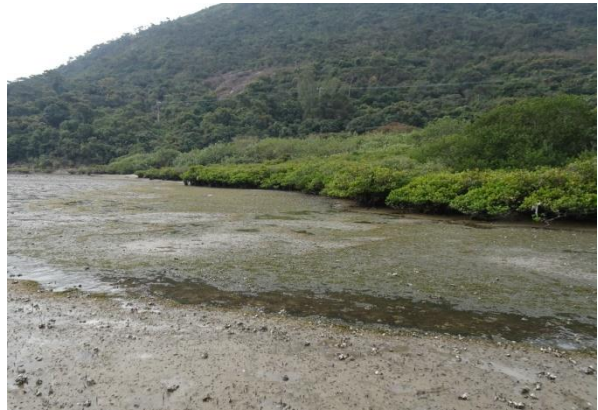
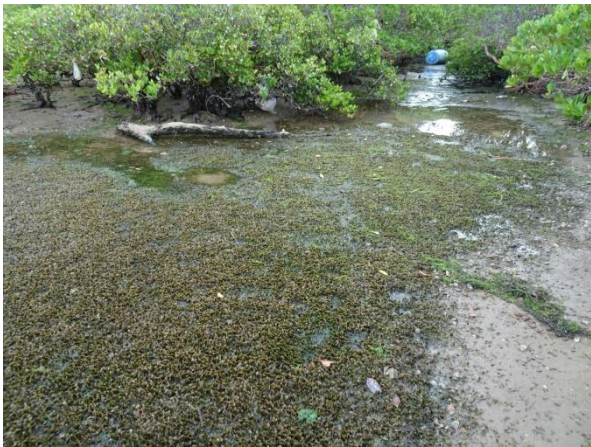
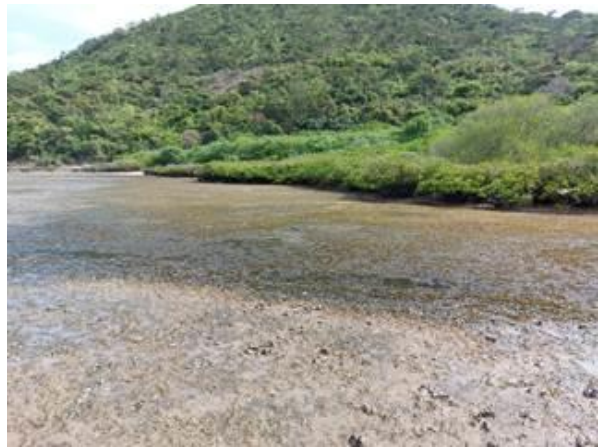
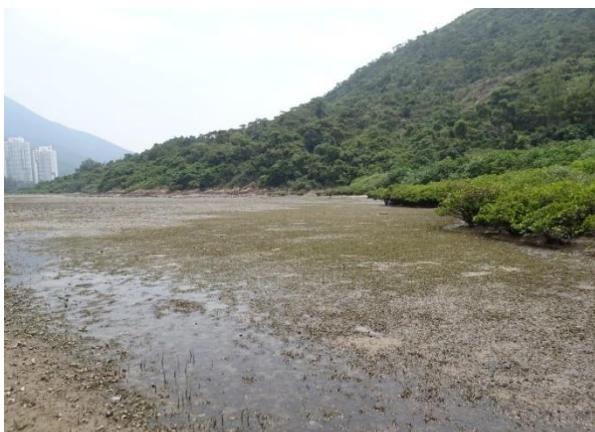
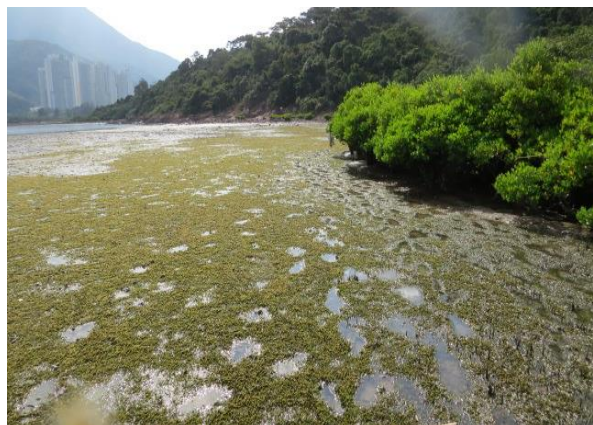
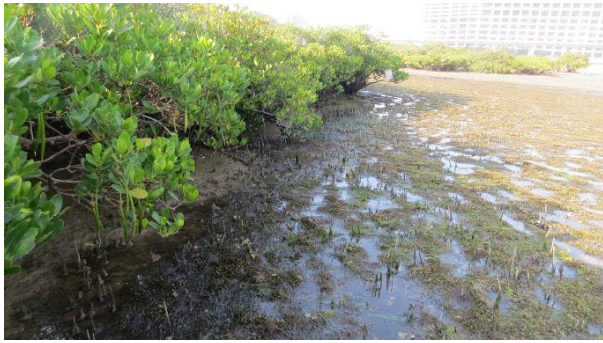
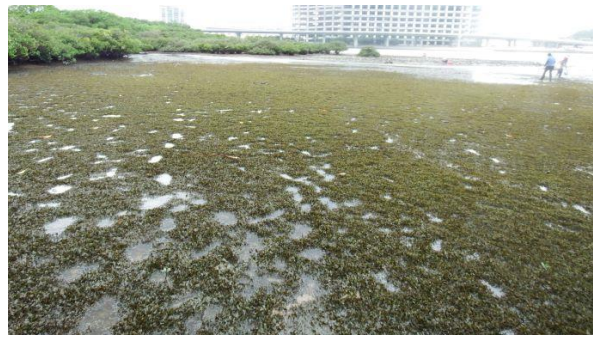
**Figure 3.12** Comparison of pictures taken in different sampling months shows the successive disappearance and recolonization of seagrass beds. The picture of December 2018 was lacking due to night-dawn survey time.

3.6.46 In December 2014, all the seagrass patches of *Halophila ovalis* disappeared in ST. **Figure 3.12 of Appendix O** shows the difference of the original seagrass beds area nearby the mangrove vegetation at high tidal level between June 2014 and December 2014. Such rapid loss would not be seasonal phenomenon because the seagrass beds at higher tidal level (2.0 m above C.D.) were present and normal in December 2012 and 2013. According to Fong (1998), similar incident had occurred in ST in the past. The original seagrass area had declined significantly during the commencement of the construction and reclamation works for the international airport at Chek Lap Kok in 1992. The seagrass almost disappeared in 1995 and recovered gradually after the completion of reclamation works. Moreover, incident of rapid loss of seagrass area was also recorded in another intertidal mudflat in Lai Chi Wo in 1998 with unknown reason. Hence, *Halophila ovalis* was regarded as a short-lived and r-strategy seagrass that could colonize areas in short period but disappears quickly under unfavorable conditions (Fong, 1998).

- 3.6.51 **Figure 3.12 of Appendix O** shows the recolonization of seagrass bed in ST from December 2014 to June 2017. From March to June 2015, 2 - 3 small patches of *Halophila ovalis* were newly found co-inhabiting with another seagrass species *Zostera japonica*. But the total patch area of *Halophila ovalis* was still very low compare with previous records. The recolonization rate was low while cold weather and insufficient sunlight were possible factors between December 2014 and March 2015. Moreover, it would need to compete with seagrass *Zostera japonica* for substratum and nutrient, because *Zostera japonica* had extended and covered the original seagrass bed of *Halophila ovalis* at certain degree. From June 2015 to March 2016, the total seagrass area of *Halophila ovalis* had increased rapidly from 6.8 m<sup>2</sup> to 230.63 m<sup>2</sup>. It had recolonized its original patch locations and covered its competitor *Zostera japonica*. In June 2016, the total seagrass area increased sharply to 4707.3m<sup>2</sup>. Similar to the previous records of March to June 2014, the original patch area of *Halophila ovalis* increased further to a

- 3.6.52 In September 2017, the whole seagrass bed of *Halophila ovalis* disappeared again along the shore of TC3 and ST (**Figure 3.12 of Appendix O**). Similar to the first disappearance of seagrass bed occurred between September and December 2014, strong water current (e.g. cyclone) or deteriorated water qualities (e.g. high turbidity) was the possible cause.

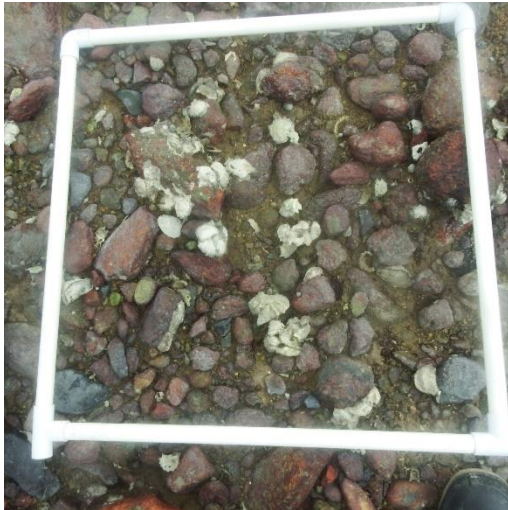
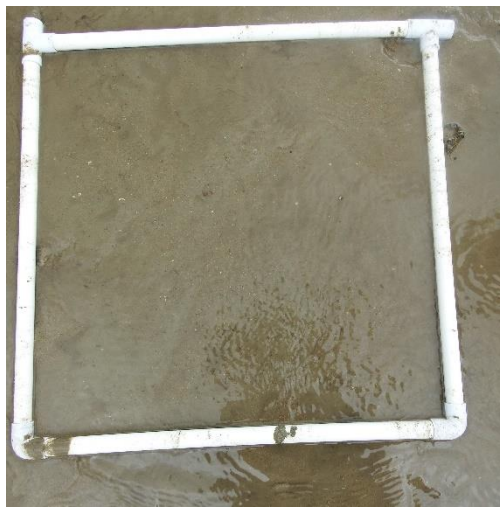
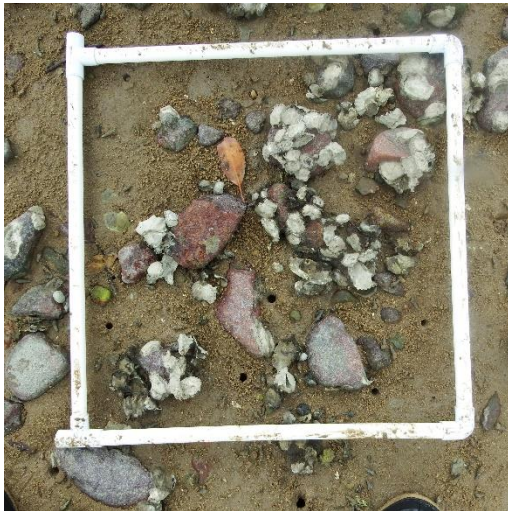
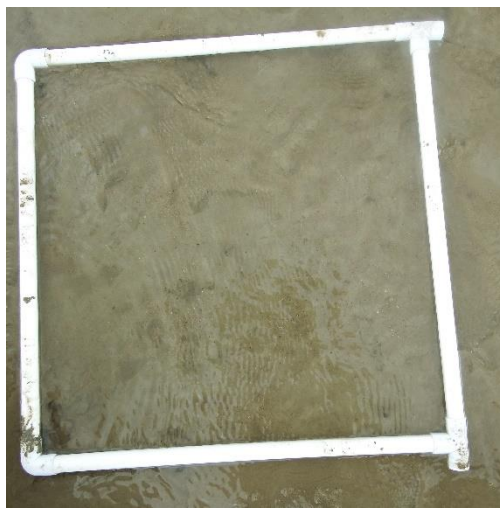
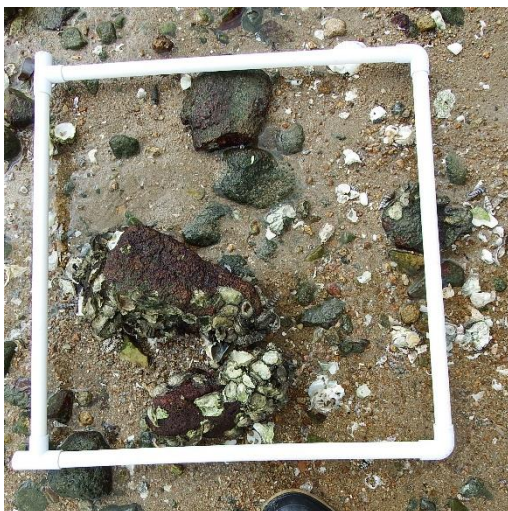
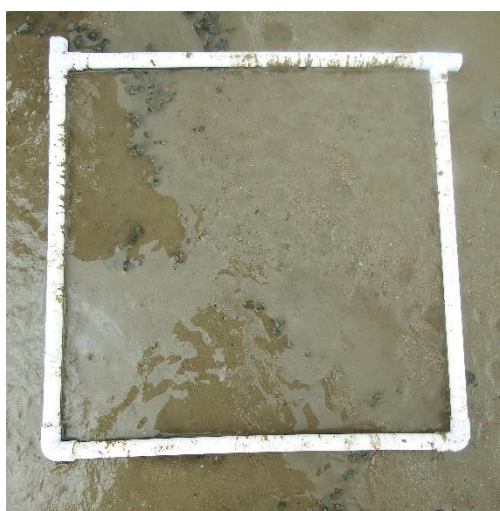
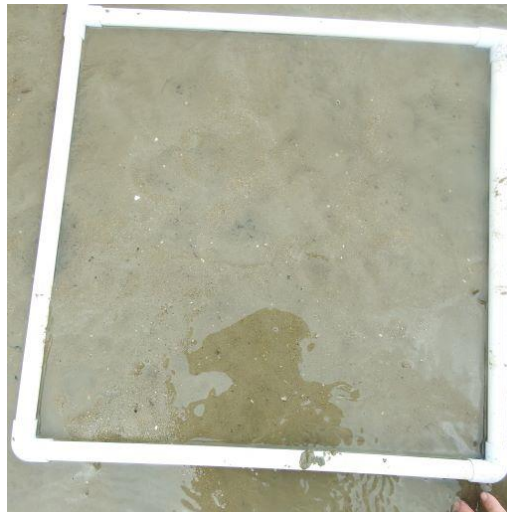
**Figure 3.13** *Examples of photographic records of quadrat for intertidal soft shore community survey (H: 2.0 m above C.D.; M: 1.5 m above C.D.; L: 1.0 m above C.D.)*

- 3.6.57 **Table 3.3 and Figure 3.13 of Appendix O** show the substratum types along the horizontal transect at every tidal level in all sampling zones. The relative distribution of substratum types was estimated by categorizing the substratum types (Gravels & Boulders / Sands / Soft mud) of the ten random quadrats along the horizontal transect. The distribution of substratum types varied among tidal levels and sampling zones:
