**Entrusted Portion of Widening of Tolo Highway /
Fanling Highway between Island House Interchange
and Fanling Stage 2**

Monthly EM&A Report

June 2015

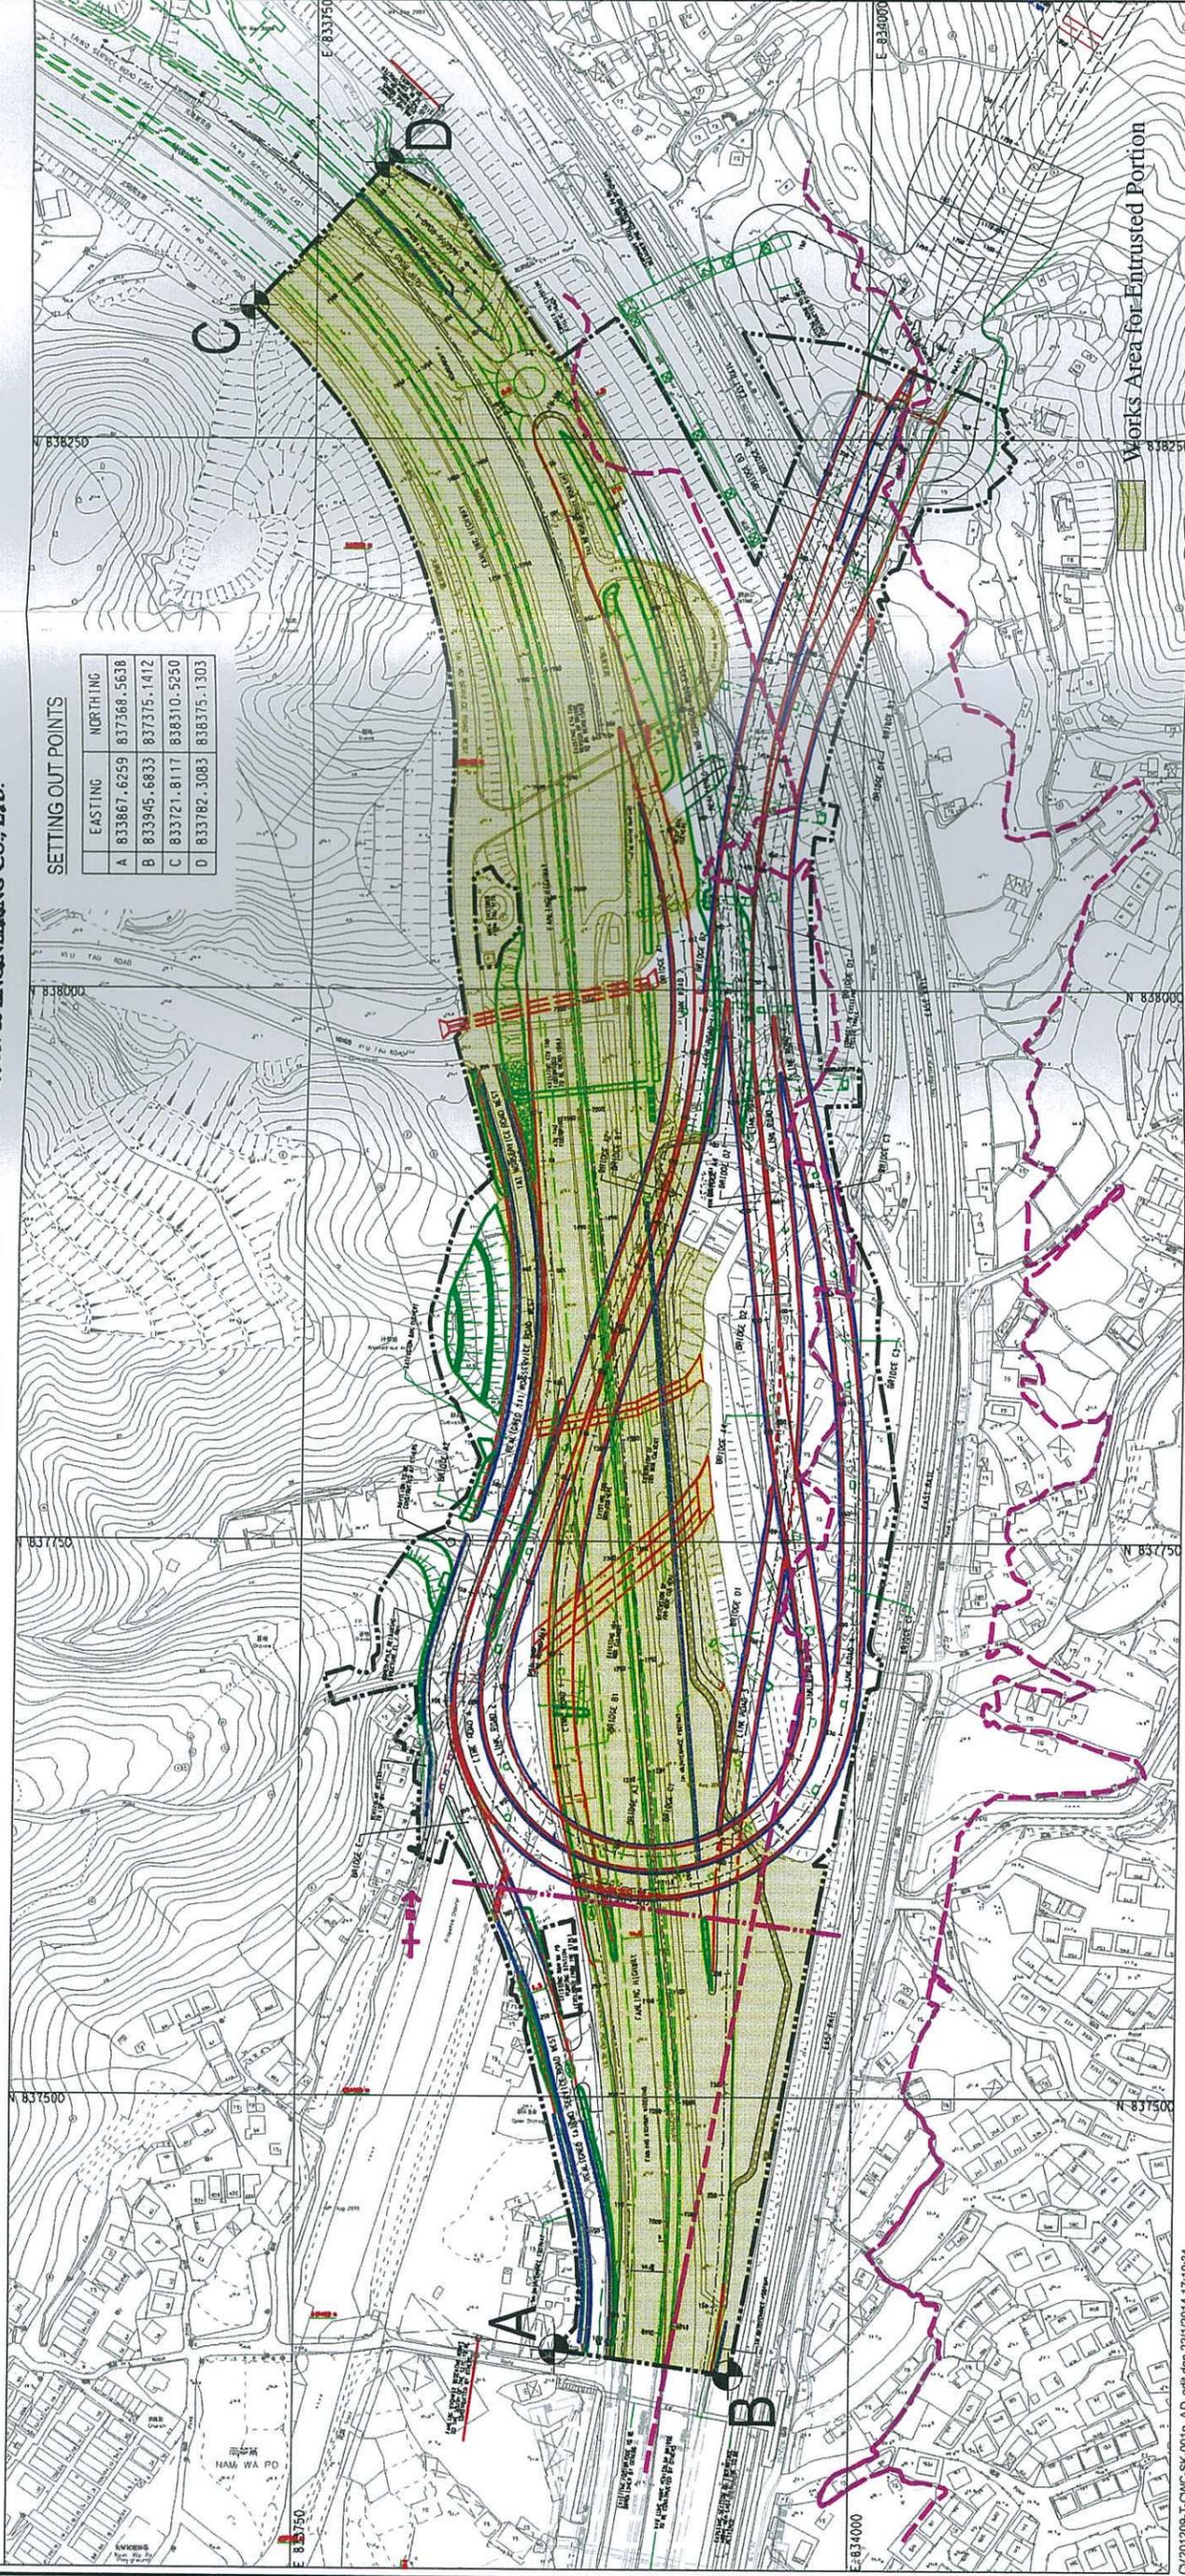
Figure 1: Demarcation of Entrusted Portion of Widening of Tolo Highway / Fanling Highway between Island House Interchange and Fanling – Stage 2

2.2.2 **Figure 1** shows the works areas for the Entrusted Portion of Widening of Tolo Highway / Fanling Highway between Island House Interchange and Fanling Stage 2.

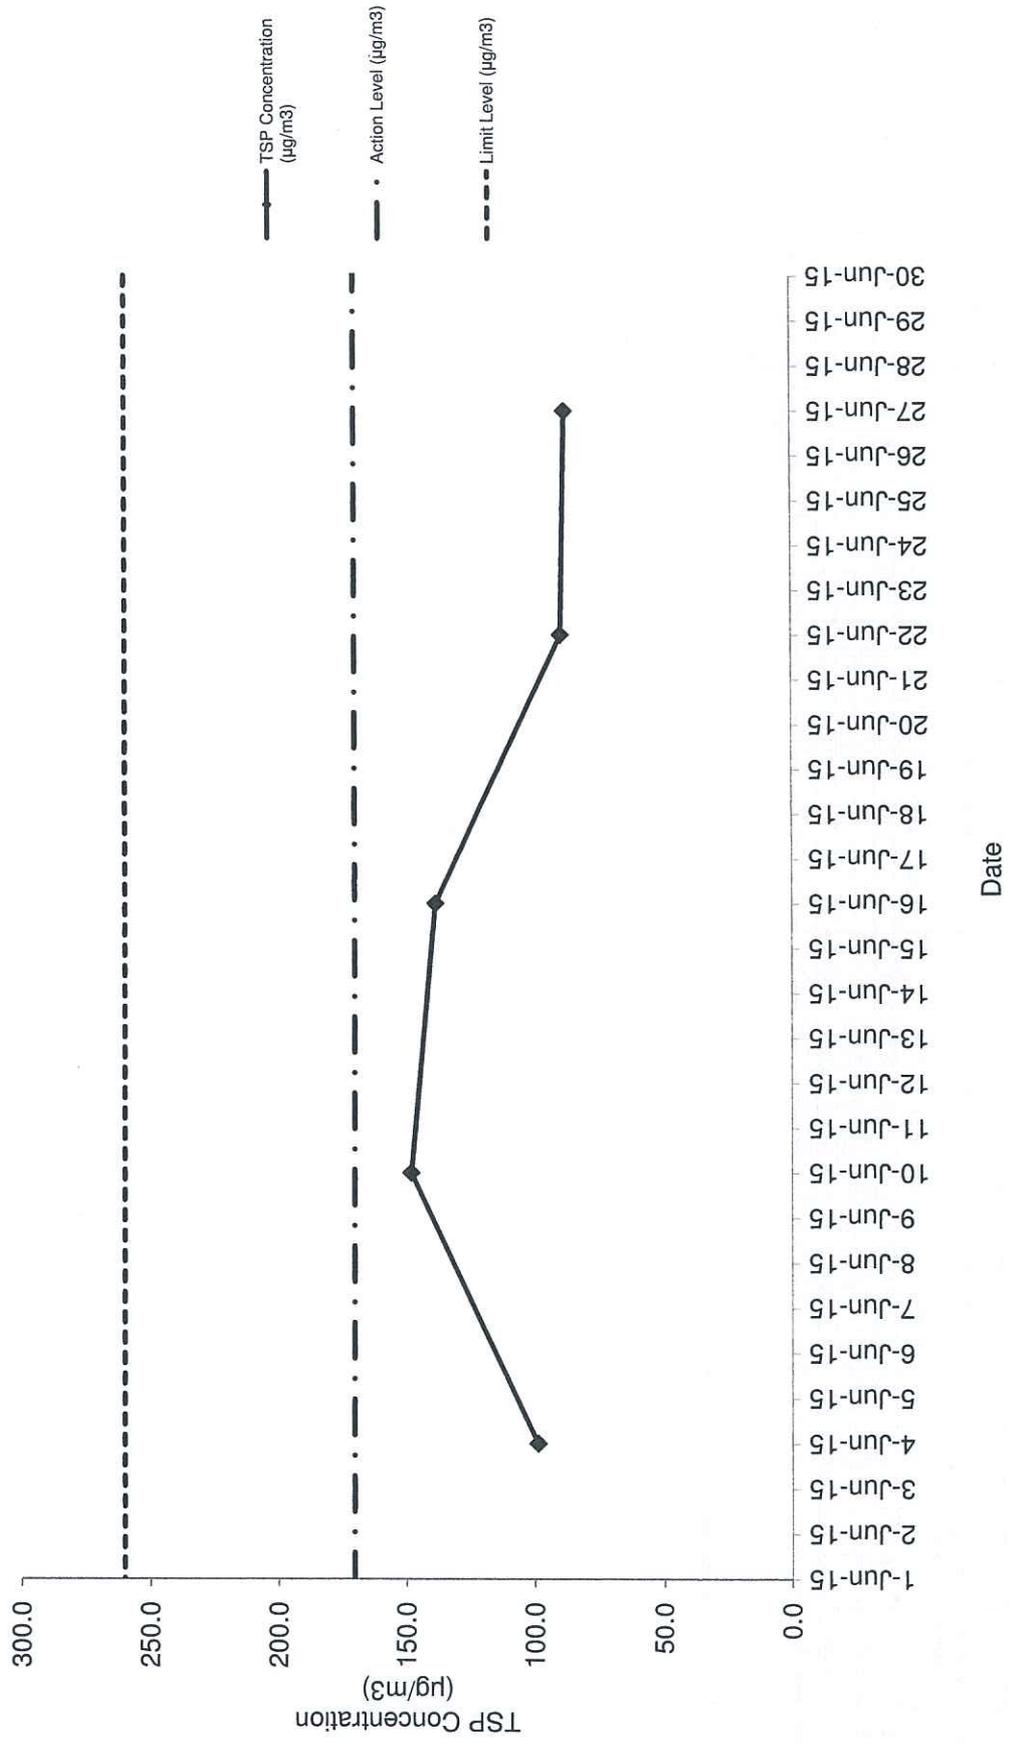
24-Hour TSP Monitoring Result at Station: SR77

No exceedance of Action and Limit Level was recorded for 24-hour TSP monitoring at the monitoring location AM1(SR77) in the reporting month.

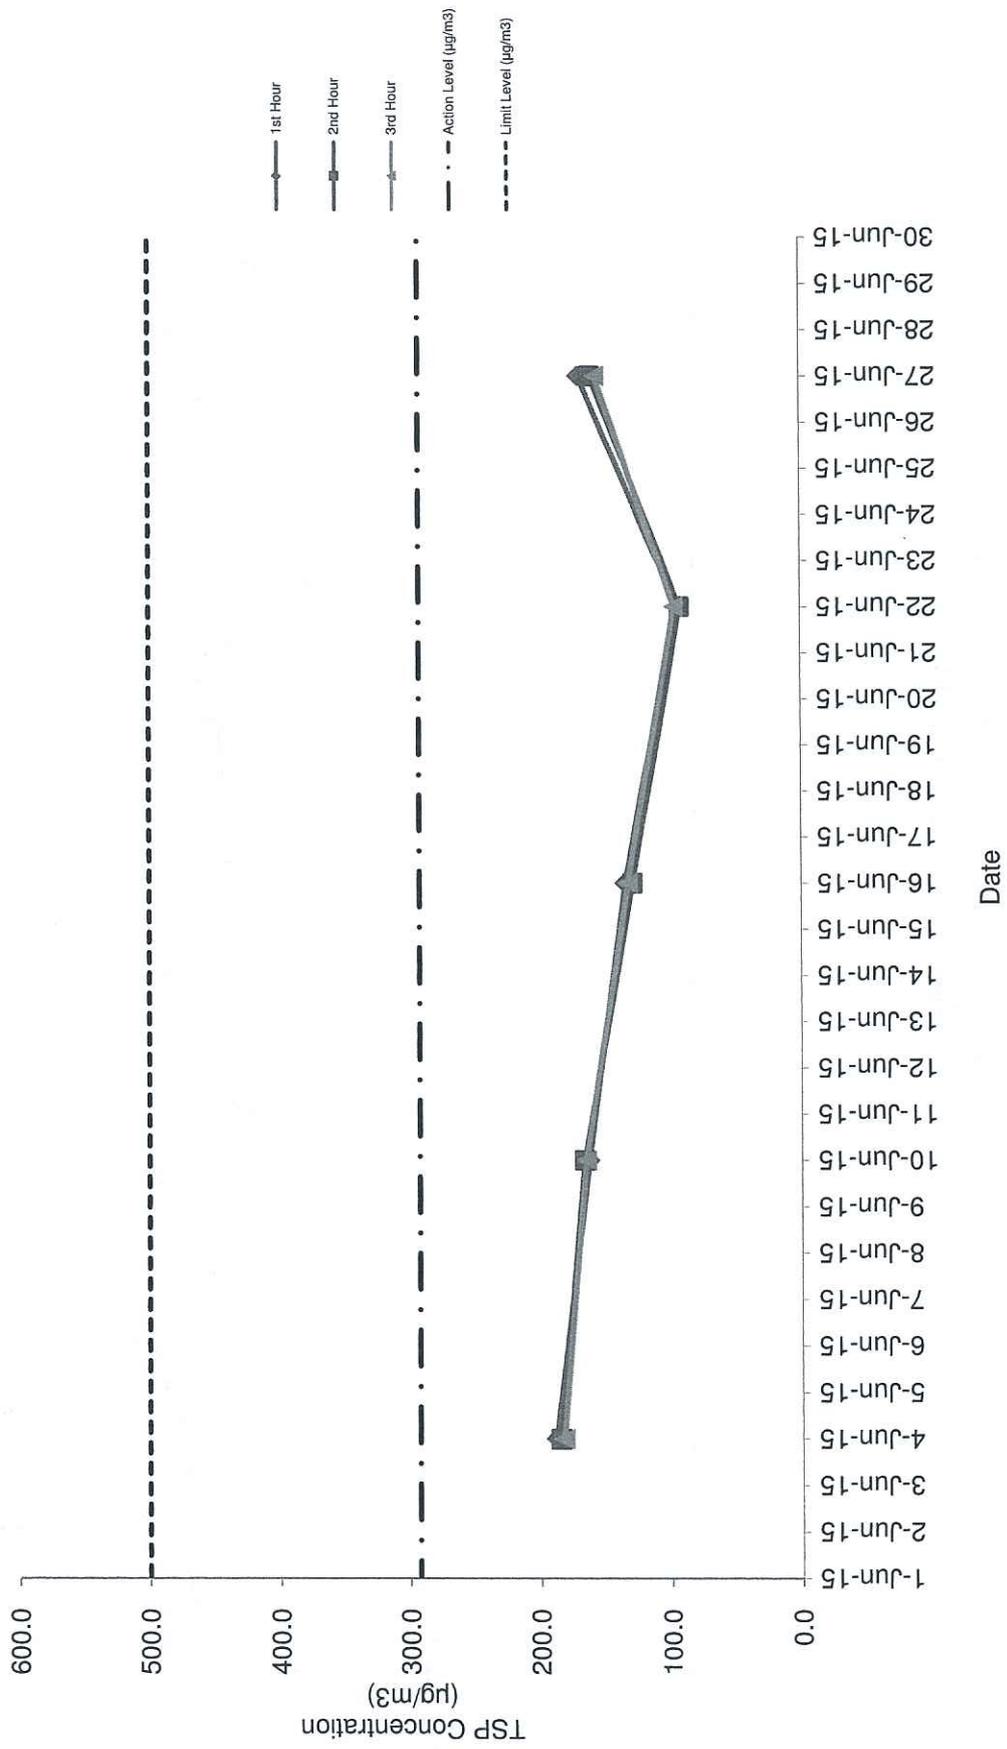
1-Hour TSP Monitoring Result at station: SR77

No exceedance of Action and Limit Level was recorded for 1-hour TSP monitoring at the monitoring location AM1(SR77) in the reporting month.

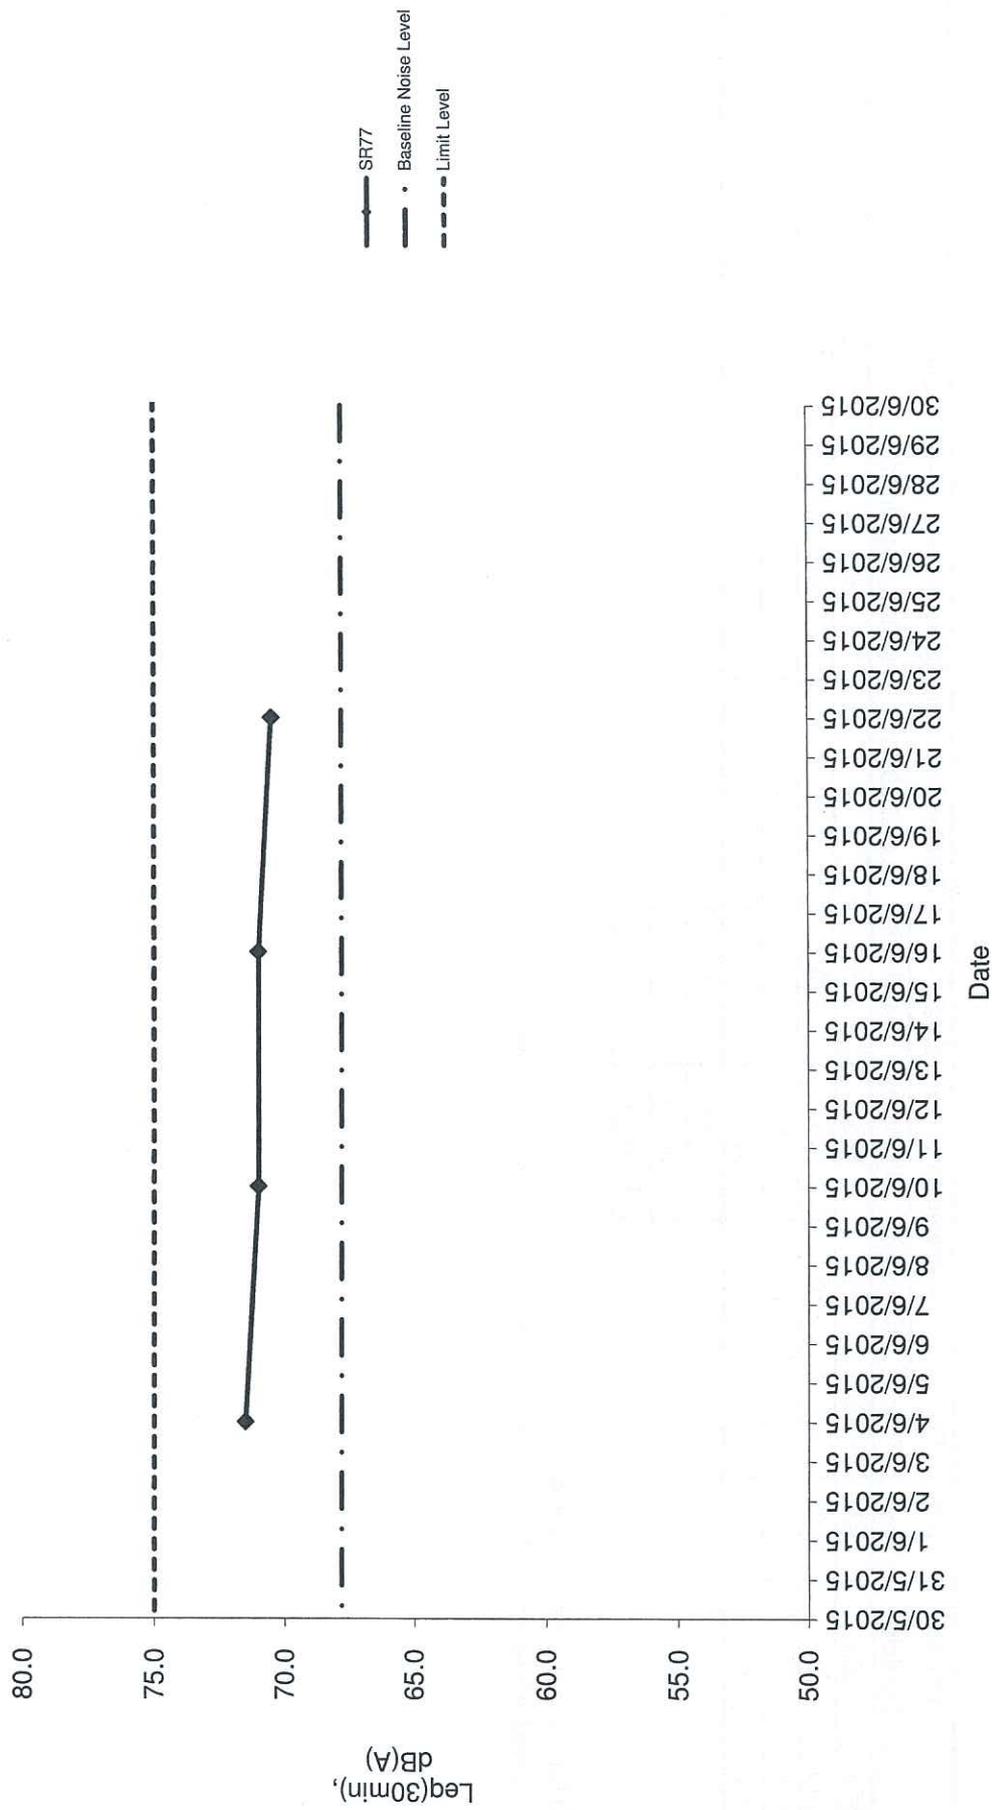
Noise monitoring result: SR77

No noise complaint was received in the reporting month, so no Action Level exceedance was recorded. Also, no Limit Level exceedance of noise monitoring was recorded in the reporting month. |
